# ARBORICULTURAL IMPACT ASSESSMENT REPORT

Wollongong Investments No.5 Pty Ltd

2-4 Gladstone Ave, 357-363 Crown St, WOLLONGONG

Date 16 December 2022

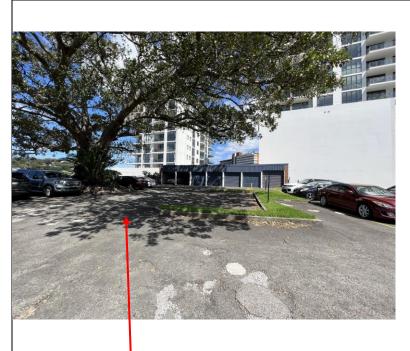
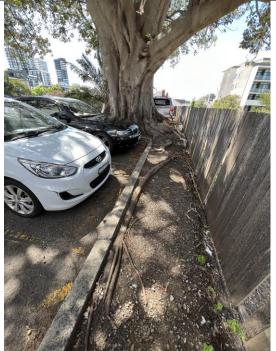
Image f: T6- All this concrete edging must be retained in place or very carefully removed by hand under project arborist supervison
