MOORE TREES

Site: 357-363 Crown Street, Wollongong NSW 2500

Re: Updated Arboricultural Impact Review of Heritage Item 6290 and associated impacts from the proposed DA-2023/156, 357-363 Crown Street Wollongong.

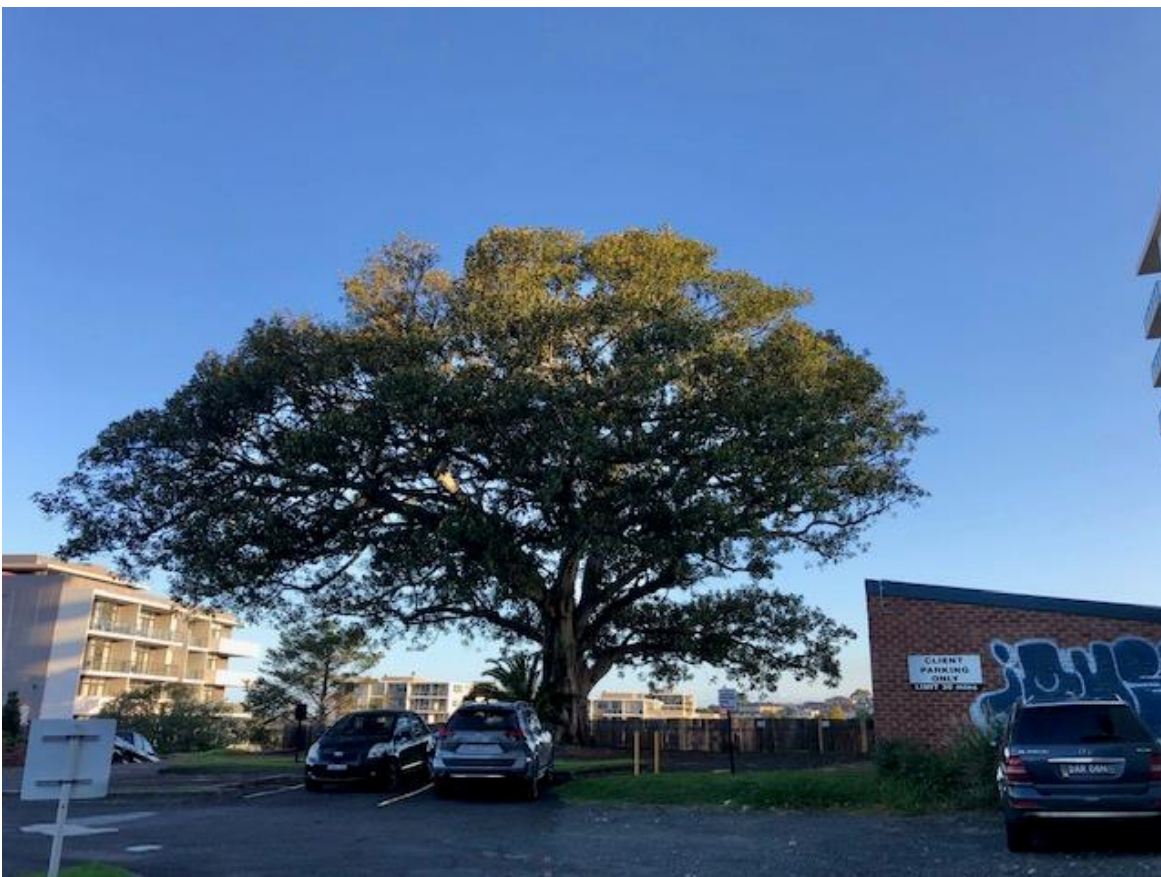
Plate 1: Image showing the subject tree from the north and the asymmetrical canopy. P. Vezgoff

The Arborist Report by Seasoned Tree Consulting (STC) details the canopy spread as being symmetrical at 15 fifteen (15) metres, whereas the actual distances measured by myself are asymmetrical and were measured as radial distances of twenty (20) metres to the north, fifteen (15) metres to the south, seventeen (17) metres to the east and fifteen (15) metres to the west. As a result, the tree canopy is not drawn accurately on the plans and has only been represented as a symmetrical circle (Diagram 3 and 4).

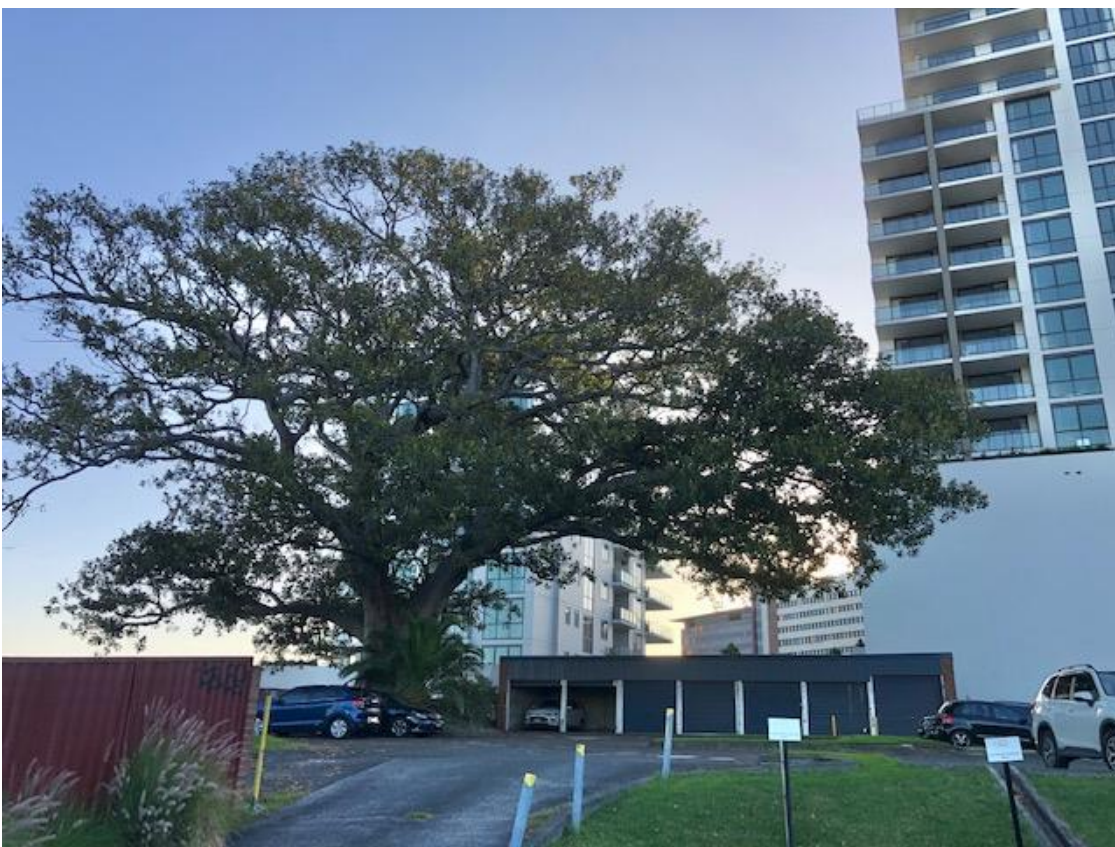
Plate 2: Image showing the subject tree from the east. P. Vezgoff

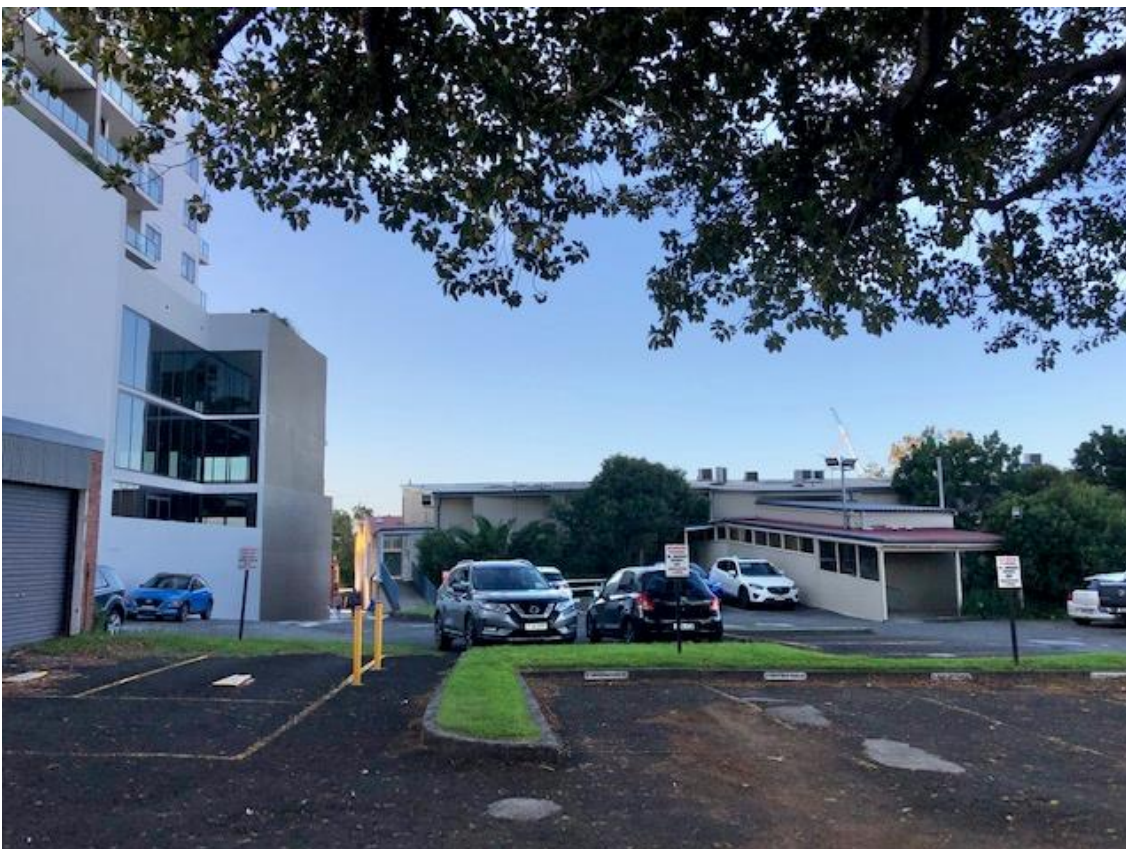
Plate 3: Image showing the existing building heights to the north. P. Vezgoff

Plans show that towers to the east and north of the tree will cast extensive shadows onto the tree that it has never experienced before. As shown in Plate 3, due to the low building heights of Crown Street, the tree currently has good solar access for most of the day, throughout most of the year. The updated shadow diagrams provided as part of this review show that extensive shadowing will still be cast from these proposed structures although it is noted there has been a slight improvement with the redesign.

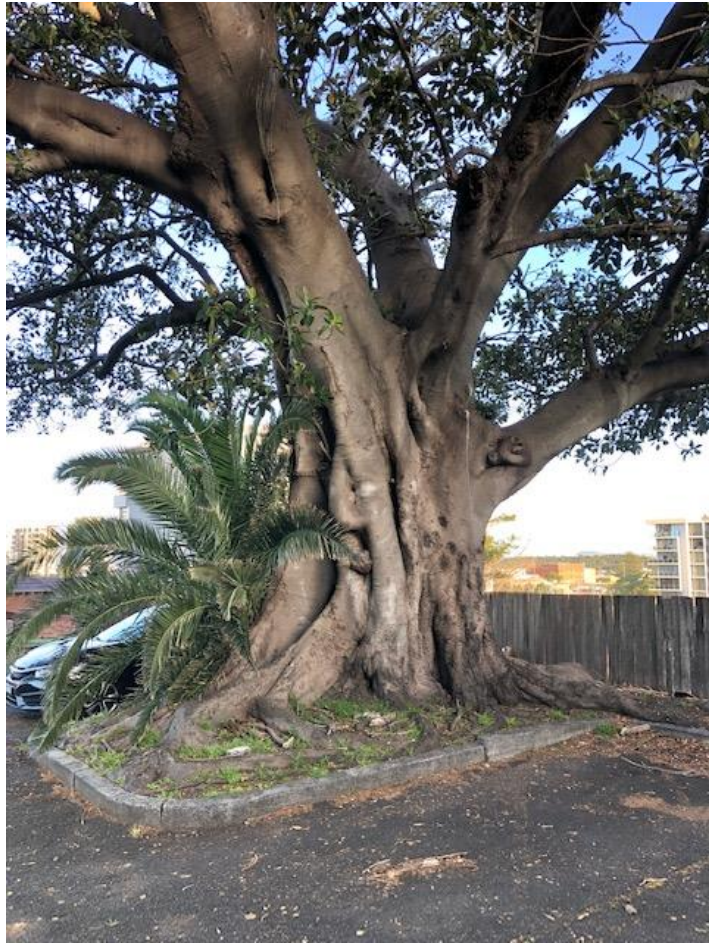
Plate 4: Image showing main stem. P. Vezgoff

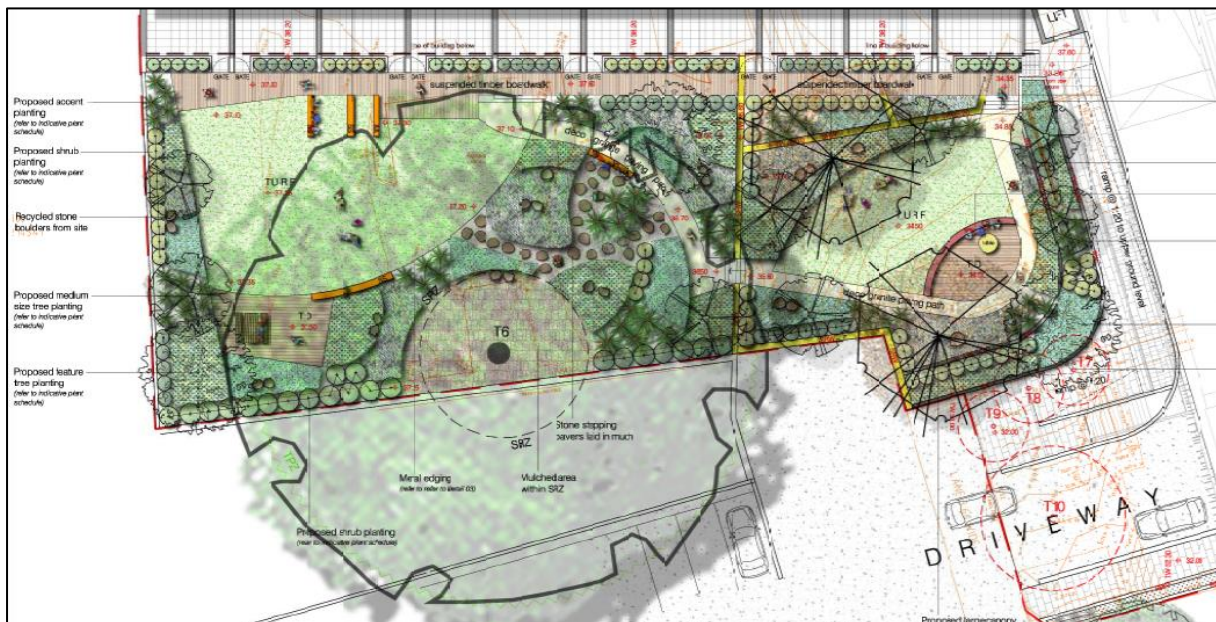
The updated landscape design, under Tree 6, will have a greater impact than the previous plan, that incorporated more garden areas to limit human traffic and garden beds, which would have helped with better soil health and condition. It will be extremely unlikely that any lawn will grow within such a high shade area. The required lawn management practices (mowing) will create ongoing compaction issues to the roots of this tree.

Diagram 1: Part plan of the previous landscape design below Tree 6 (Canvas landscape Architects).

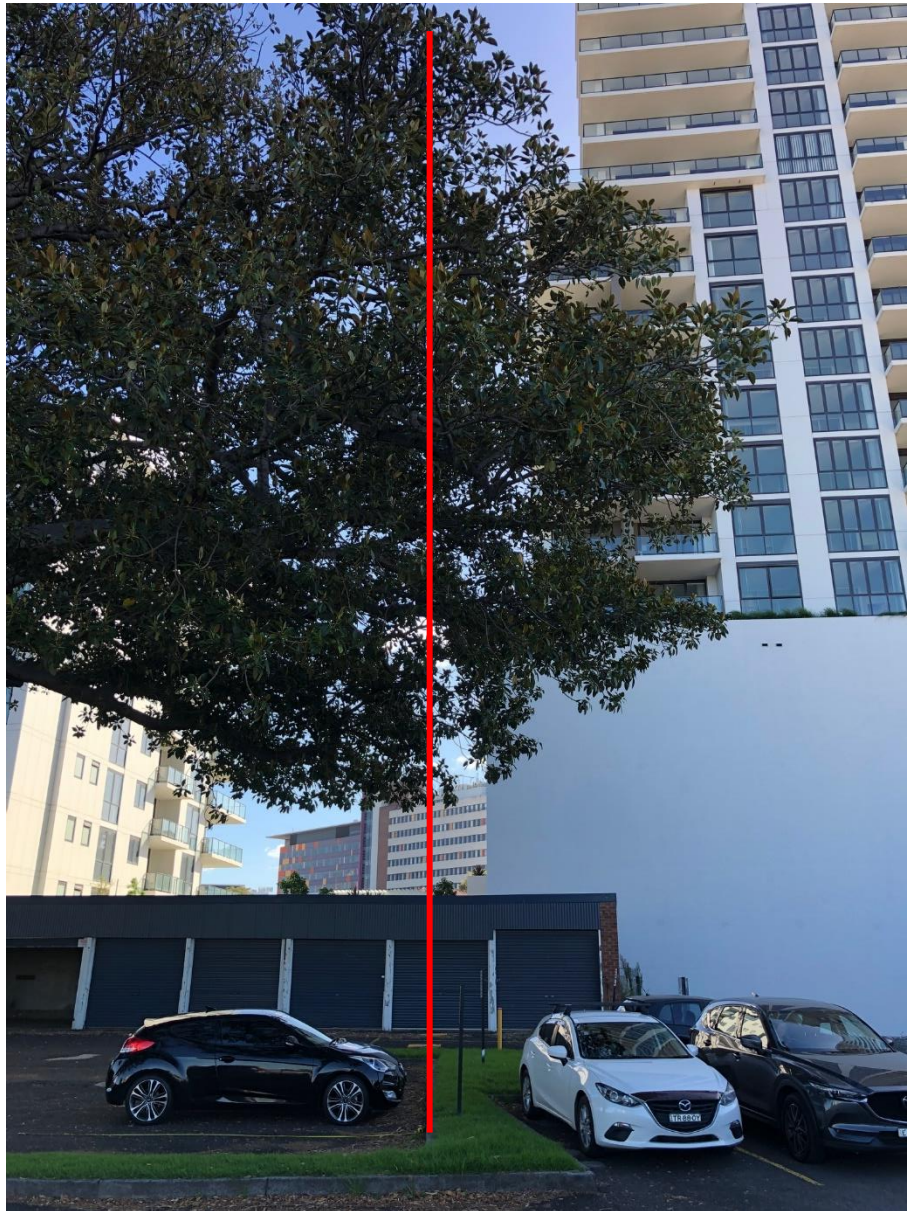
Plate 5: Image showing the fifteen (15) metre mark in relation to the canopy. P. Vezgoff

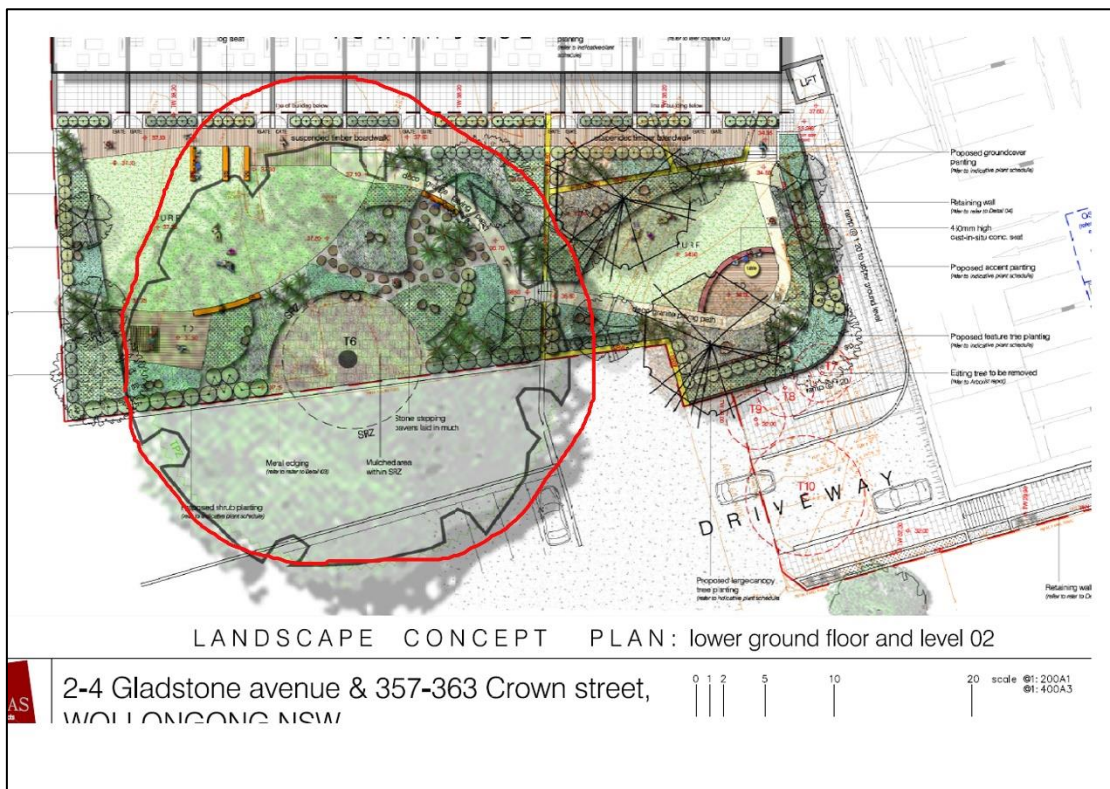
Diagram 2: Moore Trees’ mark up of the actual canopy size in red (Canvas landscape Architects).

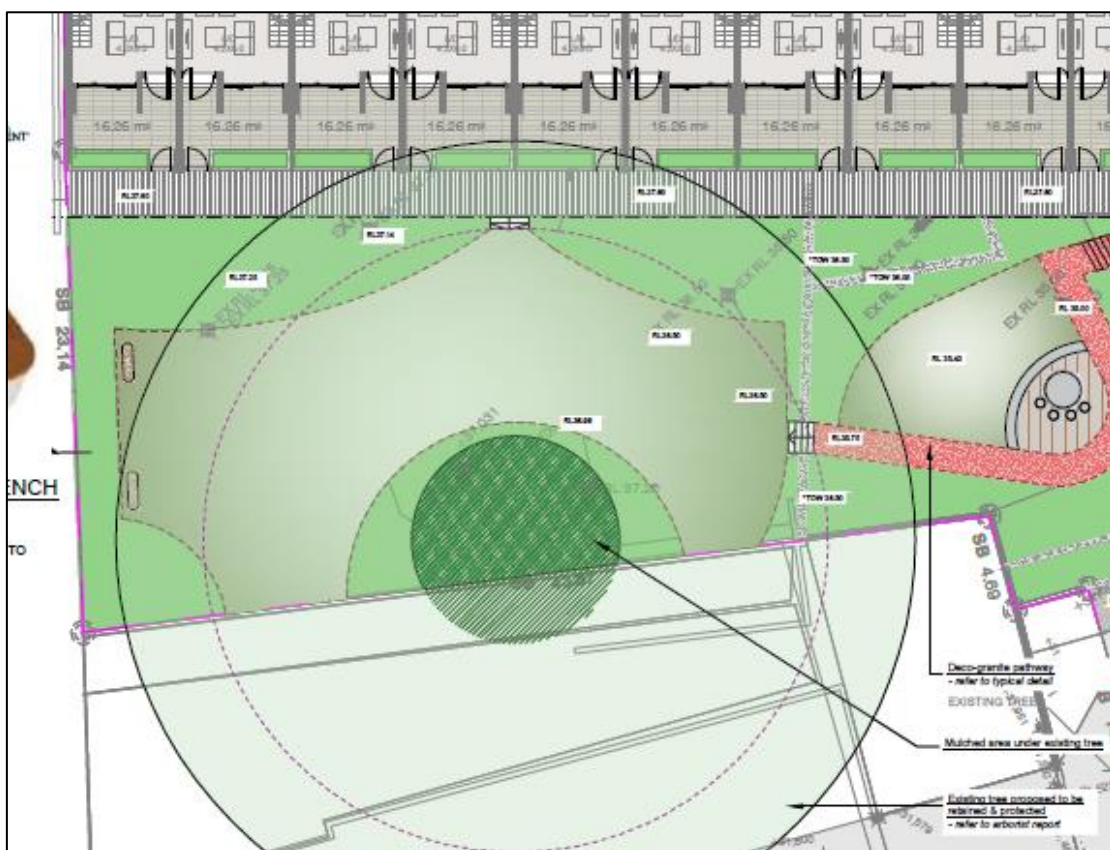
4. ASSESSMENT OF UPDATED PLANS AND DOCUMENTS: The works proposed within the TPZ include the demolition of all existing hard surfacing, basement excavation and multi-level car park construction. The previous landscape design of the area directly below the tree included stepping stones, turfing, planting, seating and a timber deck (Diagram 1). The updated landscape design by Conzept Landscape design shows most of the TPZ area in relation to the new works will be lawn (Diagram 3).

Diagram 3: Part plan showing lawn under most of the northern canopy. To the south is car park associated with an adjoining property (Conzept landscape Architects).

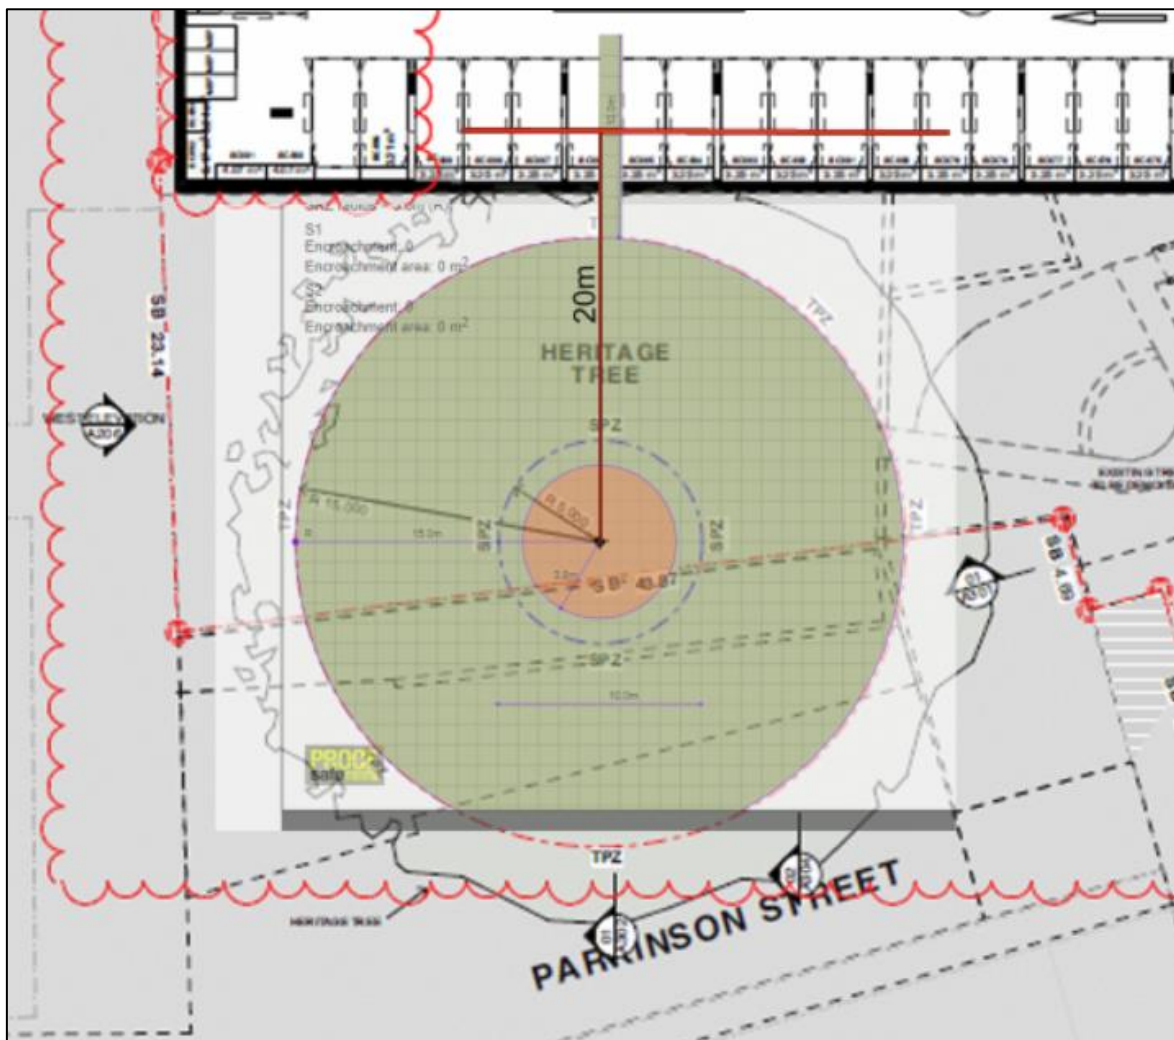
I have adapted part plan of sheet A101 to demonstrate this issue in Diagram 4. I have overlaid a scale chart to illustrate the twenty (20) metre canopy span in relation to the basement excavation. This clearly shows the canopy will be impacted by piercing/shoring works. These machines, required for these works, are quite tall and require adequate vertical clearance for safe and proper operation. Also see Diagram 5.

Diagram 4: Adapted plan of sheet A101. I have overlaid a scale chart to illustrate the 20m canopy span in relation to the basement excavation. This clearly shows the canopy will be impacted by piercing/shoring works. Also to be considered is that this work is not precise, and the excavations are expected to be even closer to the tree than shown along the thick black line.

This may be true for the upper storeys of the proposed building design however the construction of the basement will almost certainly conflict with the canopy of this tree.

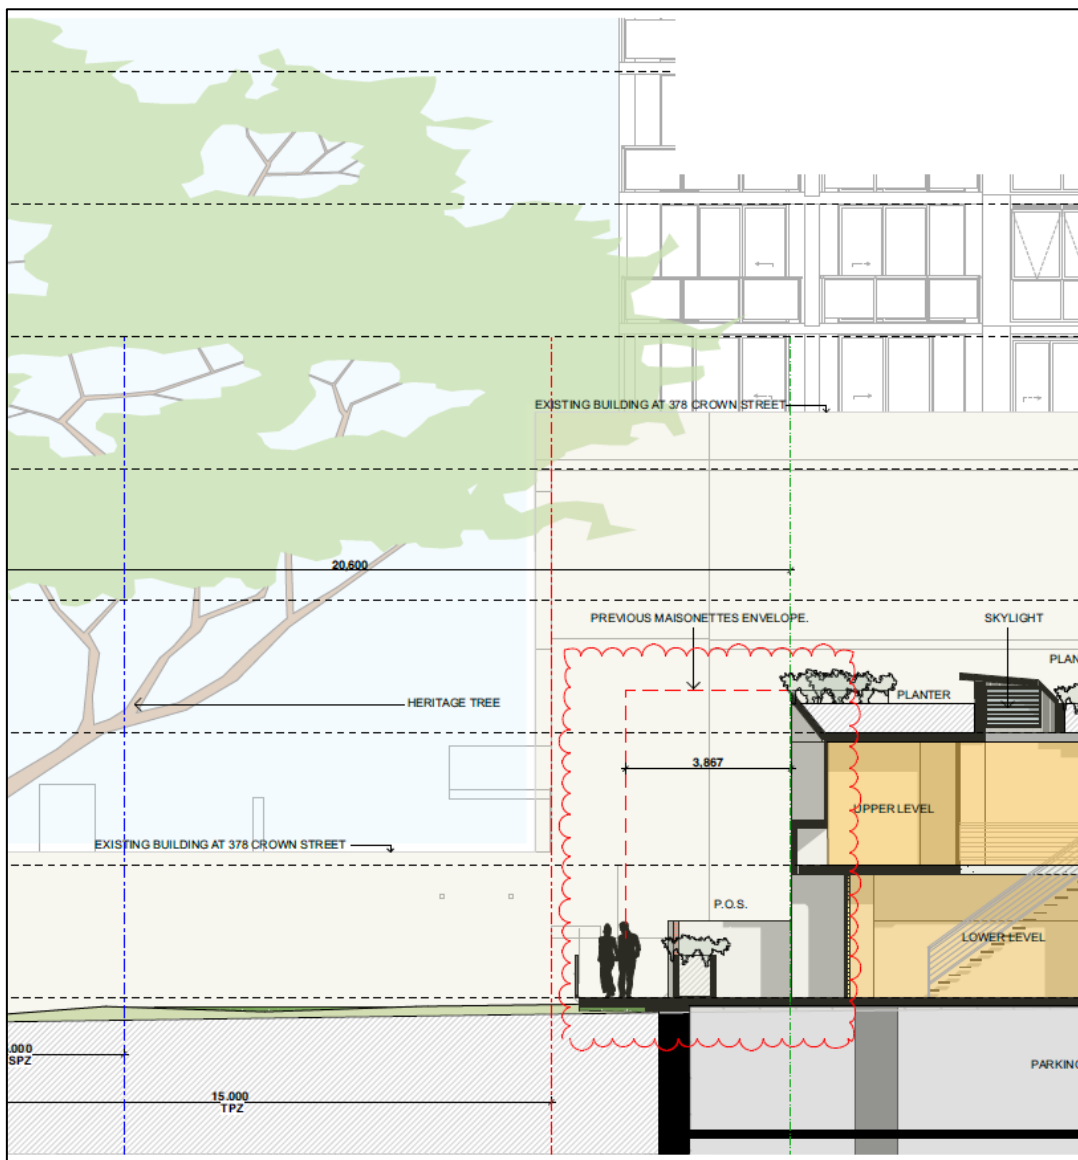
Diagram 5: Part plan of Drawing A304 showing the canopy spread 20m does not match the drawing. This section drawing also shows the basement in relation to the canopy in terms of the drill rig conflicting with the canopy.

- c) The basement excavation will require a large size drill rig that will be used to shore the wall sides. Based on the plans provided this equipment required (the drill rig) is likely to clash with the northern portion of the canopy. The current basement design will impact the canopy of this tree.

- d) The tree canopy is still not shown accurately on drawings i.e. still drawn as a symmetrical circle. Diagram 5 shows the inaccurate section drawing of the canopy.
