21 February 2023

Our ref: 23WOL-7382

The Maltings Redevelopment Modification Application & Development Application: Arboricultural Impact Assessment Addenda

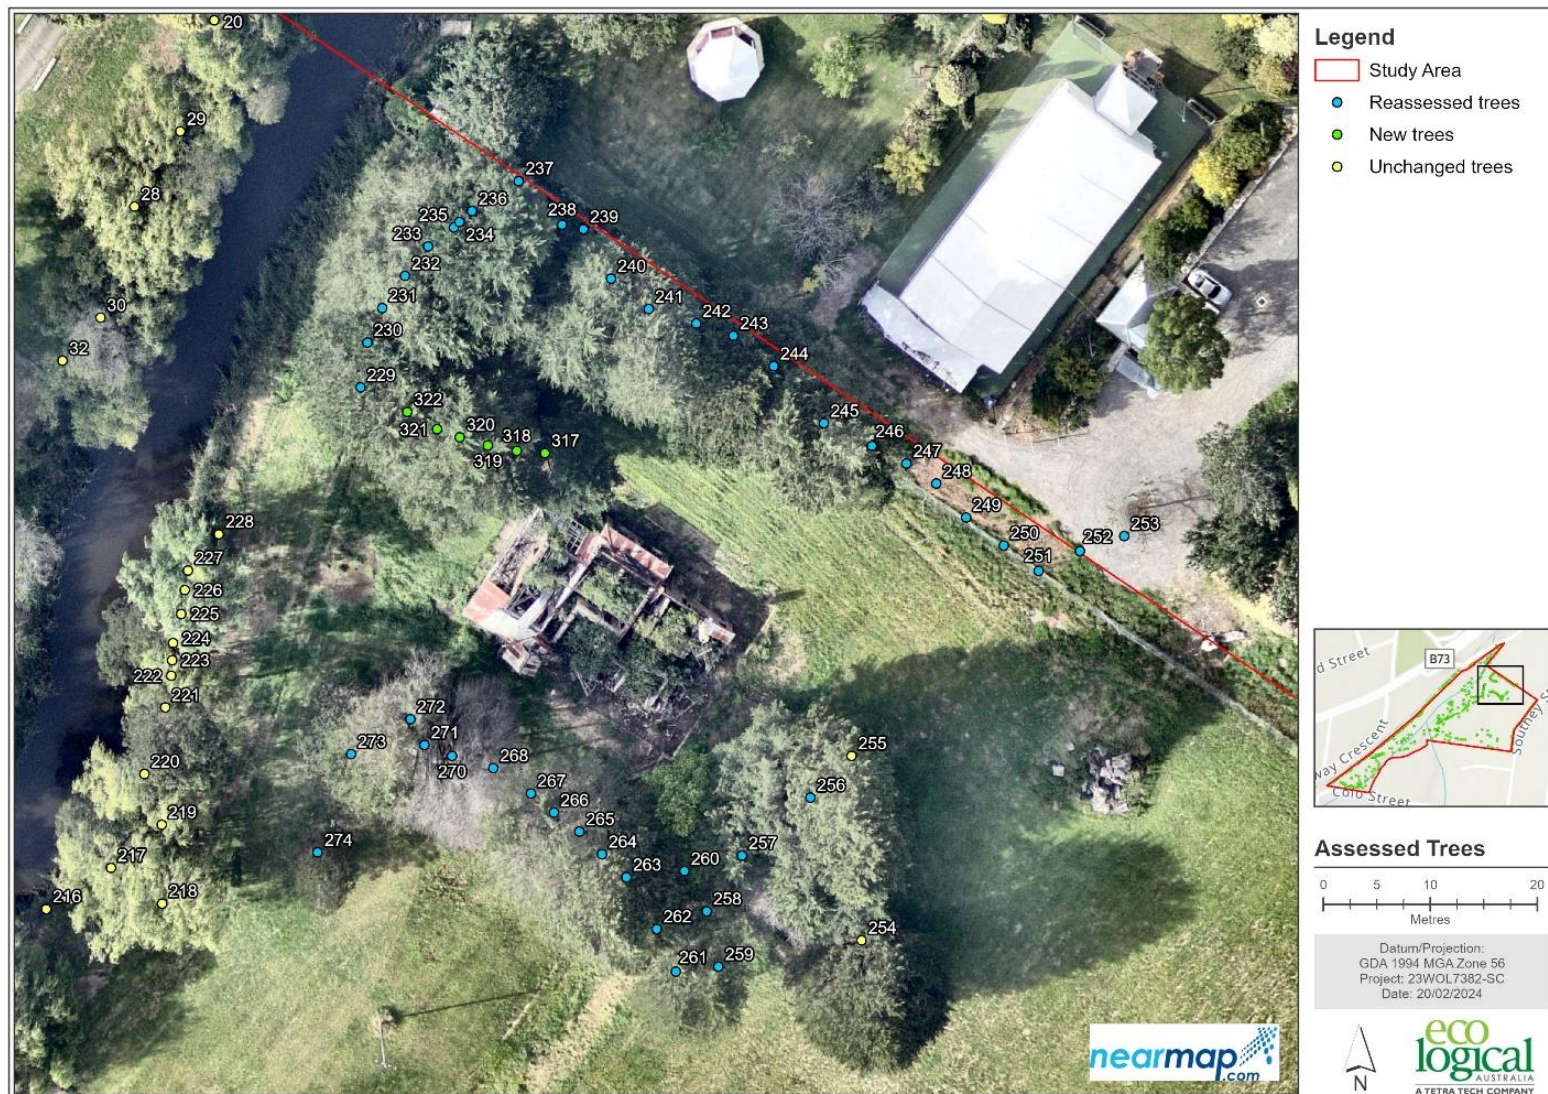
AQF Level 5 Consulting Arborist, David Bidwell, inspected trees impacted by the proposed works to the following buildings: Maltings 3, Maltings 4 and Malsters House (Figure 1 and 2). David completed the inspection on 16 January 2024, and his findings are summarised below. Individual tree assessments and measurements were not undertaken.

Figure 1: Location of re-assessed trees within proximity to Malsters House

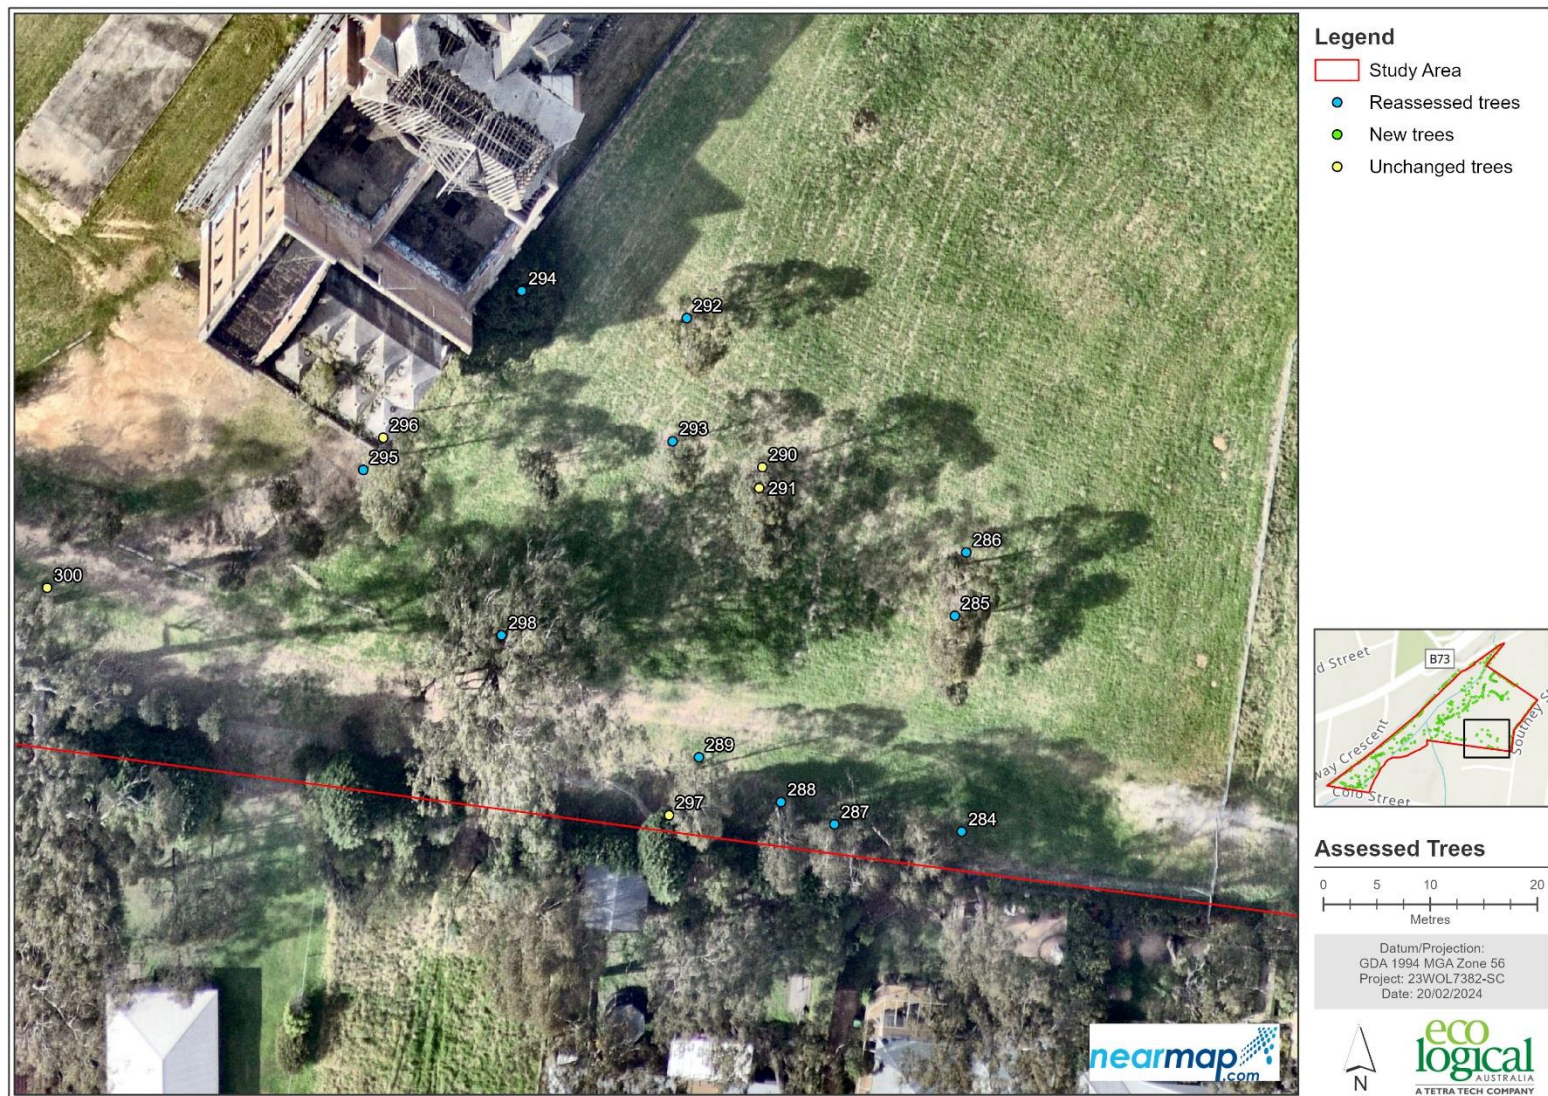
Figure 2: Location of re-assessed trees within proximity to buildings M3 and M4

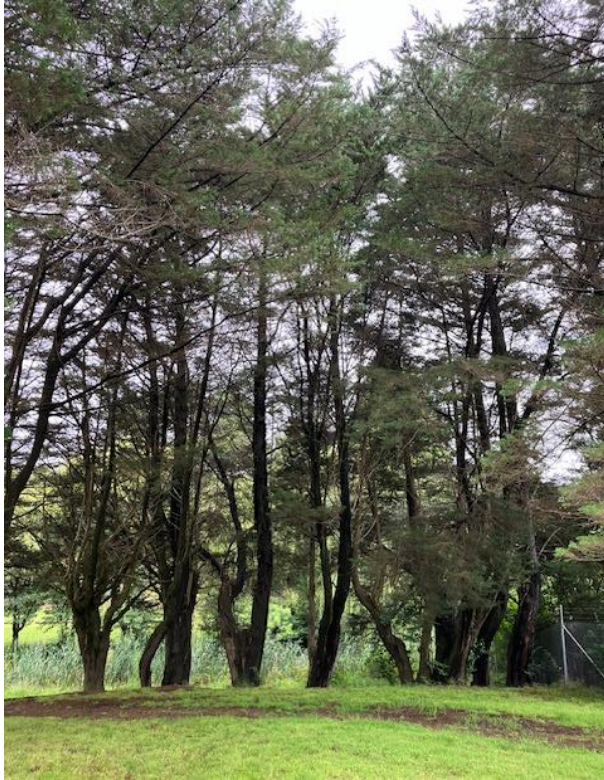
Figure 3: Trees 229-236

Trees 229-236 (Figure 3), 256, 257, 273 and 274 appeared in the same condition as previous inspection, allowing for natural growth.

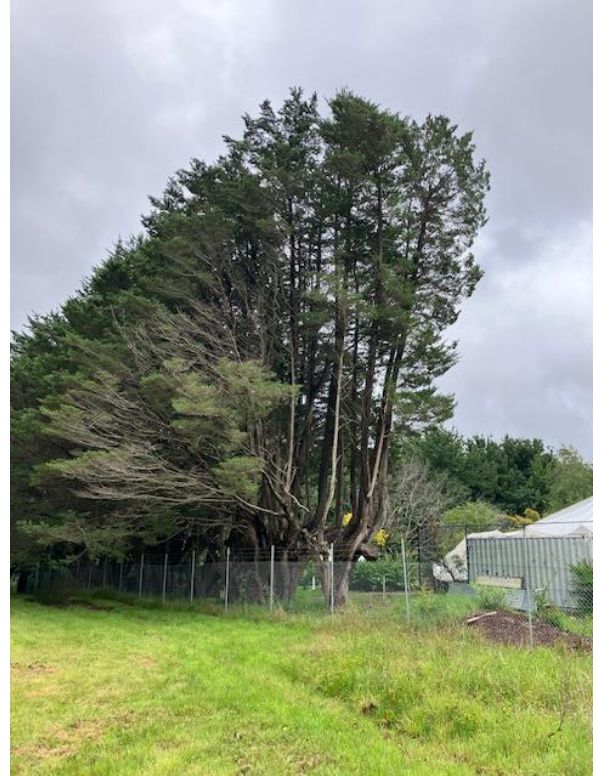
The line of Trees numbered 237-253 (Figure 4) have experienced some losses since the 2020 inspection, particularly at the eastern end of the tree line. Some of these trees show signs of old stumps being ground out. The remaining trees are in varying states of health, with the following structurally compromised and in poor condition:

Figure 4: Trees 237-253

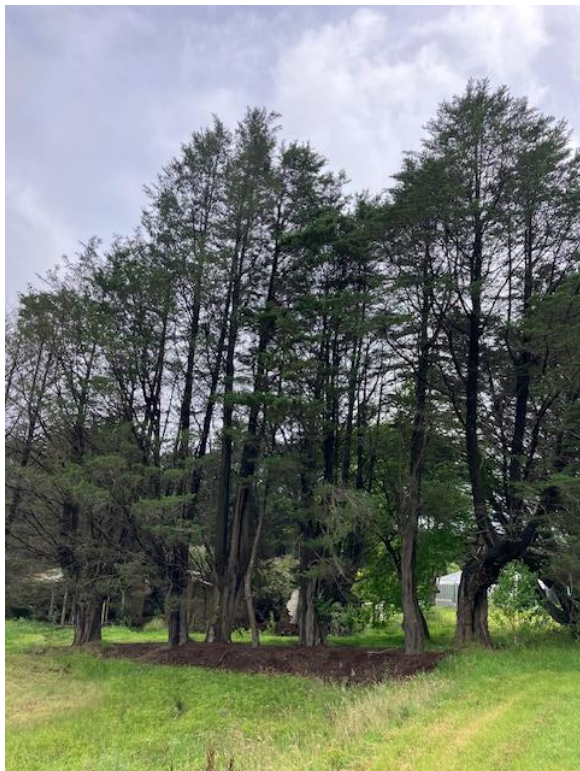
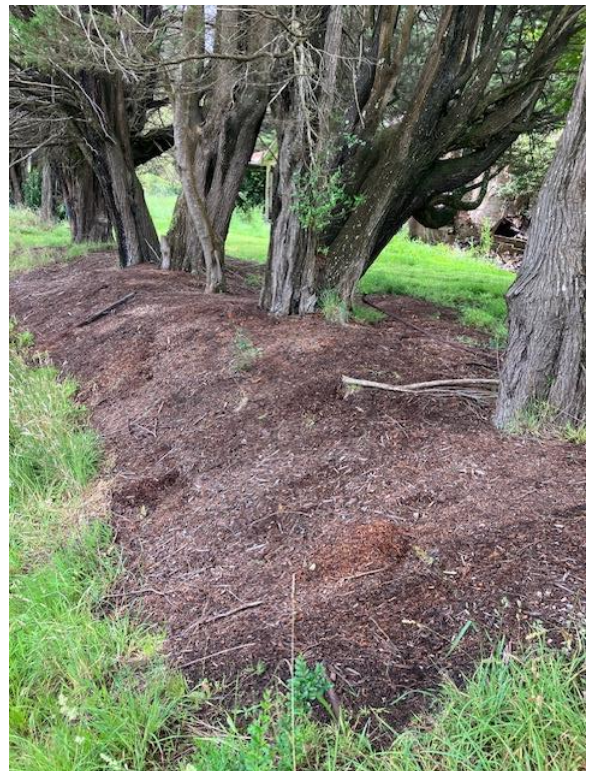
- Trees 261-267 have been heavily mulched and demonstrate fair to poor health, with some canopy thinning (Figure 5 & Figure 6).
- Trees 258 and 259 are in poor health, appearing structurally unsound (Figure 7).
- Trees 268-272 demonstrate very poor health (Figure 8), with trees 268-271 appearing to be virtually dead.

Figure 5: Trees 261-267

Figure 6: Heavy mulching of trees 261-267

It is recommended that the retention values for these unhealthy trees be decreased where they were previously classified as high retention. Table 1 summarises the trees which require a decrease in retention value due to change in condition.

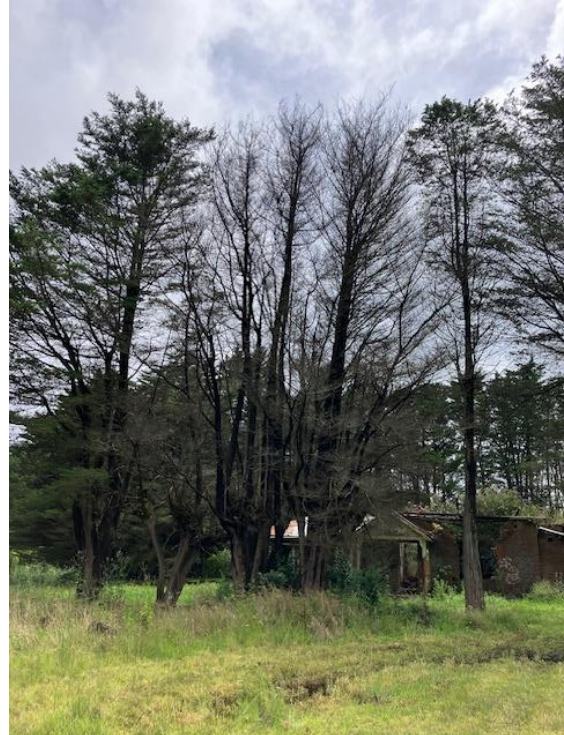
Figure 8: Trees 268-272 in very poor health

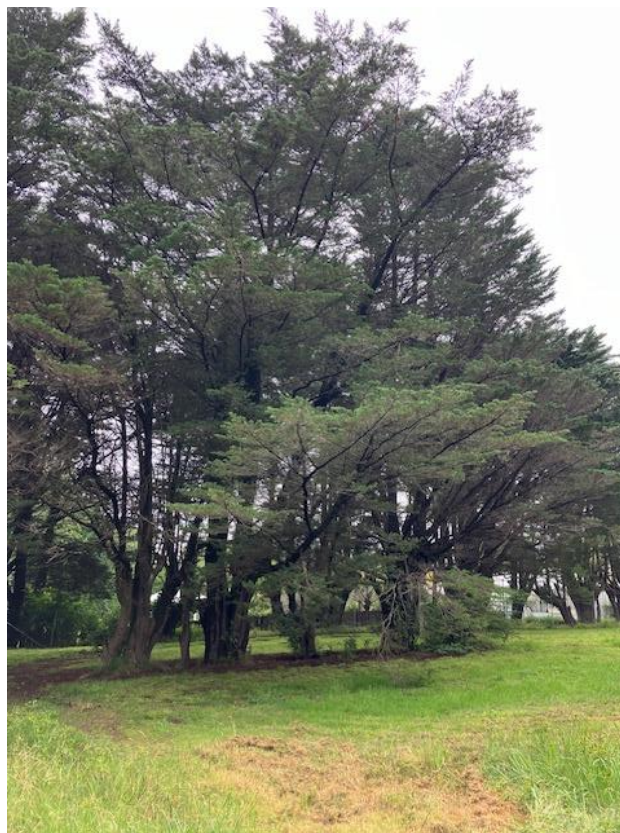
Six *Cupressus macrocarpa* located within close proximity to Malsters House were identified on the aerial image, which were not assessed as part of the original AIA (Figure 1 and Figure 9). These trees were likely excluded as the building was to be retained. If any works are required within the TPZ of these trees, tree protection measures must be in place during the works; including the marking out of the TPZ, fencing to surround the TPZ, and supervision by a suitably qualified Arborist.

Figure 9: Group of six trees not assessed in the AIA (ELA, 2020), in close proximity to Malsters House

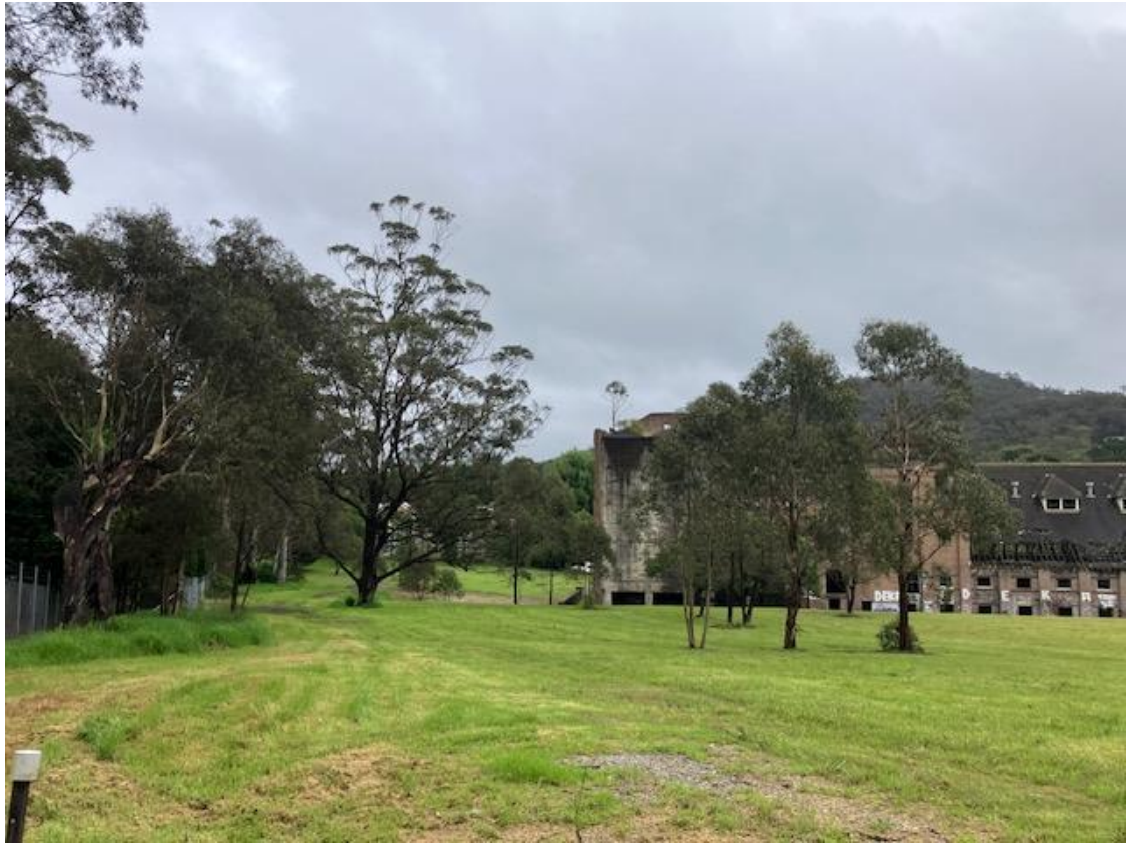
Figure 10: Trees 285-289, 292-295 and 298

Trees 285-289, 292-295 and 298 were in similar condition as previous inspection, allowing for natural growth (Figure 10). The retention value for these trees has been previously over-estimated (excluding 294 and 298, demonstrated in Figure 11 and Figure 12) and should be revised to 'Medium' due to the

relatively small size and lack of maturity. The structure of Tree 284 should be re-classified as 'poor' due to a large wound and hollow, combined with a lean on the shoulder trunk.
