# **Arboricultural Impact Statement Report**

## **St Columba's Catholic College Springwood NSW 2777**

**Prepared by Mark Bury Consulting**

**26<sup>th</sup> July 2021**

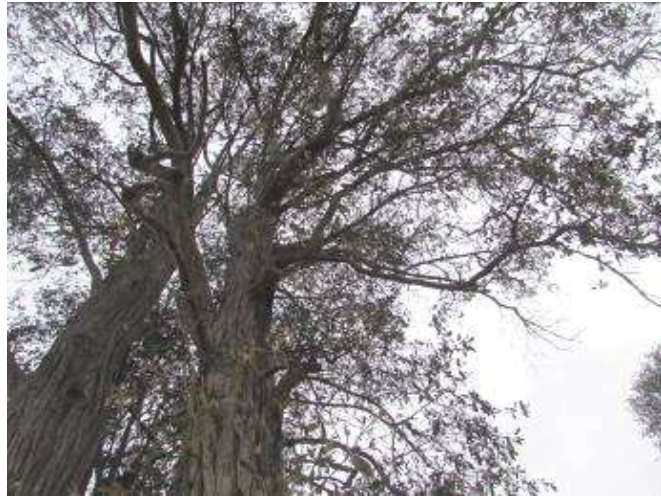
Tree 1  
*Syncarpia glomulifera*  
Turpentine

- 5.1 Tree 1 (*Syncarpia glomulifera* Turpentine) is a tree in fair condition Appendix 1 gives a description of the tree as per AS-4970-2009 Section 2. Appendix 4 gives the location of the tree on the property.

- 5.2 The tree will be affected by the proposed development (See Appendix 6 Construction Impact Statement) as it will have 50% incursion into the root TPZ of the tree (See Appendix 6). The trees soil and hydrological environments will be affected by the proposed development. Appropriate tree management in this situation would be the removal and replacement of the tree as part of the landscape plan for the proposed development.

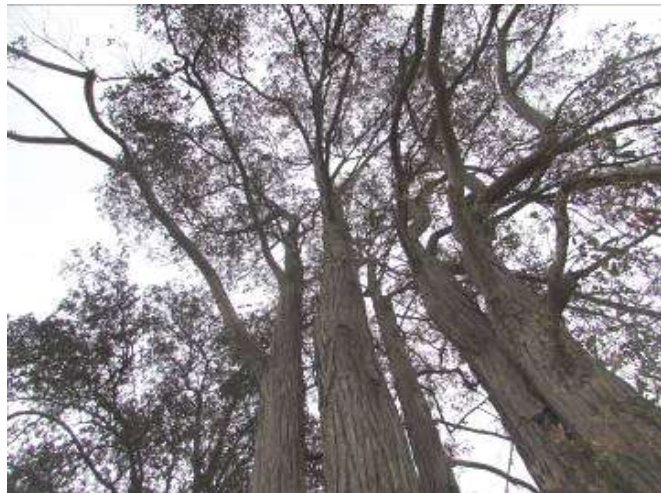
Tree 2  
*Syncarpia glomulifera*  
Turpentine

- 5.3 Tree 2 (*Syncarpia glomulifera* Turpentine) is a tree in fair condition Appendix 1 gives a description of the tree as per AS-4970-2009 Section 2. Appendix 4 gives the location of the tree on the property.

- 5.4 The tree will be affected by the proposed development (See Appendix 6 Construction Impact Statement) as it will have 50% incursion into the root TPZ of the tree (See Appendix 6). The trees soil and hydrological environments will be affected by the proposed development. Appropriate tree management in this situation would be the removal and replacement of the tree as part of the landscape plan for the proposed development.

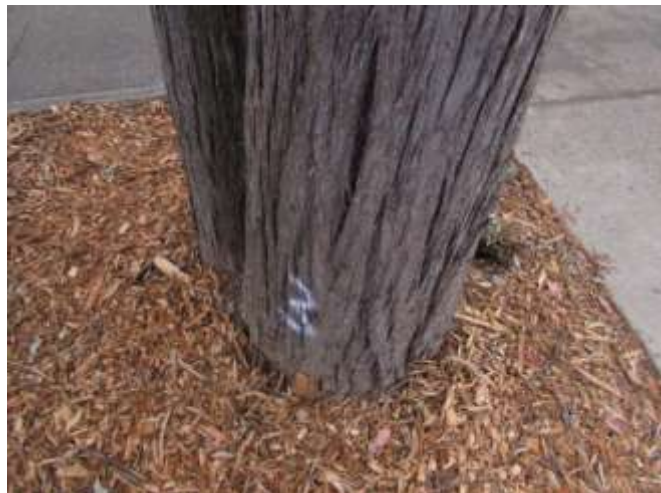
Tree 3  
*Syncarpia glomulifera*  
Turpentine

- 5.5 Tree 3 (*Syncarpia glomulifera* Turpentine) is a tree in fair condition Appendix 1 gives a description of the tree as per AS-4970-2009 Section 2. Appendix 4 gives the location of the tree on the property.

- 5.6 The tree will be affected by the proposed development (See Appendix 6 Construction Impact Statement) as it will have 50% incursion into the root TPZ of the tree (See Appendix 6). The trees soil and hydrological environments will be affected by the proposed development. Appropriate tree management in this situation would be the removal and replacement of the tree as part of the landscape plan for the proposed development.

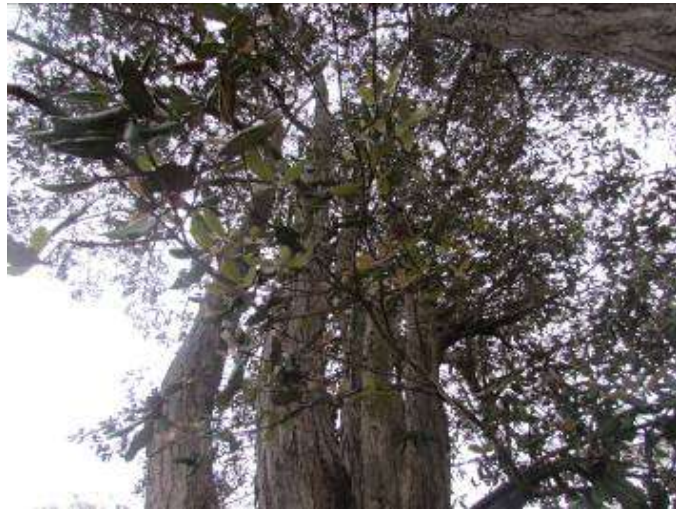
Tree 5  
*Syncarpia glomulifera*  
Turpentine

5.9 Tree 5 (*Syncarpia glomulifera* Turpentine) is a tree in fair condition Appendix 1 gives a description of the tree as per AS-4970-2009 Section 2. Appendix 4 gives the location of the tree on the property.

5.10 The tree will be affected by the proposed development (See Appendix 6 Construction Impact Statement) as it will have 50% incursion into the root TPZ of the tree (See Appendix 6). The trees soil and hydrological environments will be affected by the proposed development. Appropriate tree management in this situation would be the removal and replacement of the tree as part of the landscape plan for the proposed development

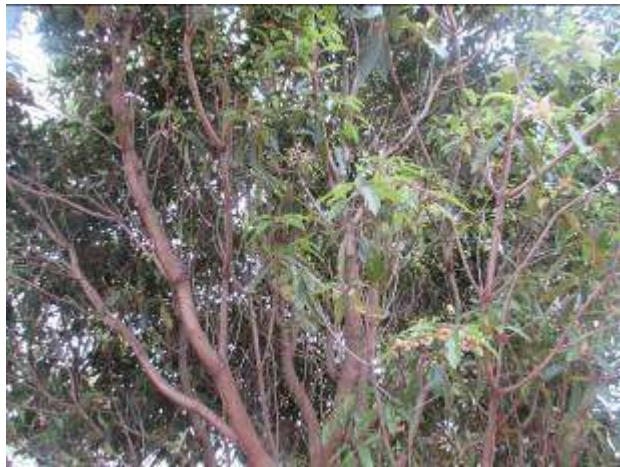
Tree 6  
*Pittosporum undulatum*  
Sweet Pittosporum

5.11 Tree 6 (*Pittosporum undulatum* Sweet Pittosporum) is a tree in fair condition Appendix 1 gives a description of the tree as per AS-4970-2009 Section 2. Appendix 4 gives the location of the tree on the property.

5.12 The tree will be affected by the proposed development (See Appendix 6 Construction Impact Statement) as it will have 50% incursion into the root TPZ of the tree (See Appendix 6). The trees soil and hydrological environments will be affected by the proposed development. Appropriate tree management in this situation would be the removal and replacement of the tree as part of the landscape plan for the proposed development

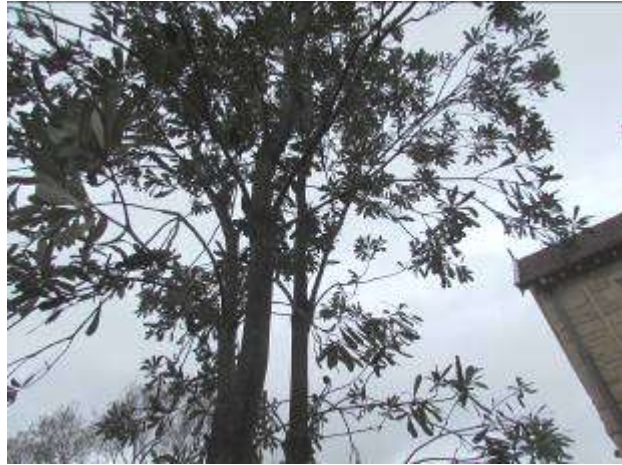
Tree 7  
*Banksia integrifolia*  
Coast Banksia

5.13 Tree 7 (*Banksia integrifolia* Coast Banksia) is a tree in fair condition Appendix 1 gives a description of the tree as per AS-4970-2009 Section 2. Appendix 4 gives the location of the tree on the property.

5.14 The tree will be affected by the proposed development (See Appendix 6 Construction Impact Statement) as it will have 50% incursion into the root TPZ of the tree (See Appendix 6). The trees soil and hydrological environments will be affected by the proposed development. Appropriate tree management in this situation would be the removal and replacement of the tree as part of the landscape plan for the proposed development

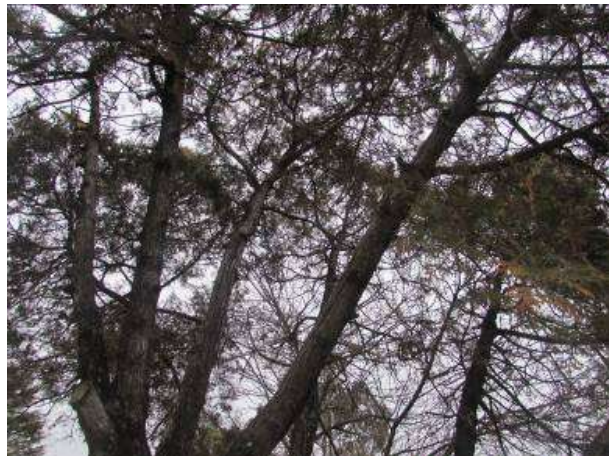
Tree 9  
*Cupressus macrocarpa*  
Monterey Pine

- 5.17 Tree 9 (*Cupressus macrocarpa* Monterey Cypress) is a tree in fair condition Appendix 1 gives a description of the tree as per AS-4970-2009 Section 2. Appendix 4 gives the location of the tree on the property.

- 5.18 The tree will be affected by the proposed development (See Appendix 6 Construction Impact Statement) as it will have 50% incursion into the root TPZ of the tree (See Appendix 6). The trees soil and hydrological environments will be affected by the proposed development. Appropriate tree management in this situation would be the removal and replacement of the tree as part of the landscape plan for the proposed development

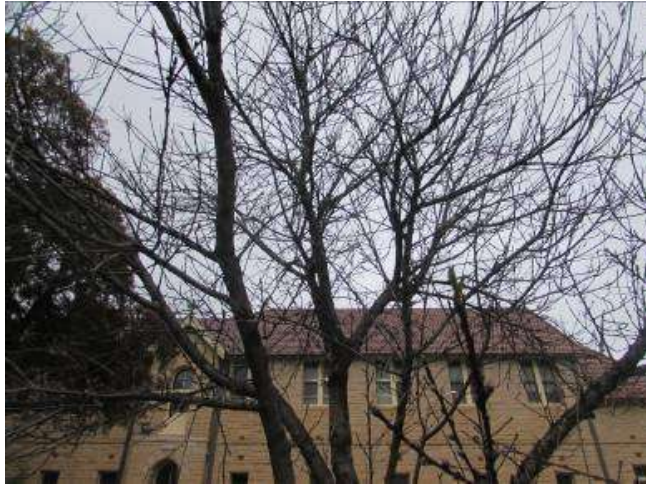
Tree 10  
*Prunus serratifolia*  
Flowering Cherry

- 5.19 Tree 10 (*Prunus serratifolia* Flowering Cherry) is a tree in fair condition Appendix 1 gives a description of the tree as per AS-4970-2009 Section 2. Appendix 4 gives the location of the tree on the property.

- 5.20 The tree will be affected by the proposed development (See Appendix 6 Construction Impact Statement) as it will have 50% incursion into the root TPZ of the tree (See Appendix 6). The trees soil and hydrological environments will be affected by the proposed development. Appropriate tree management in this situation would be the removal and replacement of the tree as part of the landscape plan for the proposed development

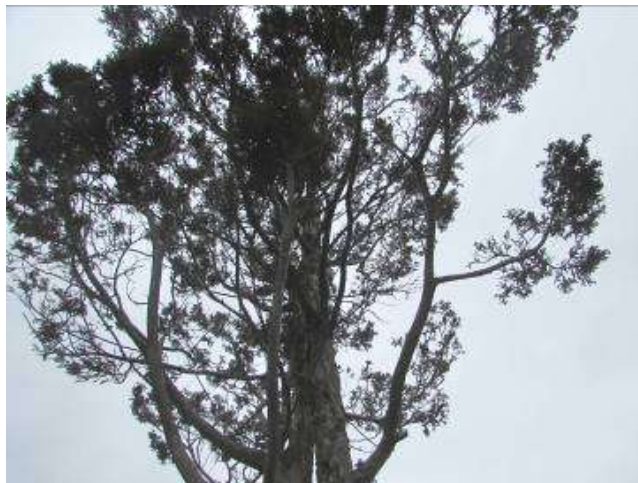
Tree 11  
*Cupressus macrocarpa*  
Monterey Pine

- 5.21 Tree 11 (*Cupressus macrocarpa* Monterey Cypress) is a tree in fair condition Appendix 1 gives a description of the tree as per AS-4970-2009 Section 2. Appendix 4 gives the location of the tree on the property.

- 5.22 The tree will be affected by the proposed development (See Appendix 6 Construction Impact Statement) as it will have 50% incursion into the root TPZ of the tree (See Appendix 6). The trees soil and hydrological environments will be affected by the proposed development. Appropriate tree management in this situation would be the removal and replacement of the tree as part of the landscape plan for the proposed development

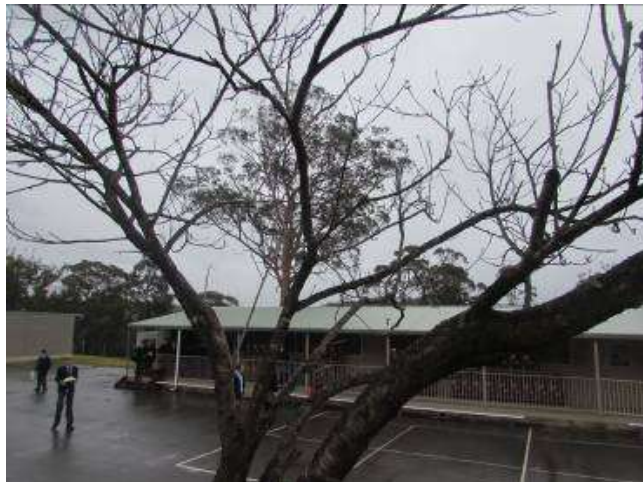
Tree 12  
*Syncarpia glomulifera*  
Flowering Cherry

- 5.23 Tree 12 (*Prunus serratifolia* Flowering Cherry) is a tree in fair condition Appendix 1 gives a description of the tree as per AS-4970-2009 Section 2. Appendix 4 gives the location of the tree on the property.

- 5.24 The tree will be affected by the proposed development (See Appendix 6 Construction Impact Statement) as it will have 50% incursion into the root TPZ of the tree (See Appendix 6). The trees soil and hydrological environments will be affected by the proposed development. Appropriate tree management in this situation would be the removal and replacement of the tree as part of the landscape plan for the proposed development
