# Arboricultural Impact Assessment, Tree Survey, and Tree Management Plan

| <b>Client:</b> | Il Capitano investments Pty Ltd c/o Allen Jack + Cottier Architects |
| <b>Site Address:</b> | Lots: 7-11 Castlereagh St, and 77-79 Bathurst st, Liverpool |
| <b>Date of report:</b> | 13 March 2019 (Version 2) |

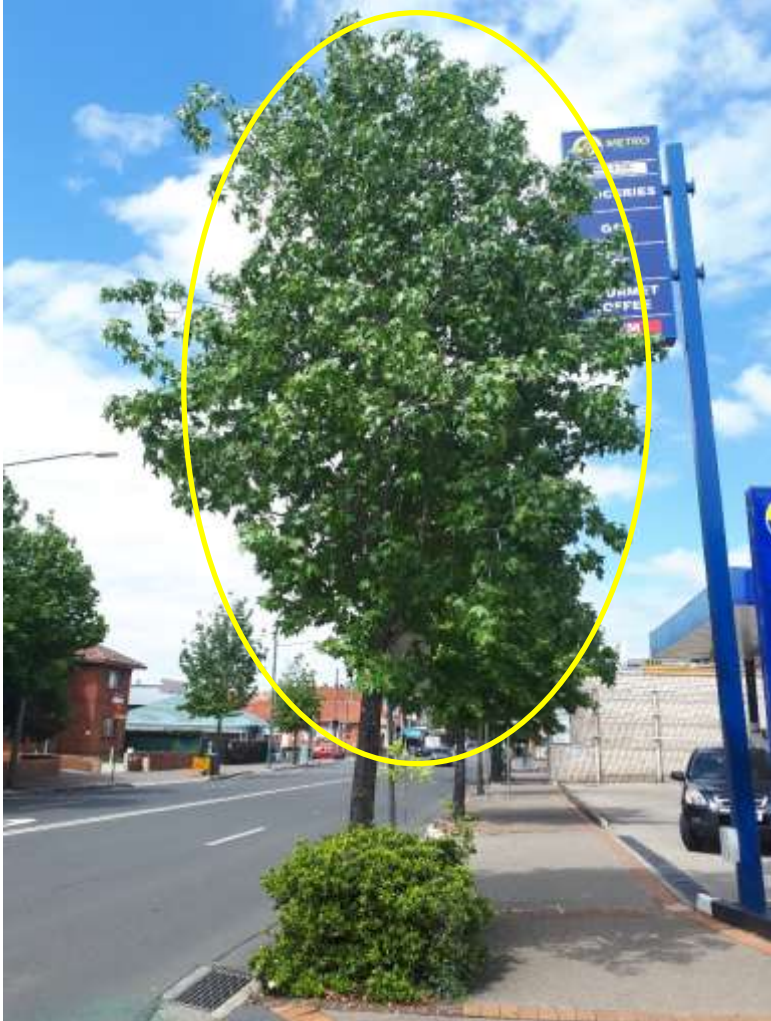
**Tree 1: *Liquidambar styraciflua* Liquid Amber**

| Notes | Sapling, garden |

- Retain trees 1,2,3,4,5,6, and 7 according to AS 4970, and 4373. Pay particular attention to roots, trunk and canopy. All efforts for retention are to be influenced by and exceed methods of protection by AS 4970.

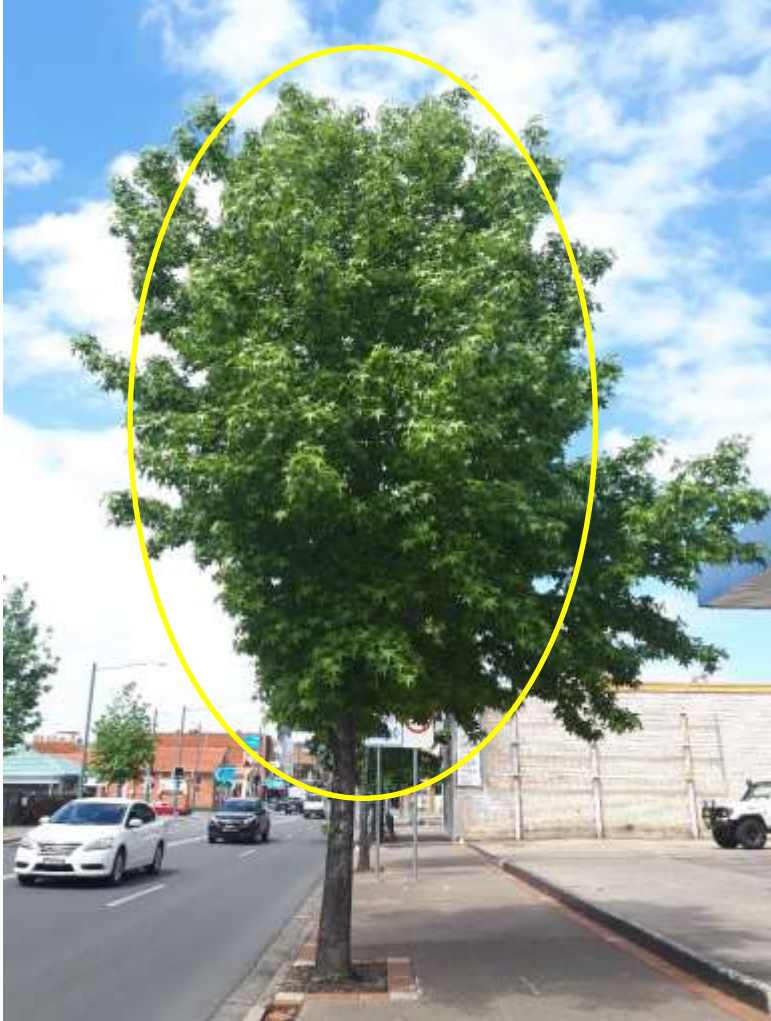
**Tree 2: *Liquidambar styraciflua* Liquid Amber**

| Notes | Sapling |

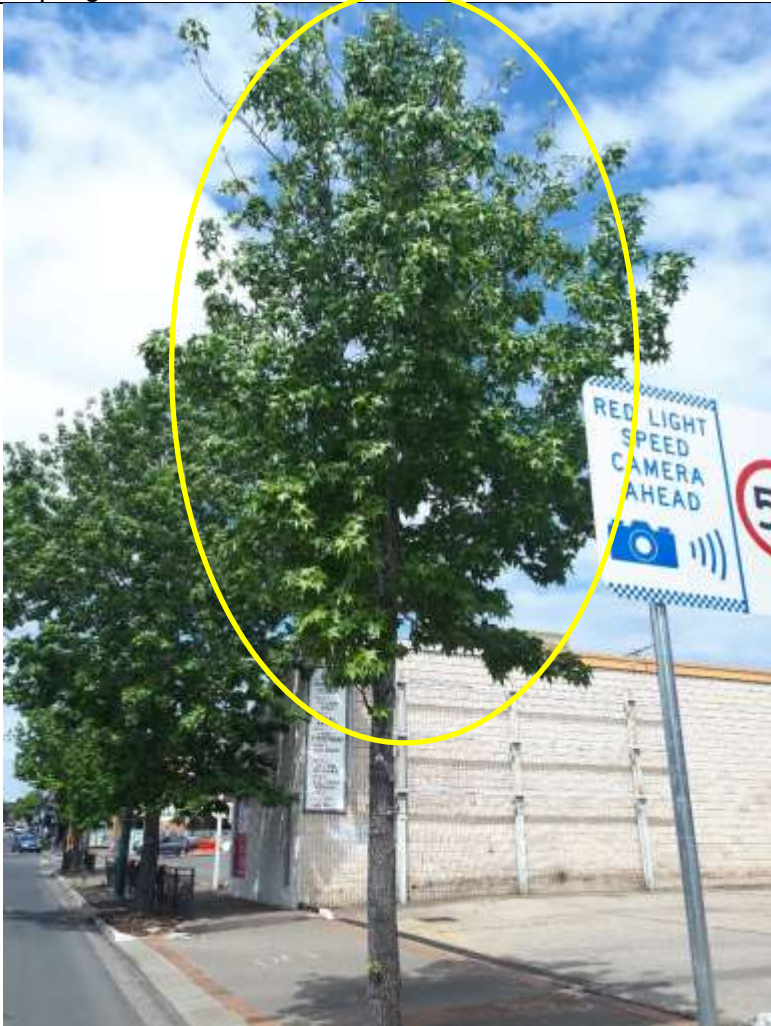
**Tree 3: *Liquidambar styraciflua* Liquid Amber**

| Notes | Sapling |

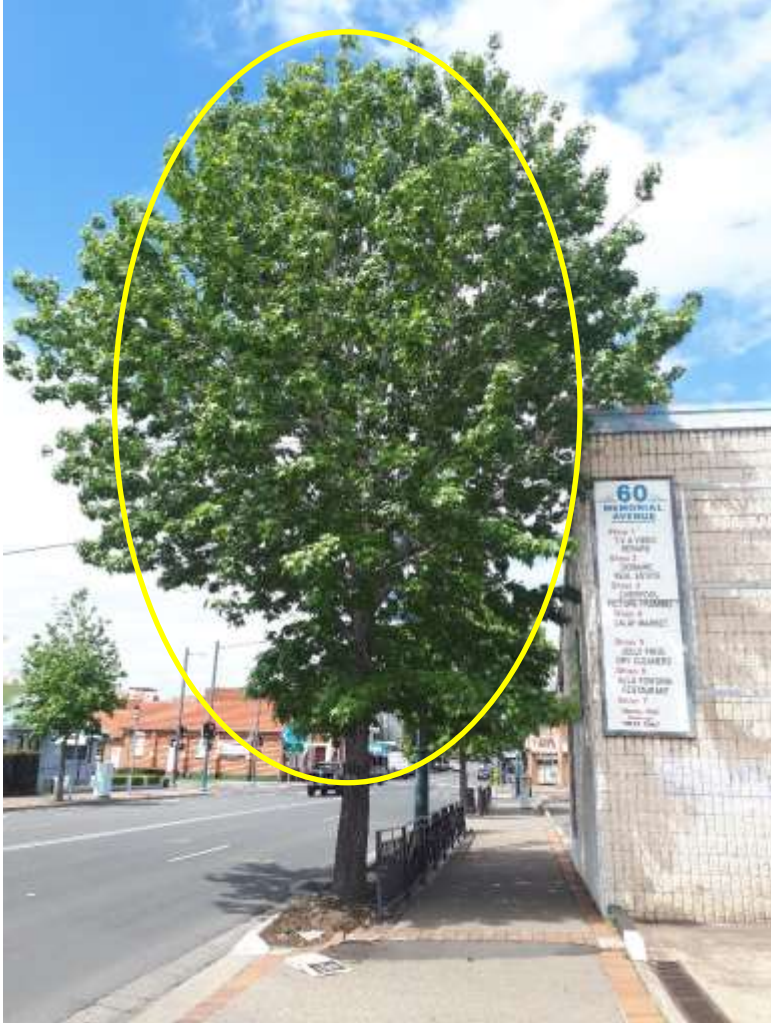
**Tree 4: *Liquidambar styraciflua* Liquid Amber**

| Notes | Sapling |

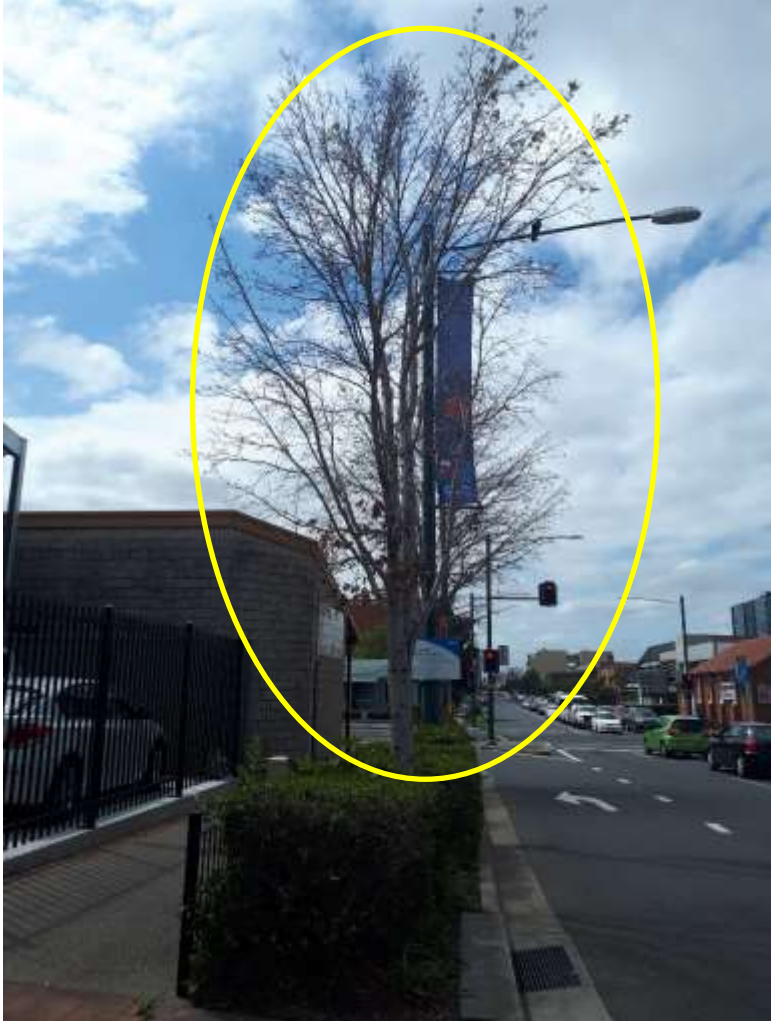
**Tree 5: Hedge Maple *Acer campestre***

| Notes | Sapling, garden, included codominants |

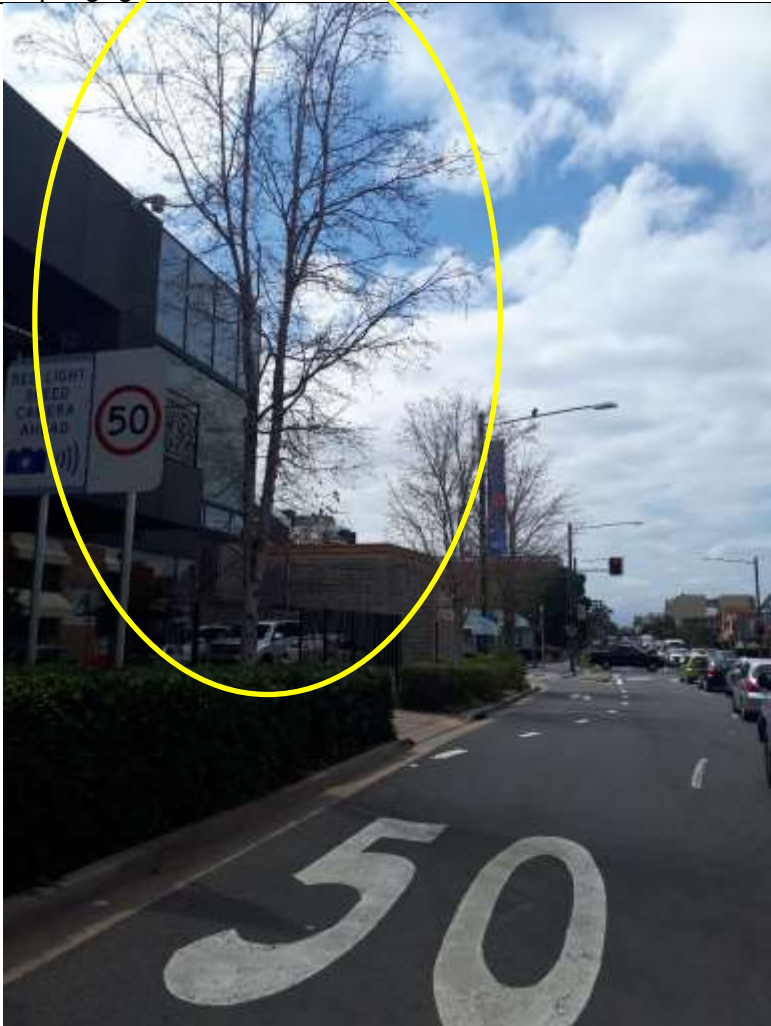
**Tree 6: Hedge Maple *Acer campestre***

| Notes | Sapling, garden, included codominants |

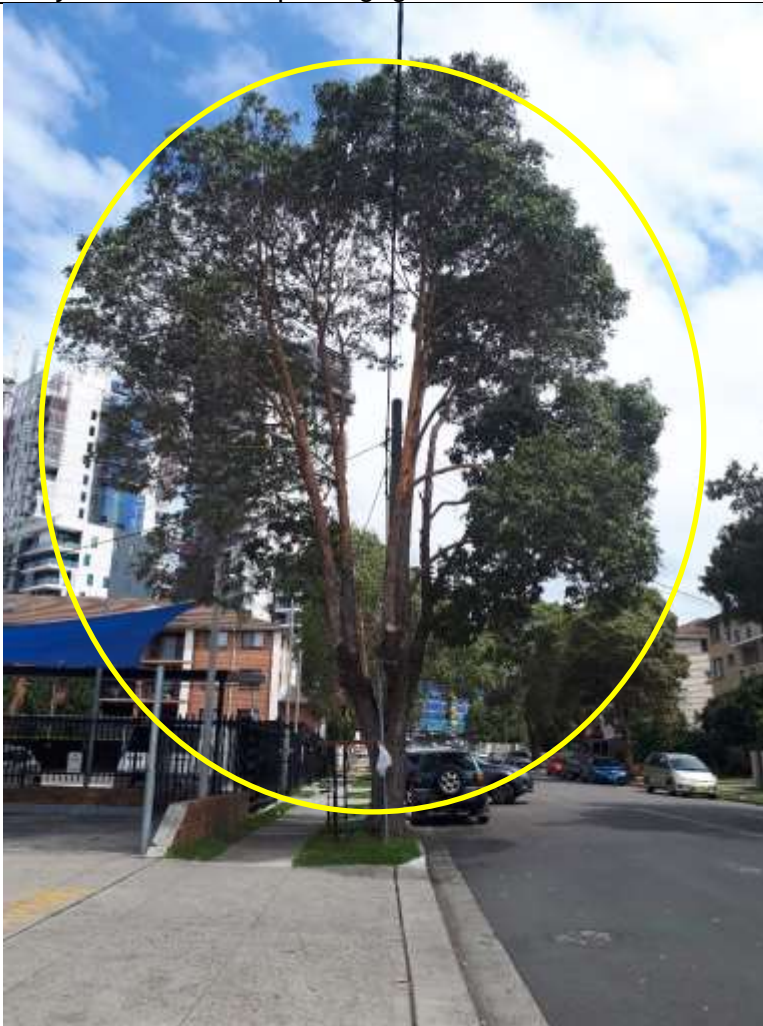
**Tree 7: Brush Box *Lophostemon confertus***

| Notes | Early Mature, Power pruning, grassed |

- 4.2. *Tree 7*; the incursion has been calculated at 5%. This shouldn't pose a major problem, with regards to the roots, however, specific measures are to be adhered particularly regarding the canopy and trimming in anticipation of the structure. This is to be in line with the Tree Management Plan (separate document)

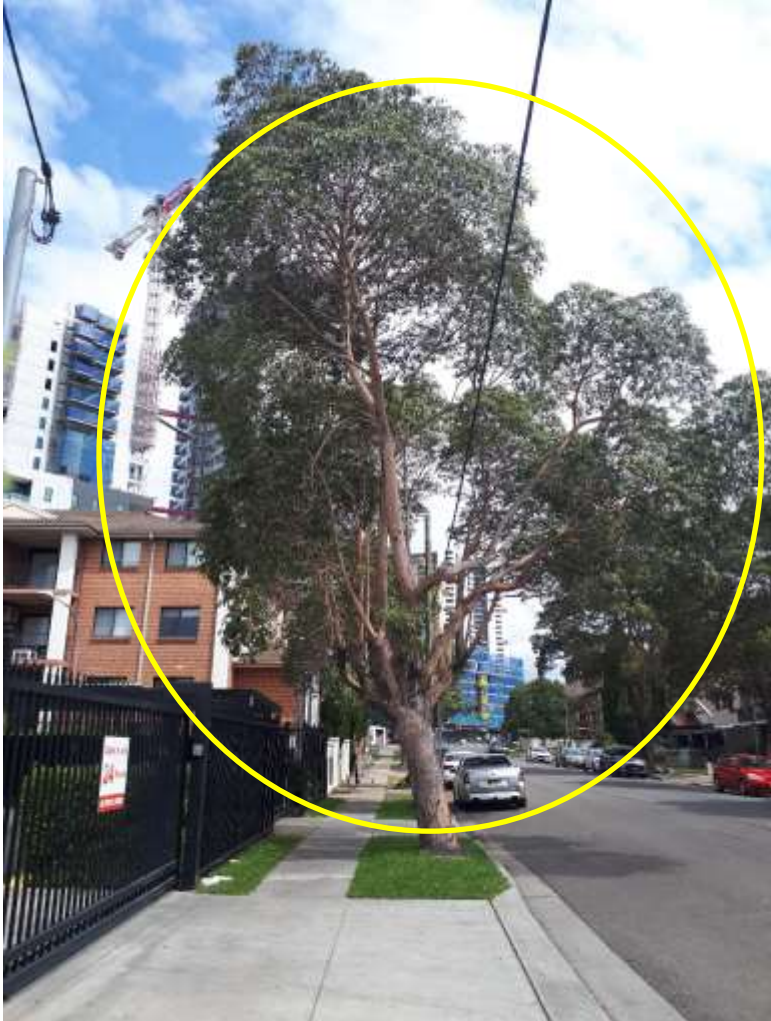
**Tree 8: Brush Box *Lophostemon confertus***

| Notes | Early Mature, Power pruning, grassed |

- 4.3. *Trees 8 and 9*; There has been a problem discovered by the traffic planner. The proposed driveway (between trees 8 and 9) are to comply with AS2890. This means that the trees will be substantially compromised by compliant works.

- Removal of specimens 8 and 9 as per best practice and code of conduct.
  - Prior to commencement of works, all tree protection fencing (if necessary) and measures are to be witnessed, documented and certified to ensure they are congruent with AS 4970. Particular efforts are to be made to prune the driveway trees prior to use as a haul road, appropriate location of temporary services, Site Office, Washout and storage.

- Replacement of Trees 8 and 9 with 2 x 75 L Brush box specimens. The specimens are to be grown with NATSPEC standards, and installed by a L3 Arborist.

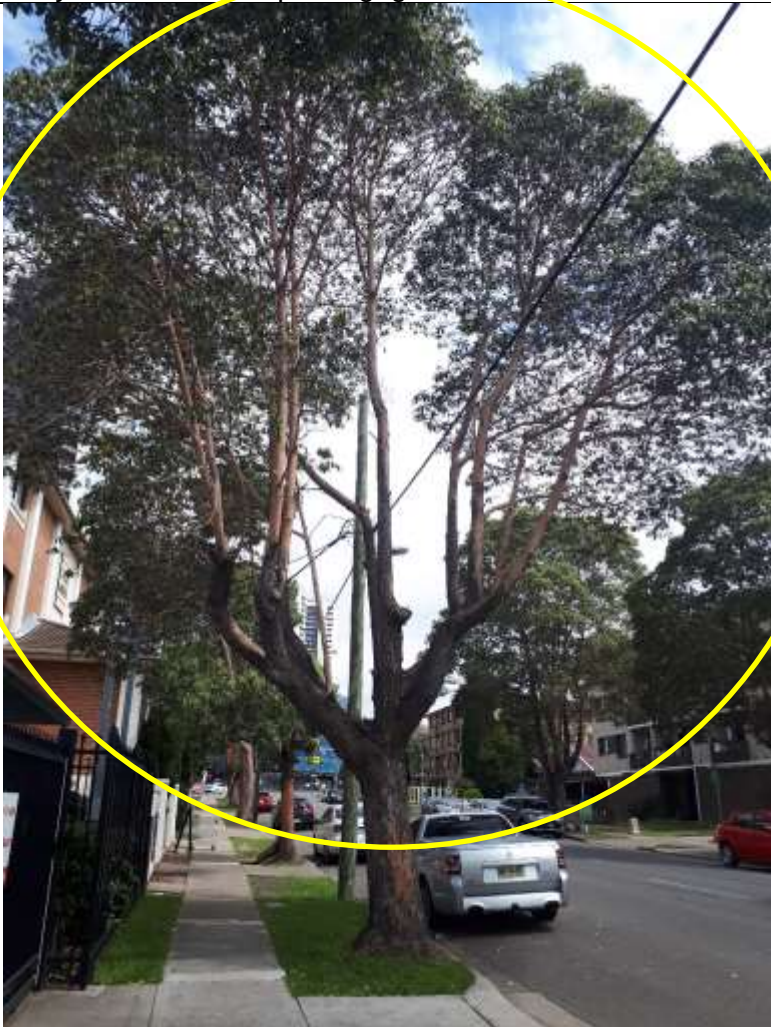
**Tree 9: Brush Box *Lophostemon confertus***

| Notes | Early Mature, Power pruning, grassed |
