3 August 2021

Arboricultural Impact Assessment Report regarding one thousand three hundred seventy-five (1375) trees located within the vicinity of the proposed Nepean Memorial Park development at Wallacia Country Club, 13 Park Road, Wallacia

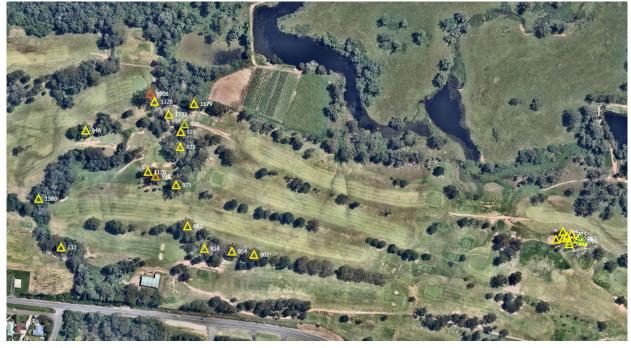
Figure 7. Location of trees with habitat potential. (ArborSite, 2021).

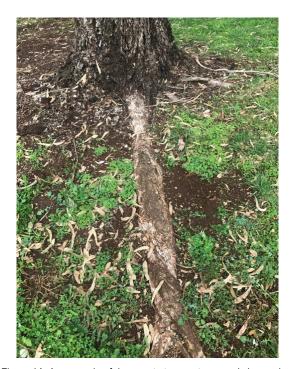
Figure 14. An example of damage to tree roots caused via mowing. (Luke Dawson, June 2017).

Another advantage to mulching around the trunk and root crown is that it limits damage to both parts from mowing equipment. This in turn reduces mechanical damage and compaction.

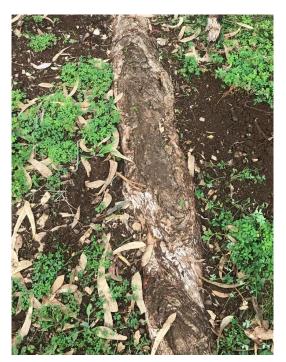
Figure 15. Image showing wound caused to upper portion of surface root by mower. (Luke Dawson, June 2017).

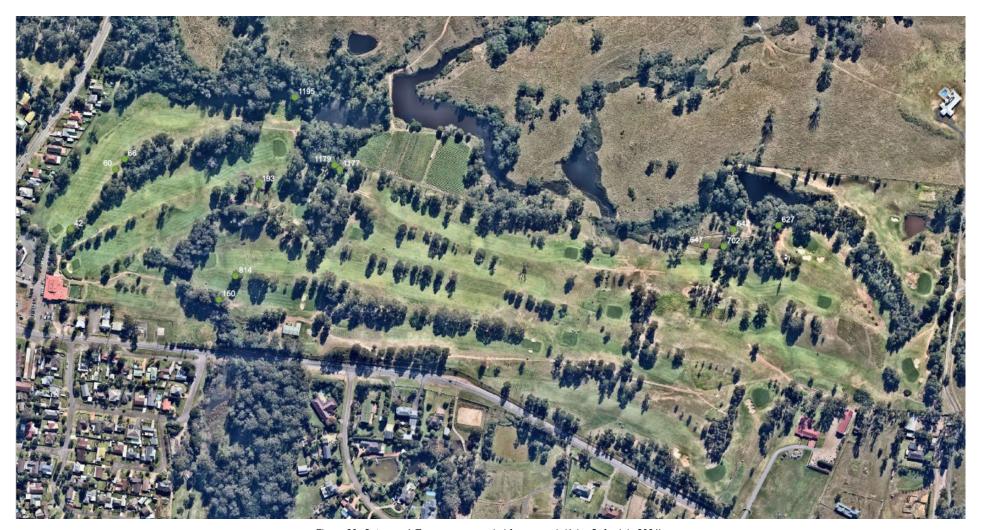
8.4 Category A Trees for Removal

Figure 20. Category A Trees recommended for removal. (ArborSafe, July 2021).

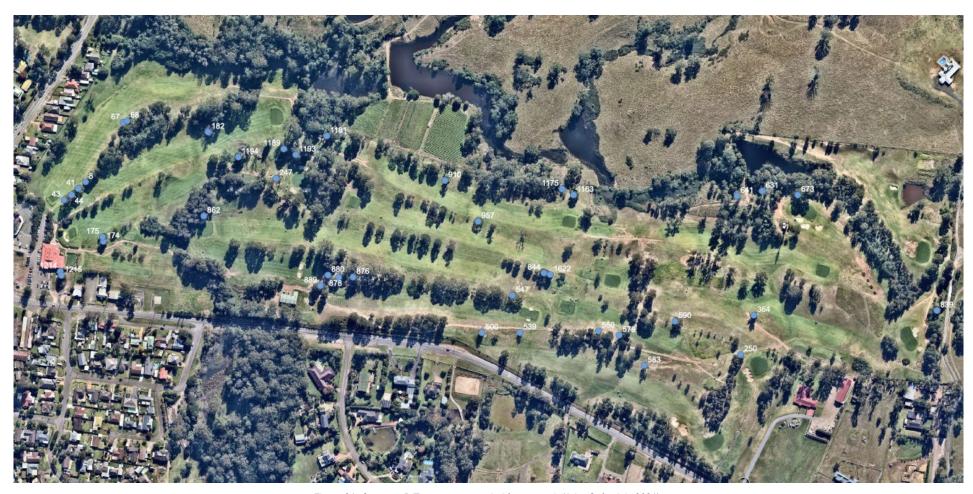
8.5 Category B Trees for Removal

Figure 21. Category B Trees recommended for removal. (ArborSafe, July 2021).

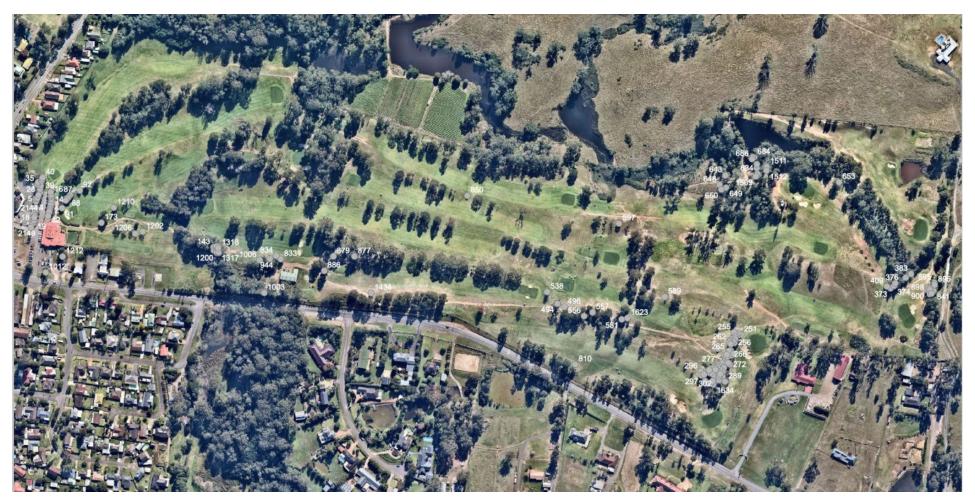
8.6 Category C Trees for Removal

Figure 22. Category C Trees recommended for removal. (ArborSafe, July 2021).

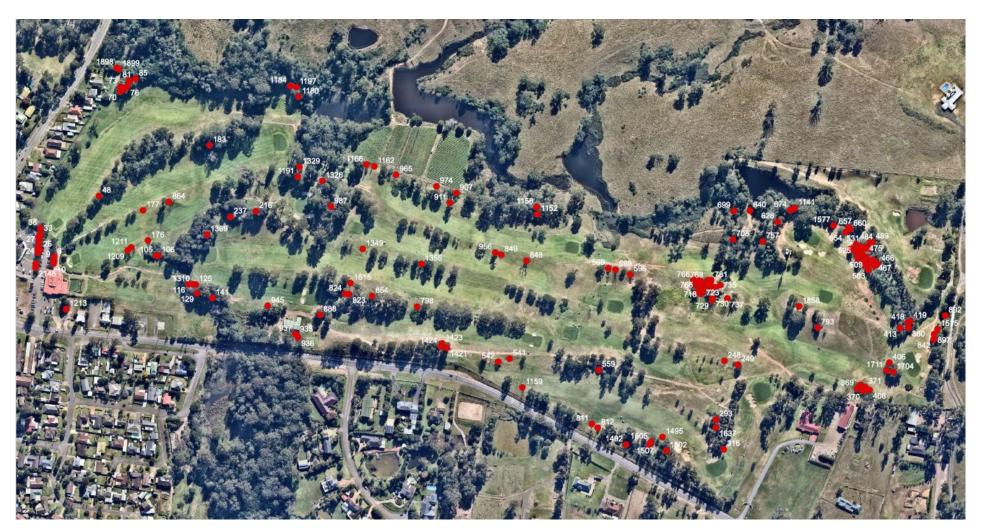
8.7 Category U Trees for Removal

Figure 23. Cemetery Zone (north) - Category U Trees for Removal. (ArborSite, July 2021).

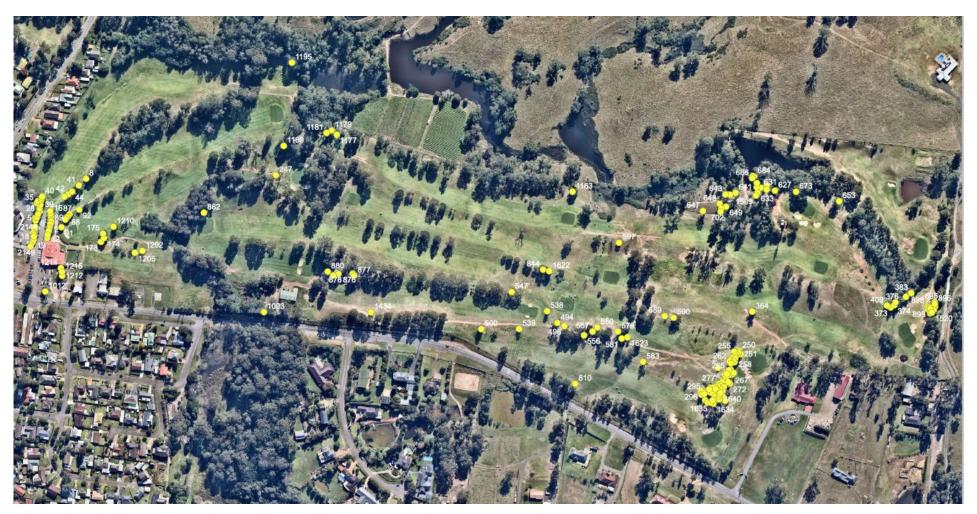
8.8 Trees requiring removal due to major encroachment

Figure 24. Trees with Major encroachment located in extent of disturbance area. Removal required based on project design. (ArborSafe, July 2021)

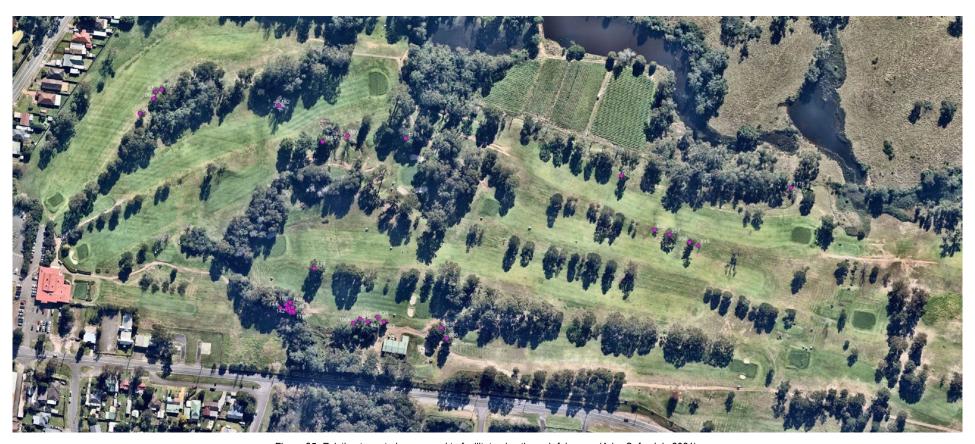
8.9 Existing trees to be removed to facilitate play through fairways

Figure 25. Existing trees to be removed to facilitate play through fairways. (ArborSafe, July 2021).

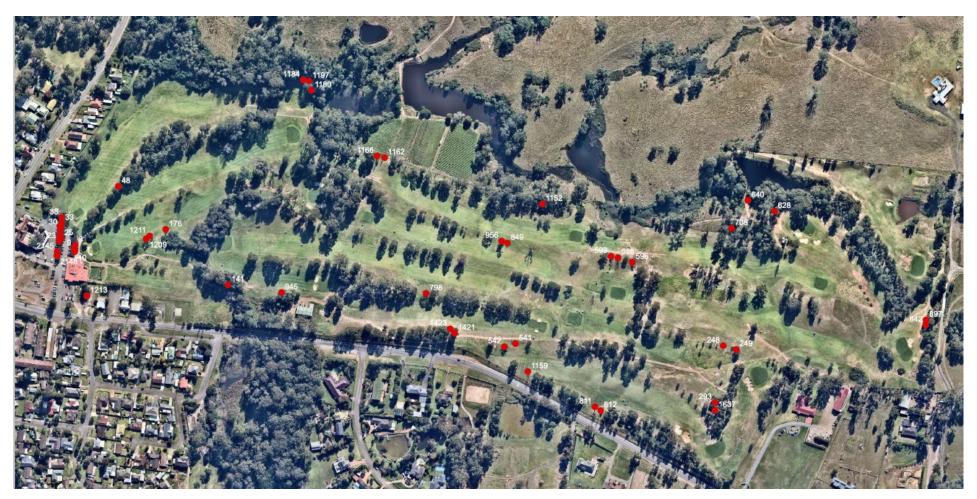
8.10 Category U Trees with potential of development impact

Figure 26. Category U Trees with potential of development impact. (ArborSafe, July 2021).
