Project No: BOURKE/HEALTHCARE/24 Report No: BOURKE/HEALTHCARE /AIA/A

ARBORICULTURAL IMPACT ASSESSMENT TREE PROTECTION SPECIFICATION

Bourke Integrated Primary Healthcare Centre
88-96 Mitchell Street, BOURKE

18th November 2024

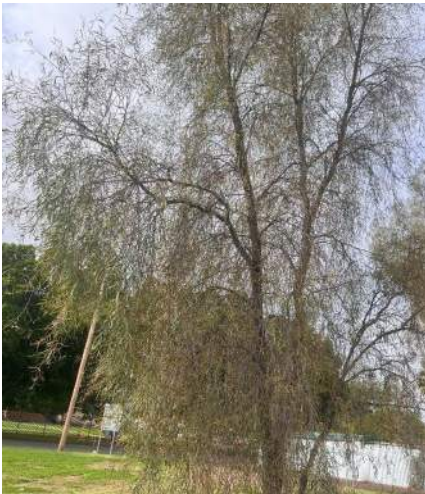
Plate 1: Showing Tree 1

- 3.1.1 Tree 1 was identified as *Acacia salicina* (Cooba) and is located in the south-eastern area of the site. The tree is in fair health and fair structural condition as evidenced by a crown density of 50-75% and a major included branch junction. Tree 1 is of low Landscape Significance and has been allocated a Retention Value of *Consider for Removal*.
- 3.1.2 The supplied plans show Tree 1 is to be removed to accommodate the proposed building.

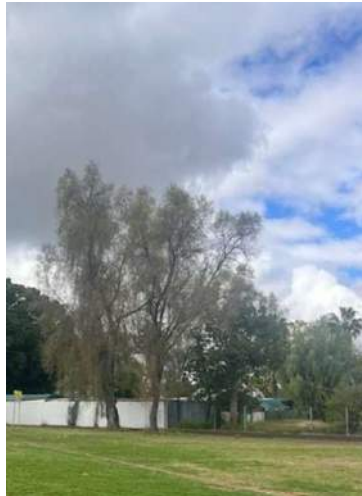
Plate 2: Showing Trees 2 & 3

- 3.2.1 Tree 2 was identified as *Acacia salicina* (Cooba) and is located directly adjacent to the southern boundary and the recently paved informal road. The tree is in fair health and poor structural condition as evidenced by a crown density of 50-75%, a major included branch junction and several previous branch failures. Tree 2 is of moderate Landscape Significance and has been allocated a Retention Value of *Consider for Retention*.

- 3.2.2 The supplied plans show Tree 2 is to be retained with construction of an outdoor plant structure and fence proposed within its Tree Protection Zone (TPZ). As the encroachment from the outdoor plant structure is less than 10% of the TPZ and outside of the Structural Root Zone (SRZ), the extent of works represents a *Minor Encroachment* as defined by AS-4970. A *Minor Encroachment* is considered acceptable by AS-4970 when it is compensated for elsewhere and contiguous within the TPZ. The encroachment should be compensated for by extending the TPZ to the west.

- 3.3.1 Tree 3 was identified as *Acacia salicina* (Cooba) and is located adjacent to the southern boundary. The tree is in fair health and fair structural condition as evidenced by a crown density of 0-25% with small (0-25mm \varnothing) deadwood in high volumes and large (75mm+ \varnothing) epicormic growth in moderate volumes throughout the crown. Several previous branch failures were also noted. Tree 3 is of low Landscape Significance and has been allocated a Retention Value of *Priority for Removal*.
- 3.3.2 The supplied plans show Tree 3 is to be retained with no works proposed within the TPZ.
- 3.3.3 Recommendations
- Tree 3 is recommended for removal due to its poor overall condition, irrespective of the proposed works
 - TPZ fencing should be established at the perimeter of the TPZ within the site

- 3.2.3 Recommendations
- Trunk protection should be installed to protect the tree from impact damage
 - TPZ fencing should be established at the perimeter of the TPZ within the site, setback to accommodate the outdoor plant structure

- The existing laneway provides suitable ground protection and can be used as construction access
 - Excavation for the installation of fence posts should be undertaken by hand. The location of the fence posts should be adjusted to allow for the retention of roots (>25mm \varnothing). The fence should be modified as required to ensure adequate setback from the trunk for tree growth and movement in wind

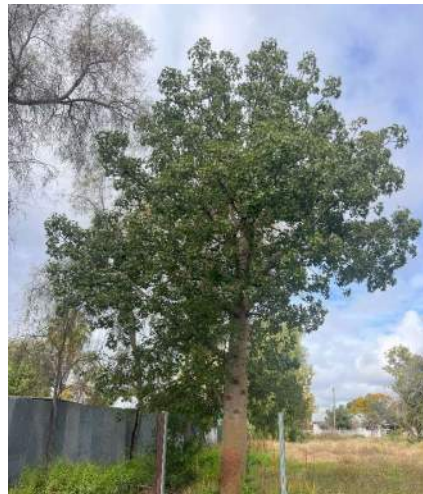
Plate 3: Showing Tree 4

3.4.1 Tree 4 was identified as *Brachychiton populneus* (Kurrajong) and is located within the property of 119 Oxley Street which is south of the site and separated by the informal road. The tree is in good health and good structural condition with no significant defects identified at the time of assessment. The recently laid asphalt is approx. 1m from the tree's base. Tree 4 is of moderate Landscape Significance and has been allocated a Retention Value of *Consider for Retention*.

3.4.2 The supplied plans show Tree 4 is to be retained with no works proposed within the TPZ.

- Trunk protection should be installed
- The existing laneway provides suitable ground protection and can be used as construction access

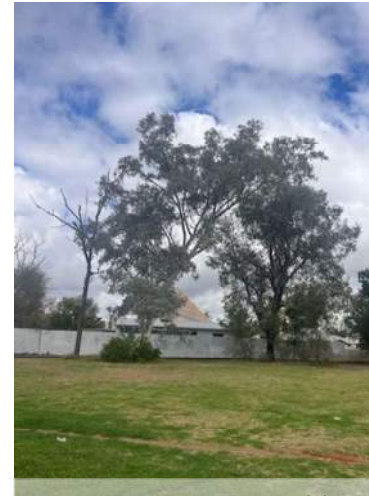
Plate 4: Showing Trees 5 (L), 6 & 7

3.5.1 Tree 5 is dead and should be removed.

3.6.1 Tree 6 was identified as *Eucalyptus camaldulensis* (River Red Gum) and is located adjacent to the southern boundary. The tree is in good health and good structural condition with a slight phototropic lean. Medium (25-75mmØ) deadwood in moderate volumes and several storm-damaged branched were noted. Tree 6 is of moderate Landscape Significance and has been allocated a Retention Value of *Consider for Retention*.

3.6.2 The supplied plans show Tree 6 is to be retained with construction of a carparking area and fence proposed within its TPZ. The carpark represents 13% of the TPZ and is defined as a *Major Encroachment* as defined by AS-4970. The works are located outside of the SRZ and the tree is in good health. Therefore, with the implementation of best practice tree protection measures, the proposed works should not adversely impact the tree.

3.7.1 Tree 7 was identified as *Eucalyptus sideroxylon* (Mugga Ironbark) and is located adjacent to the southern boundary. The tree is in good health and fair structural condition due to the multiple branch attachment (3x) at 4 metres above grade and the adaptive growth on one side. Several storm damaged branches were also noted. Tree 7 is of high Landscape Significance and has been allocated a Retention Value of *Consider for Retention*. Although Tree 7 meets the criteria to be allocated Retention Value of *Consider for Retention*, the tree has a short (5-15 years) Useful Life Expectancy.

3.7.2 The supplied plans show Tree 7 is to be removed as it falls within the footprint of the carpark driveway entry.

- TPZ fencing should be established at the perimeter of the TPZ within the site, setback to accommodate the carpark
- Preliminary hand excavation (to the depth of the proposed pavement and subbase profile) and root pruning by the Project Arborist should be undertaken prior to bulk excavation works. No over-excavation should be undertaken
- Excavation for the installation of fence posts should be undertaken by hand. The location of the fence posts should be adjusted to allow for the retention of roots (>25mmØ)

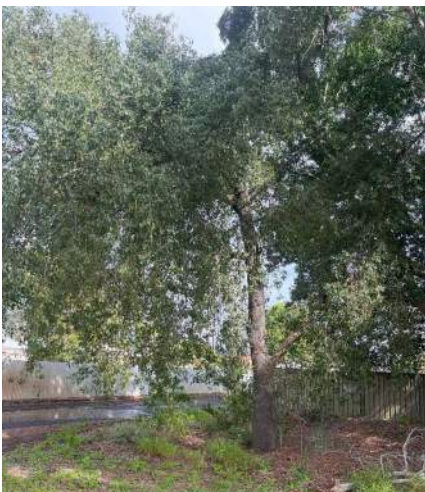
Plate 5: Showing Tree 8

- 3.8.1 Tree 8 was identified as *Brachychiton populneus* (Kurrajong) and is located in the south-western corner of the site. The tree is in good health and fair structural condition and is heavily suppressed on one side by Tree 9. Tree 8 is of low Landscape Significance and has been allocated a Retention Value of *Consider for Removal*.

- 3.8.2 The supplied plans show Tree 8 is to be retained with construction of a shed proposed within its TPZ. The extent of works represents a *Minor Encroachment* as defined by AS-4970. The encroachment should be compensated for by extending the TPZ to the east. In addition, new permeable paving is proposed in the TPZ and represents a *Major Encroachment* as defined by AS-4970. Therefore, tree sensitive methods should be used to minimise adverse impacts.

- 3.8.3 Recommendations
- TPZ fencing should be established at the perimeter of the TPZ
 - The permeable paving (including subbase) should be installed above existing grade and supported on a permeable subbase

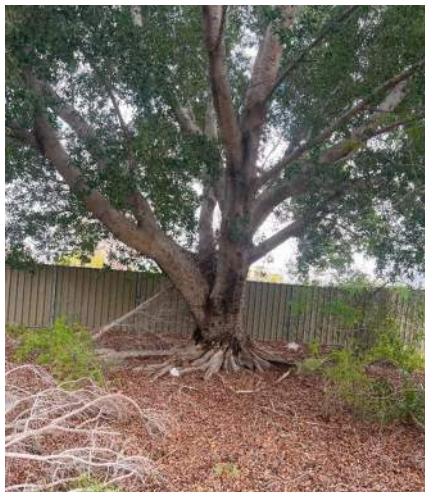
Plate 6: Showing Tree 9

- 3.9.1 Tree 9 was identified as *Ficus microcarpa* var. *Hilli* (Hills Fig) and is located in the south-western corner of the site. The tree is in good health and fair structural condition due to the presence of bark inclusions, typical of species. Tree 9 is of moderate Landscape Significance and has been allocated a Retention Value of *Consider for Retention*.

- 3.9.3 Recommendations
- TPZ fencing should be established at the perimeter of the TPZ, setback to accommodate the shed
 - The permeable paving (including subbase) should be installed above existing grade and supported on a permeable subbase

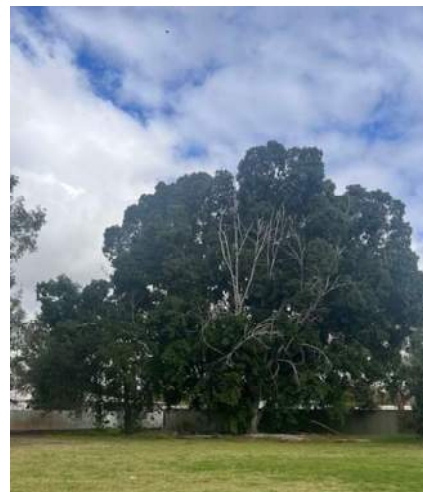
Plate 7: Showing Tree 10

- 3.10.1 Tree 10 was identified as *Ficus microcarpa* var. *Hilli* (Hills Fig) and is located in the south-western corner of the site. The tree is in fair health and fair structural condition and is heavily suppressed on one side by Tree 9. Several dead branches extend to the east and wounding was noted on the lower stem and buttress roots. Tree 10 is of low Landscape Significance and has been allocated a Retention Value of *Priority for Removal*.
- 3.10.2 The supplied plans show Tree 10 is to be retained with construction of a shed, carpark, fire/water tanks proposed within its TPZ and represents 12% of the TPZ. In addition, new permeable paving is proposed in the TPZ. The extent of works represents a *Major Encroachment* as defined by AS-4970. Therefore, tree sensitive methods should be used to minimise adverse impacts.

- Tree 10 is recommended for removal due to its overall condition, irrespective of the proposed works
- TPZ fencing should be established at the perimeter of the TPZ, setback to accommodate the shed, carpark and fire/water tank
- Preliminary hand excavation (to the depth of the proposed carpark pavement/slabs and subbase profile) and root pruning by the Project Arborist should be undertaken prior to bulk excavation works. No over-excavation should be undertaken
- The permeable paving (including subbase) should be installed above existing grade and supported on a permeable subbase

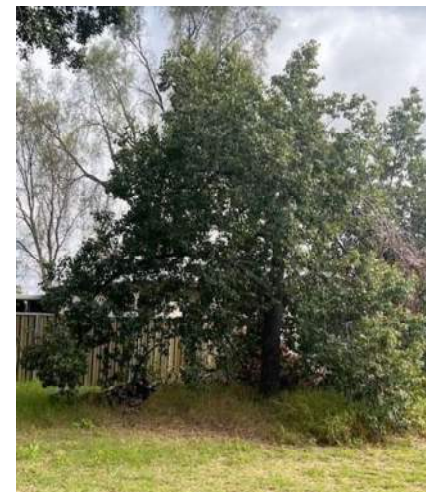
Plate 8: Showing Tree 11

3.11.1 Tree 11 was identified as *Brachychiton populneus* (Kurrajong) and is located in the western area of the site. The tree is in good health and fair structural condition due to a damaged terminal leader. Tree 11 is of low Landscape Significance and has been allocated a Retention Value of *Consider for Removal*.

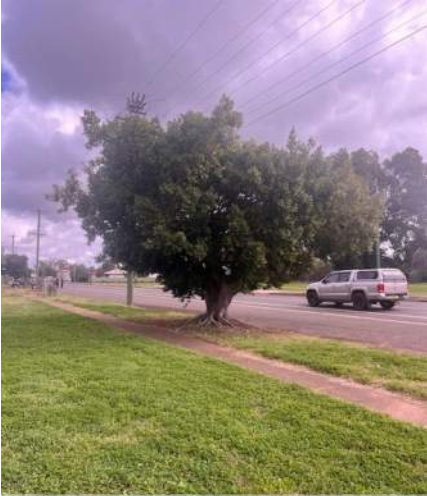
Plate 9: Showing Tree 12

3.12.1 Tree 12 was identified as *Ficus microcarpa* var. *Hilli* (Hills Fig) and is located on the road reserve of the Mitchell Street frontage of the site. The tree is in good health and poor structural condition due to being repeatedly lopped for powerline clearance and wounds on the buttress due to mower damage. Tree 12 is of low Landscape Significance and has been allocated a Retention Value of *Consider for Removal*.

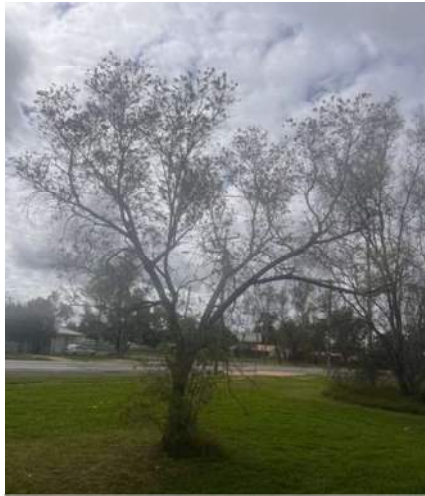
Plate 10: Showing Tree 13

3.13.1 Tree 13 was identified as *Callistemon viminalis* (Bottlebrush) and is located adjacent to the northern boundary. The tree is in fair health and fair structural condition due to a crown density 25-50% and small (<25mmØ) deadwood in moderate volumes. A co-dominant inclusion and basal wounds from mower damage are also present. Tree 13 is of low Landscape Significance and has been allocated a Retention Value of *Consider for Removal*.

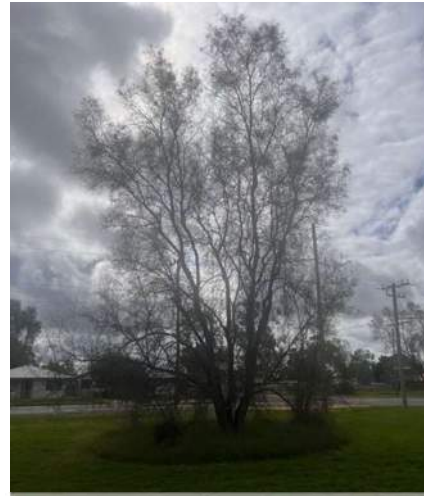
Plate 11: Showing Tree 14 & 15

3.14.1 Trees 14 and 15 are identified as *Acacia salicina* (Cooba) and are located adjacent to the northern boundary. The trees are in poor health and fair structural condition with a crown density of 0-25% and poor branching structure. The trees are of low Landscape Significance and have been allocated a Retention Value of *Priority for Removal*.
