### **RFI Response**

**Response to RFI IDAS-2025-10715 from  
Department Climate Change, Energy, the  
Environment and Water – Water Group**

Document Number: DCCEEW01  
Title: RFI Response  
Project: Lithgow Mountain Bike Park, DA170/25  
Author: Paul Smith (RPEng 918356-1758)

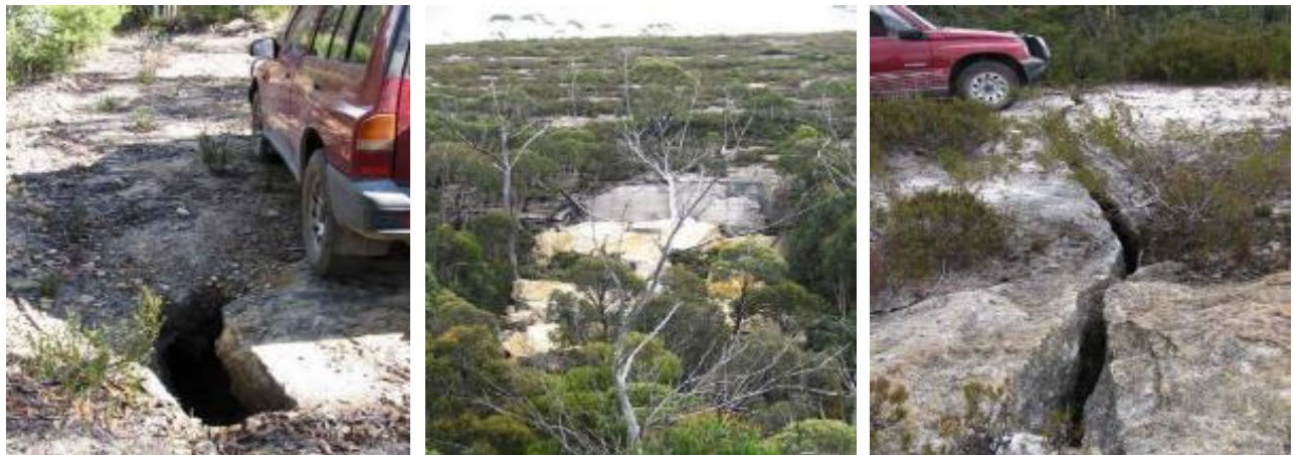
**Figure 3: Subsidence cracks above Cobar Park Colliery adjacent to Lithgow State Mine**

The bord and pillar mining technique, combined with the regular use of explosives, is known to have the potential to cause surface cracks and disturbances, such as the surface crack shown in the following picture adjacent to the Cobar Park Mine, which is located nearby to the Lithgow State Mine. (Extracted from 'history-of-bord-and-pillar-subsidence-damage-leg-2024')<sup>1</sup>

Such cracking is also understood to cause the potential loss of surface water flows, as this can flow down into underground voids and cracks associated with historical mining (as is discussed further below).

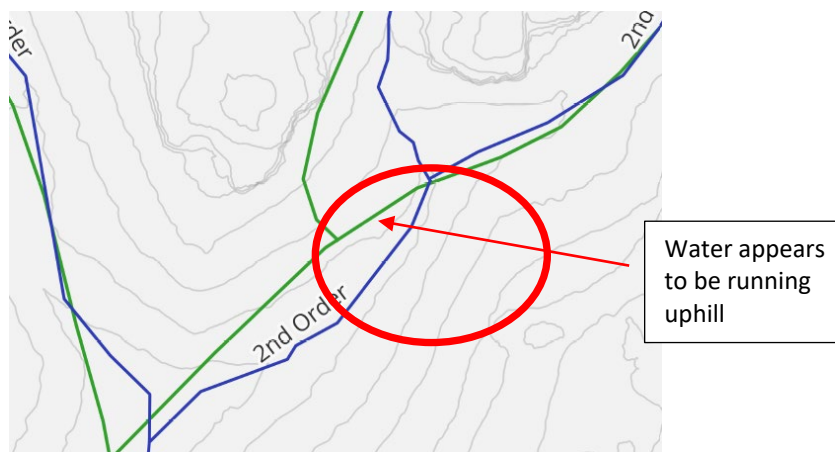
**Figure 5: NSW Hydrolines Layer with Errors.**

For example, in the following picture in the red circle, the green line is the NSW hydroline mapped against the LiDAR 1m DEM contours (which is generally understood to be more accurate). These contours appear to show the water flowing up hill. Accordingly, in the maps provided, the blue hydrolines were developed to match the contour low points and provide a more accurate representation of the actual stream locations inspected on Site:

The new hydrolines were developed from the desktop and may contain errors introduced from the LiDAR or flat contours. The LiDAR data is reasonably accurate; however, it has

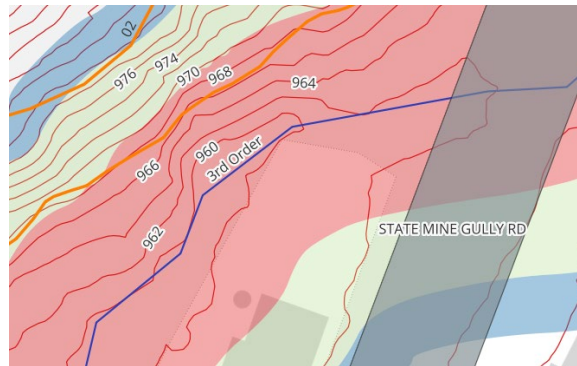
**Figure 6. 2m contours - Creek to Orange Trail shows 6m of fall which is incorrect as it was measured as 25m**

These flat, wide contours in Figure 6 may introduce errors to the actual stream location as it cannot be confidently determined (from the desktop) where the creek enters the flat, wide contour 962m, for instance.

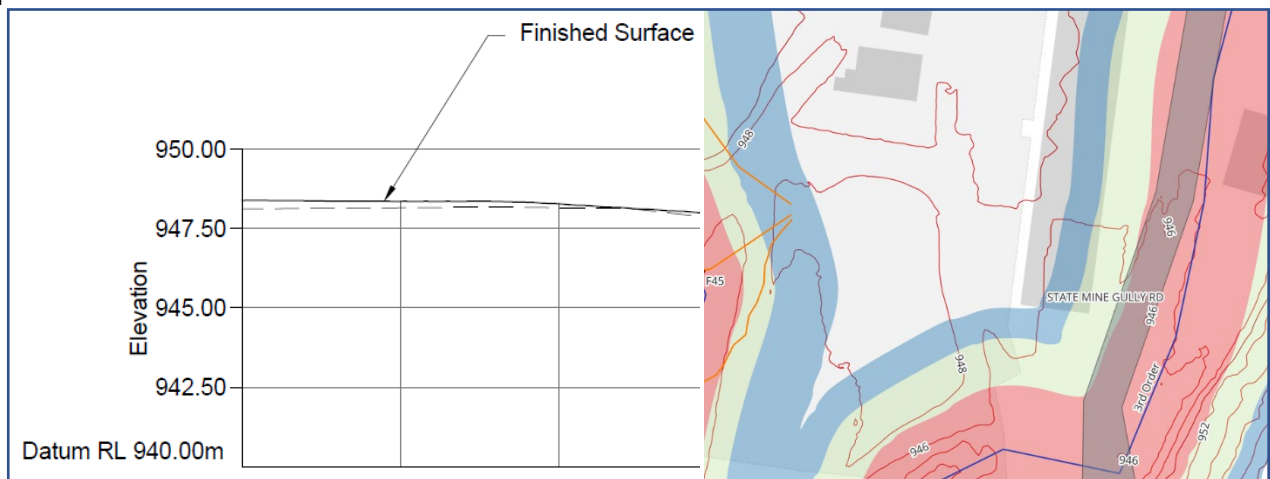
The LiDAR data has been proven to be correct where the vegetation is low. For example, a topographical survey completed by Integrated Consulting (qualified surveyor) shows that at the proposed car park at the Site, the AHD measurements match the NSW Special Services LiDAR:

**Figure 7: Surveyed AHD matches LiDAR AHD (948m) – likely consistent in low vegetation areas**

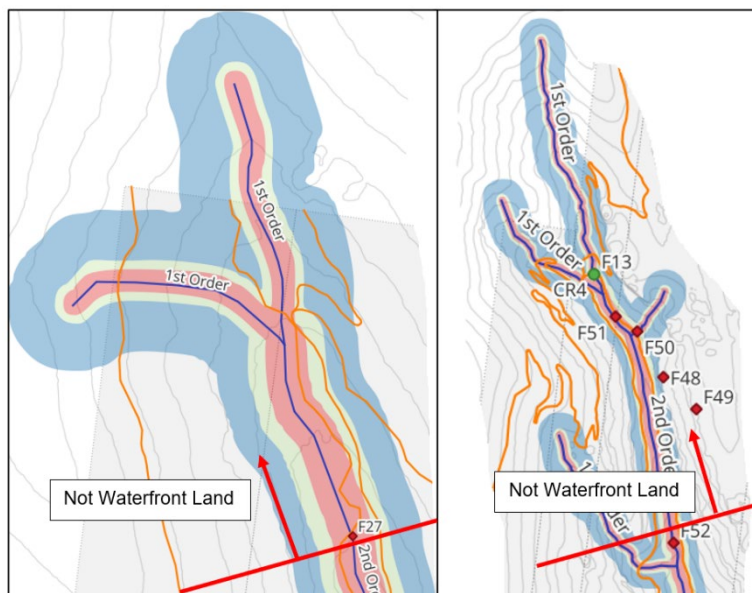
Based on these observations, there are a number of areas at the Site where, despite watercourses being identified on the NSW hydrolines, it is unclear whether these watercourses and the surrounding area would meet the definition of waterfront land under the WM Act. In particular, the adjacent 2 areas on Branch 2 and 3 do not appear to be waterfront land, as no bed or bank for the watercourse was visible – please refer to detailed features summary and photos.

**Figure 8. Areas that are not waterfront land as per photos.**

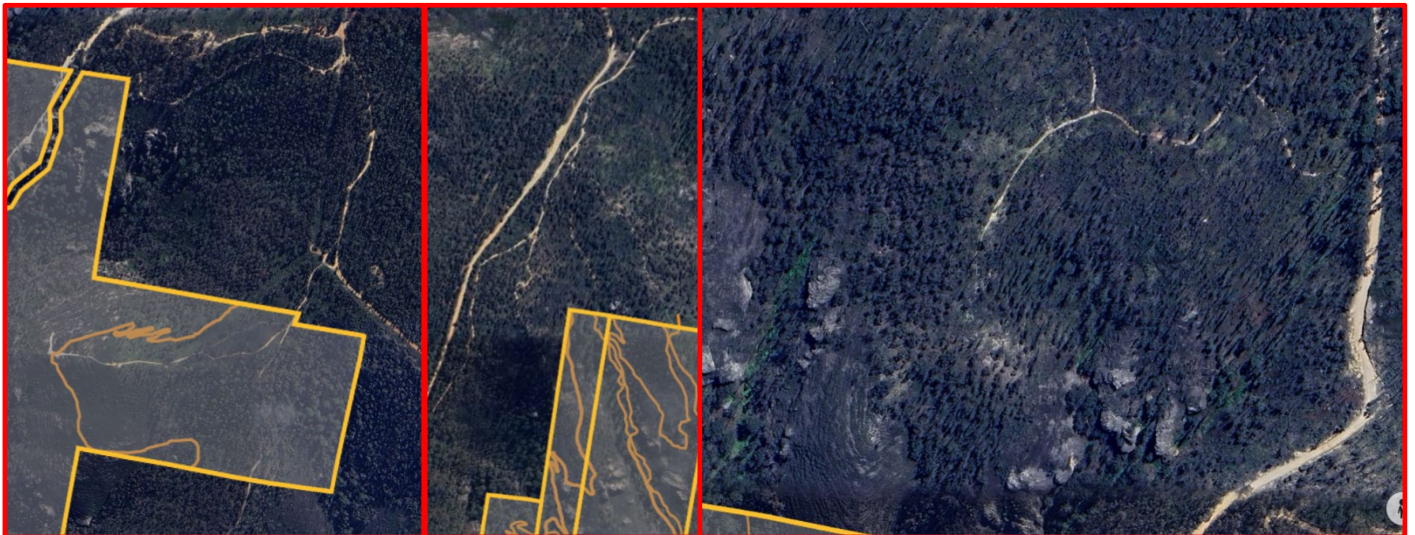
As evidenced by the site photographs (F1a, F1b, F1c, F1d, F2, F28a & F28b), the watercourses have been impacted in some areas by 4WD activity. This damage consists of 4 to 8 meters wide, unsealed and illegal roads that have been pushed through bushland directly in and adjacent to the creeks over decades (Particularly Branch 4). It is noteworthy that despite this illegal activity, turbidity measurements have remained low. Development of the Site as a mountain bike trail site could also assist in deterring the continuation of illegal 4WD activity.

**Figure 16. Extensive Upstream Illegal 4WD Damage**

Furthermore, the proposed trails construction and management, combined with increased visitation by the public, could assist in reducing illegal 4WD activity and improve the existing damage this has caused.
