JANUARY 20, 2017

# ARBORICULTURAL IMPACT ASSESSMENT 3-31 WALTER STREET,& 462 WILLOUGHBY ROAD,WILLOUGHBY,

# TREE INVENTORY 3-31 WALTER STREET, WILLOUGHBY

LEE HANCOCK LEE@LEEHANCOCKARBORIST.COM.AU AQF Level 5 Mobile 0408 582 871

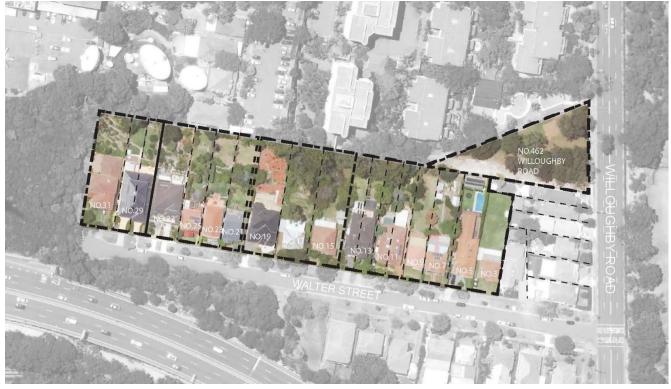
# 3. Site Map

Walter street, is a No Through Road carriageway sloping to the south east. The existing street trees are predominantly *Tristaniopsis laurina* with *Melaleuca citrina*, a small percentage of the remaining trees appear to have been planted by the residents of the street. The trees on the north side of the street are living in 6-metre-wide nature strips, while trees on the southern side of carriageway are living in 5.5metre nature strips.

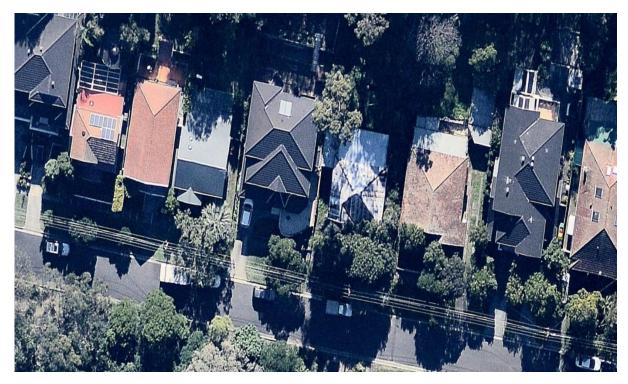
The sites are semi detached dwellings No. 11 and 11A are Federation era houses. While 13 – 13A is a modern dual occupancy building. Both buildings have long rear yards, the existing vegetation is predominantly native species.

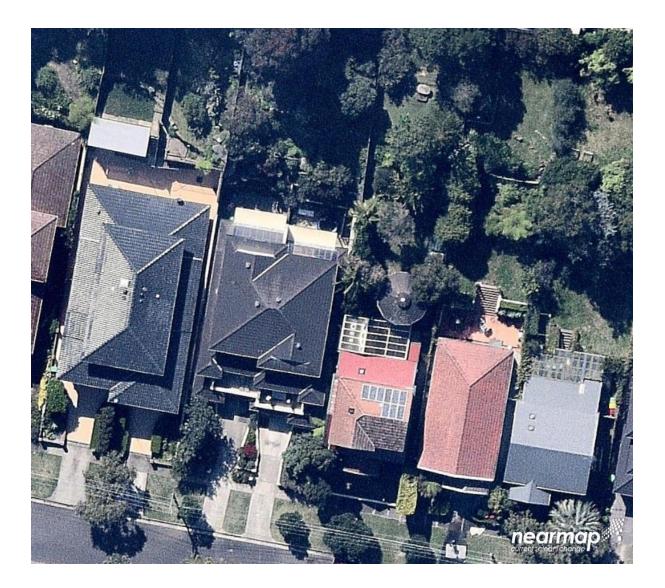
The sites face south at the base of a steep rock face which has necessitated in terracing all the rear yards of the properties. The existing vegetation of all properties are a mixture of native and exotic vegetation.
