Residential Subdivision of No. 105 Cooby Road, Tullimbar NSW

Report on Preliminary Geotechnical Assessment

Our Ref: TERRA18320.Rep1.Rev1

15 August 2019

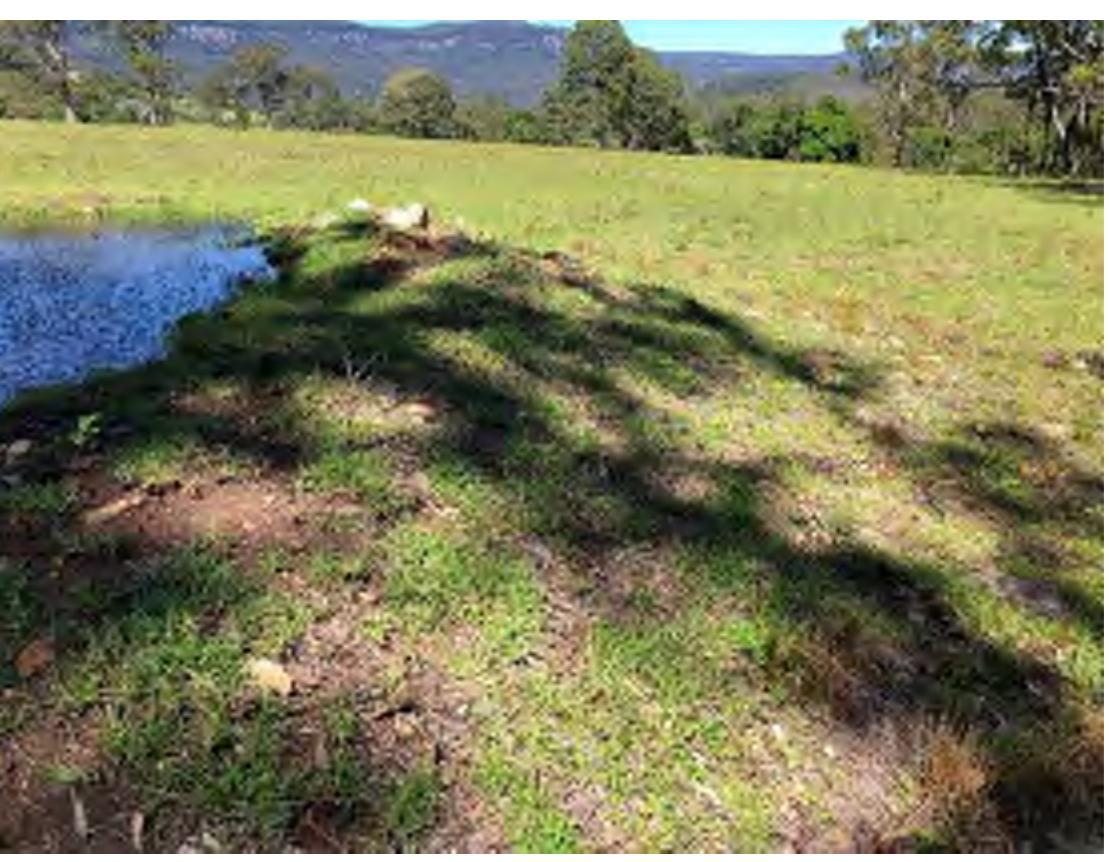
Photograph 4: looking south west at the northern wall of Dam South

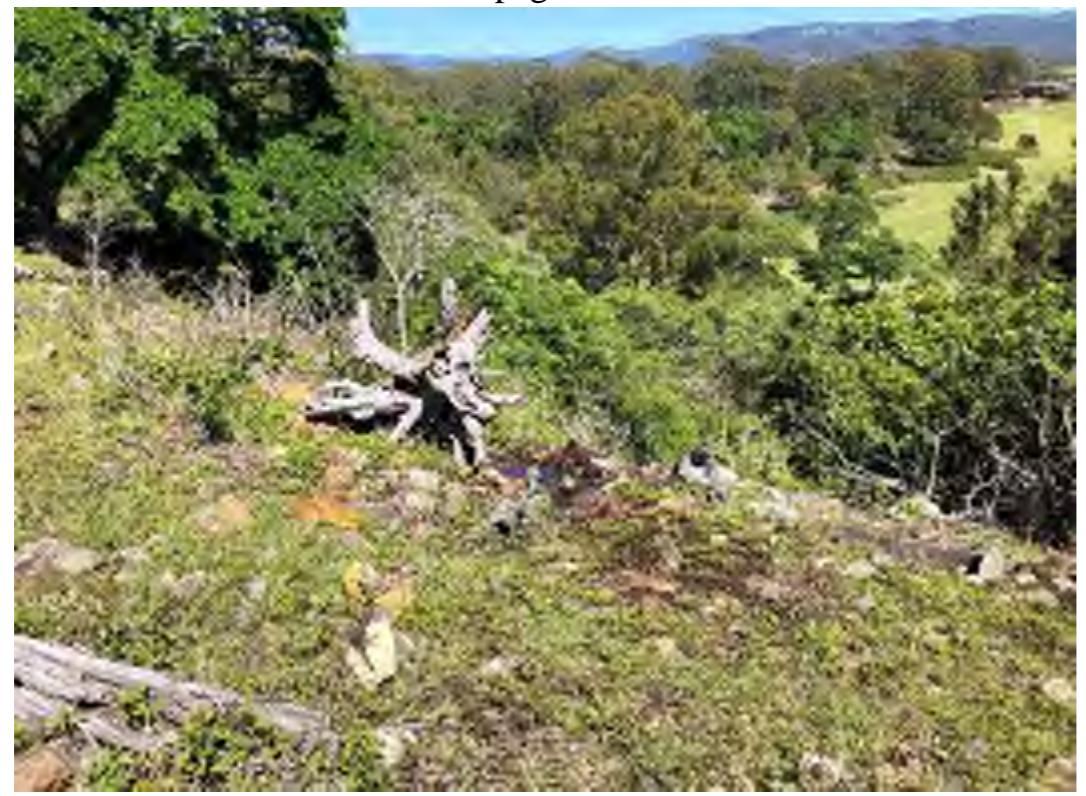
Photograph 7: looking west on the western edge of Terrace 1A, showing water and latite rock on Area 2s escarpment edge

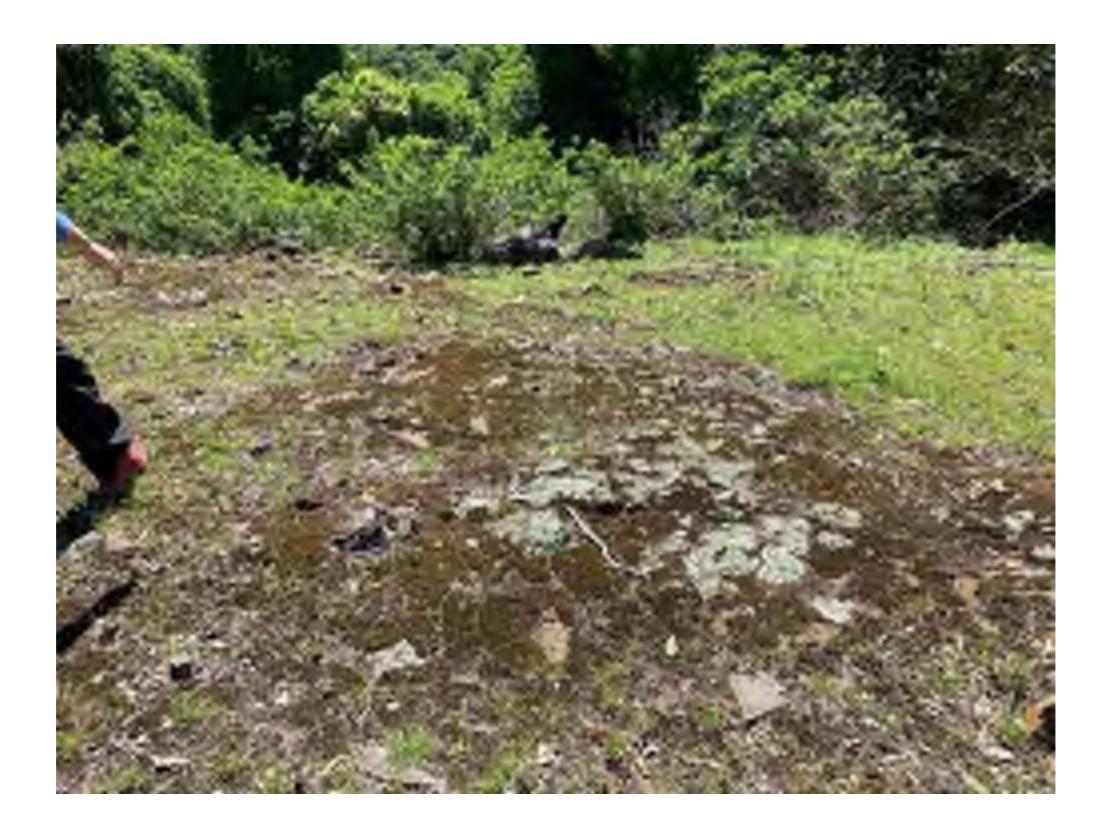
Photograph 15: Outcropping latite in the middle section of Terrace 1B

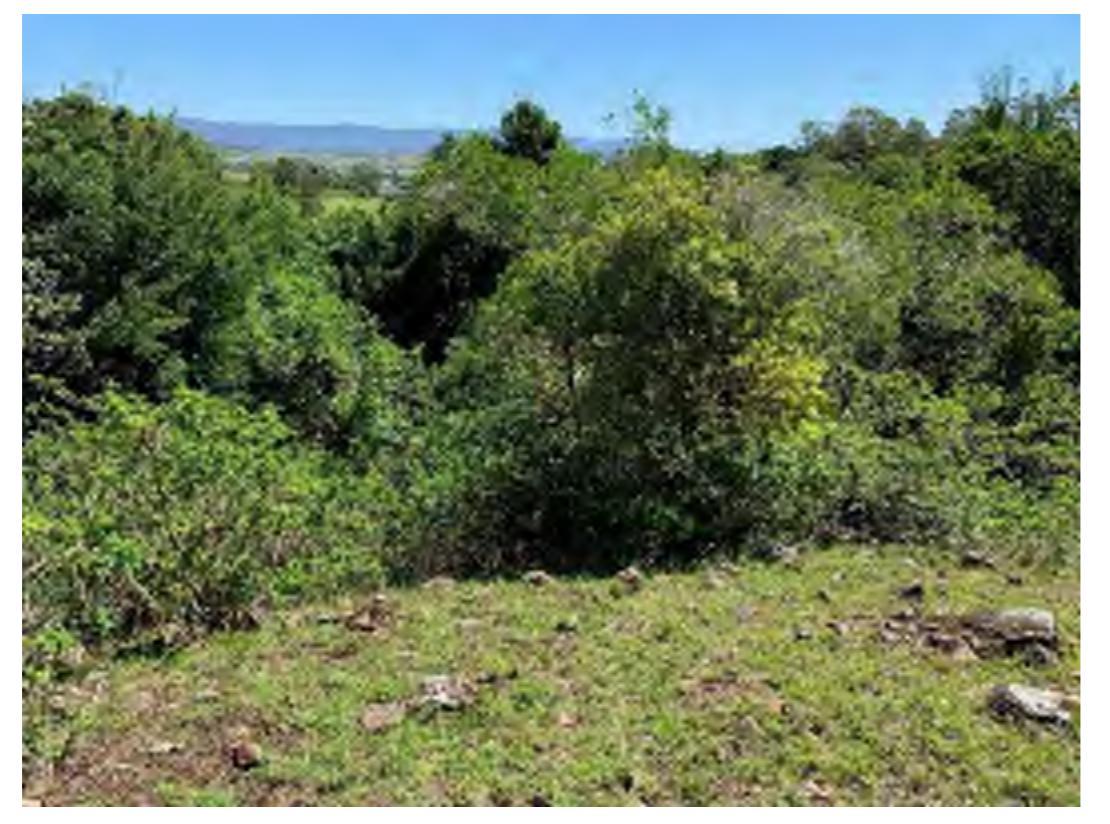
Photograph 23: View from the southern section of Terrace 1B looking north. Showing the steep drop and thick vegetation of Area 2

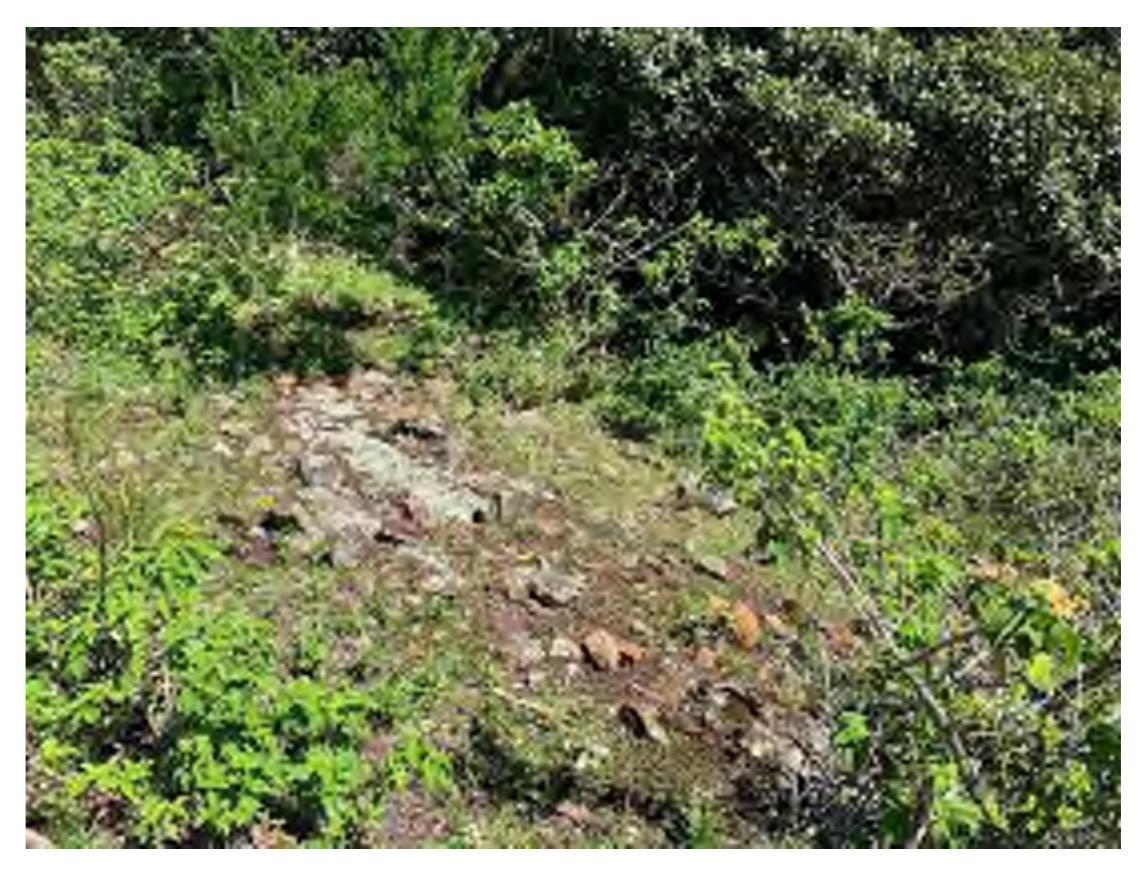
Photograph 24: Rock outcropping on the boundary of Terrace 1B and Area 2

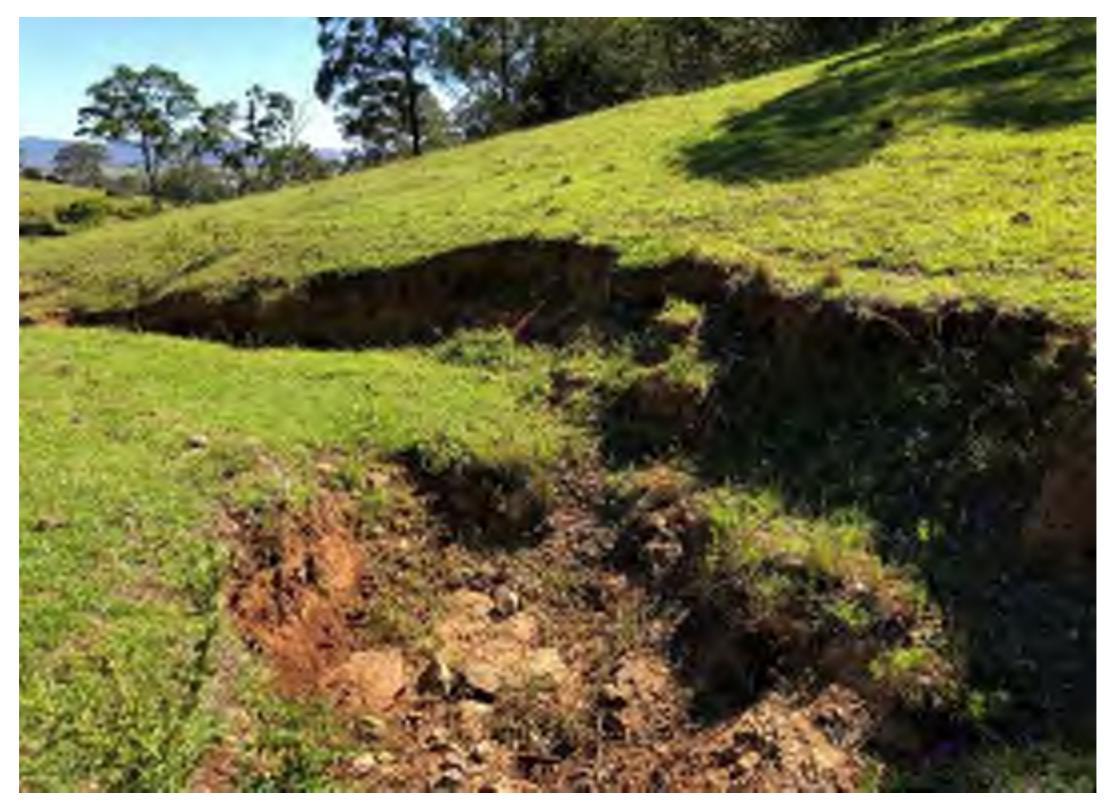
Photograph 39: View of heavy erosion of spill way on Dam West

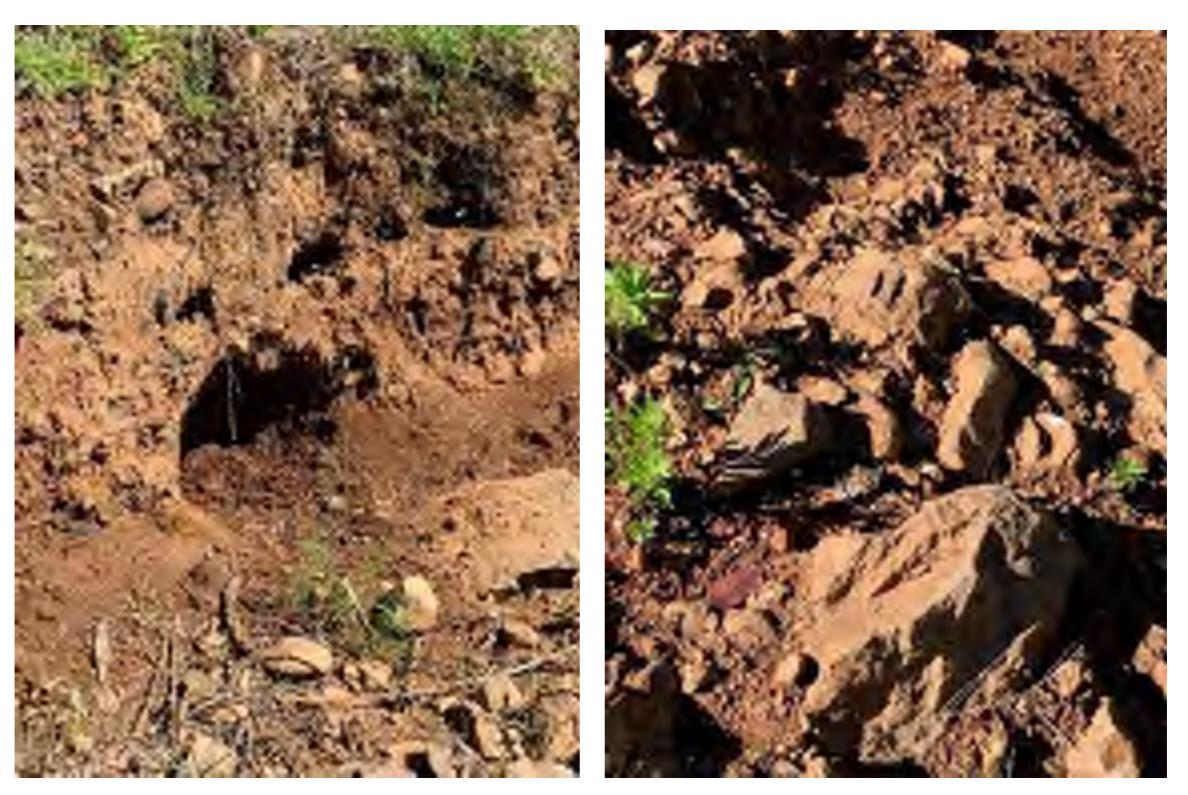
Photograph 40: View of colluvial sediments exposed by spill way erosion. Gravel and cobbles largely consist of sandstone with some latite from escarpments above

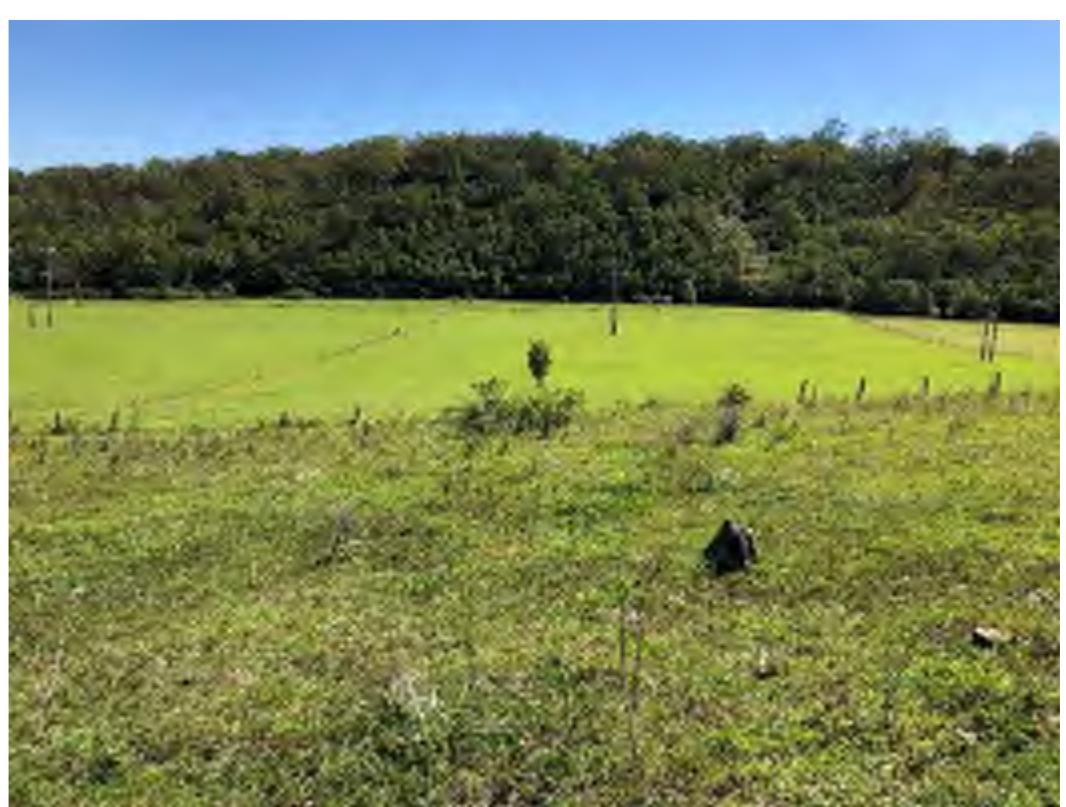
Photograph 52: View looking east in Area 3 showing medium sized latite boulder from Area 2 to the south

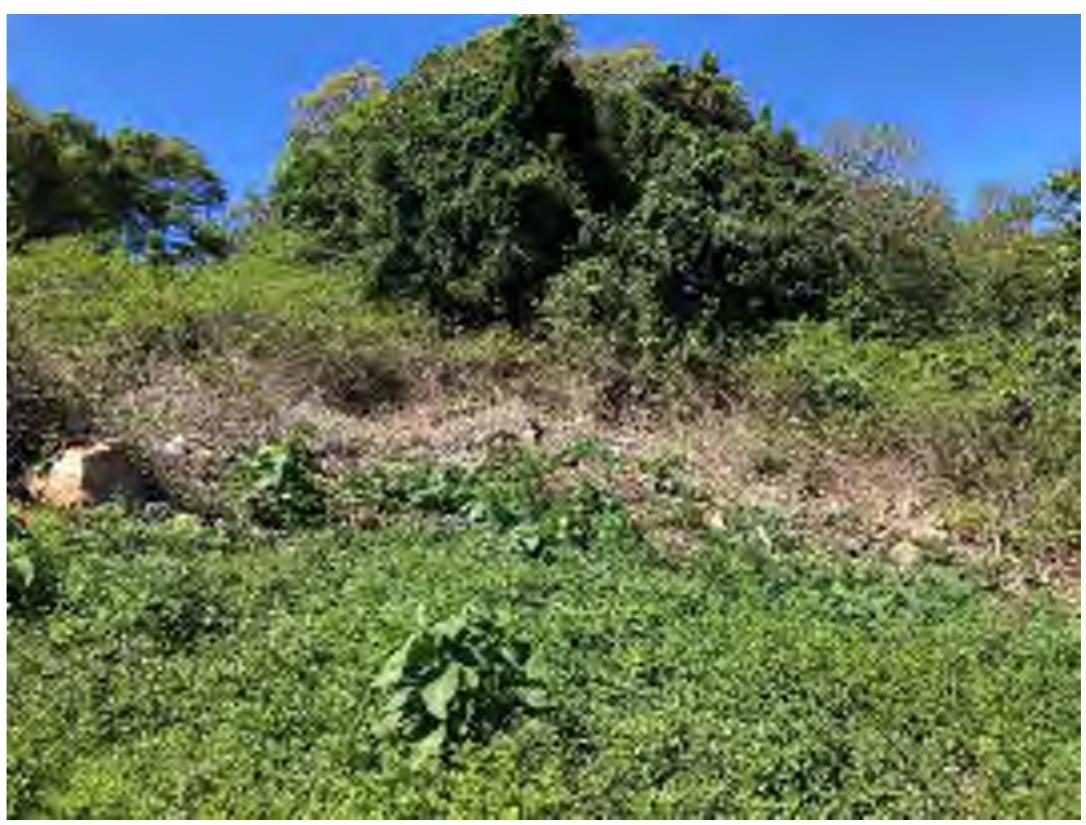
Photograph 56: North eastern Area 2, vegetated with boulders

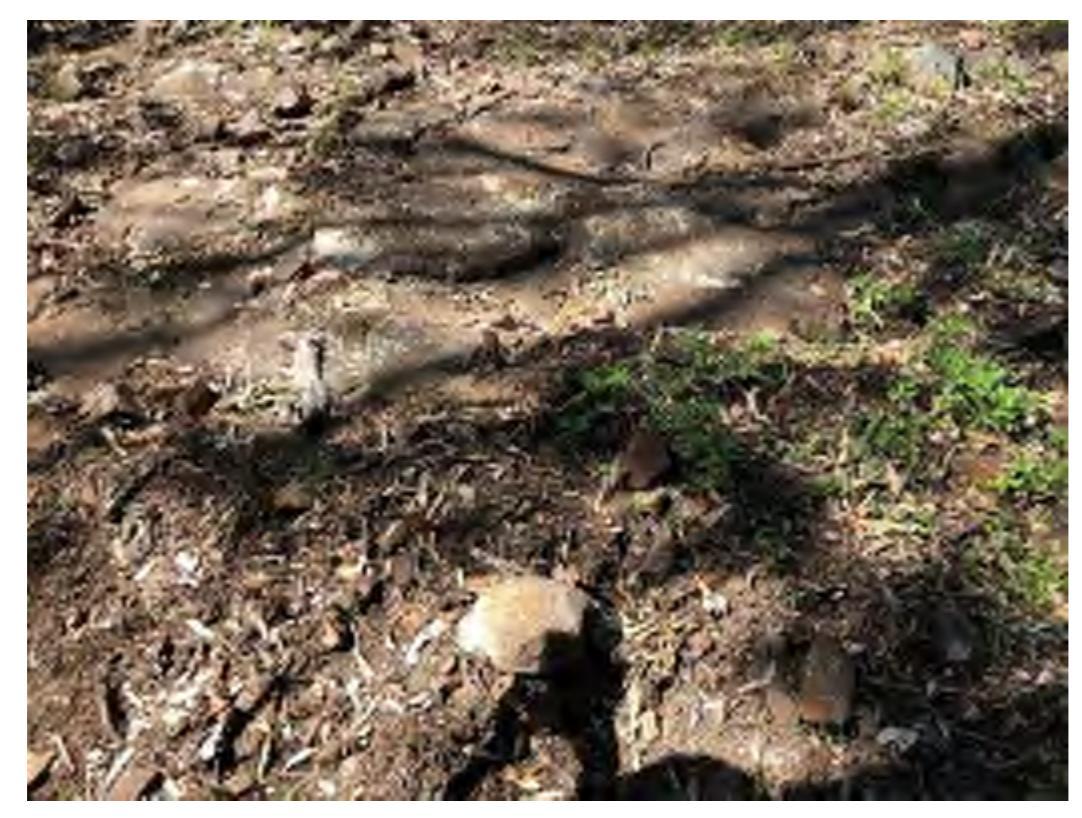
Photograph 59: Latite rock outcropping on access road in Area 2

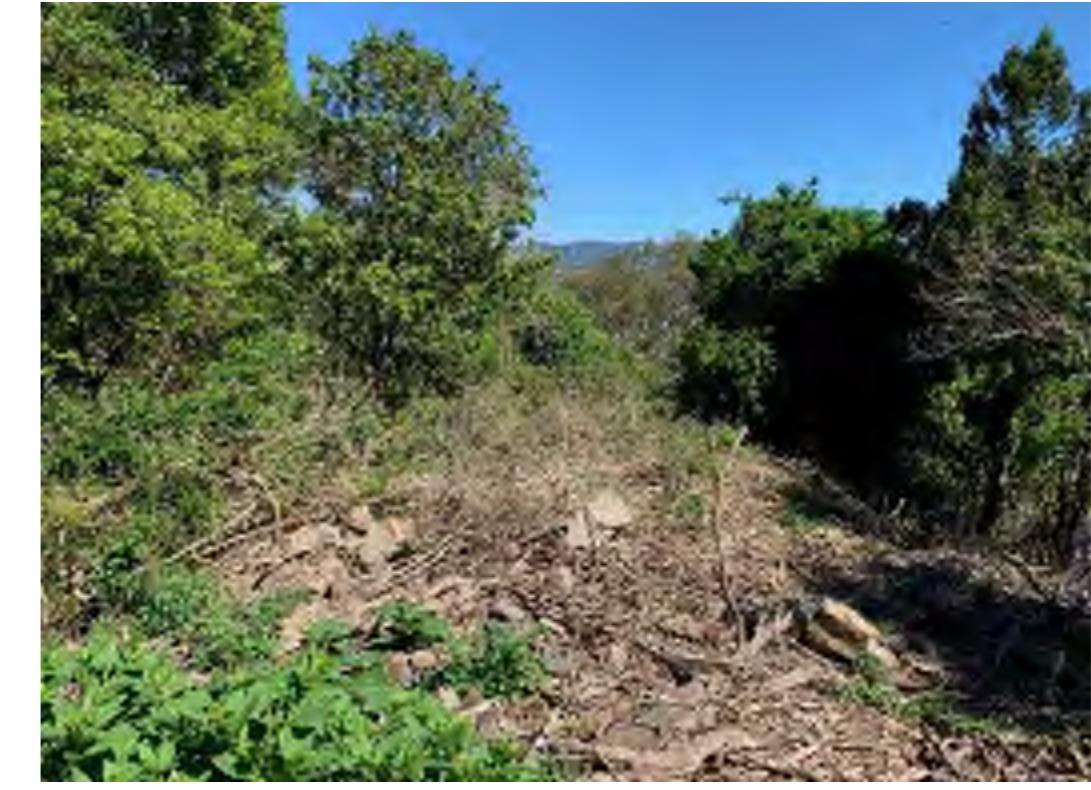
Photograph 62: View looking north from the top of Zone 4. Showing the thick vegetation and latite cobbles and boulders
