Report on
Desktop Geotechnical Assessment

Aland Leppington – Civic Centre
Lots 1 & 2 DP812366, 173 - 183 Rickard Road,
Leppington

Project 217600.01
August 2023

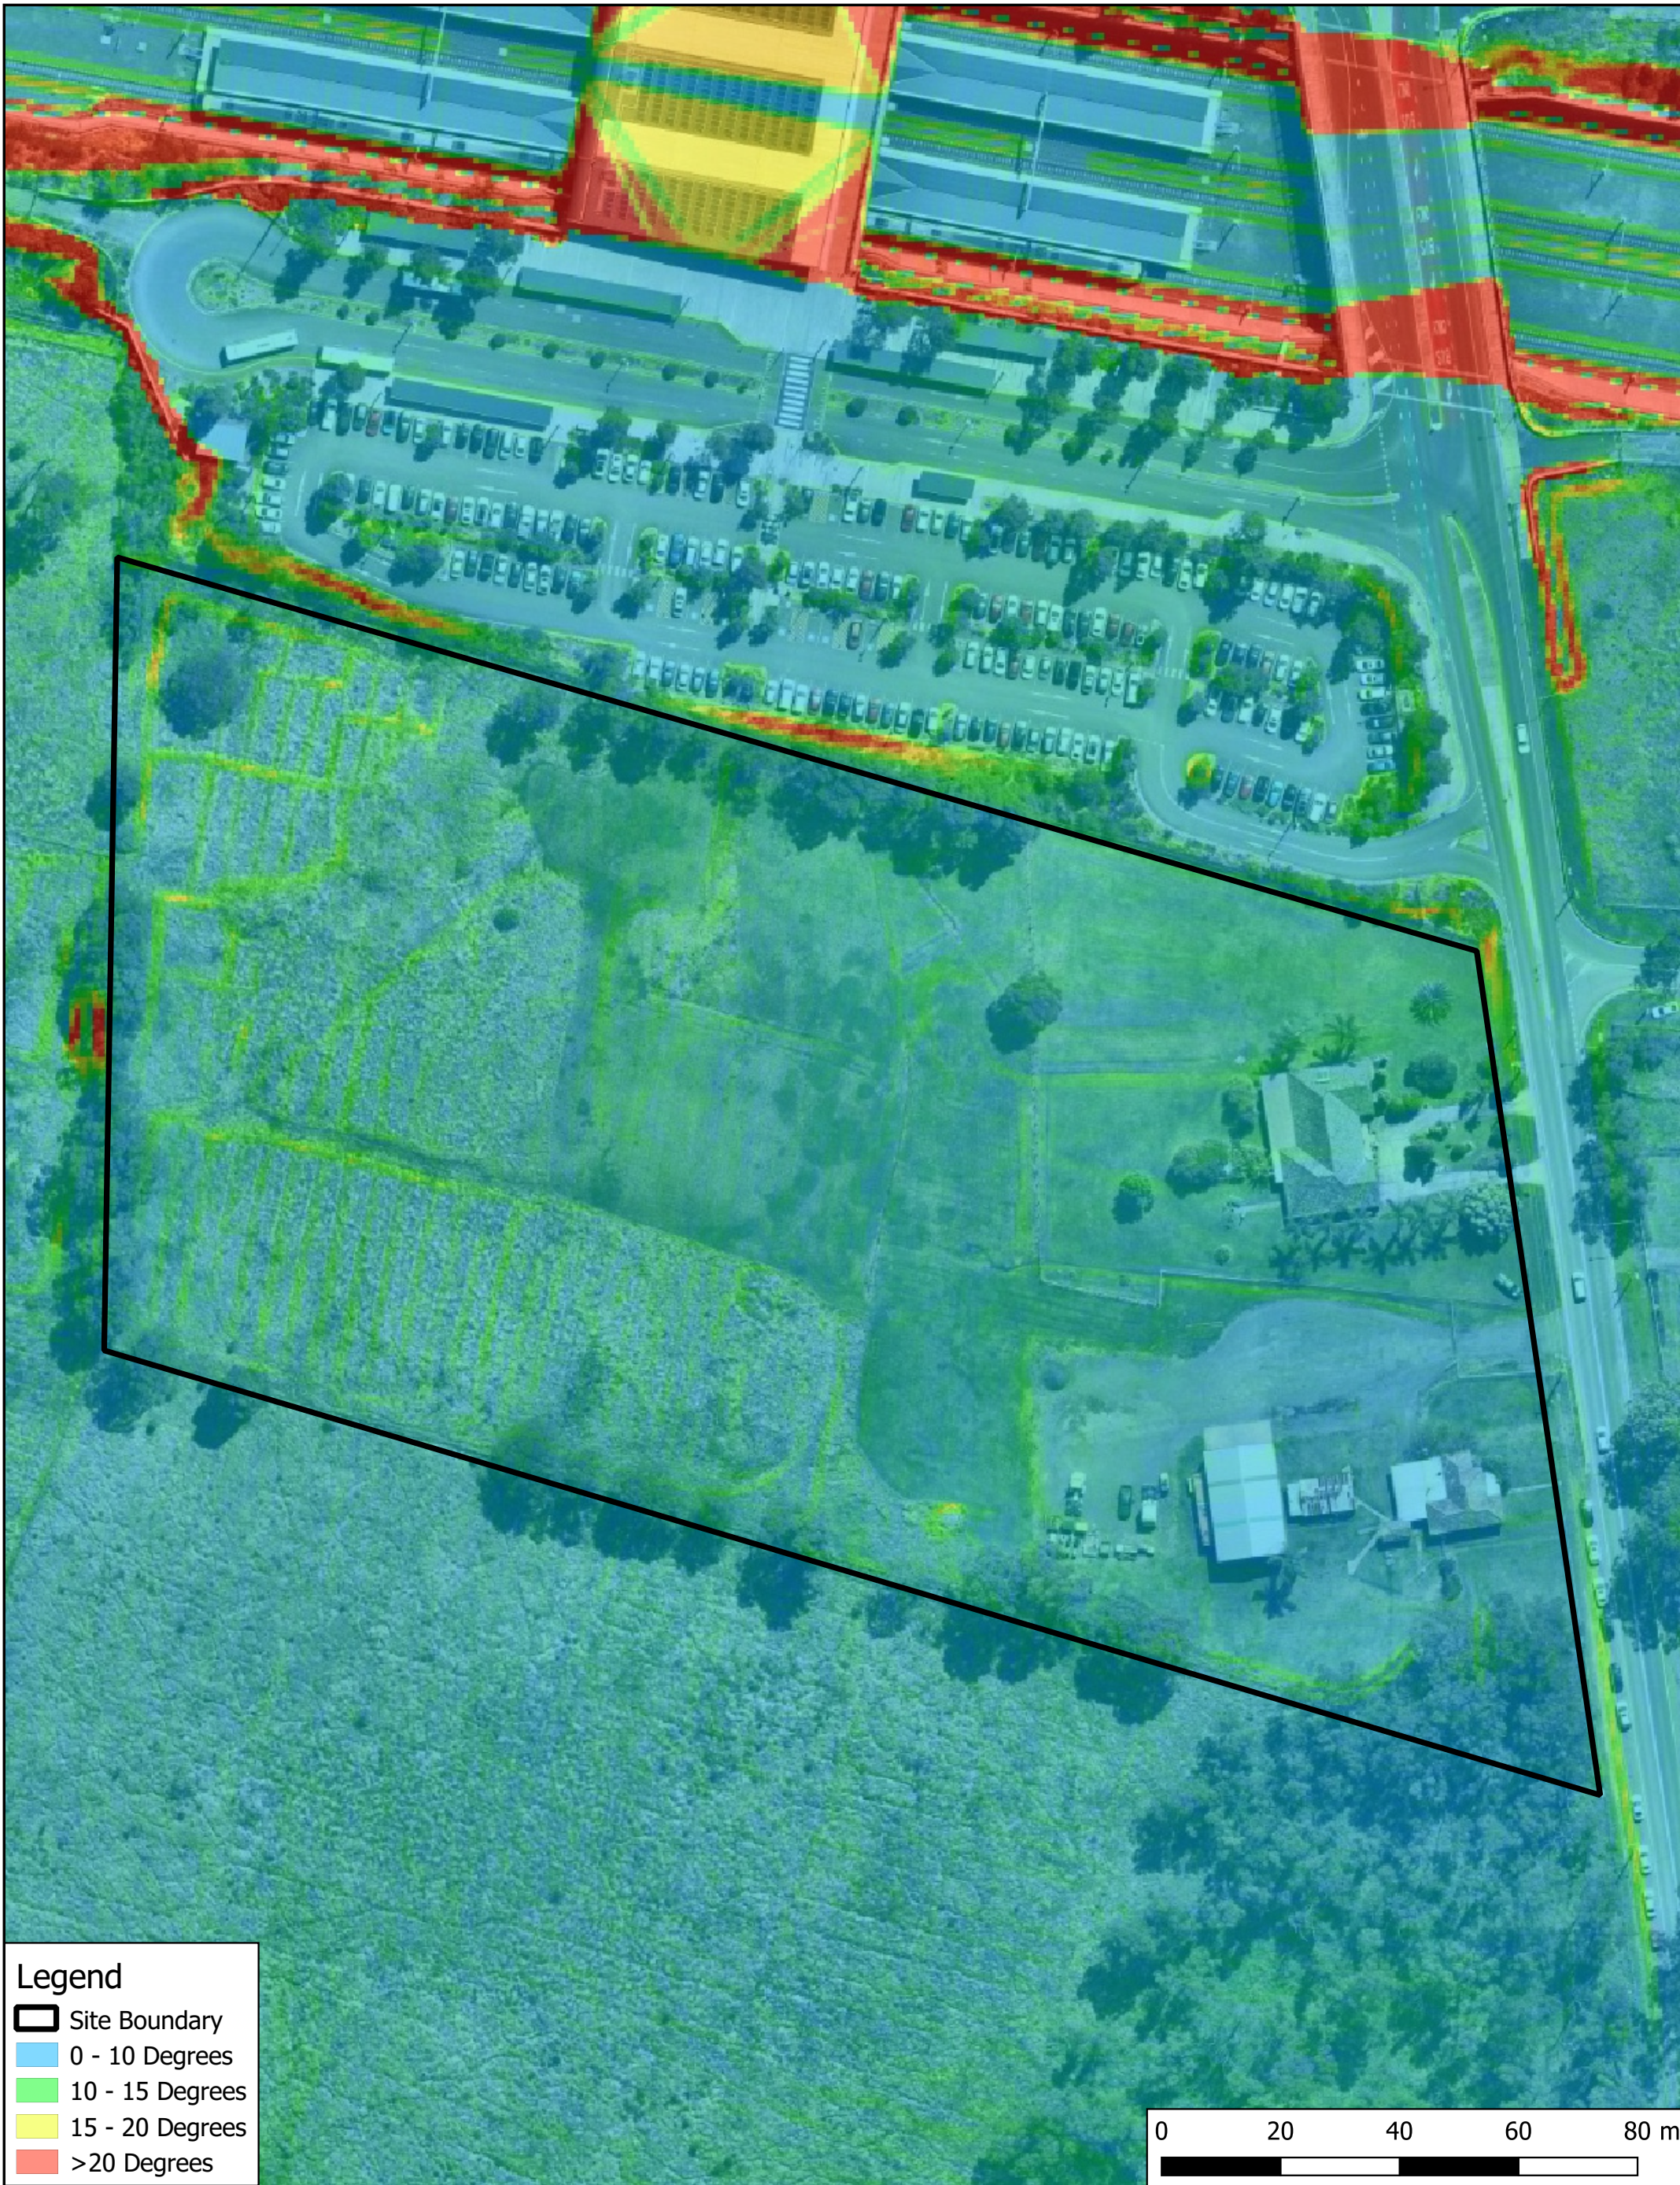
Desktop slope analysis mapping based on 2019 publicly available government LIDAR data (refer Drawing 2, Appendix B) was undertaken in conjunction with the site walkover investigation. In areas where steep grades were observed during the walkover (refer Section 5) and where noted on Drawing 2 in excess of approximately 15 – 20 degrees, care will be required to ensure that earthworks and excavation are undertaken in a safe manner and in accordance with design requirements. Any areas with steep grades that are to remain as part of the development must be assessed by a geotechnical engineer for stability and suitability.

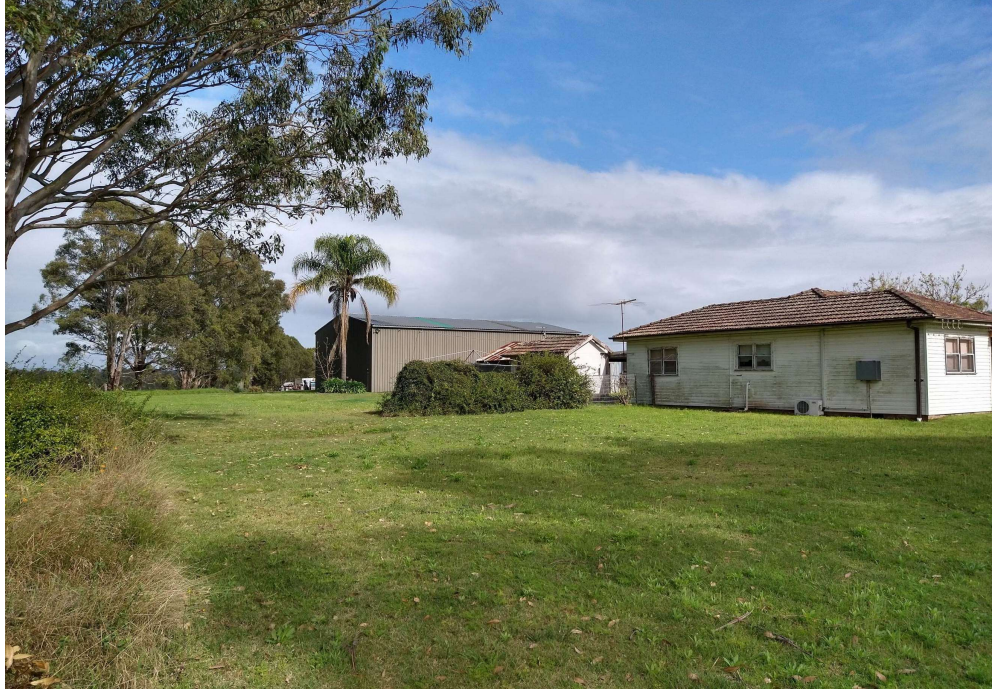
- The site has flat area adjacent Rickard Road in the location of the residences and workshop (Photos 1 and 2);
- Beyond the residences and workshop, the site gently slopes down to the north west at grades of generally 5 – 15 degrees (Photo 3);
- No evidence of recent slope instability on the site.

- The sites were occupied by multiple residential dwellings and workshops/sheds (Photos 1 and 4); and
- Overhead electrical services were observed along the Rickard Road site boundaries (Photo 7).

Photograph 1 - Residence and shed, looking north west from south east boundary

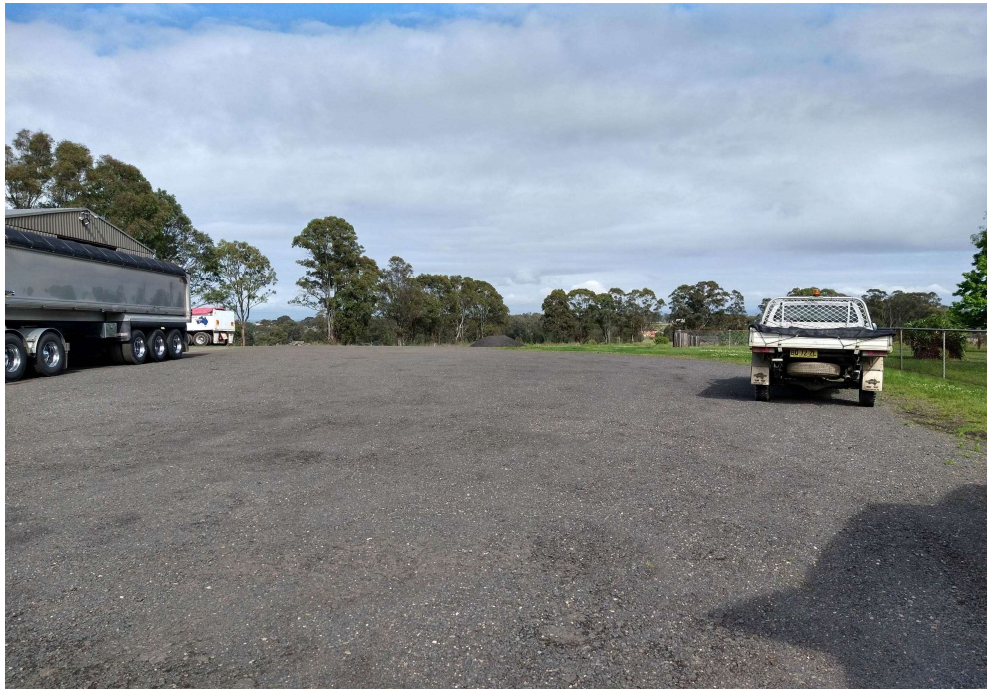
Photograph 2 - Looking west from gravel hardstand

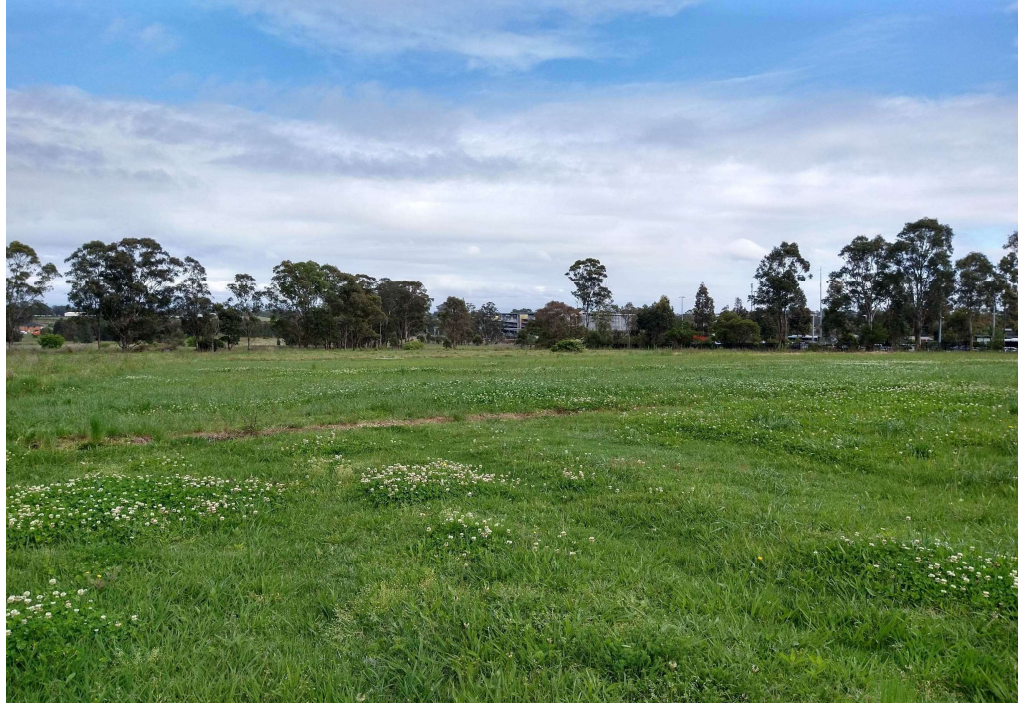
Photograph 3 - Centre of site looking north west

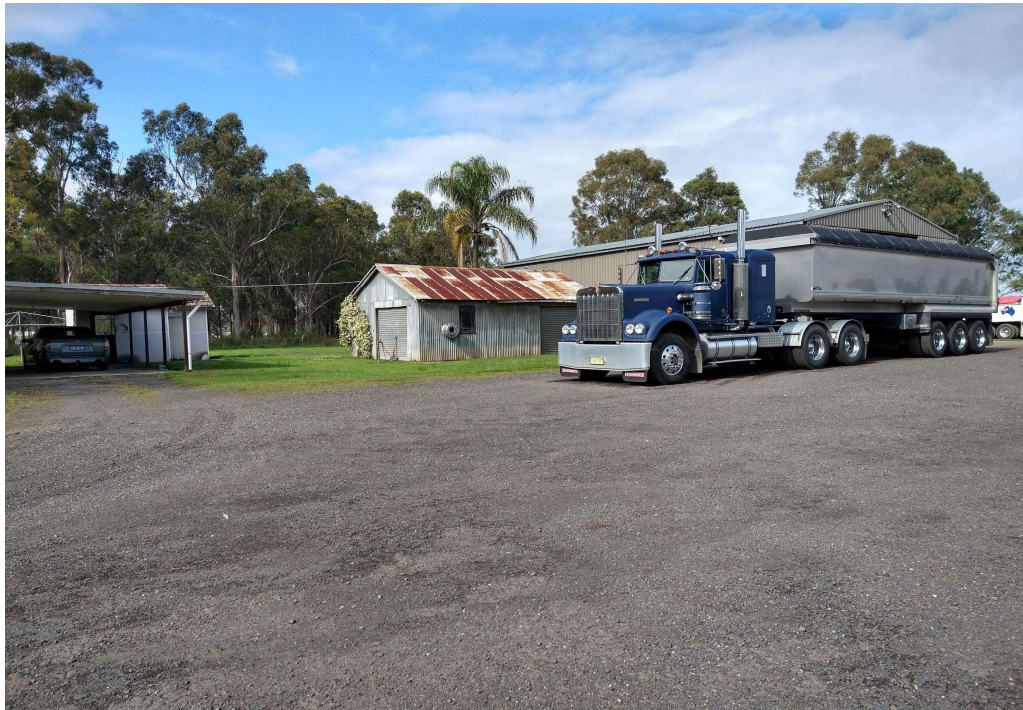
Photograph 4 - Workshop

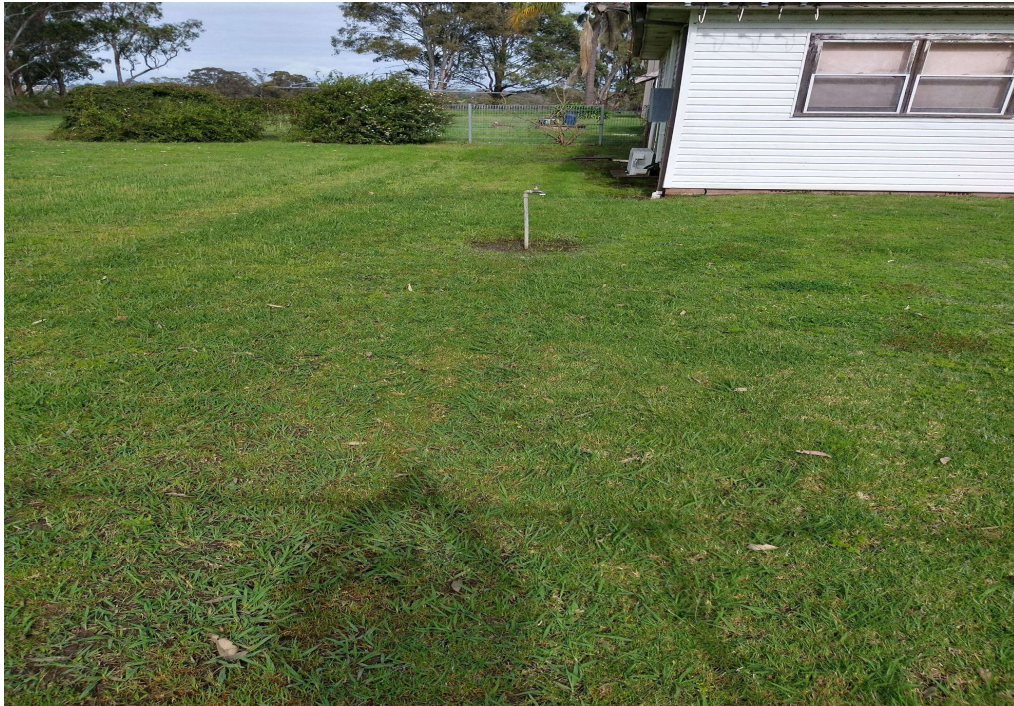
Photograph 5 - Water services adjacent residence in south east of site

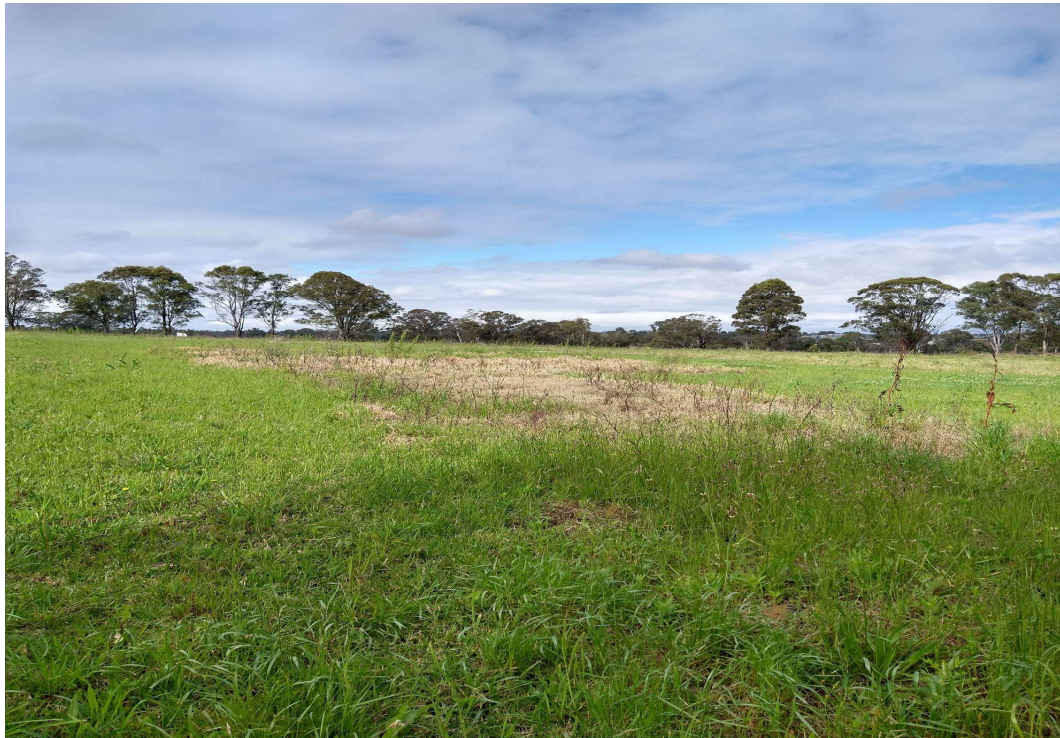
- Multiple structures were observed across the sites including the residences, workshops, sheds and installed services along with hardstands and unsealed driveways. Fill is expected to be present and associated with these structures and areas where earthworks have been undertaken on site (Photos 7 and 8); and
- Uncontrolled fill was observed in the eastern part of the site, refer Drawing 1 (Photo 6).

Photograph 6 - Uncontrolled fill in north west, looking south

- Stripping of topsoils;
- Removal of all uncontrolled fill;
- Test rolling of exposed subgrades;
- Cutting (where required) to achieve design levels; and
- Placement of controlled fill in accordance AS3798 2007 Guidelines on Earthworks for Commercial and Residential Development.

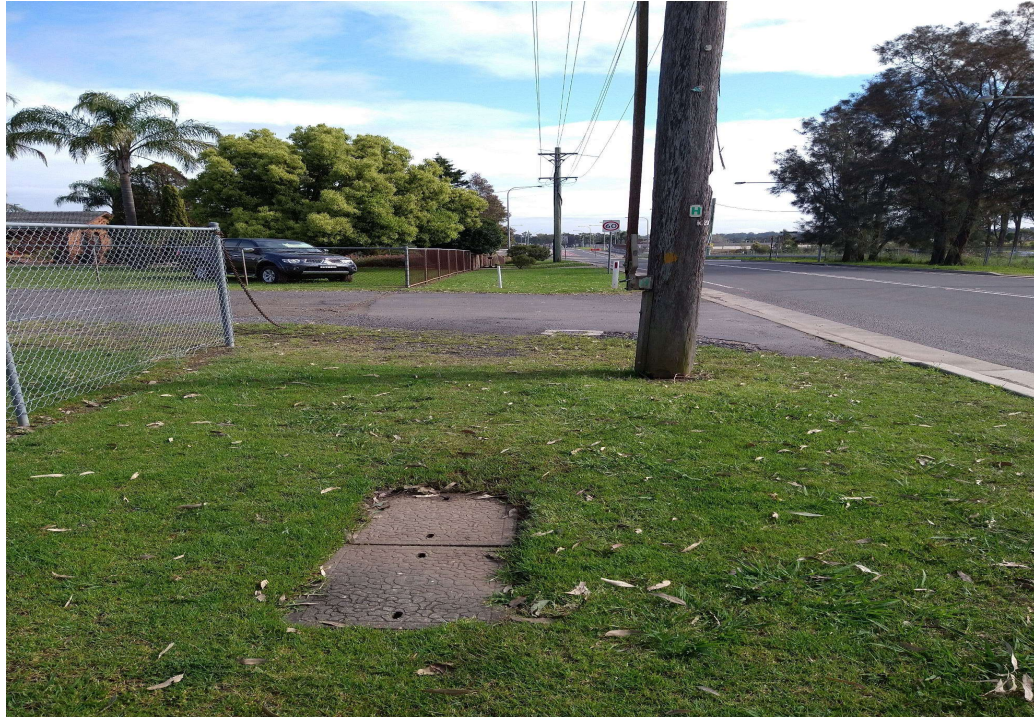
- Underground services, including telecom and water, were observed within the site (Photos 7 and 8); and
- Underground pipe appearing to be connected to the house was observed to the south of the residence (Photo 9).

Photograph 7 - Telstra pit and overhead electrical services along Rickard Road

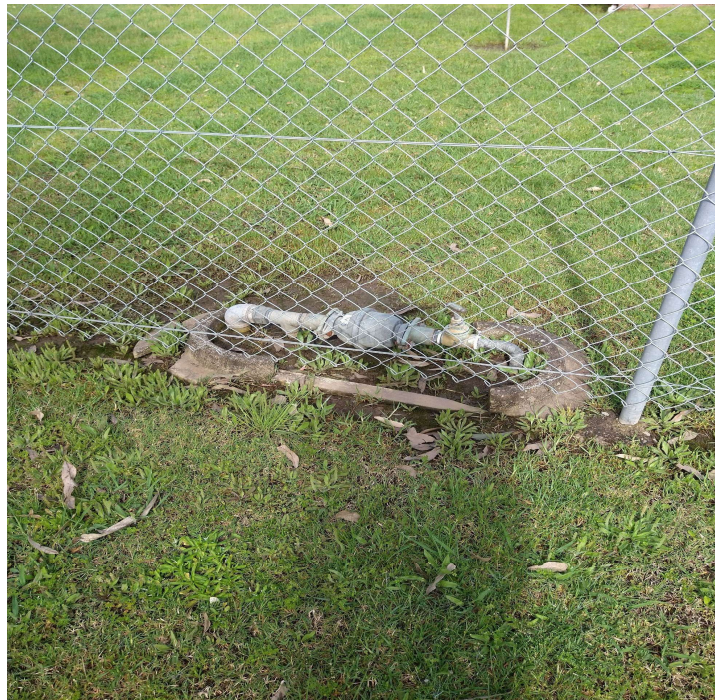
Photograph 8 - Water services along Rickard Road boundary

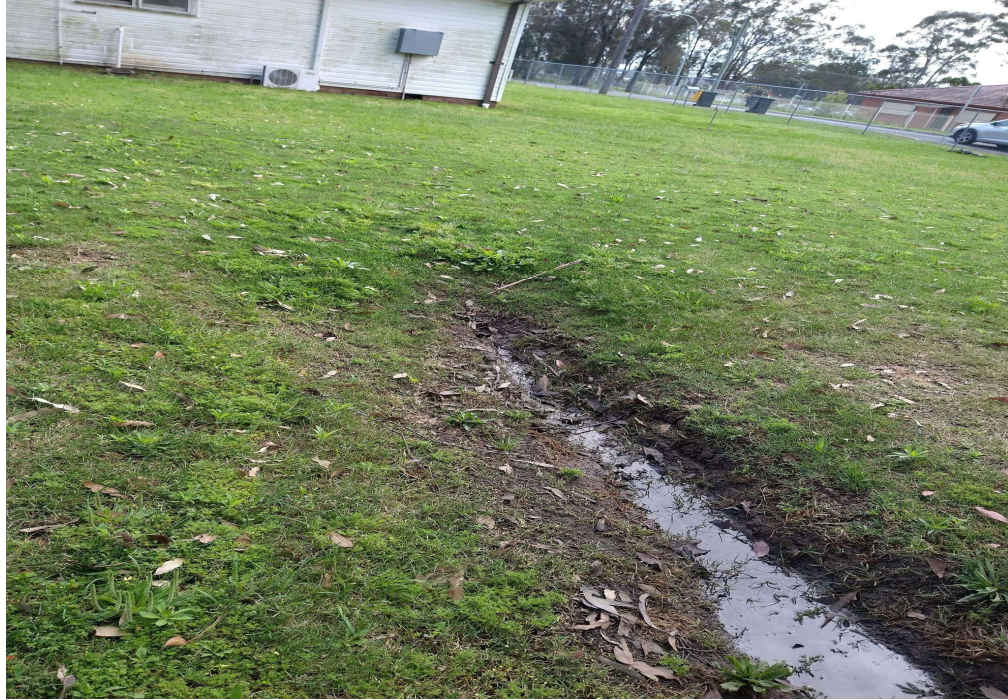
Photograph 9 - Underground pipe connected to southern residence

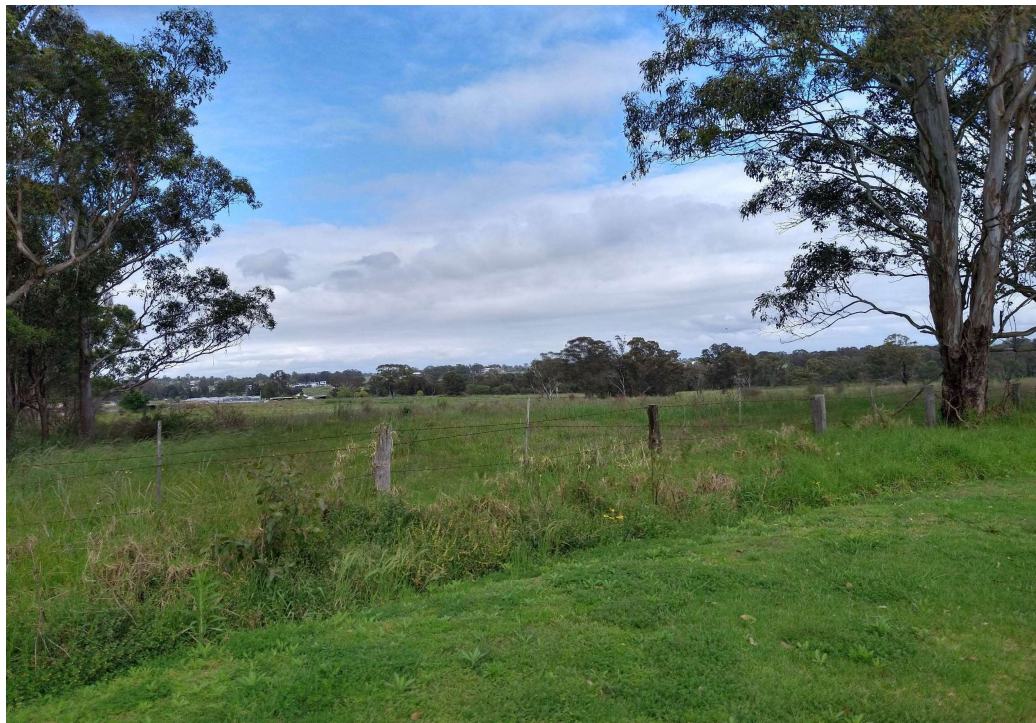
- Water logging was observed along the southern boundary (Photo 10) and in the central area where a drain had been constructed (Photos 11 and 12);
- No surface erosion or salt efflorescence was observed.

Water logging may be a constraint to development in the lower-lying areas of site, as noted on Drawing 1. Further investigation should be undertaken including borehole or test pit excavation to determine soil moisture profiles.

Photograph 10 - Waterlogging along southern boundary

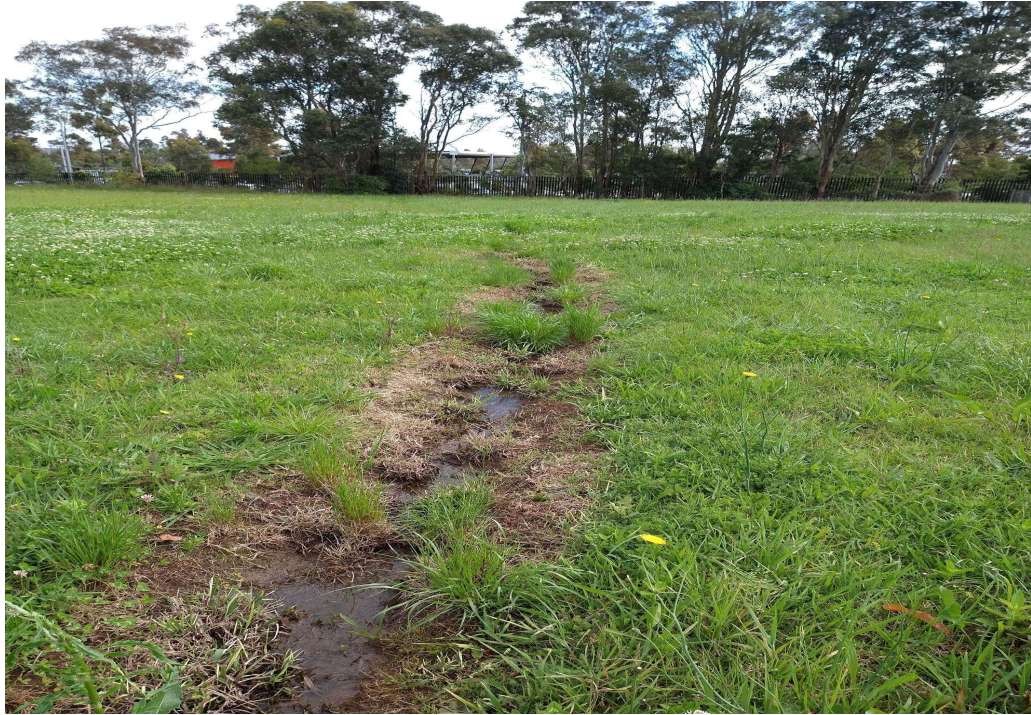
Photograph 11 - Waterlogging in central area looking north

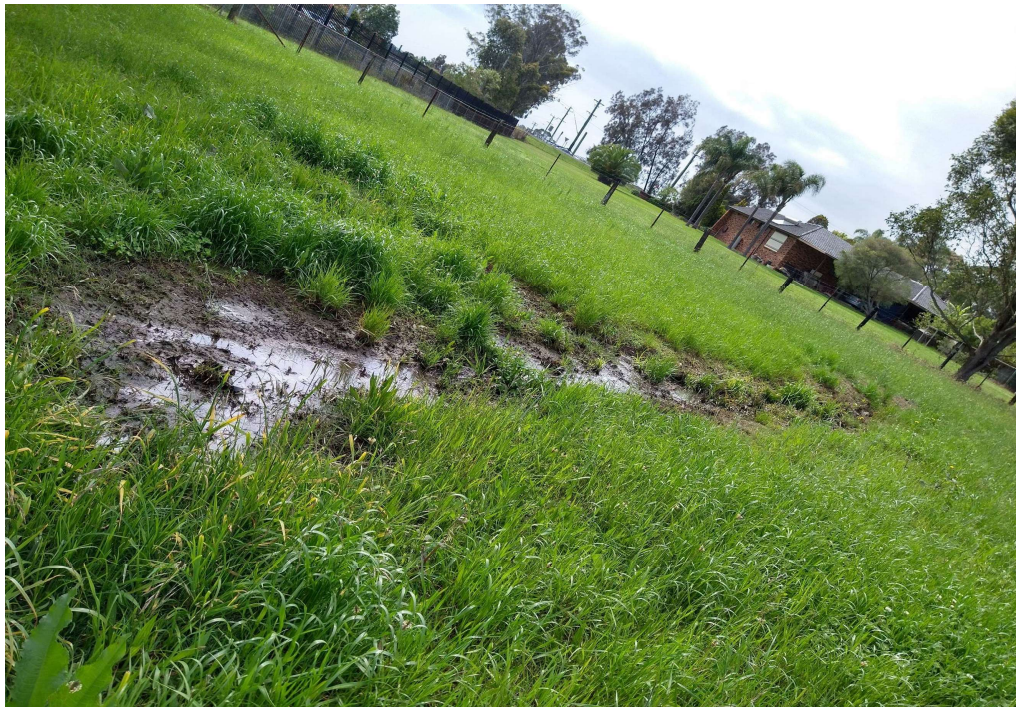
Photograph 12 - Waterlogging in central area looking east
