Report on
Desktop Geotechnical Assessment

Aland Leppington – Residential Core
Lots 37 & 38A DP8979, 156 - 166 Rickard Road,
Leppington

Project 217600.01
August 2023

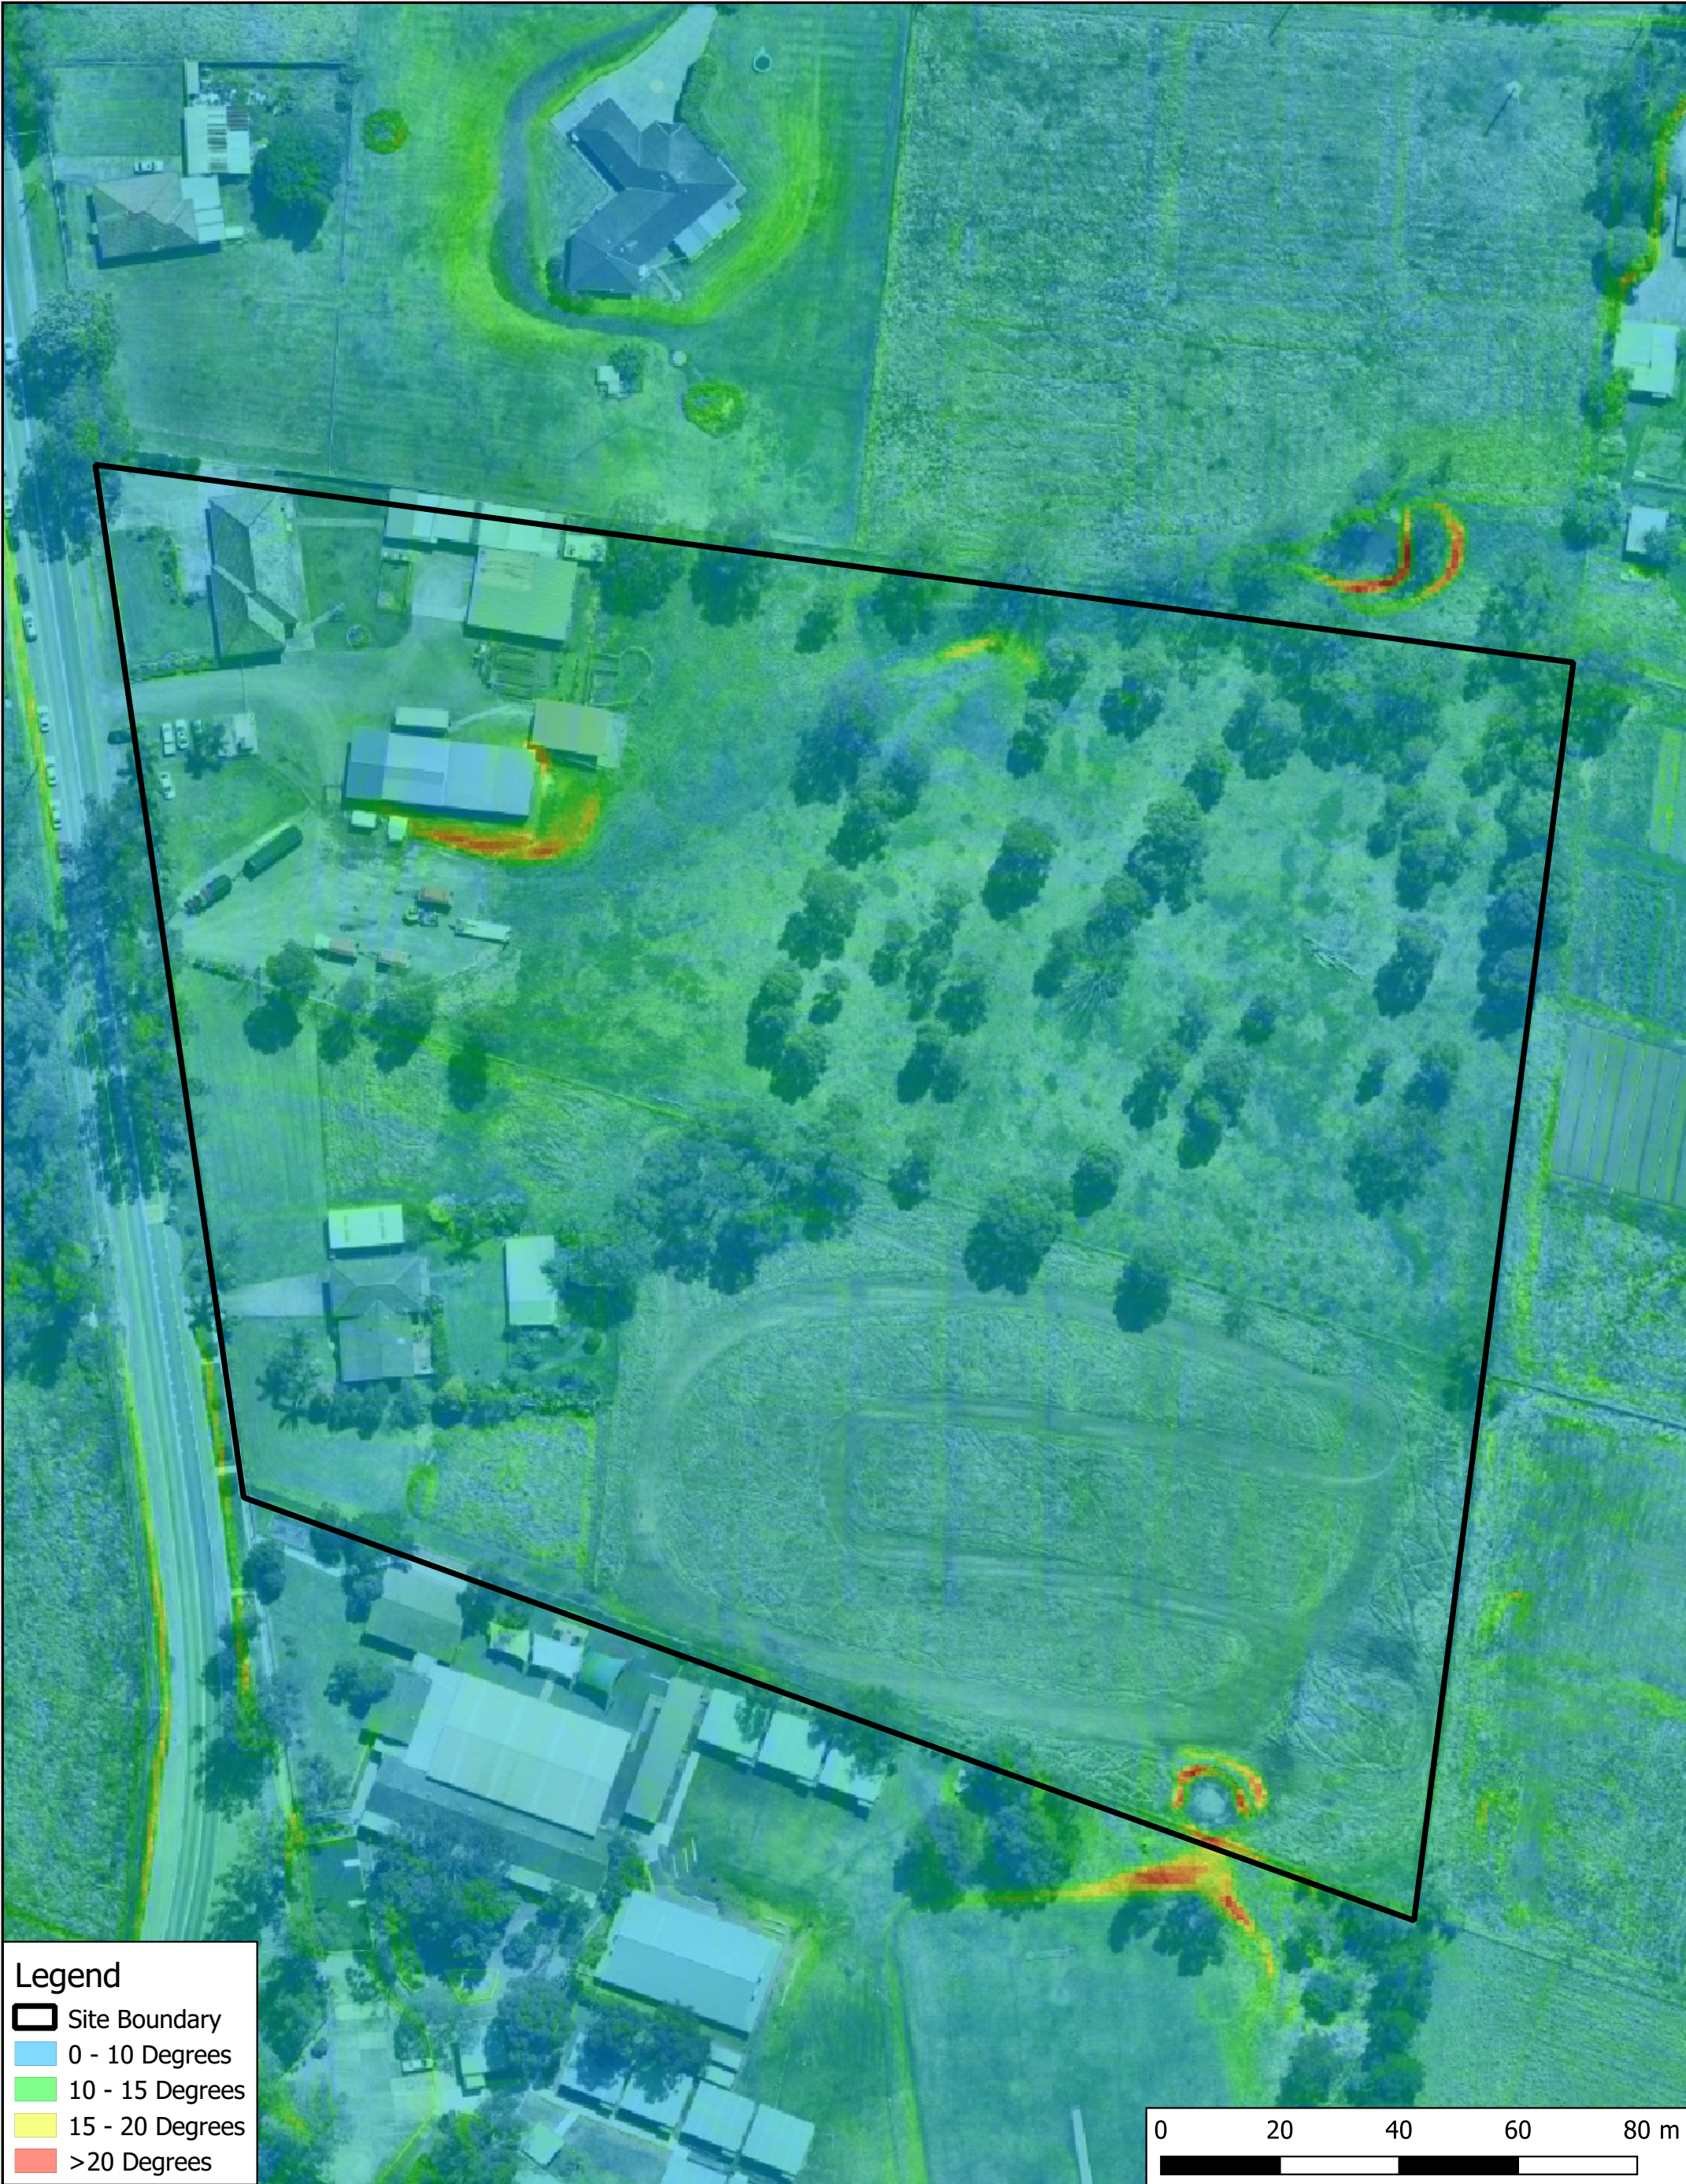
TITLE: **Slope Analysis Plan**
Desktop Geotechnical Assessment
Lots 37 & 38A DP8979, 156-166 Rickard Road, Leppington

Desktop slope analysis mapping based on 2019 publicly available government LIDAR data (refer Drawing 2, Appendix B) was undertaken in conjunction with the site walkover investigation. In areas where steep grades were observed during the walkover (refer Section 5) and where noted on Drawing 2 in excess of approximately 15 – 20 degrees, care will be required to ensure that earthworks and excavation are undertaken in a safe manner and in accordance with design requirements. Any areas with steep grades that are to remain as part of the development must be assessed by a geotechnical engineer for stability and suitability.

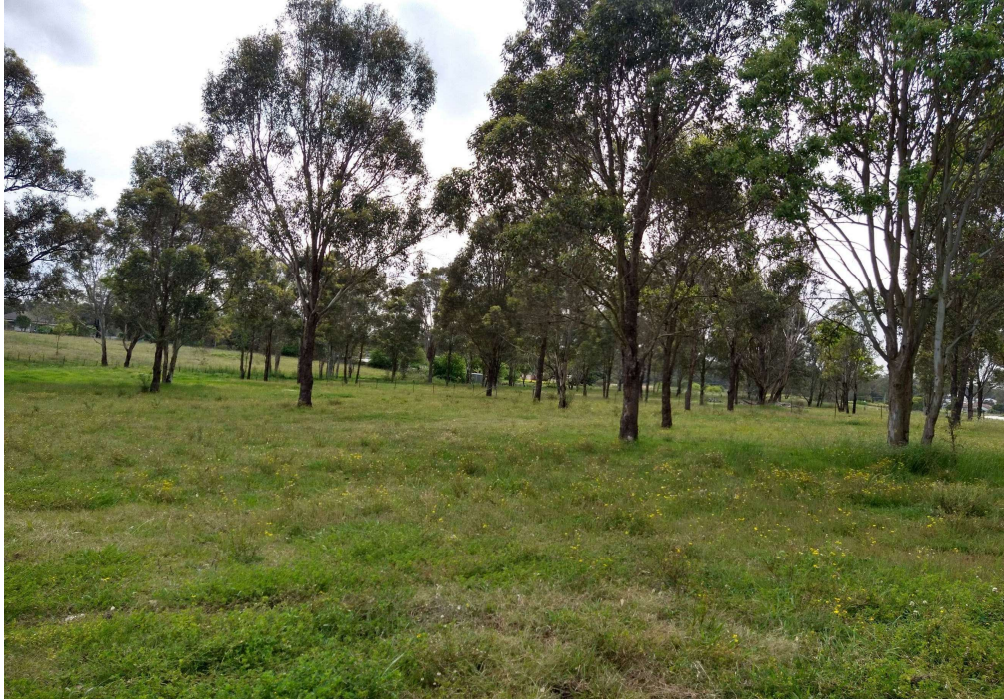
Photograph 1 - View looking north from center

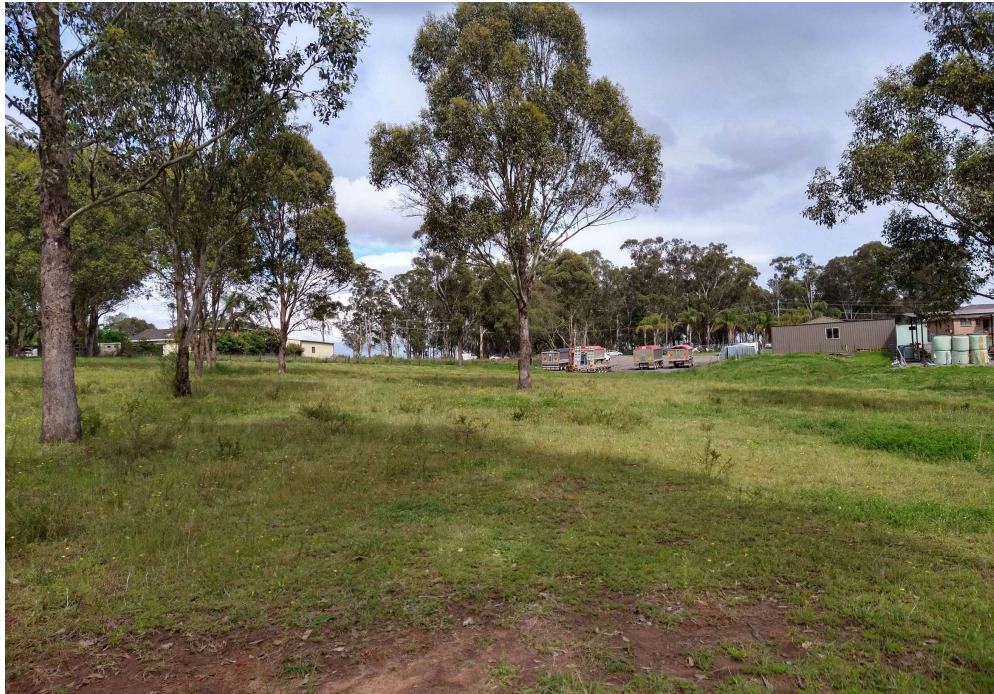
Photograph 2 - View looking west from northern area

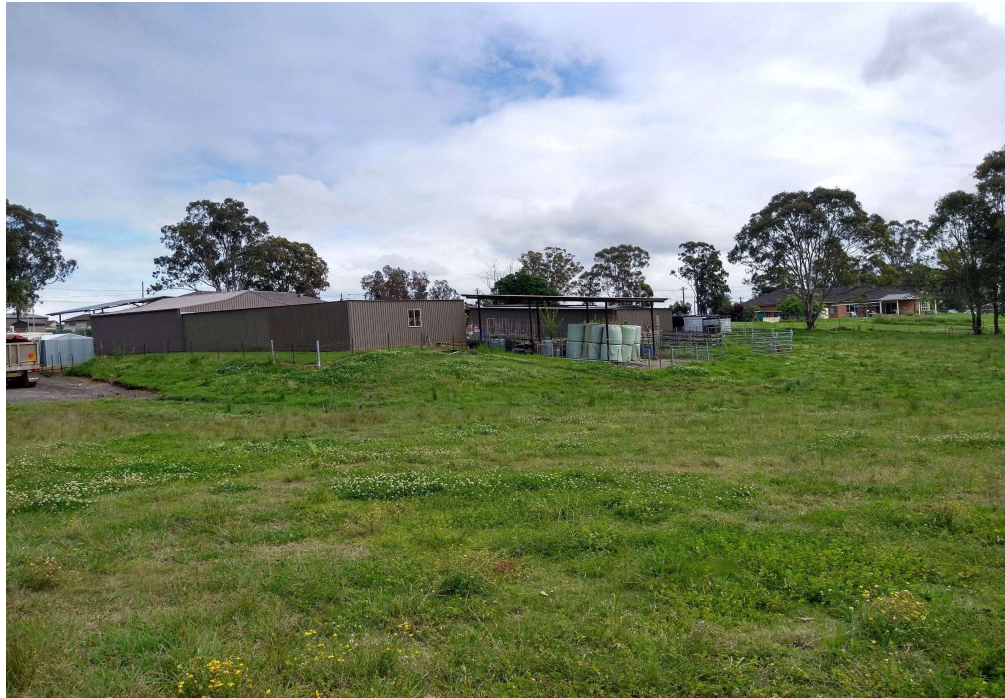
Photograph 3 - Batter adjacent shed

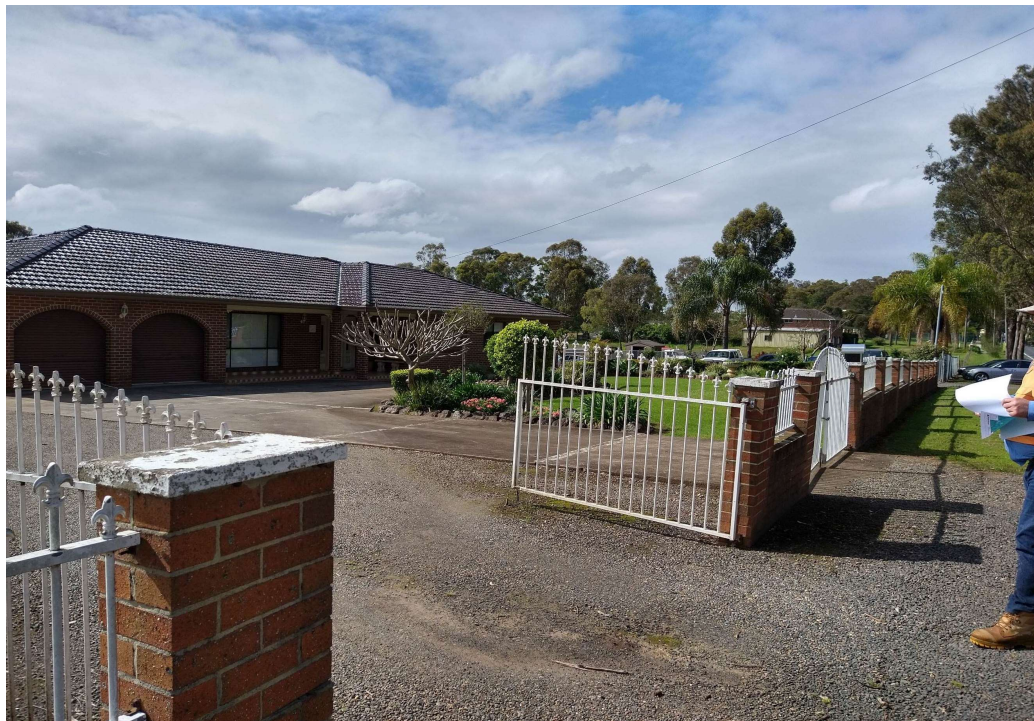
- The sites were occupied by multiple residential dwellings and workshops/sheds (Photos 1 and 6); and
- Overhead electrical services were observed along the Rickard Road site boundaries (Photo 4).

Photograph 4 - Northern residence

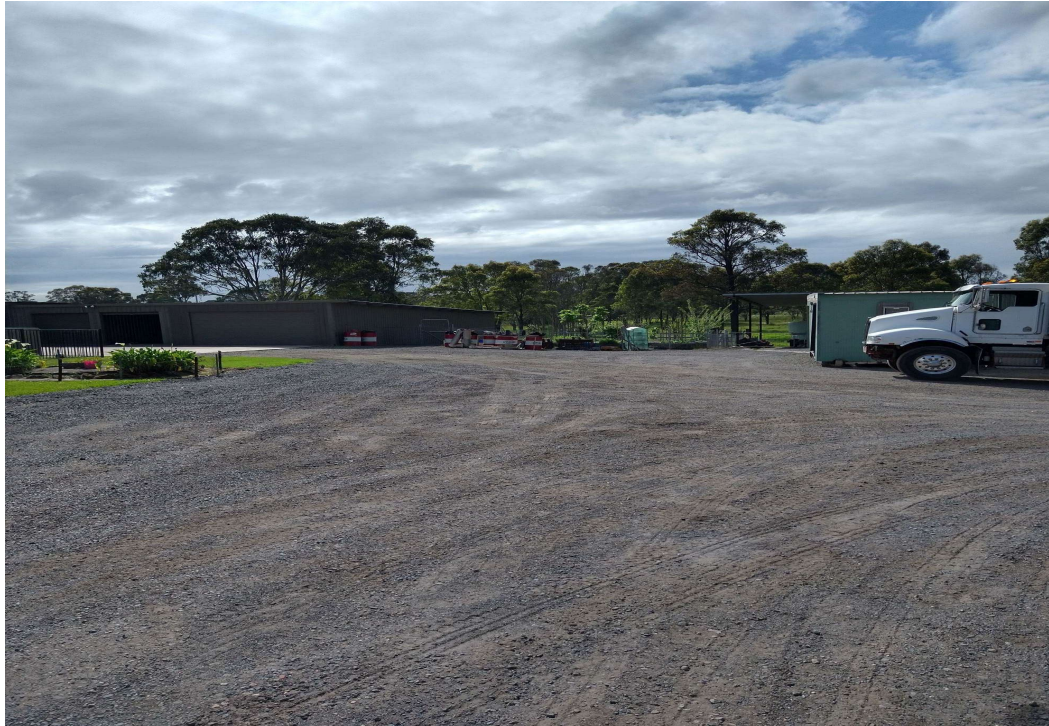
Photograph 5 - Hardstand looking east

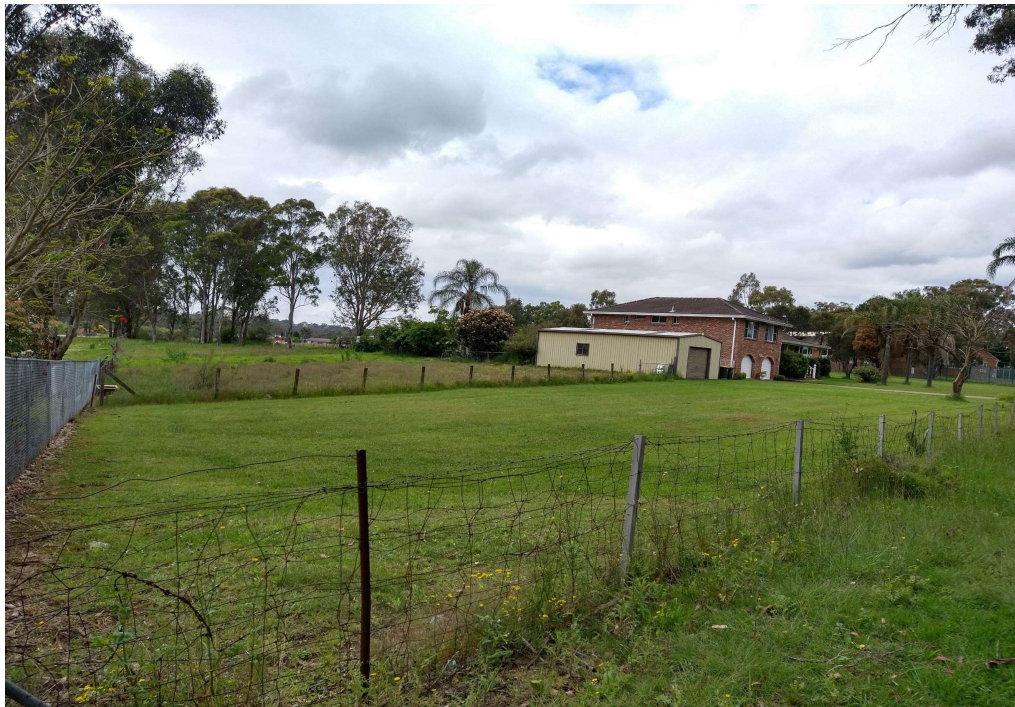
Photograph 6 - Southern residence

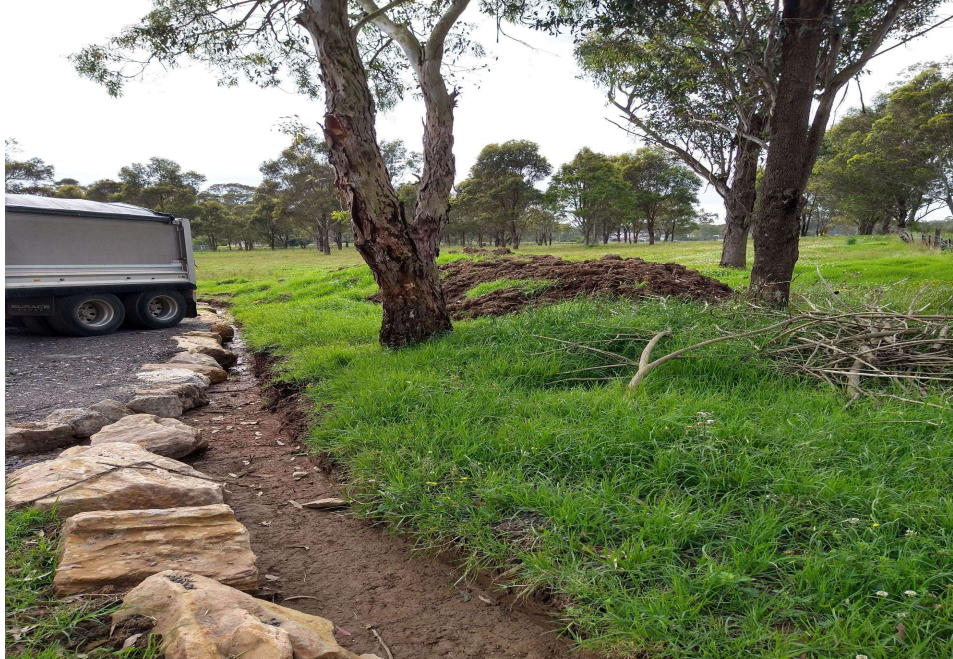
Photograph 7 - Stockpile adjacent hardstand drain

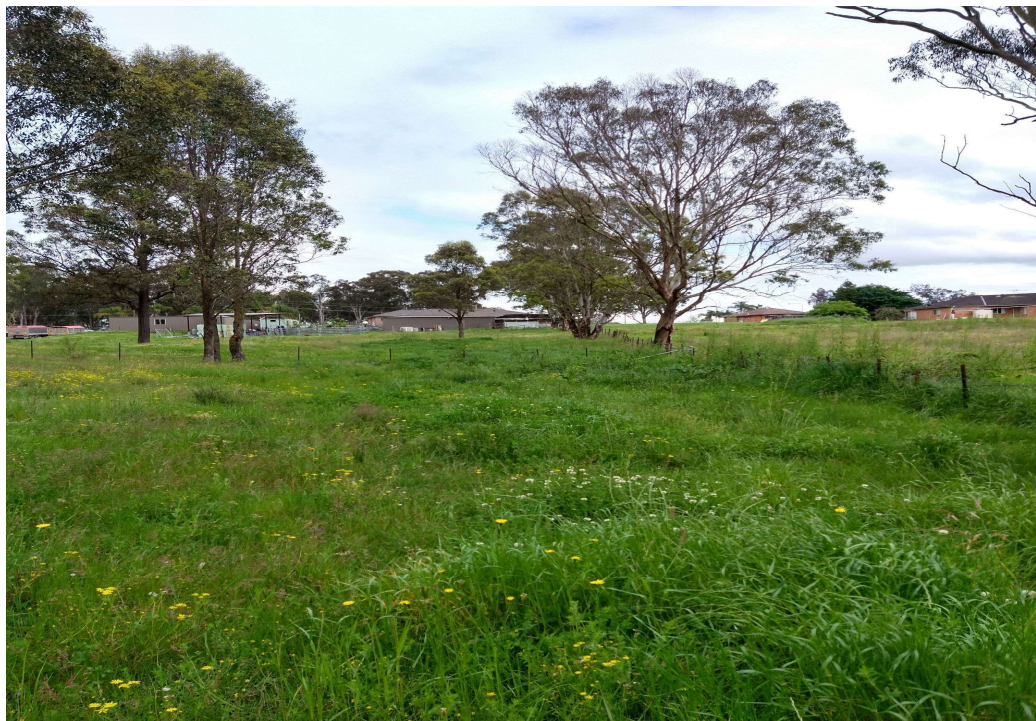
- Water logging was observed along the northern lower lying areas in the vicinity of the neighbouring property's dam (Photos 8 and 9);
- Water logging was observed on the northern low side of the dam wall located on the south eastern boundary of the site (Photo 10); and
- No surface erosion or salt efflorescence was observed.

Photograph 8 - Waterlogging in northern area looking west

Water logging may be a constraint to development in the lower-lying areas of site, such as around the dam located on the south eastern boundary and around the neighbouring property's dam on the northern boundary. Further investigation should be undertaken including borehole or test pit excavation to determine soil moisture profiles.

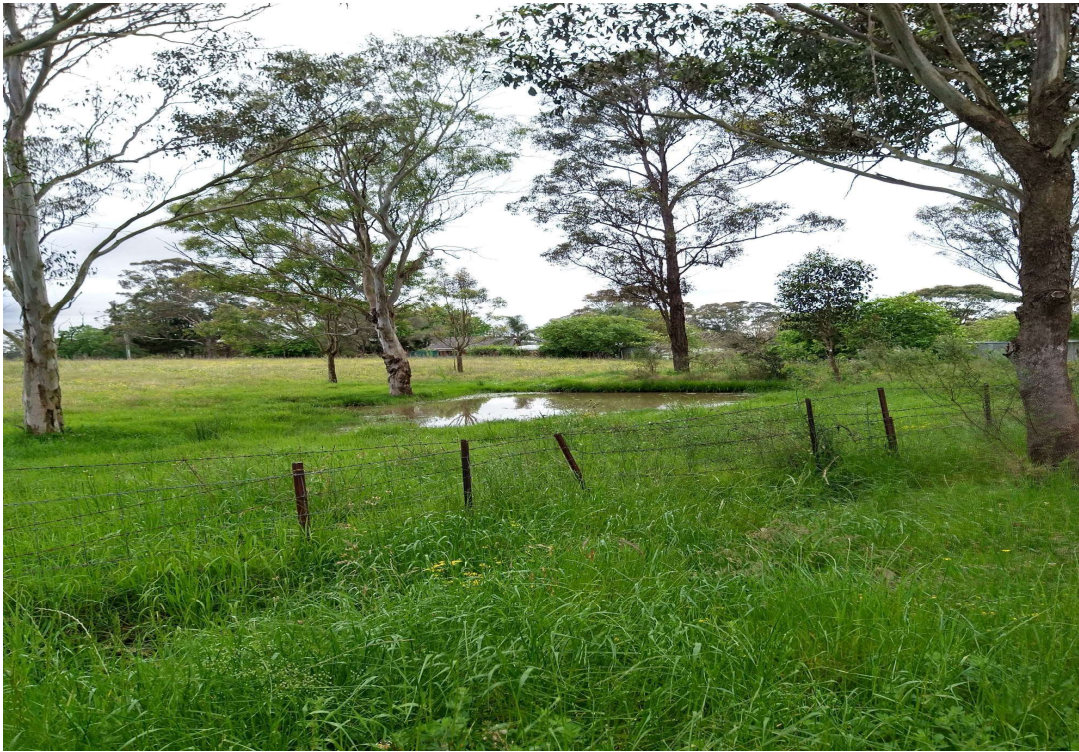
Photograph 9 - Neighboring dam outside northern boundary

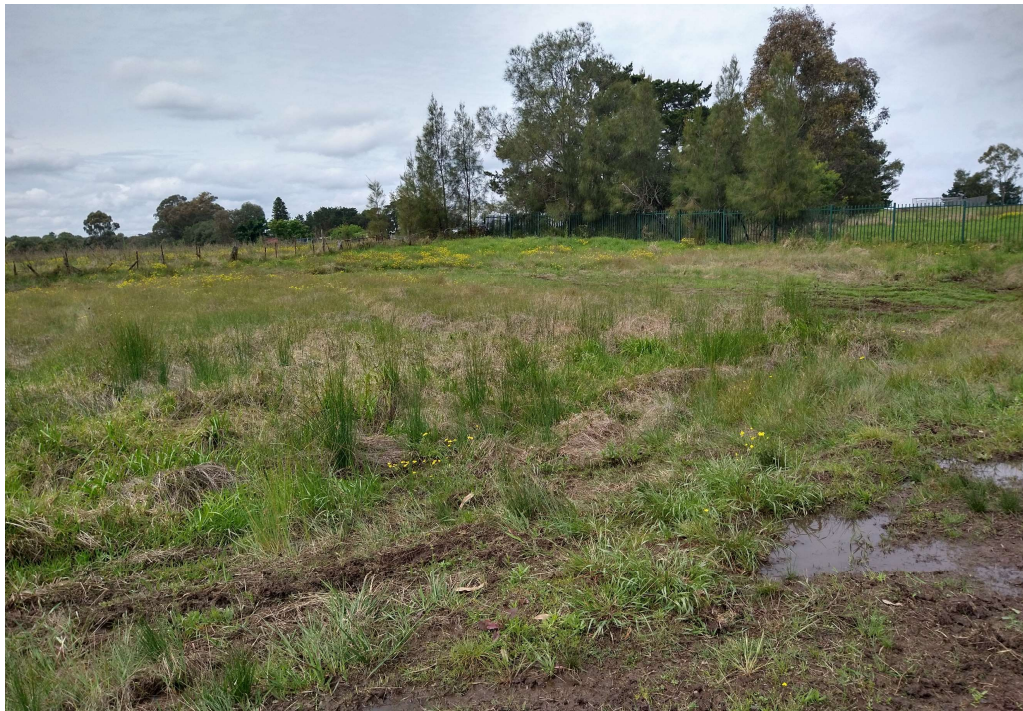
Photograph 10 - Dam on south eastern boundary

A methodology may need to be developed for desilting and filling of the dam on the southern boundary if it is not retained during the site redevelopment and would include:

- Disposal of water away from the dam and spreading on the ground surface;
- Excavation of the silt and water affect material then moisture conditioning (drying) prior to blending;
- Removal of the uncontrolled fill in the dam wall, drying and blending for use as controlled fill or landscaping (subject to environmental and geotechnical suitability), or removed off site; and
- Placement of controlled fill to achieve design levels.
