# QUEEN MARY BUILDING

## BUILDING SERVICES INFRASTRUCTURE REPORT

**Project:** Queen Mary  
**Reference:** S10082  
**Revision:** D  
**Issue Date:** 01/03/11

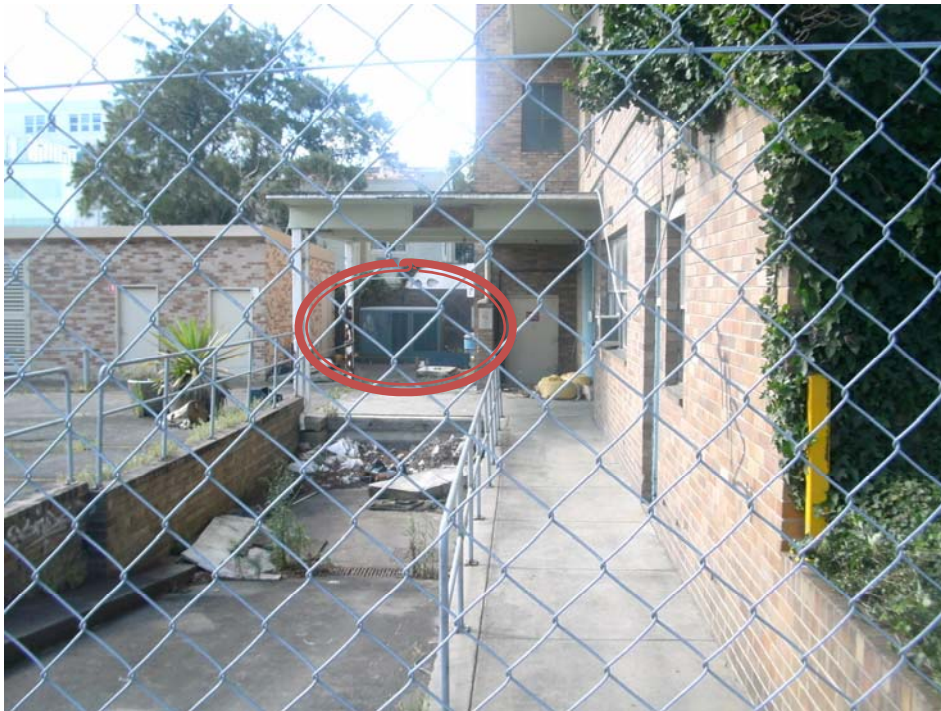
Existing Substation

The Queen Mary Building is currently served by an existing 800A/phase floor mounted substation kiosk (S3224) located adjacent to the building at the western end of the site with underground power cables as shown on Appendix A and B. Energy Australia is the service authority responsible for electricity supply to the area and has confirmed the above condition. In 2005, when the Queen Mary building was occupied, the transformer was supplying approximately 600A. However in year 2000, when the Queen Mary building was fully occupied, the substation was supplying approximately 100A. This indicates that there will be about 200A remaining to accommodate any upgrade. Hence the current electrical infrastructure (substation) is inadequate in respect to its capacity and configuration for the proposed future refurbishment on the site.

The estimated maximum demand for the new refurbishment is approximately 1800A/phase which is well above the capacity of the existing infrastructure, with the result that there will be alterations or upgrades to the existing transformer or the incoming high voltage supply. The first step in determining a required scope of works and solution is for an Application to be submitted to Energy Australia. Preliminary discussion has been held with Energy Australia, more details will be issued at DA stage. EA has suggested that the only solution for the upgrade is by adding additional substations, but depending on the type of substation, it may result in more than one additional substation, which means additional space is required to accommodate the substations.

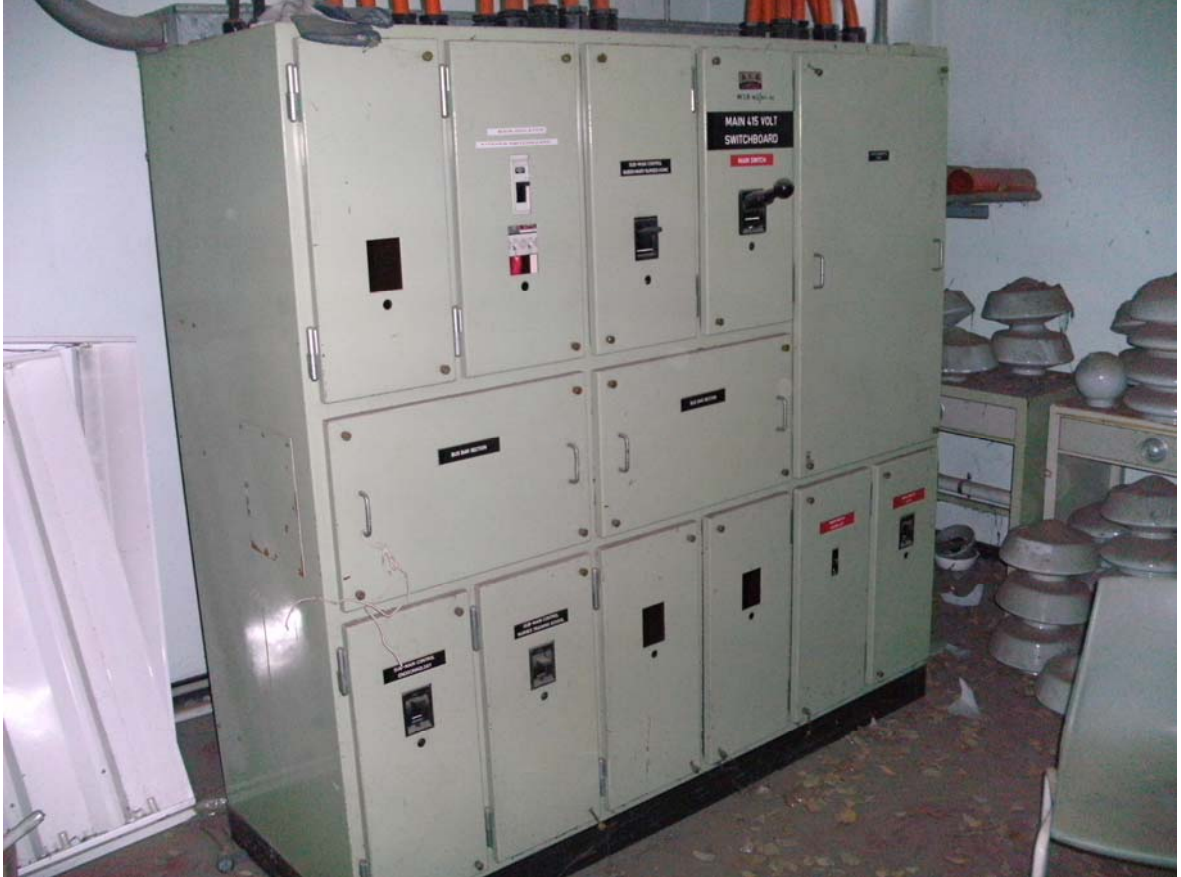
## 2.2 EXISTING MSB

Based on our maximum demand estimation, the current MSB is inadequate to supply the new load (1800A), it is to be replaced with a new MSB to accommodate the new facility.

The MSB, authority meters, underground consumer mains and conduits are to be replaced. New trenches will be required to accommodate the new conduits and underground consumer mains.
