# arboricultural impact assessment – waterbrook bayview, cabbage tree road, bayview

26<sup>th</sup> November 2018

prepared by Melanie Howden - Ass. Dip. Hort. (Haw. Ag. C.), SoA. Arb. MAIH, MIACA

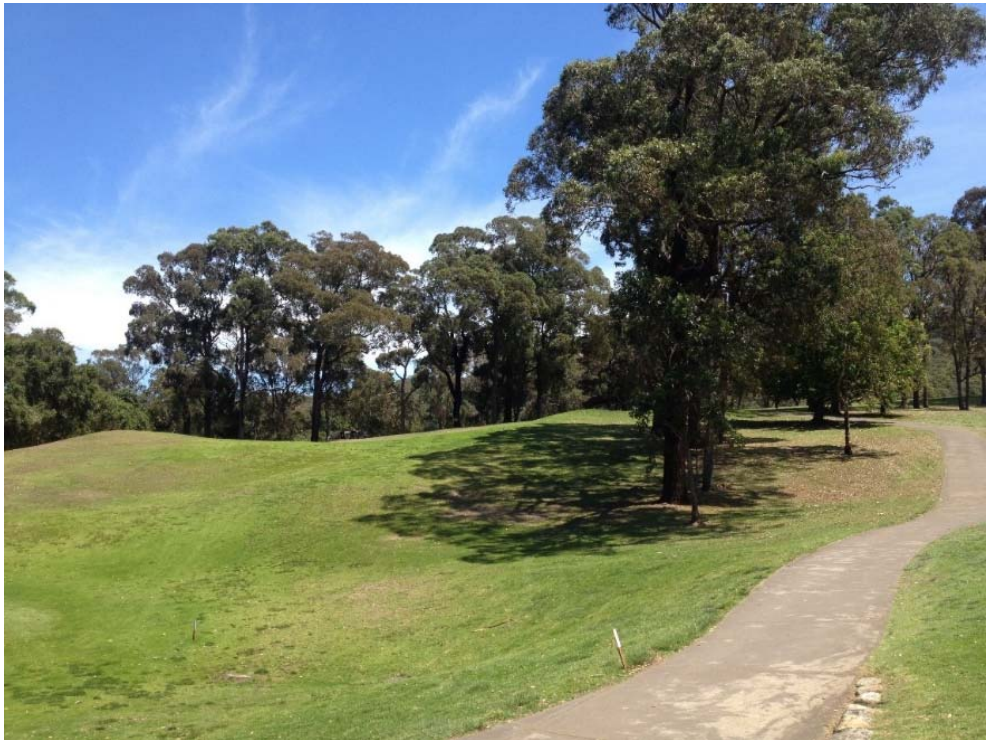
Figure 27.1 Looking west across the site with Tree No's 283 & 282 to the right in the foreground

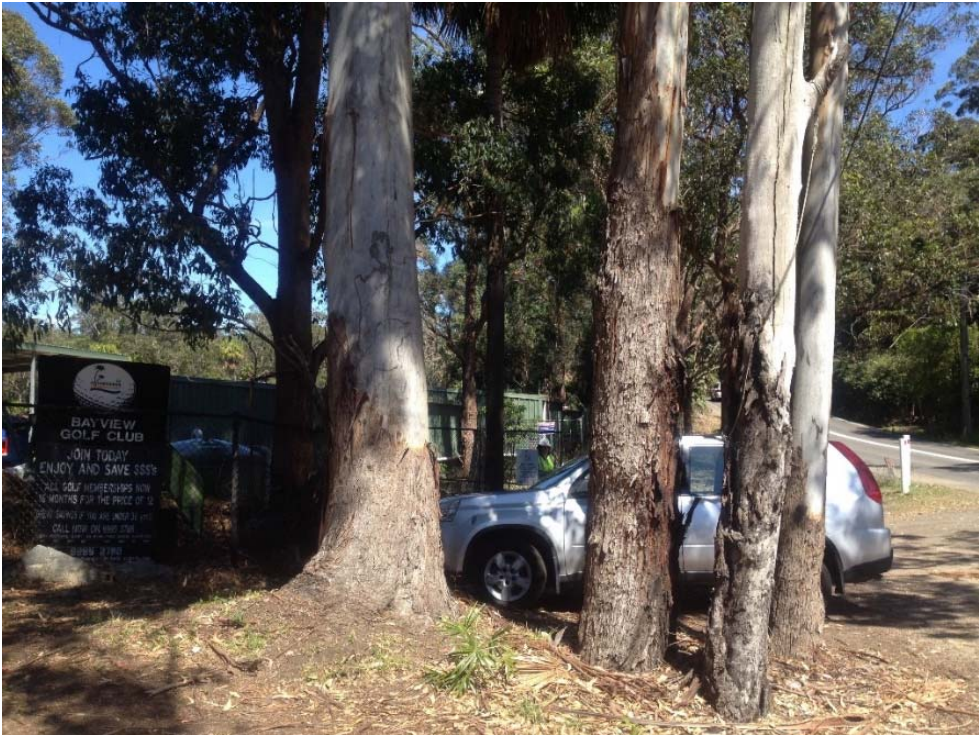
Figure 28.2 Tree No's 250, 249, 247 & 246 (left to right) on the southern side of Cabbage Tree Road adjacent the proposed traffic roundabout

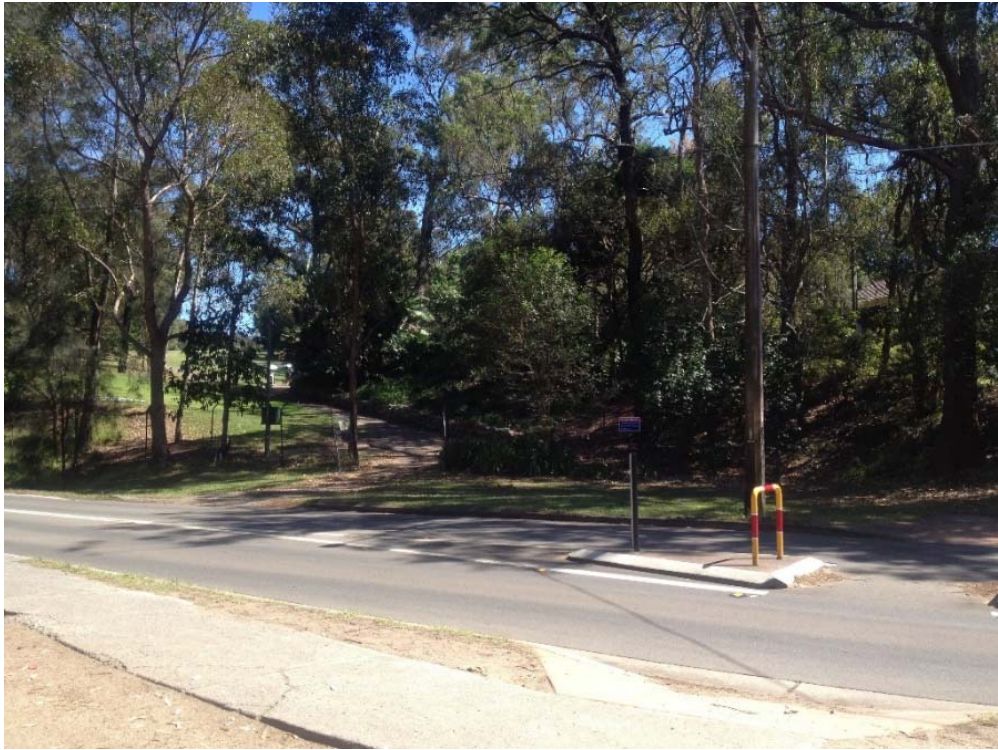
Figure 27.3 The location of the proposed traffic roundabout on Cabbage Tree Road looking north onto the site.
