Our Ref: GF1404-A

Date: 17 May 2022

Re: Geotechnical Assessment for Proposed Boarding House at 71-73 Thomas Street, Parramatta

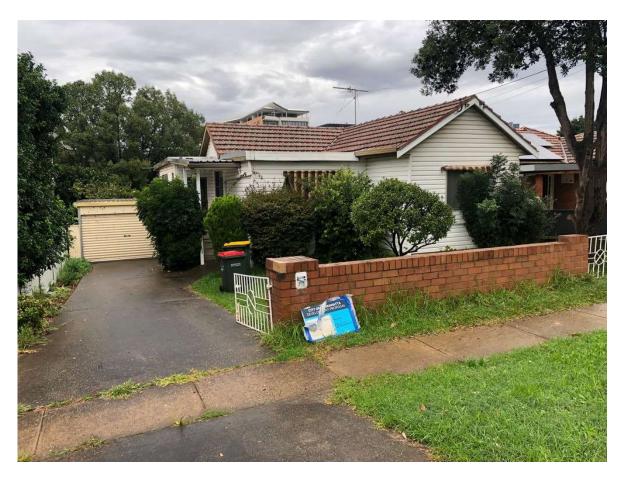
Photo 1: Looking from Thomas Street

- A single-storey weatherboard dwelling with a carport occupies the street frontage.
- Lawns are present in the remaining parts.
- Large trees are noted on the south-western corner.
- The elevation difference between the northern and southern parts is about 2.2m, supported by a brick retaining wall (up to 1m high) near the middle section.
- The elevation difference between the site (i.e. high side) and the properties to the south (i.e. low side) is approximately 1.7m
- Surface level is similar between the site and the properties to the west.

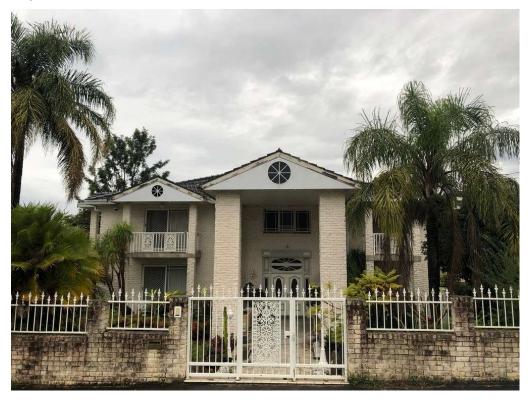
Photo 4: Looking from Thomas Street

- A two to three-storey brick house occupies the middle section of the site.
- Lawns are present in the north-eastern, north-western parts and the southern end of the site.
- Remaining areas are concreted surfaces.
- The elevation difference between the northern and southern parts of the site is about 3.8m.
- A brick retaining wall is located on the south-western of the site, retaining the existing garden.
- The elevation difference between the site (i.e. high side) and the properties to the south (i.e. low side) is approximately 1.6m.

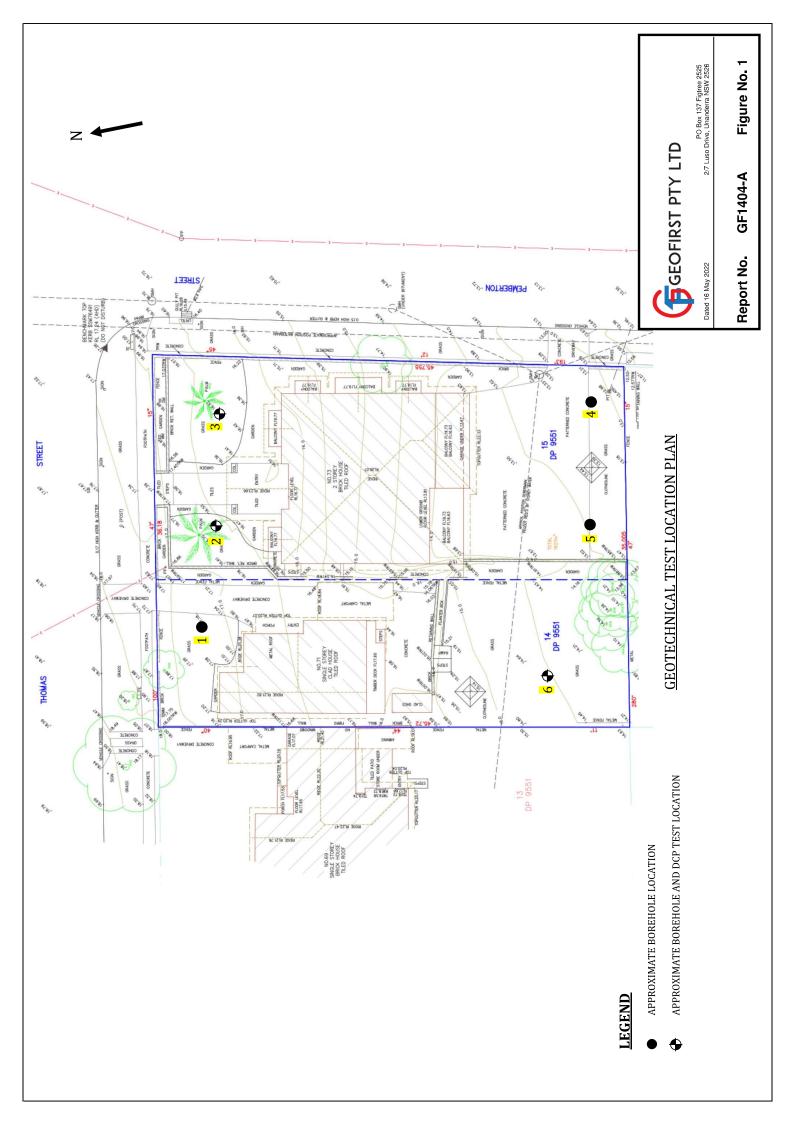
DYNAMIC CONE PENETRATION TEST RESULT

restea By 1		1 ome Blamee	eri Bommi	
	Num	ber of Blows per 100mm F	enetration	
Test Location	BH2	ВН3	BH6	
Depth (mm)	DCP2	DCP3	DCP6	
0 - 100	1	1	1	
100 - 200	2	5	1	
200 - 300	2	6	2	
300 - 400	4	11	3	
400 - 500	2	3	4	
500 - 600	3	3	5	
600 - 700	3	4	4	
700 - 800	4	3	5	
800 - 900	7	6	4	
900 - 1000	End	10	4	
1000 - 1100	Bouncing	17	6	
1100 - 1200		End	4	
1200 - 1300		Bouncing	5	
1300 - 1400			15	
1400 - 1500			25	
1500 - 1600			11	
1600 - 1700			11/50mm	
1700 - 1800			End	
1800 - 1900			Refusal	
1900 - 2000				
2000 - 2100				
2100 - 2200				
2200 - 2300				
2300 - 2400				
2400 - 2500				
2500 - 2600				
2600 - 2700				
2700 - 2800				
2800 - 2900				
2900 - 3000

- 1. The procedure used for this test is similar to that described in AS1289.6.3.2-1997, Method <math>6.3.2.
- 2. Usually 8 blows per 20mm is taken as refusal
