Report on  
Preliminary Waste Classification

Proposed Grade Separated Interchange and Drainage  
Channel  
Kings Hill, North Raymond Terrace

Prepared for  
PM No 1 Pty Ltd

Project 81502.10  
September 2019

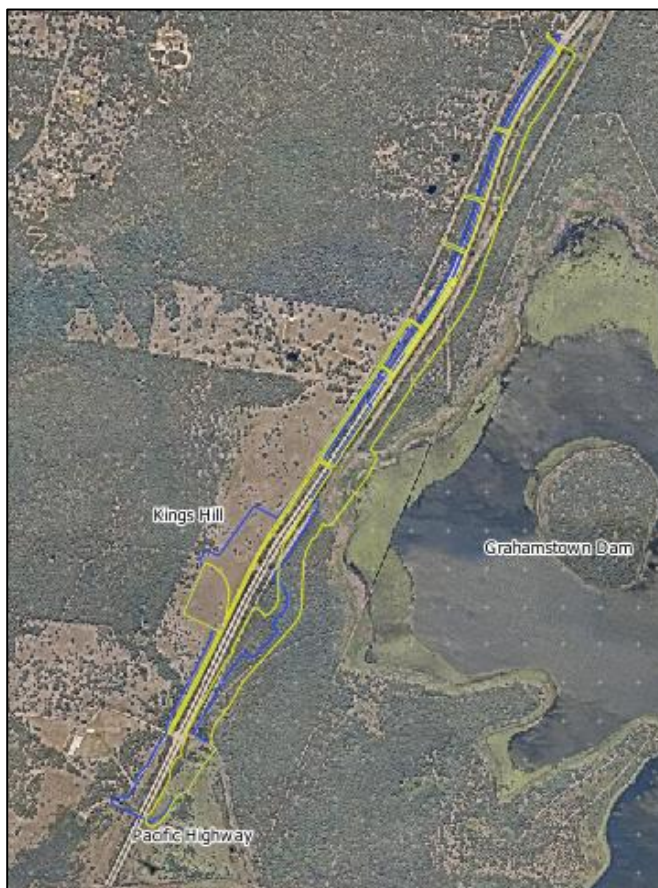
The Figure 1, below, provides an aerial image of the proposed drainage alignment and grade separated interchange locations. The majority of the alignment lies within either cleared sections of forested areas or within undisturbed areas. Some parts of the alignment lie within close proximity to the existing Pacific Highway.

**Figure 1: Aerial image showing impact area of the proposed Grade Separated Interchange (blue) and Drainage Channel (yellow)**

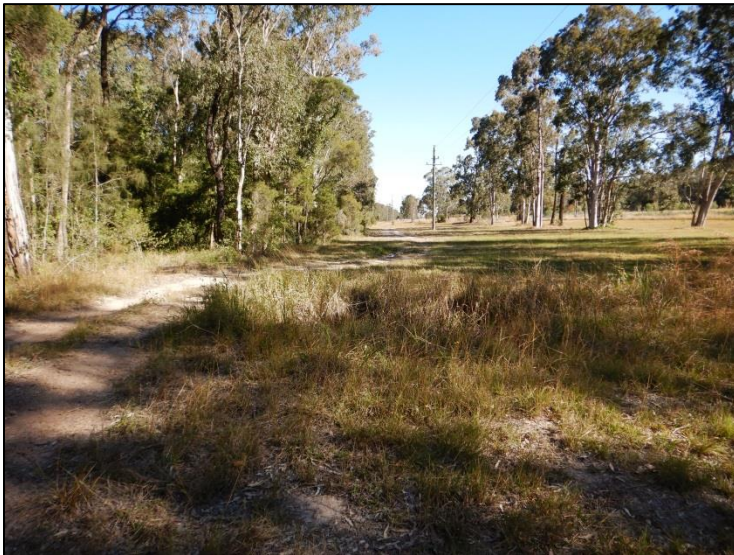
Within this area, the alignment is through areas which contain mature trees and varying undergrowth (refer Figure 2).

**Figure 2: View looking south-west along drainage channel alignment (existing unsealed access track)**

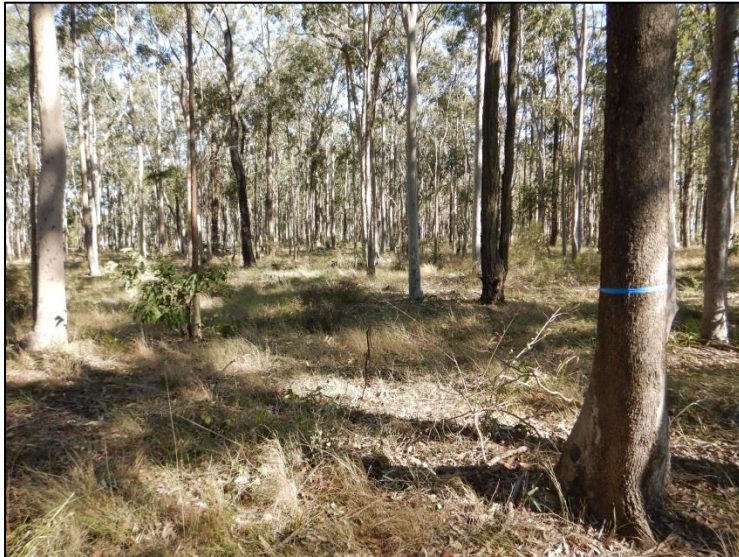
**Figure 3: Bushland in northern area of alignment**

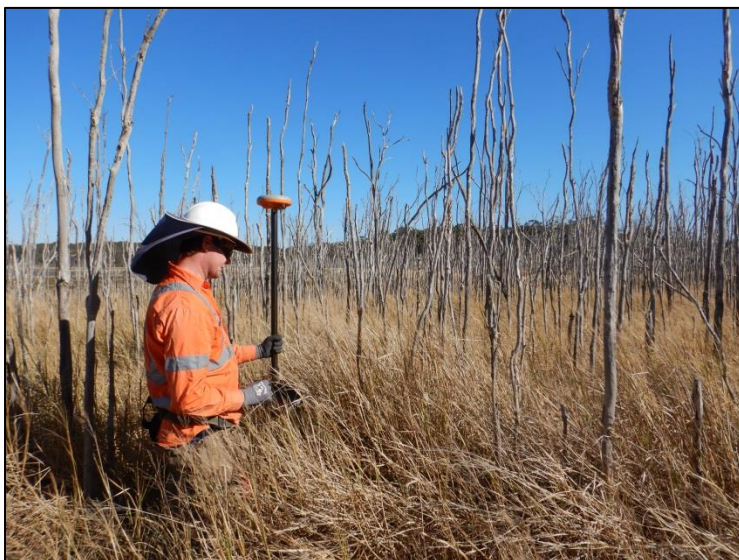
From about Ch 1750, the alignment passes through a low lying section, which was covered with tall grass at the time of field work (refer Figures 3 and 4).

**Figure 4: Tall grass in area between approximately Ch1750 and Ch 2050**

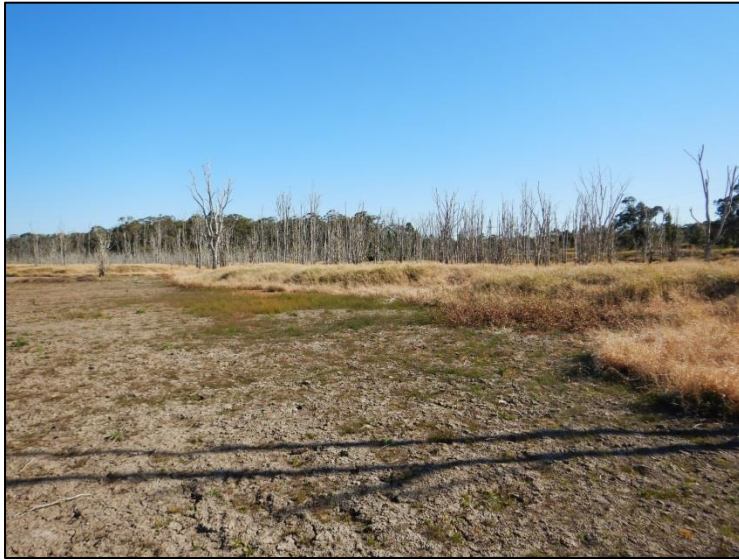
**Figure 5: Dry dam edge of alignment at about Ch 1850, looking south-west**

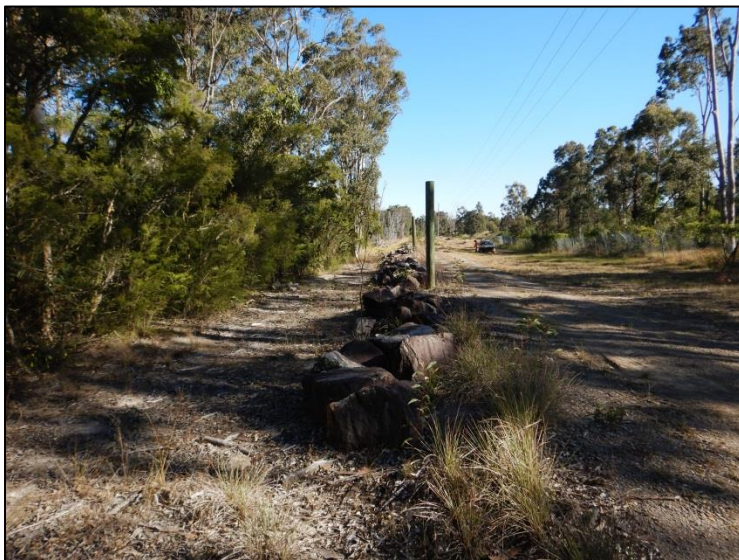
Over an approximately 250 m length, from about Ch 1750 to Ch 2050, a Hunter Water Corporation (HWC) access road appeared to be constructed on ballast rock fill and was supported on a fill embankment up to about 2 m to 3 m high (refer Figure 6). The proposed drainage channel centreline is approximately 20 m to the east of this embankment.

**Figure 6: View of start of existing access embankment, looking south-west**

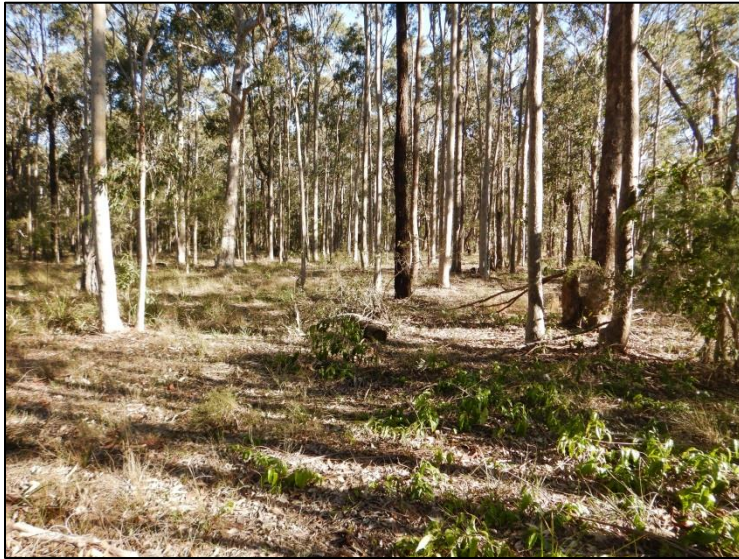
**Figure 7: Dense bushland at approximately Ch 2700**

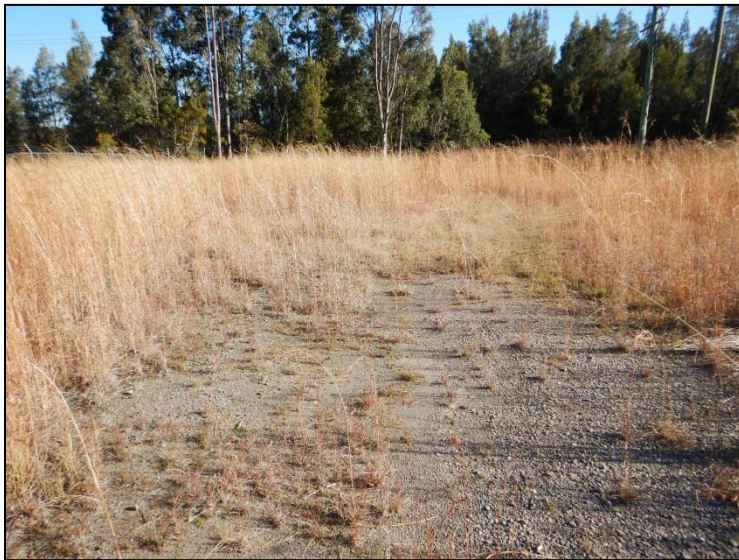
At approximately Ch 3120, the alignment passes an existing sealed access road and a former compound (refer Figure 8 and Figure 9).

**Figure 8: Former compound at approximately Ch 3120, looking south**

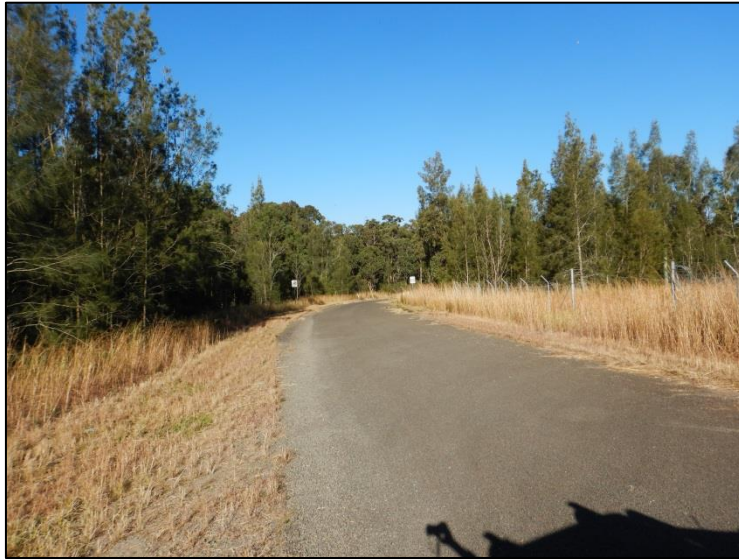
**Figure 9: Sealed access road to existing spillway at approximately Ch 3120**

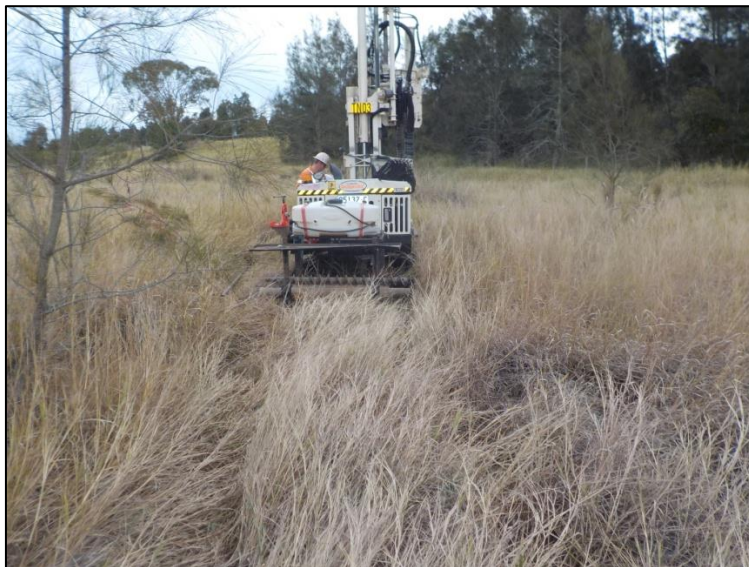
The southern end of the drain alignment, from approximately Ch 3150 to its end, is located within a low lying area, which was covered with tall grass at the time of investigation (refer Figure 10).

**Figure 10: Low lying grass covered area (photo taken during previous investigation)**

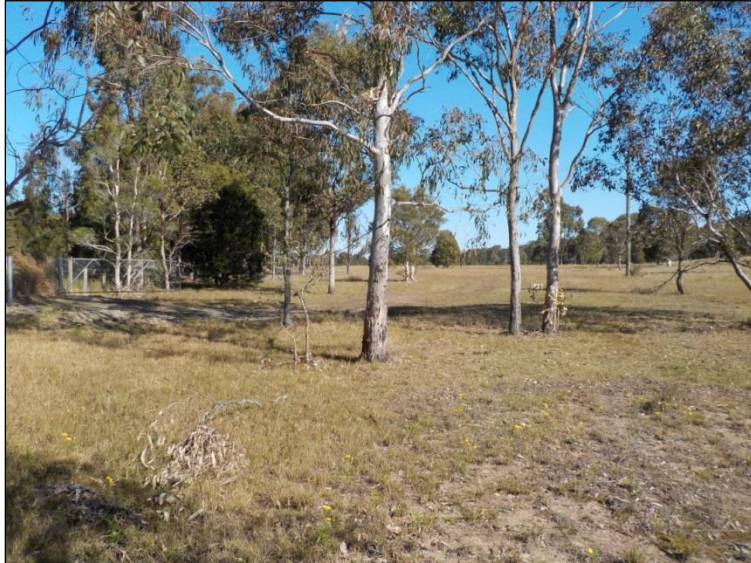
The western approach to the interchange is predominantly within cleared paddocks. Topography within these areas generally falls to the south-west at slope of less than 10° (refer Figure 11 and Figure 12).

**Figure 11: Typical view of area on western side of Pacific Highway**

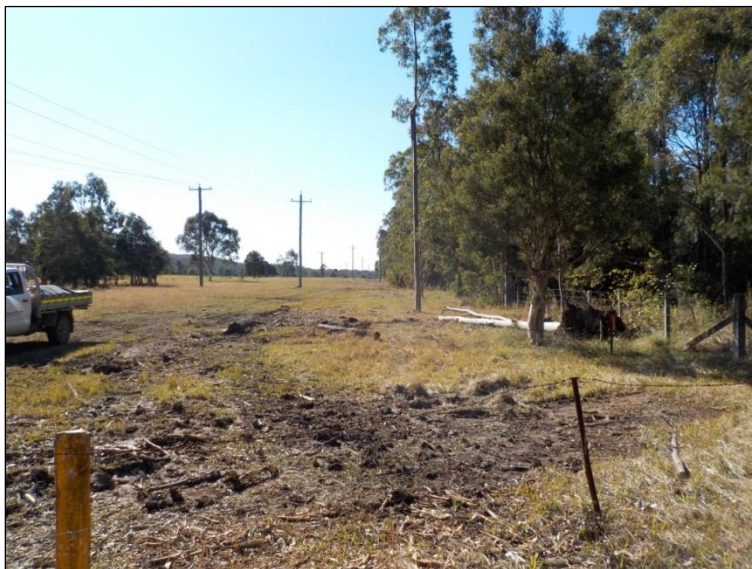
**Figure 12: View along western side of Pacific Highway, looking north**

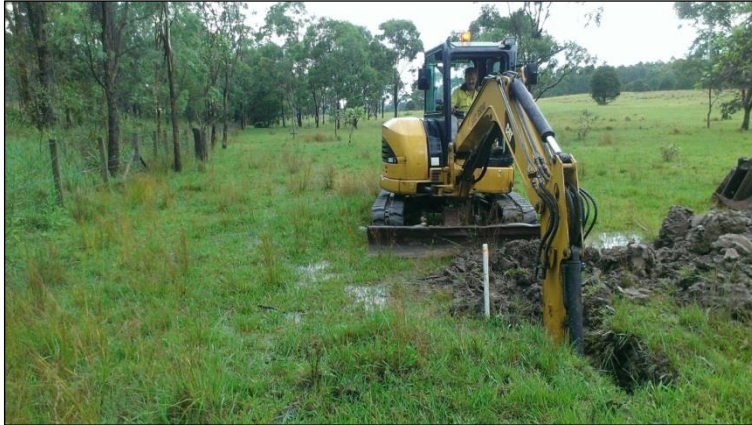
Towards the northern end of the proposed northern entry ramp (near Pit 203 on Drawing 5) some ponded surface water was present at various stages during the present and previous investigations (refer Figure 13 taken during previous investigation).

**Figure 13: Ponded water near Pit 203 excavated during previous investigation (December 2014)**

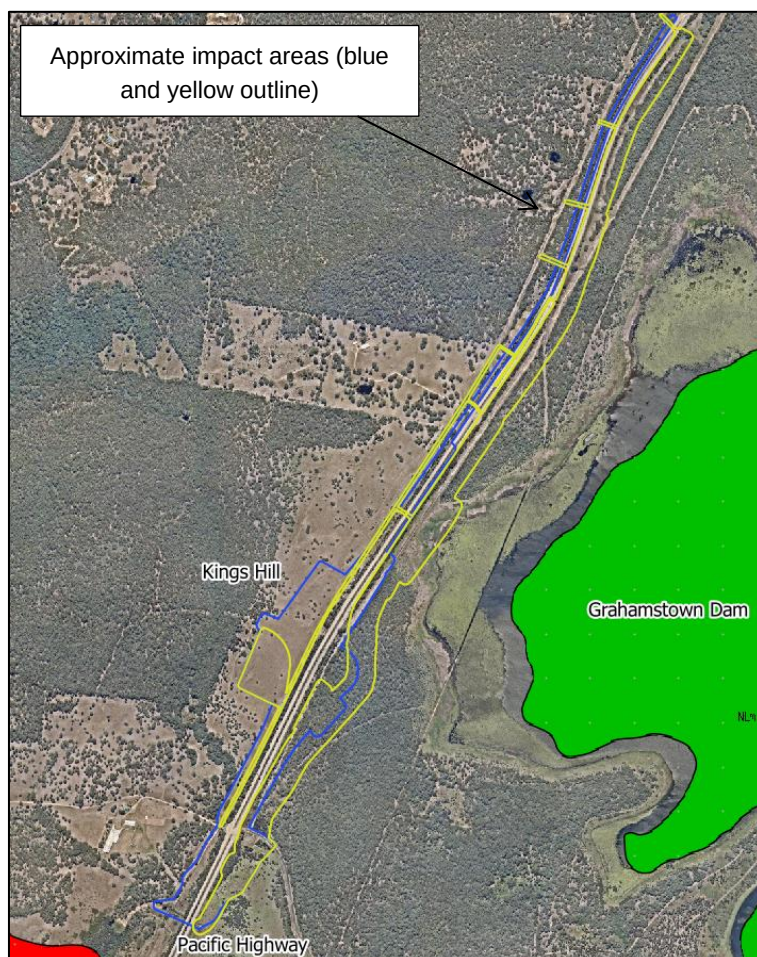
Reference to the local acid sulfate soil risk map indicates that the areas of impact for the grade separated interchange and the drainage channel are in an area with no known occurrence of acid sulfate soils. It is noted that an area mapped as having a high probability of acid sulfate soils is located to the south of the investigation area. Figure 15 below is an extract from the ASS risk mapping.

**Figure 15: Extract from Acid Sulfate Soil Mapping**

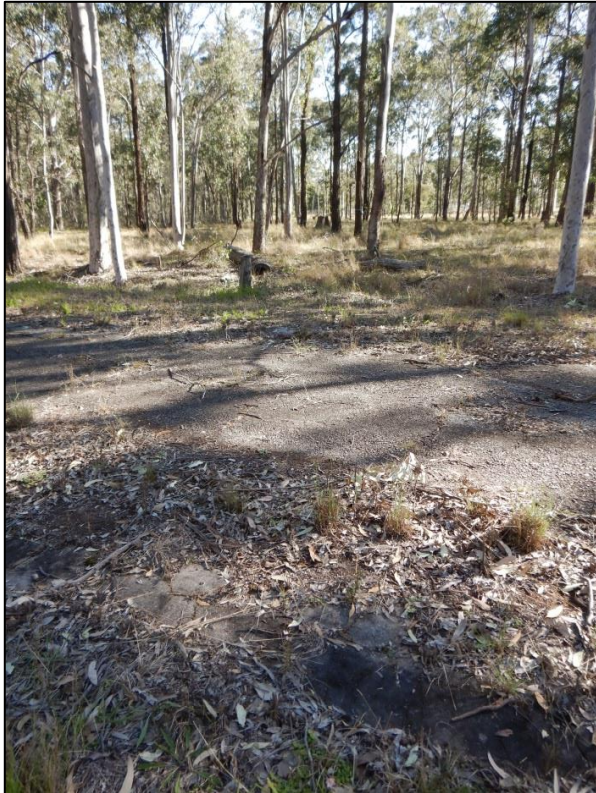
- The majority of the drainage channel alignment is either within bushland or within the cleared area between Grahamstown Dam and the Pacific Highway;
- No obvious areas of fill was noted within the majority of the anticipated impact areas during the inspection with the exception of the following:
  - The existing Pacific Highway and associated fill embankments;
  - The former compound and adjacent sealed access road at approximately Ch1320 (refer Figure 8);
  - A former access embankment to the south of the compound area and extending to the southern end of the impact areas (refer Drawing 7);
  - Several unsealed access pavements crossing the alignment;
  - A sealed pavement for the Riding for the Disabled facility towards the southern end of the area; and
  - The sealed former Pacific Highway alignment towards the centre of the alignment (refer Figure 17);

**Figure 17: Former Pacific Highway pavement (near Bore 2001)**

It is noted, however, that the filling encountered within Bore 2001, located where the drainage channel alignment crosses the former Pacific Highway alignment, returned PAH concentrations above detection limits together with a concentration based on total concentration (CT1) for benzo (a) pyrene (5.8 mg/kg) above the maximum criteria for "Restricted Solid Waste" of 3.2 mg/kg. It is noted that Bore 2001 is located within close proximity to the spray seal wearing course of the former Pacific Highway. Examination of the sample taken from Bore 2001 indicated that it included some asphalt pieces. It is noted that the underlying natural sandy silt sample (2001/0.4 to 0.5) had detected concentrations of PAH, which would preclude classification as VENM. This material would be classified as GSW based on the total contaminant concentrations, however may be suitable for classification as ENM subject to additional testing in accordance with RRO (EPA, 2014b). It is recommended that this area be treated as a *Hot Spot* and additional investigation is undertaken to determine the extent of the elevated contamination levels and options for disposal / reuse.

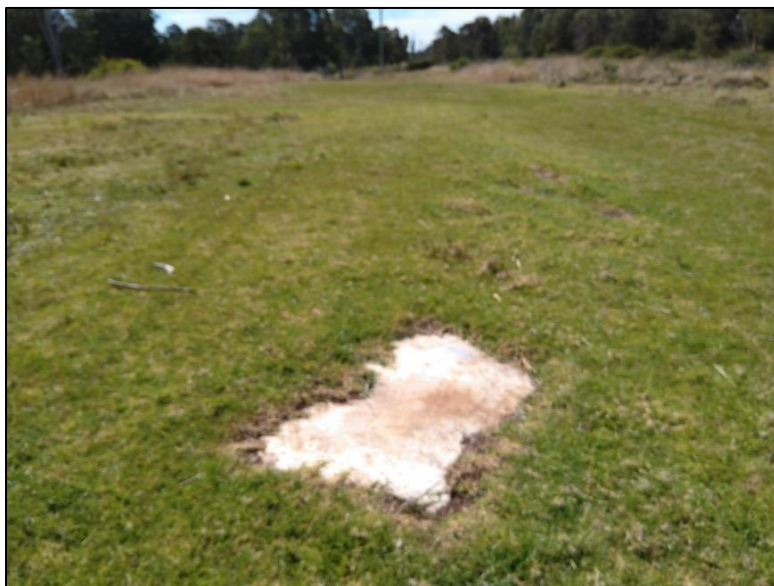
- In the area to the west of the Pacific Highway and between the access to the Riding for the Disabled access road and the Balickera Spillway, some signs of fill were observed (refer Figure 18).

**Figure 18: Buried metal sheet in ground surface south of Riding for the Disabled Access Road**

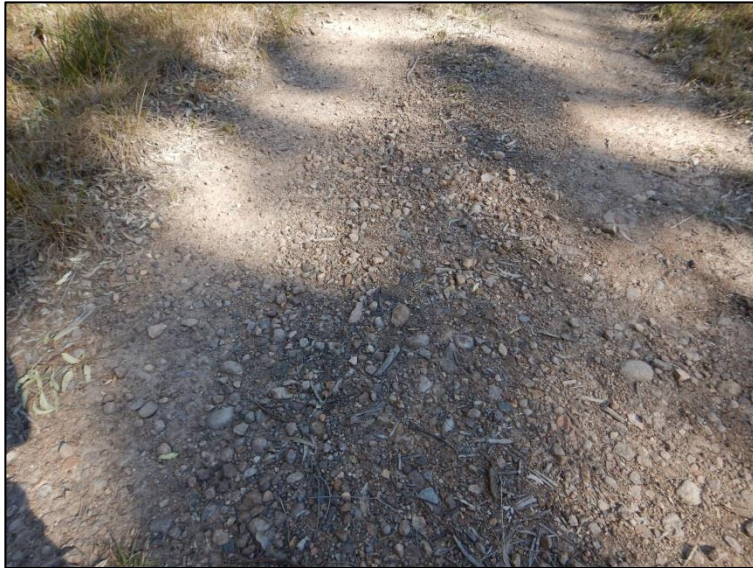
- It is noted that shallow fill (appears to be a quarried natural gravel) has been placed along the main north-south HWC access track seemingly to assist with access during wet weather (refer Figure 19);

**Figure 19: Typical gravel placed along access tracks**

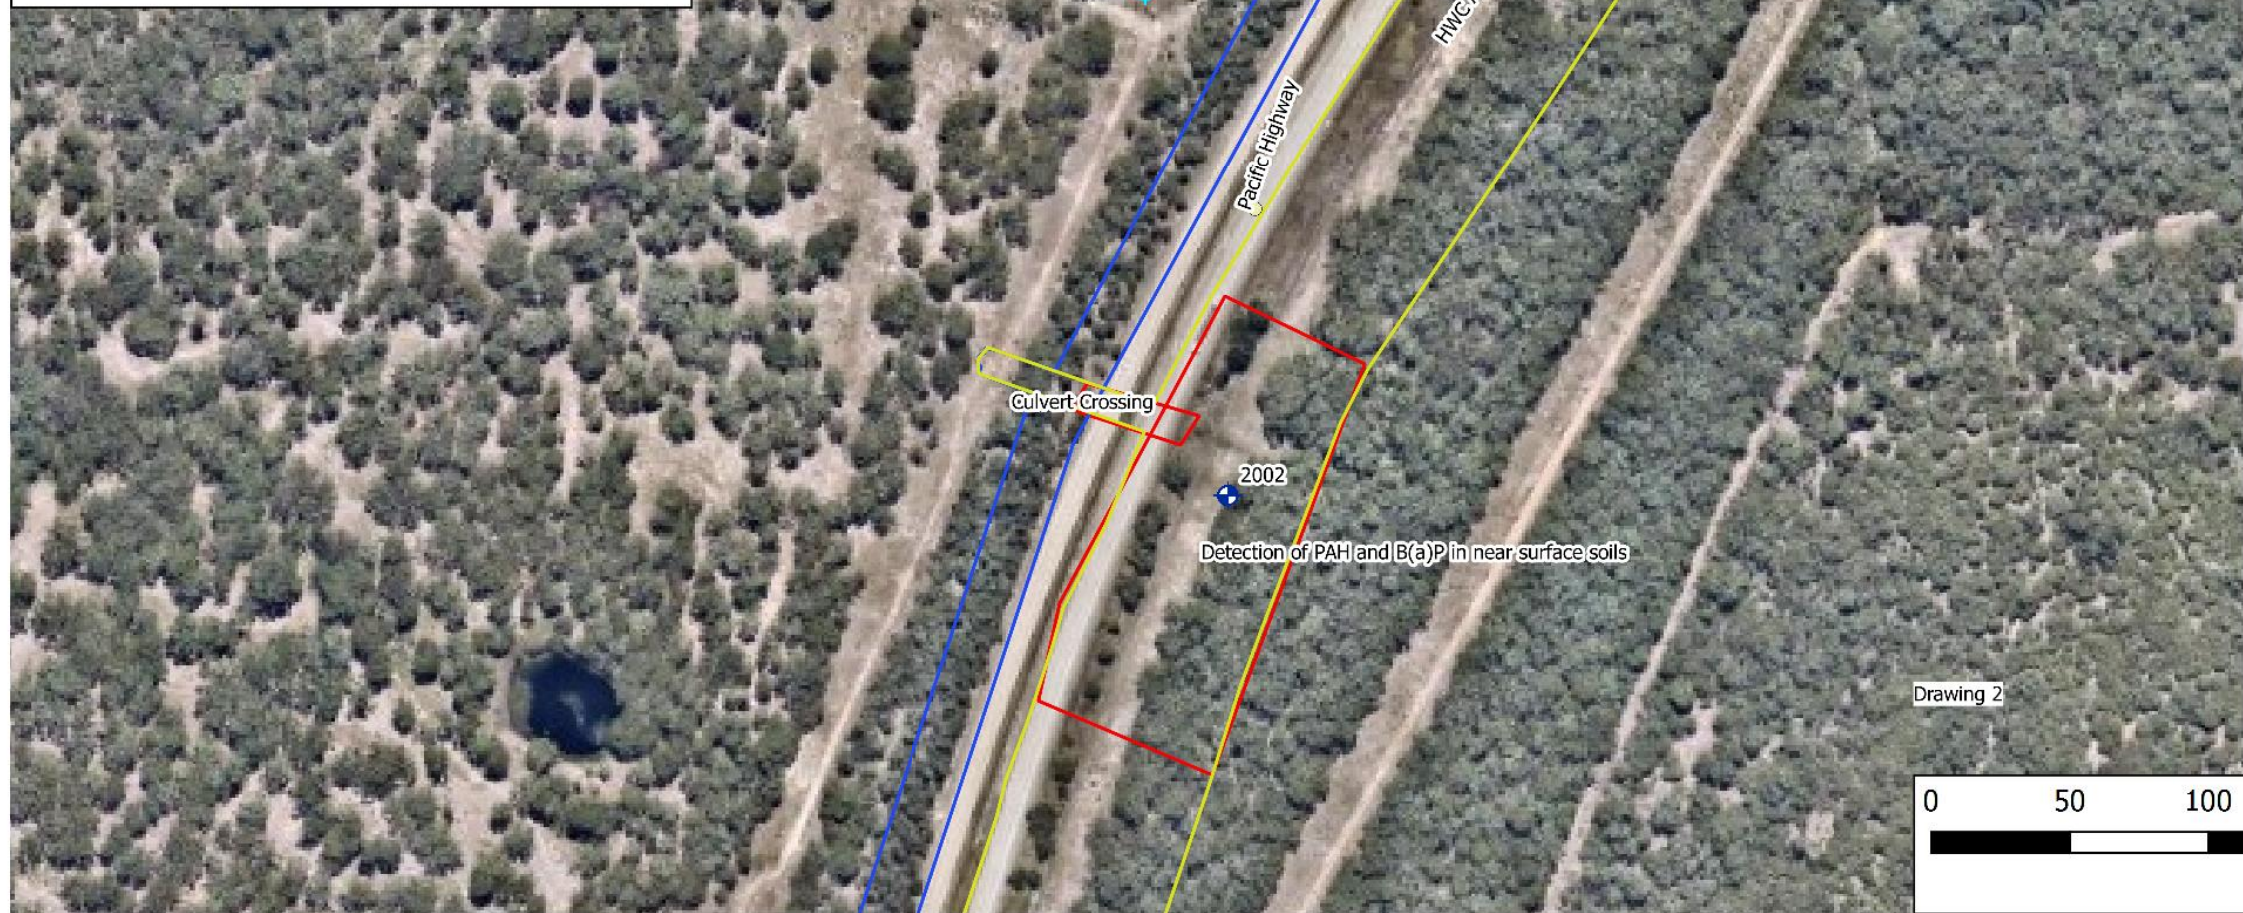
| <div> <div> <b>Douglas Partners</b><br/> Geotechnics Environment Groundwater </div> </div> | CLIENT: PM No 1 Pty Ltd | | TITLE: <b>Test Location Plan (showing areas excluded from this assessment)</b><br><b>Preliminary Waste Classification, Proposed Grade Separated Interchange and Drainage Channel</b><br><b>Kings Hill, North Raymond Terrace</b> | | PROJECT No: 81502.10 |

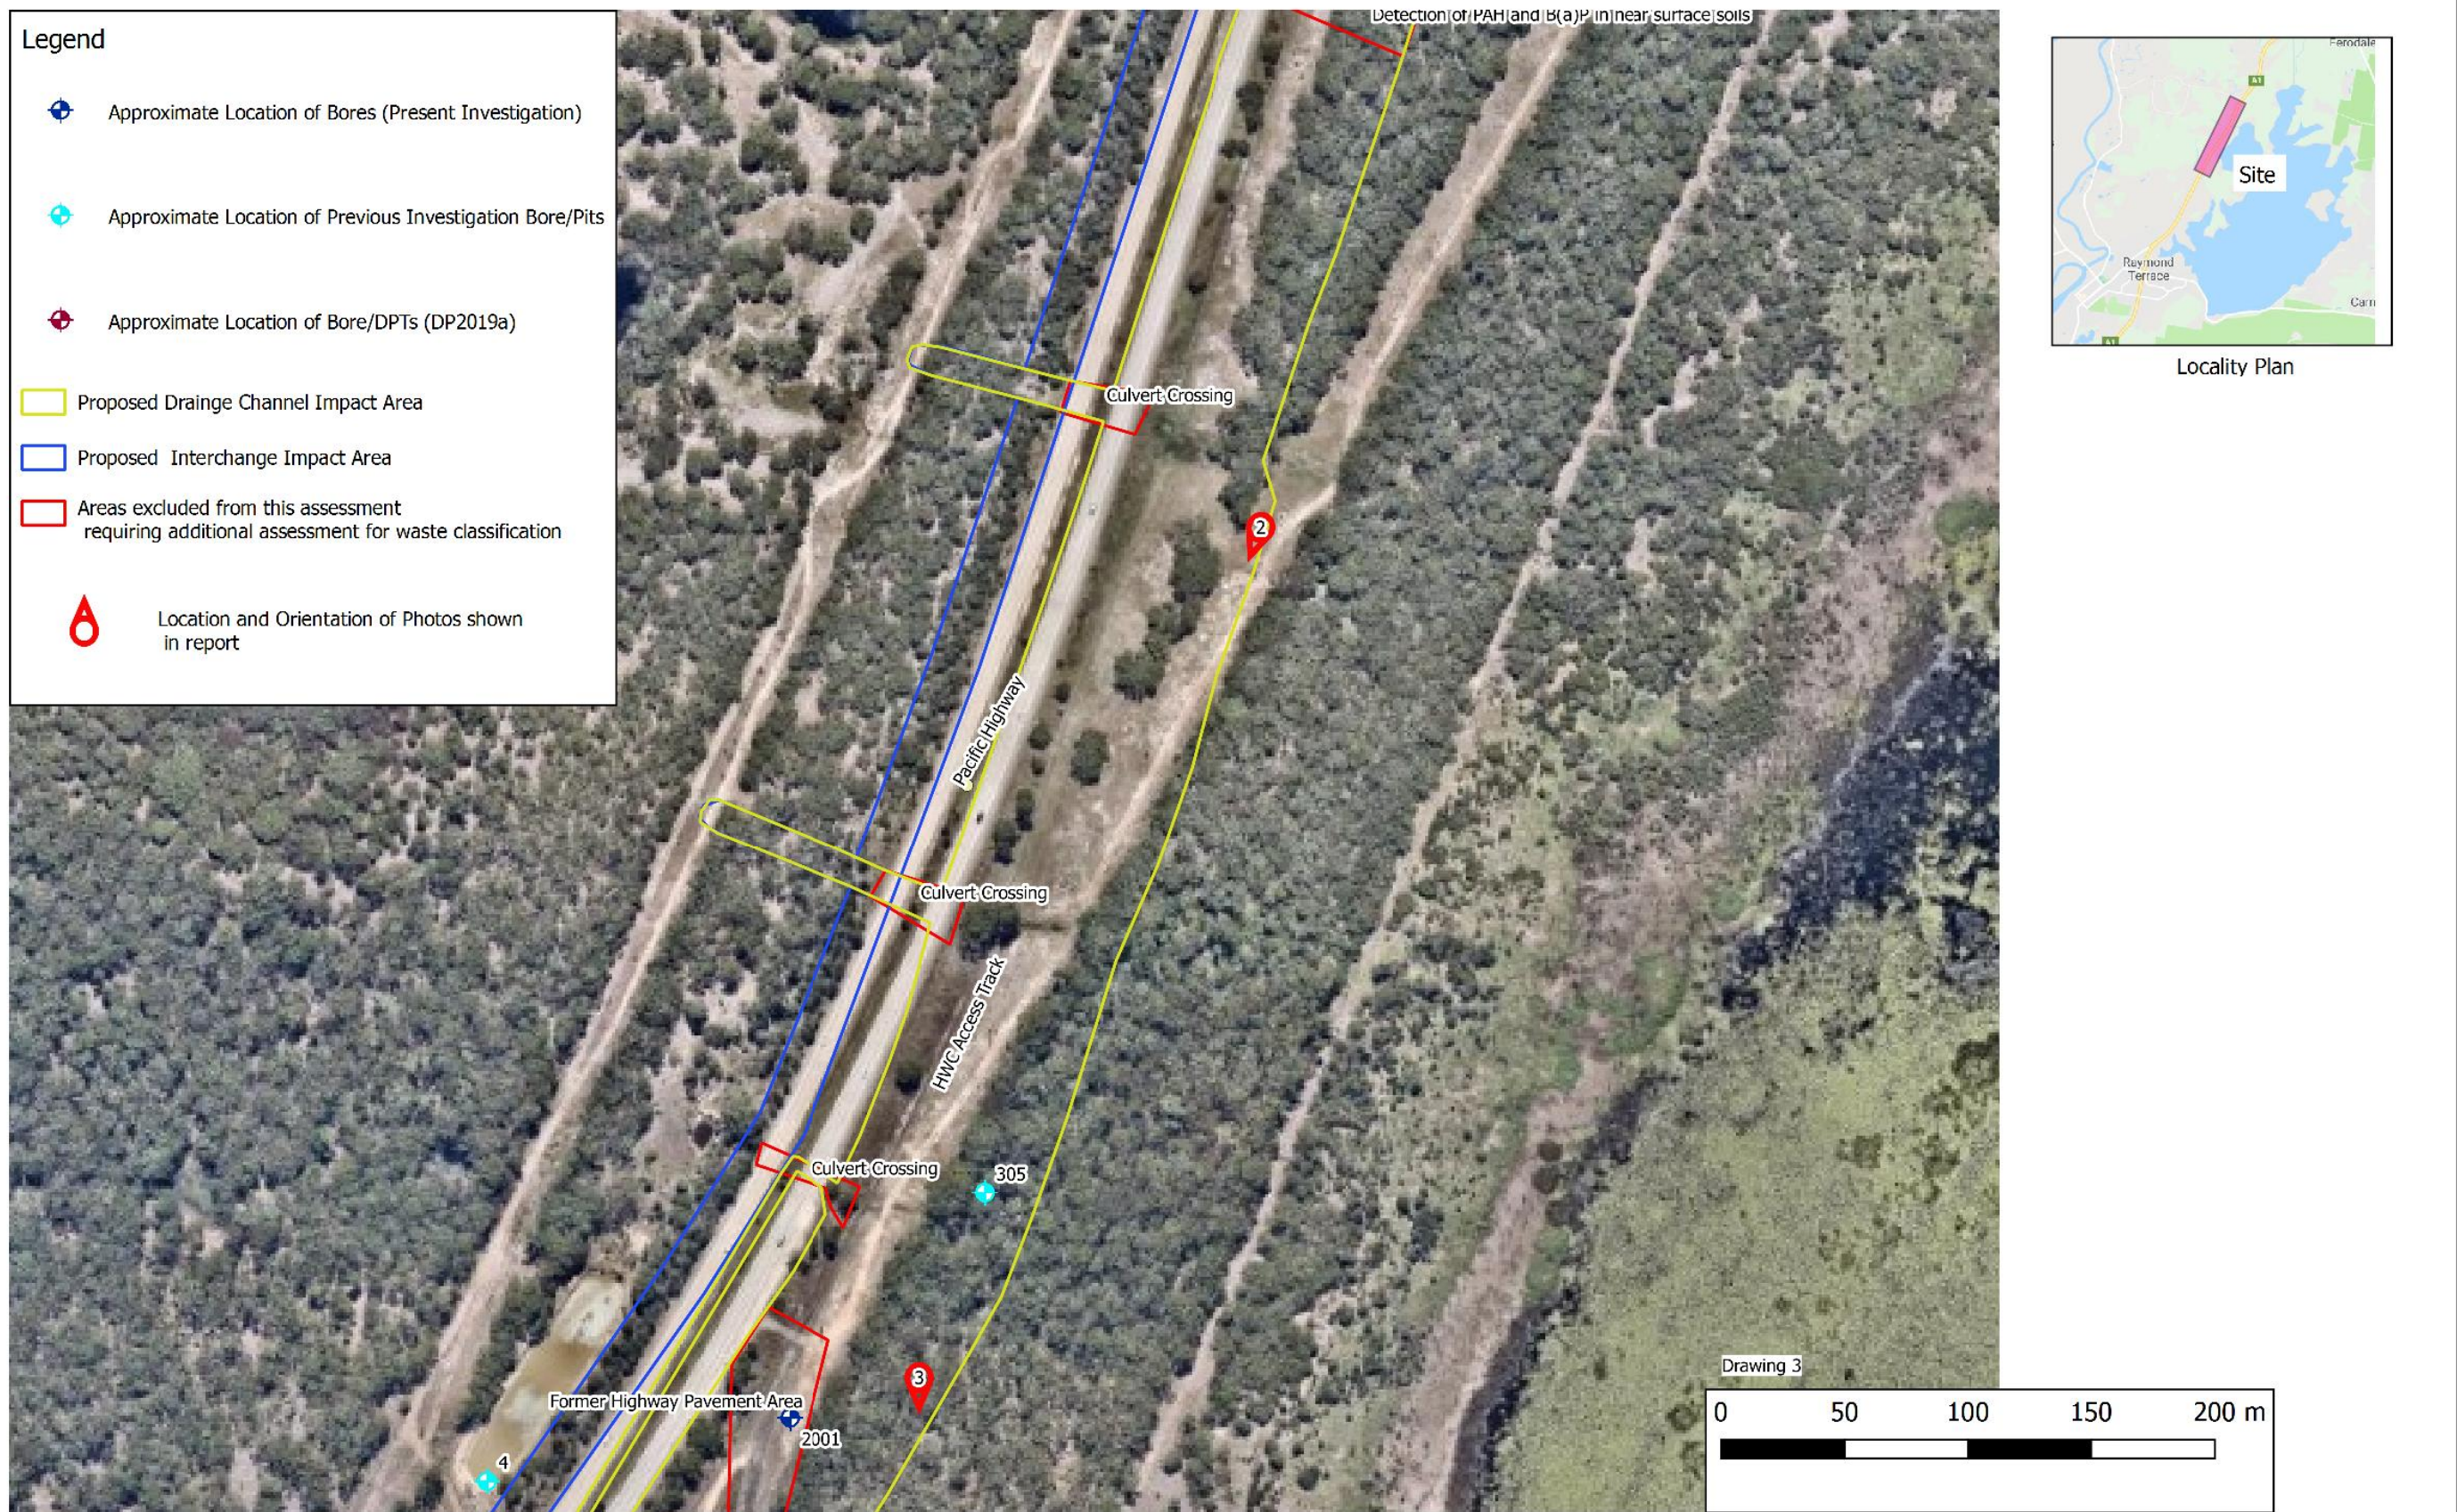
| <b>Douglas Partners</b><br><i>Geotechnics Environment Groundwater</i> | CLIENT: PM No 1 Pty Ltd | | TITLE: <b>Test Location Plan (showing areas excluded from this assessment)</b><br><b>Preliminary Waste Classification, Proposed Grade Separated Interchange and Drainage Channel</b><br><b>Kings Hill, North Raymond Terrace</b> | | PROJECT No: 81502.10 |

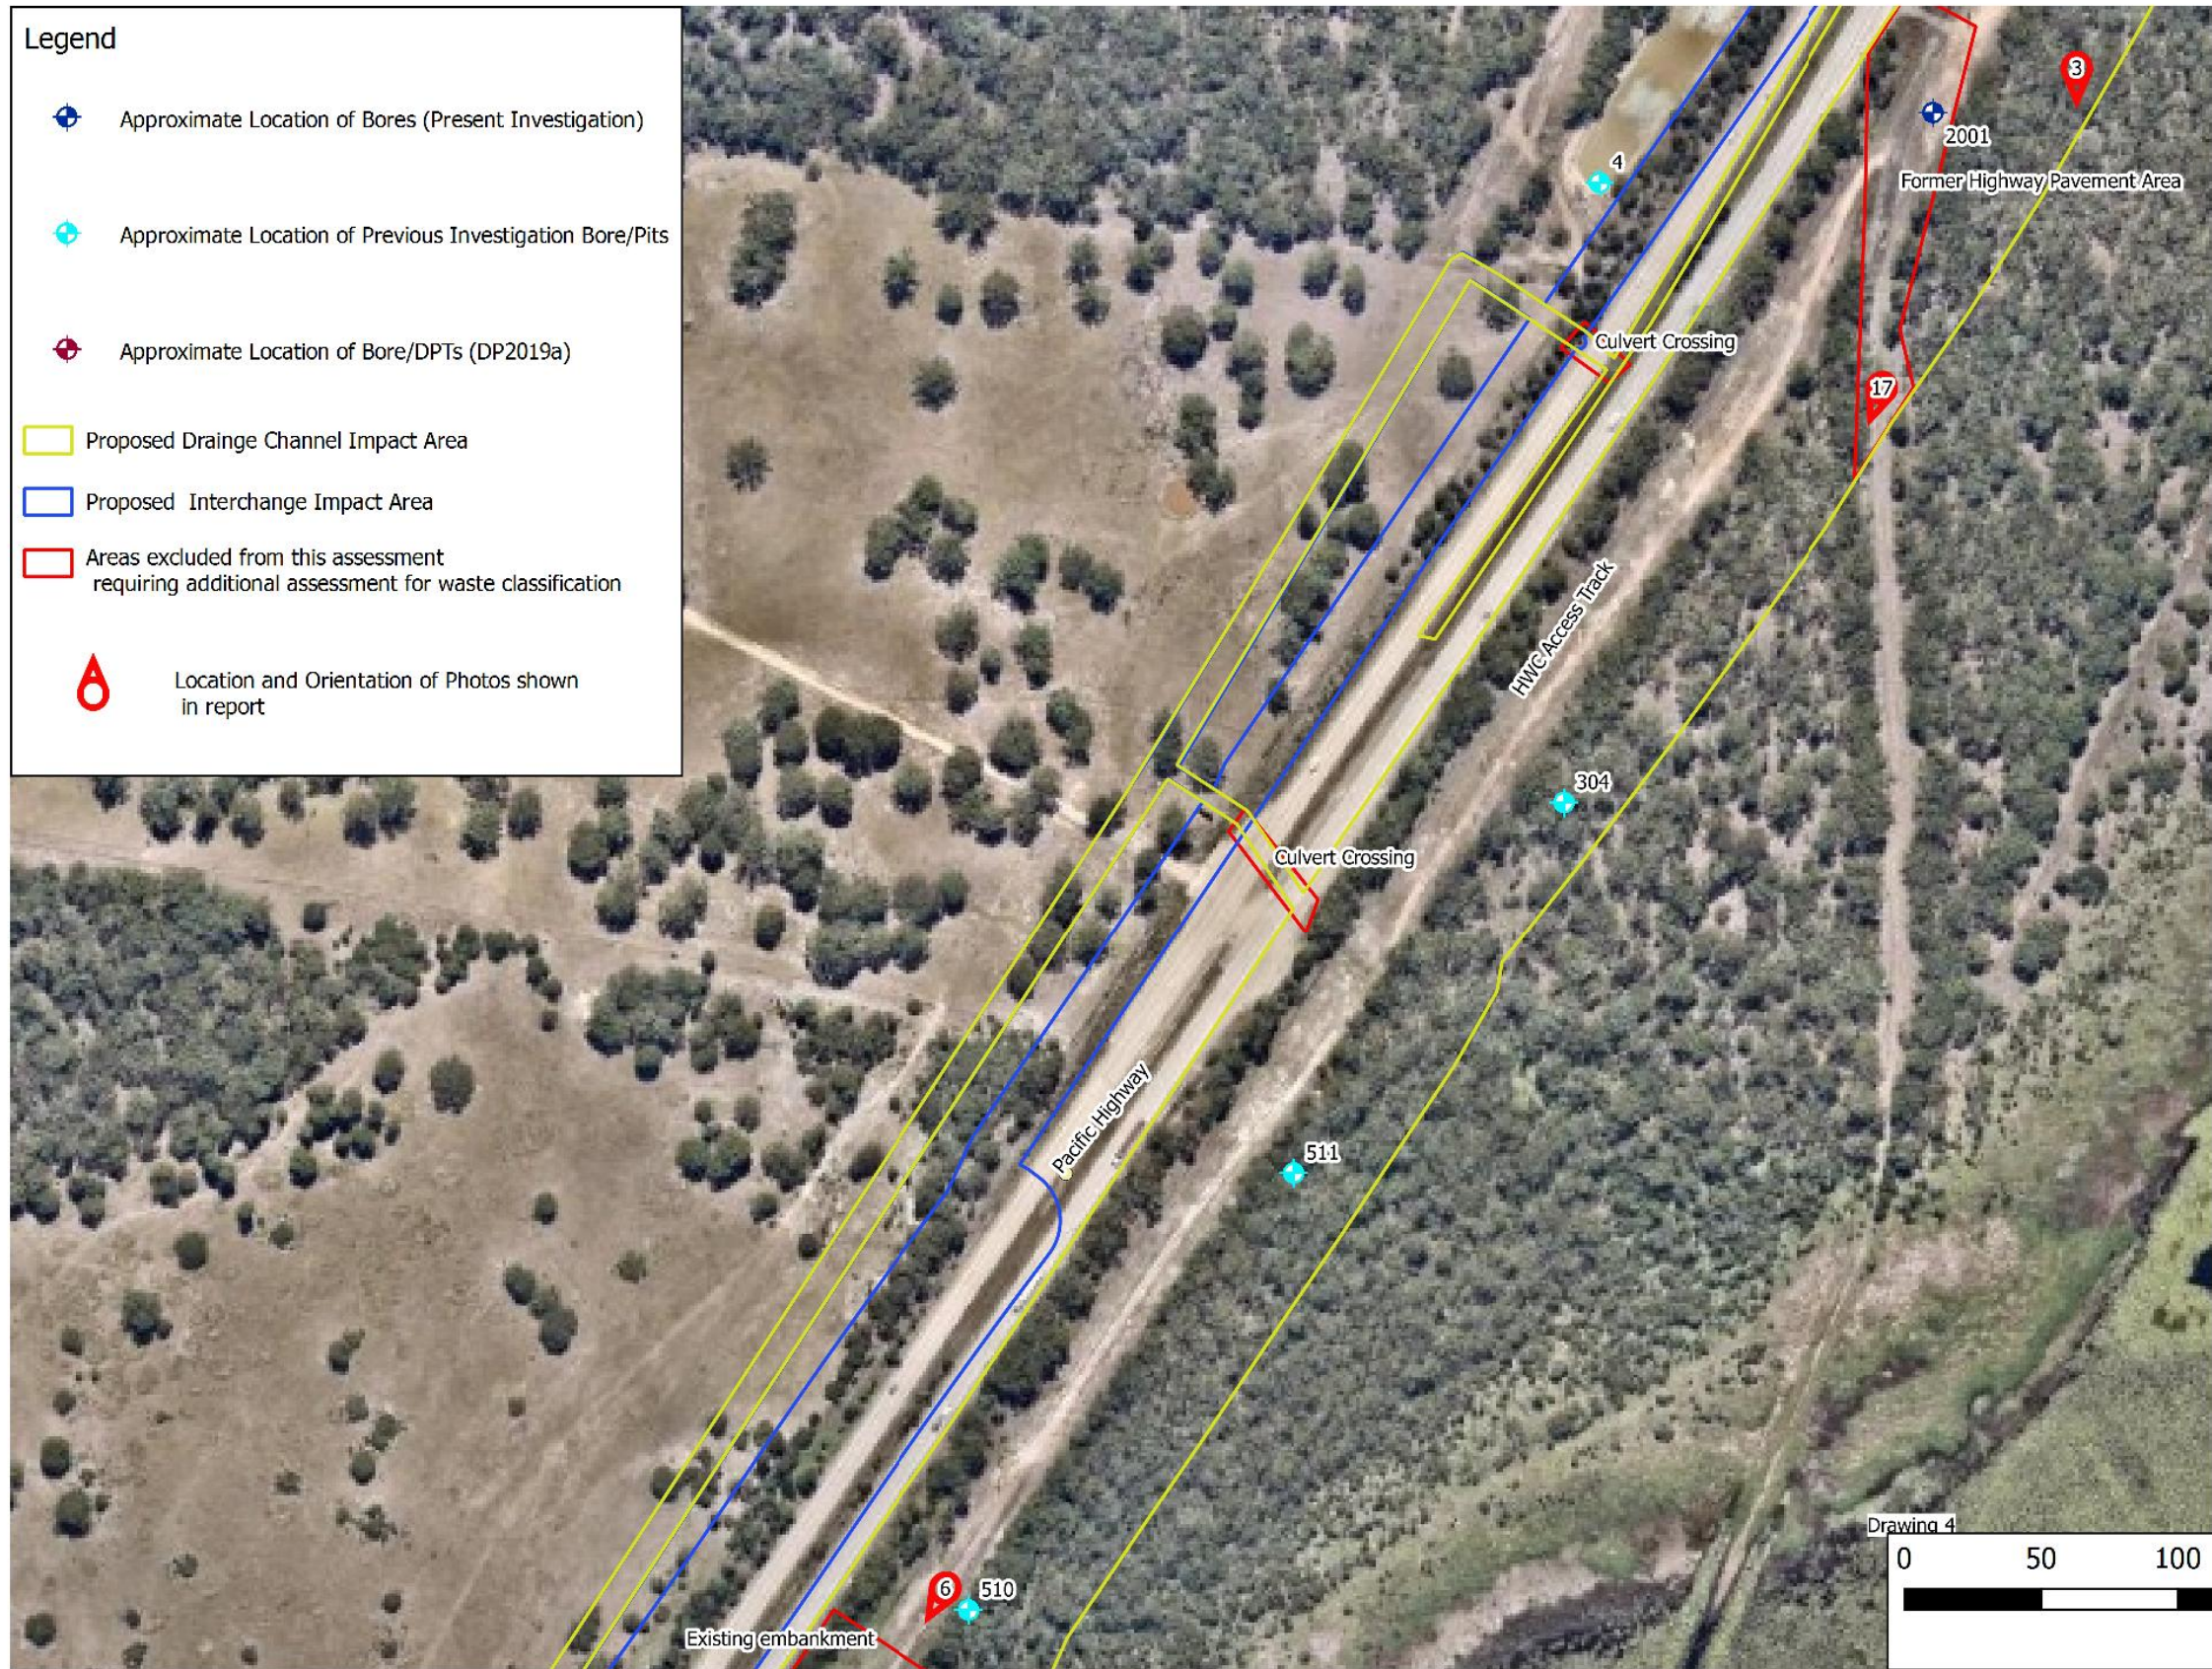
| | CLIENT: PM No 1 Pty Ltd | | TITLE: <b>Test Location Plan (showing areas excluded from this assessment)</b><br><b>Preliminary Waste Classification, Proposed Grade Separated Interchange and Drainage Channel</b><br><b>Kings Hill, North Raymond Terrace</b> | | PROJECT No: 81502.10 |
