Our Ref: TERRA19271.Rep1.Rev1

9 August 2023

RE: Lot 106 DP755923 Inyadda Dr, Manyana NSW

Report on Geotechnical Investigation

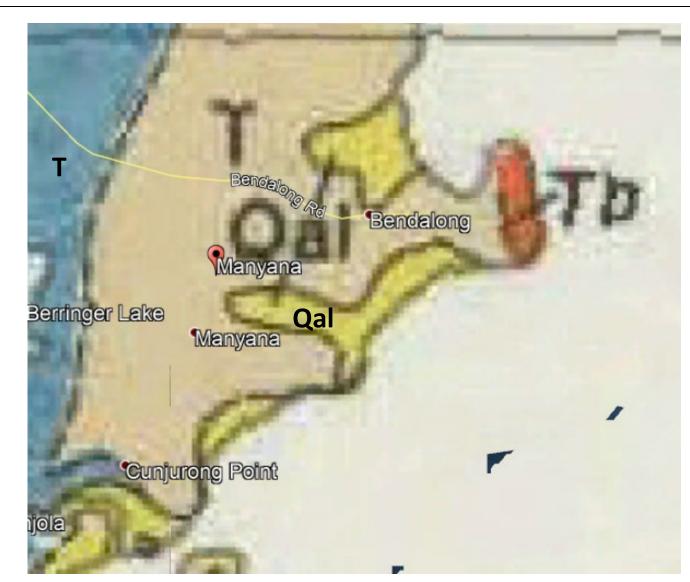
Ulladulla 1:250,000 geological map

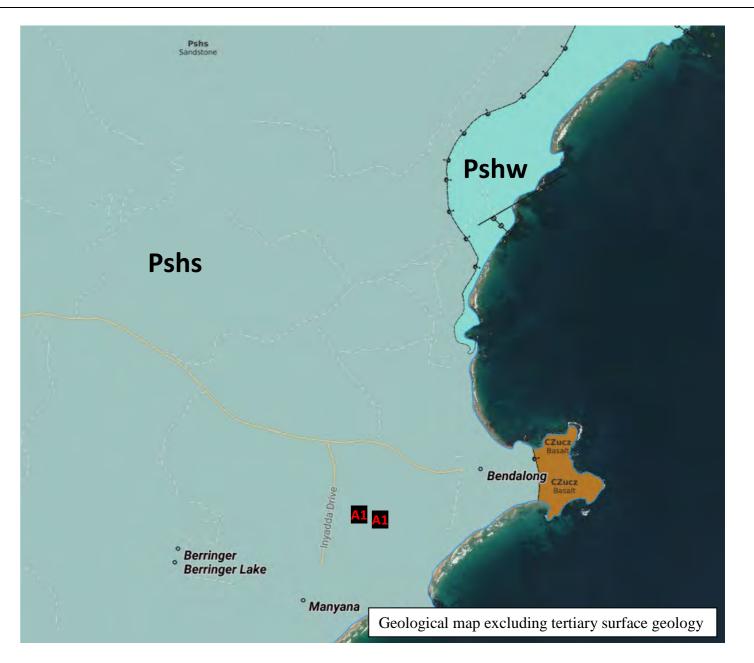
# **Site Geology**

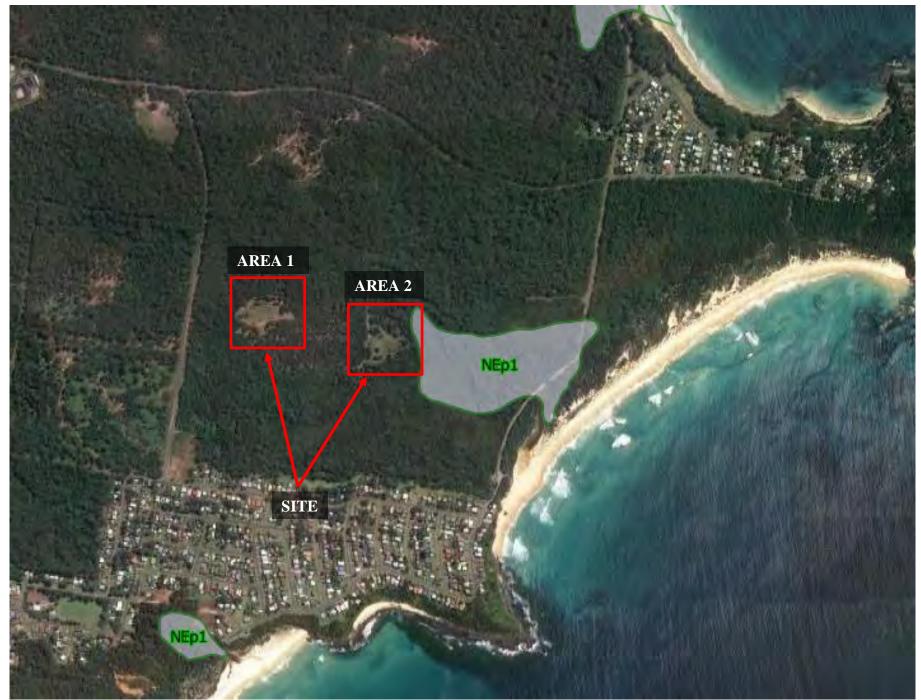
_	client: HEIR ASQUITH		
	TERRA INSIGHT	project: Geotechnical Investigation for ASS Lot 106 DP755923 Inyadda Drive, Manyana NSW		
scale	NTS	title: ASS Mapping Excerpt		
original size	A3	project no: TERRA19271	figure no: FIGURE 4

The Site's geology mapping indicates the potential for alluvial soils along the southern part of Area 1 and along the eastern part of area 2. The ASS mapping indicates ASS is most likely to be found in the alluvial soils along the eastern part of Area 2 with no known occurrence of ASS along Creek 2.

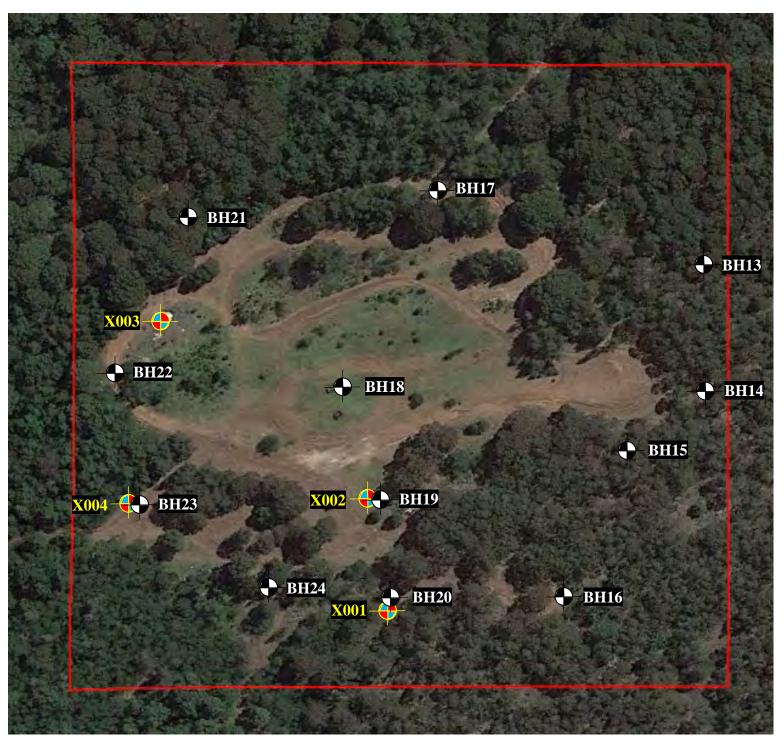
TERRA INSIGHT		project: HEIR ASQUITH  Droject: Geotechnical Investigation for ASS Lot 106 DP755923 Inyadda Drive, Manyana NSW		
scale	NTS	title: Test Site Locations - Area 1		itions - Area 1	
original size	A3	project no: TE	RRA19271	figure no: FIGURE 5

Test locations BH01 to BH012 were located within and around Area 2 whilst test locations BH13 to BH24 were located within and around Area 1. The location of each test site within and around Area 1 and Area 2 are shown on Figure 5 and 6 respectively. The subsurface conditions encountered in the boreholes are summarised on Table 3.1 and 3.2 respectively. Engineering logs are provided in Appendix D. A groundwater table was not encountered during the investigation.

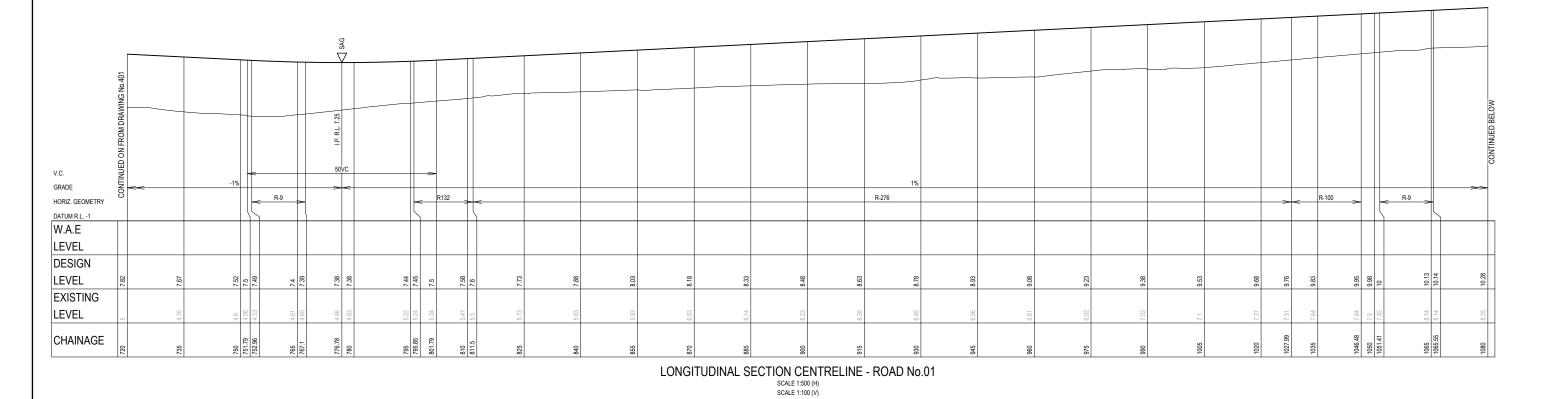
> LONGITUDINAL SECTION CENTRELINE - ROAD No.01 SCALE 1:500 (H) SCALE 1:100 (V)

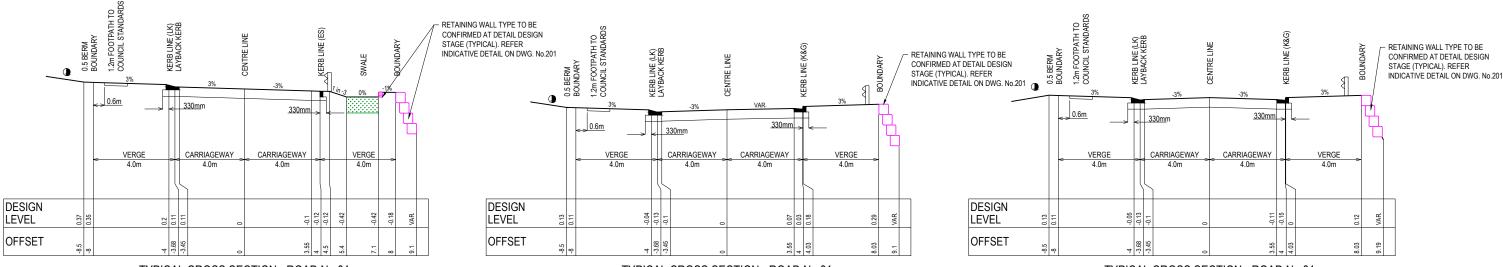
TYPICAL CROSS SECTION - ROAD No.01 CH 0 - CH 710 & CH 805 - CH 1046 SCALE 1:100 (H) 1:100 (V)

TYPICAL CROSS SECTION - ROAD No.01 CH 1046 - CH 1065 SCALE 1:100 (H) 1:100 (V)

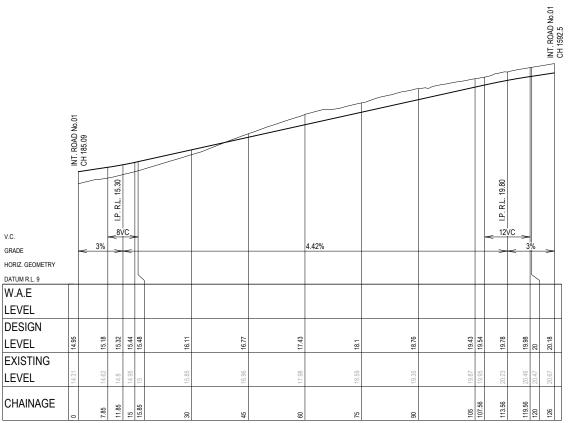
LONGITUDINAL SECTION CENTRELINE - ROAD No.02

SCALE 1:500 (H)
SCALE 1:100 (V)

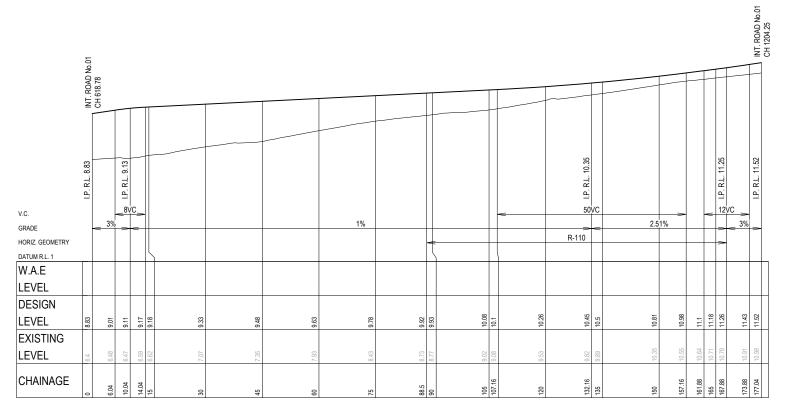
LONGITUDINAL SECTION CENTRELINE - ROAD No.03

SCALE 1:500 (H)
SCALE 1:100 (V)

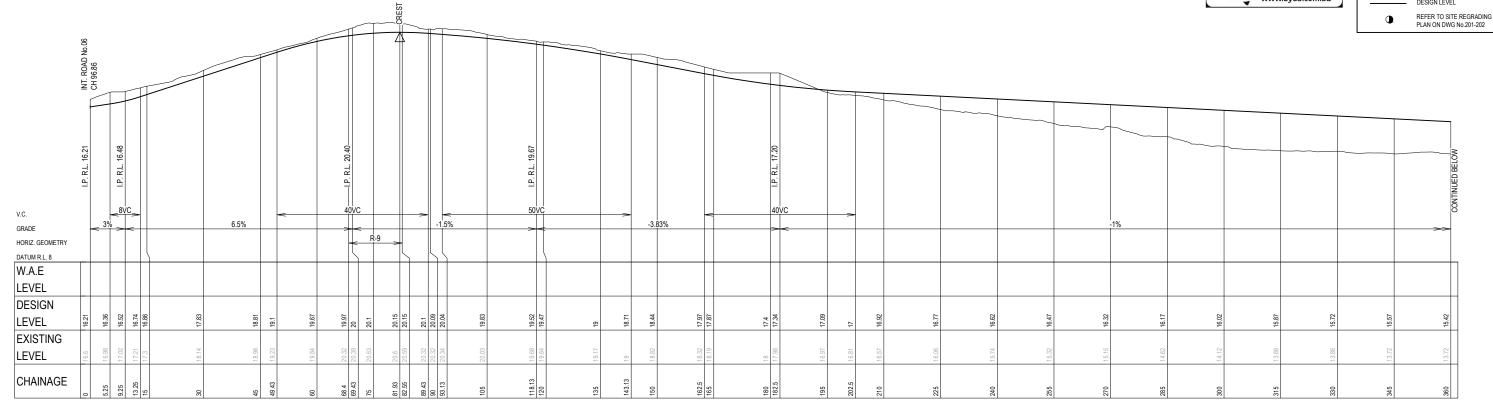
LONGITUDINAL SECTION CENTRELINE - ROAD No.07

SCALE 1:500 (H)

SCALE 1:100 (V)

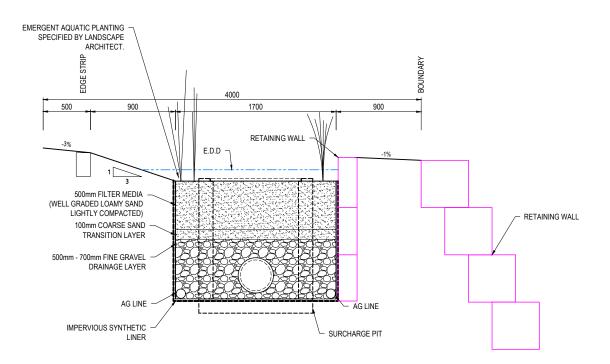
TYPICAL DETAIL ALONG BIO SWALE & BIO BASIN SCALE 1:20

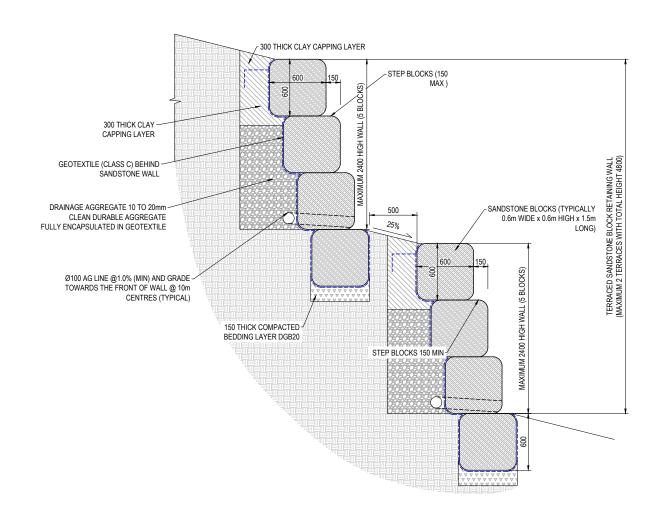
TERRACED SANDSTONE BLOCK WALL
TYPICAL SECTION
SCALE 1:10
