Preliminary Site Investigation

Preliminary Site Investigation 54 Terry Road, Rouse Hill NSW

EI Report No.: E23615.E01.Rev0
Date: 28 November 2017

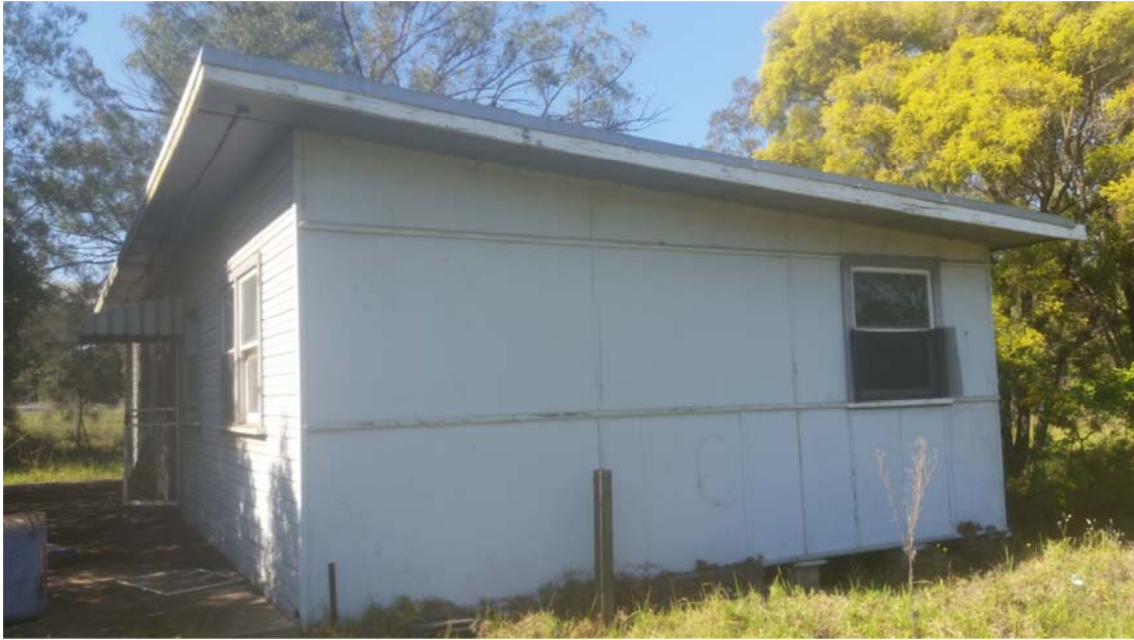
- A vacant single-storey fibre dwelling (potentially asbestos containing) was located on the central portion of the site and appeared to be dilapidated (see **photographs B1**);

Photograph B1: Residential property located on the southern portion of the site.

- Prior to site demolition, carry out a Hazardous Materials Survey on existing site structures to identify potentially hazardous building products that may be released to the environment during demolition. This survey is necessitated by the legislative requirements of protecting site personnel from potential exposure risks and informing implementation of special waste management measures (if necessary);

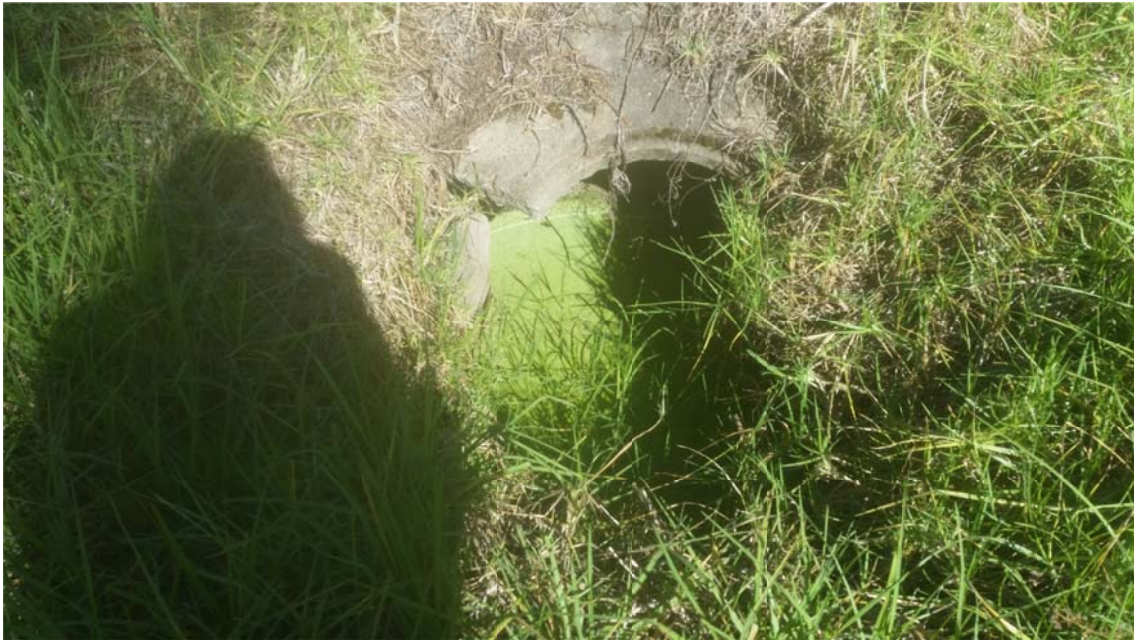
- There is a potential septic tank located adjacently west of the residential property (see **photographs B2**);
- Metal sheds are located southern and western portion of the site. The sheds contain various amounts of rubbish stored (see **photographs B3**);

Photograph B2: Septic tank located south-west of the residential property.

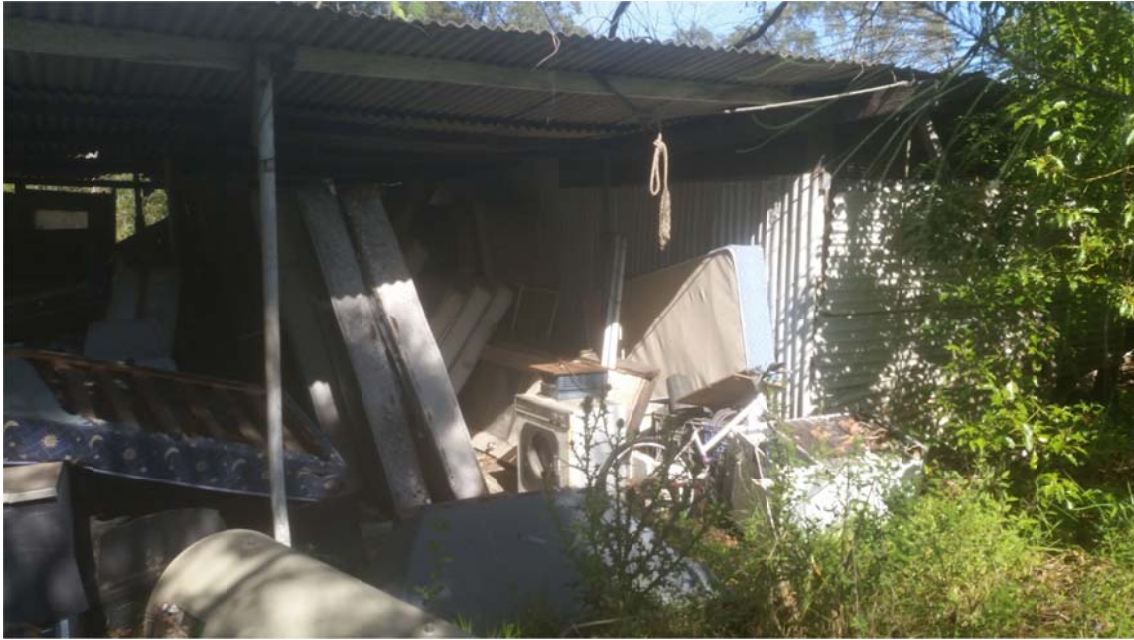
Photograph B3: Shed containing waste stockpiles, located in the southern portion of the site.

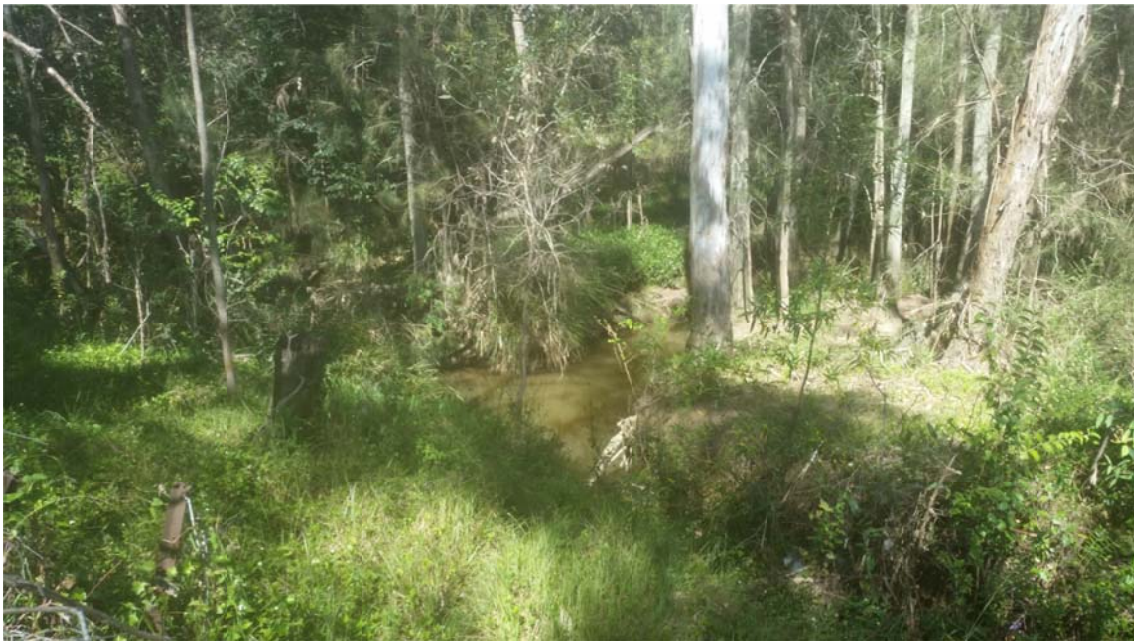
- There is a creek (Seconds Ponds Creek) located on the western portion of the site (see **photograph B4**);
- A man made dam was present on the central portion of the site.

Photograph B4: Seconds Ponds Creek, located in the western portion of the site.

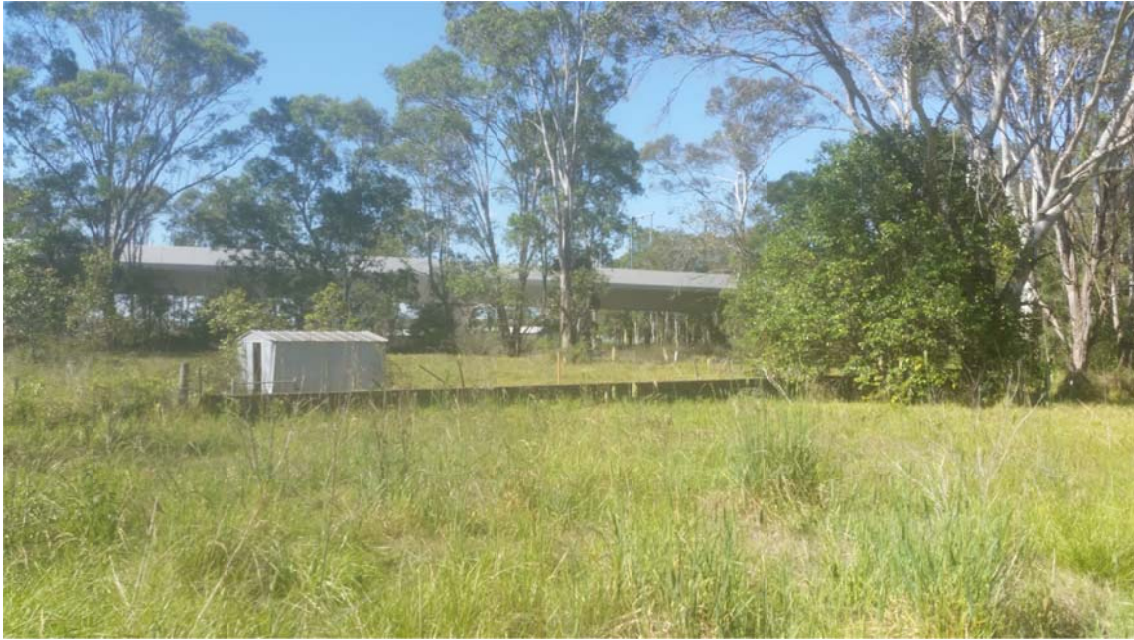
- The grass patch across the site was observed to have minimal signs of distress, with most of the vegetation being overgrown (see **photographs B5 & B6**);

Photograph B5: Overgrown- vegetation located on the site. Photograph directed towards the northern direction.

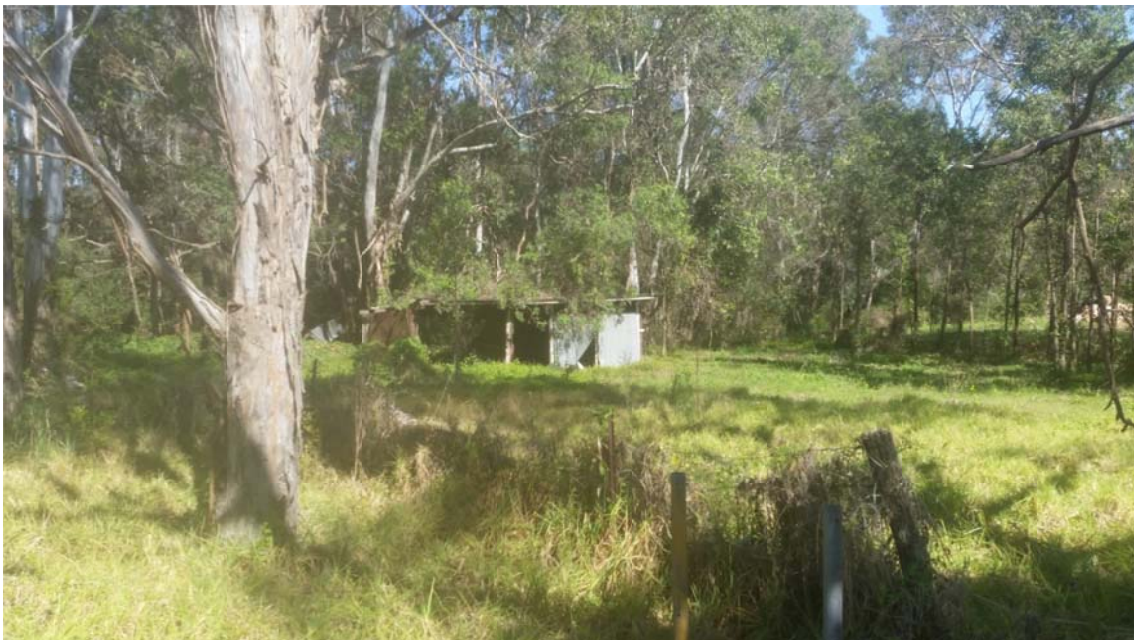
Photograph B6: Overgrown- vegetation located on the site. Photograph directed towards the western direction.
