Our ref: 7406-4-R1 Rev 1
31 October 2024

Perisher Express Quad Chair Top Station Lift Operators Hut, Perisher NSW Geotechnical Assessment

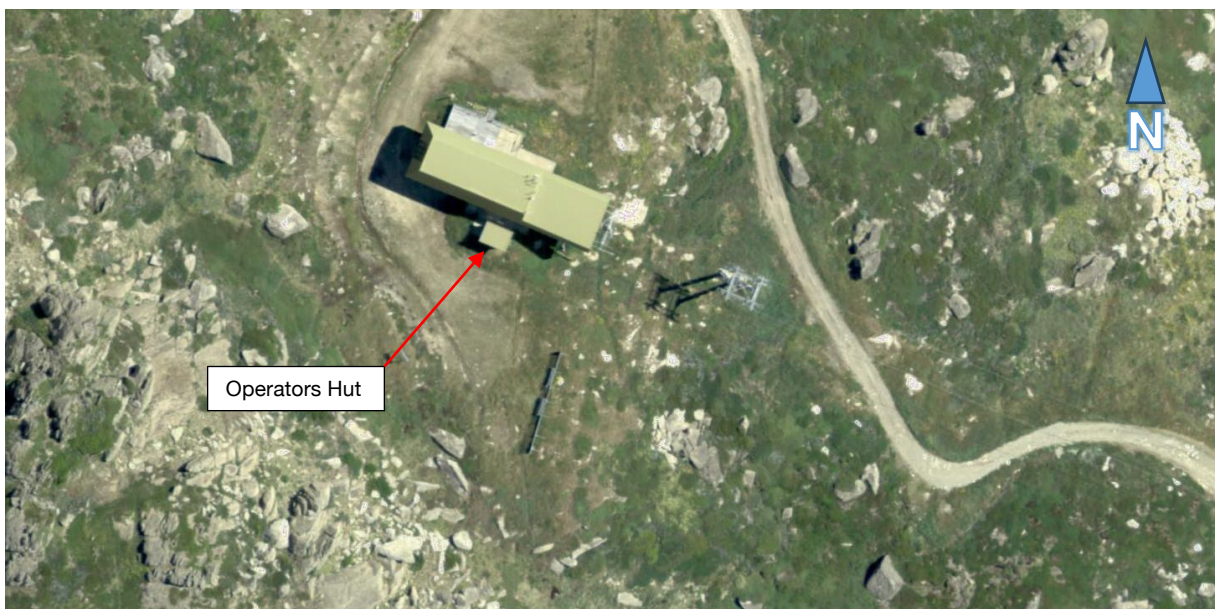
Plate 2 – Plan of Top Station showing Location of Operators Hut

The Site is located about 1.6km west north-west of the Perisher Valley Terminal as shown in Plate 1. A plan of the Top Station is shown in Plate 2.

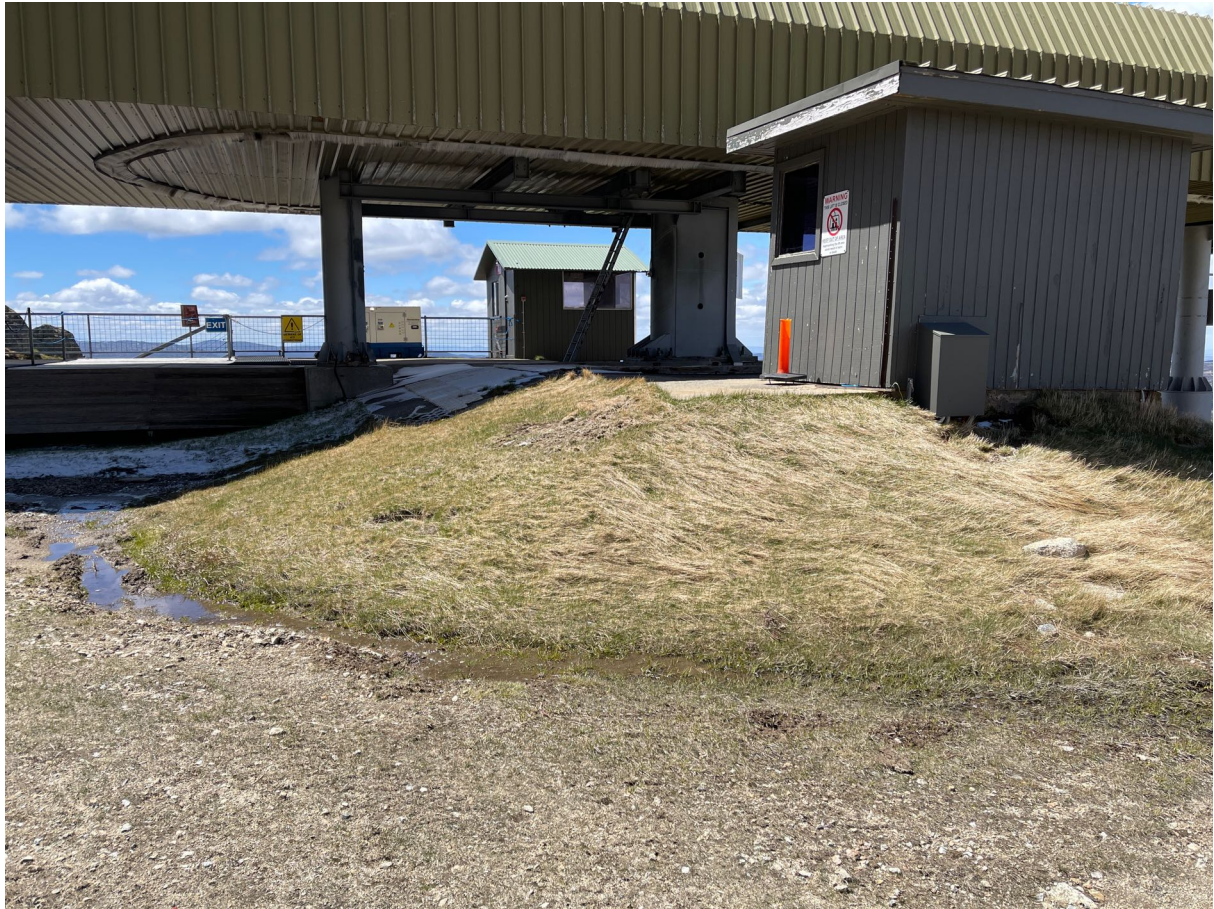
Photo 1

Numerous granite core-stones and outcrop were observed at various locations in the site vicinity. A fill embankment has been constructed to support the existing Operators Hut, appearing to be up to about 1.5m thick based on adjacent ground surface levels, and including granite boulders as evidenced by the site photos. It is expected that variably weathered granite is located at relatively shallow depth below the original ground surface.

Overview of Lift Operators Hut

- Demolition of existing Operators Hut.
- Removal of existing fill embankment.
- Constructing strip footings and blockwork to support the new Operators Hut.

Where strip footings are founded on extremely weathered or better granite anticipated at shallow depth beneath the original ground surface, a revised classification of Class A would apply and a conservative allowable bearing pressure of 150kPa could be adopted.

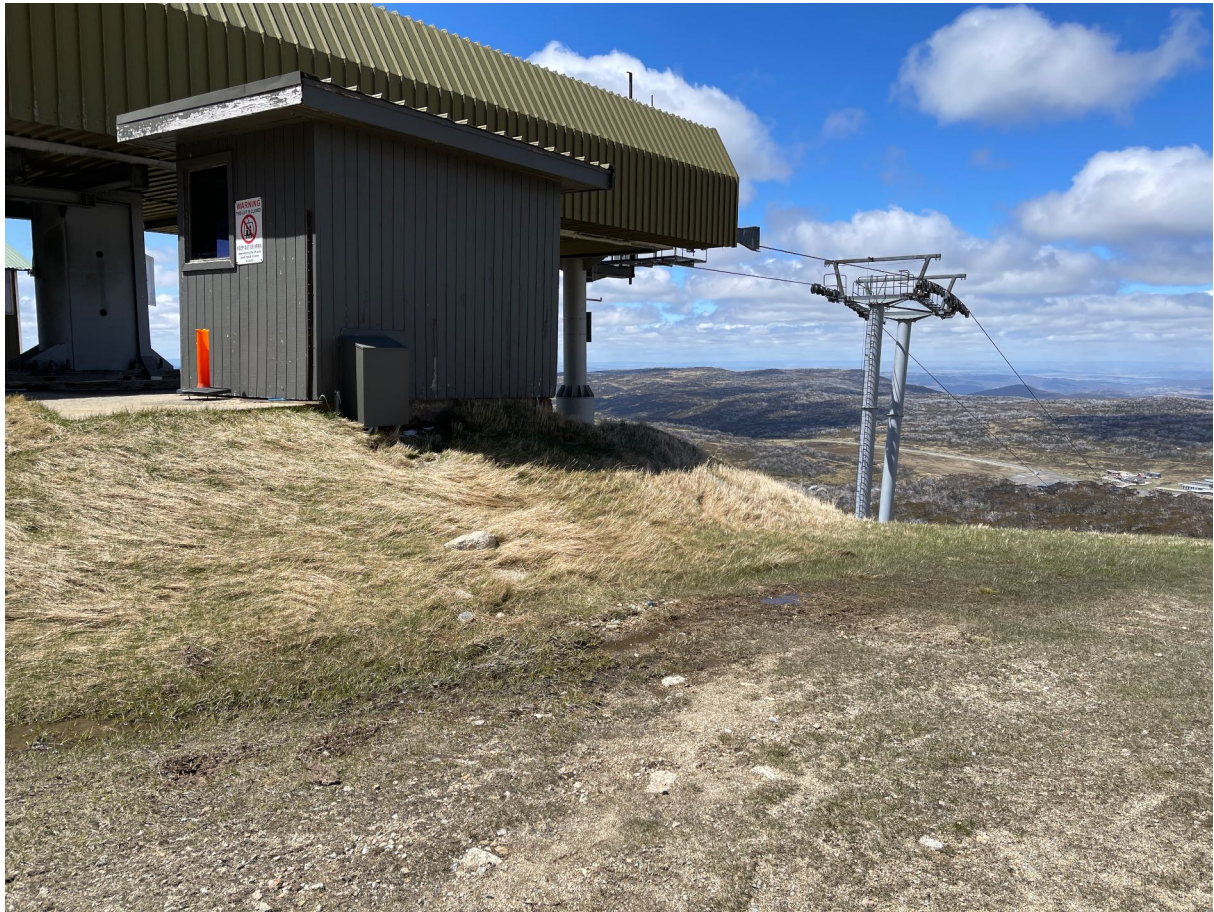
Photo 2

Overview of Lift Operators Hut – continuation of Photo 1.

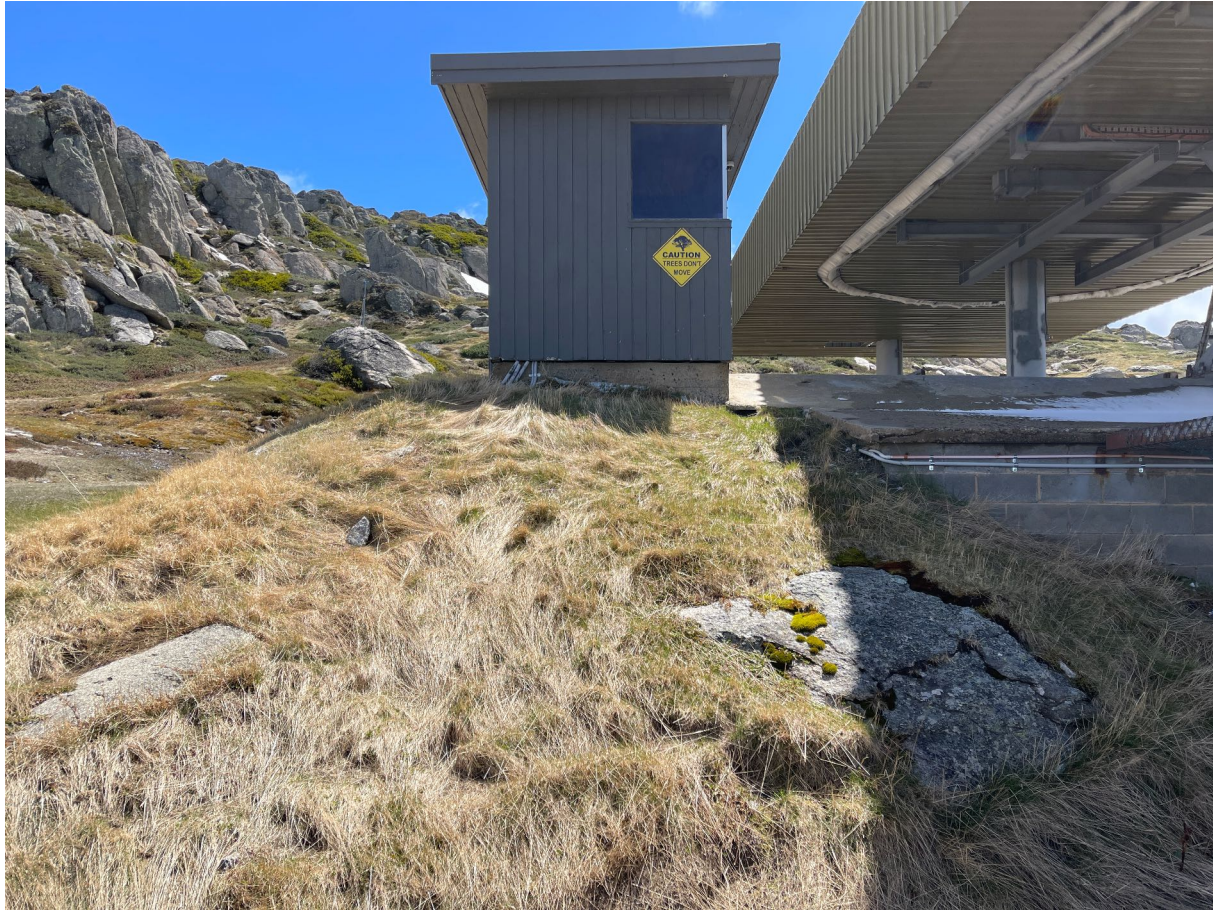
Photo 3

Localised ponded water was observed upslope of the embankment.

View of Lift Operators Hut viewed from downslope.
