PRELIMINARY GEOTECHNICAL AND HYDROGEOLOGICAL ASSESSMENT

**Proposed Additions and Alterations
5 Villiers Road, Padstow Heights NSW 2212**

15 April 2025

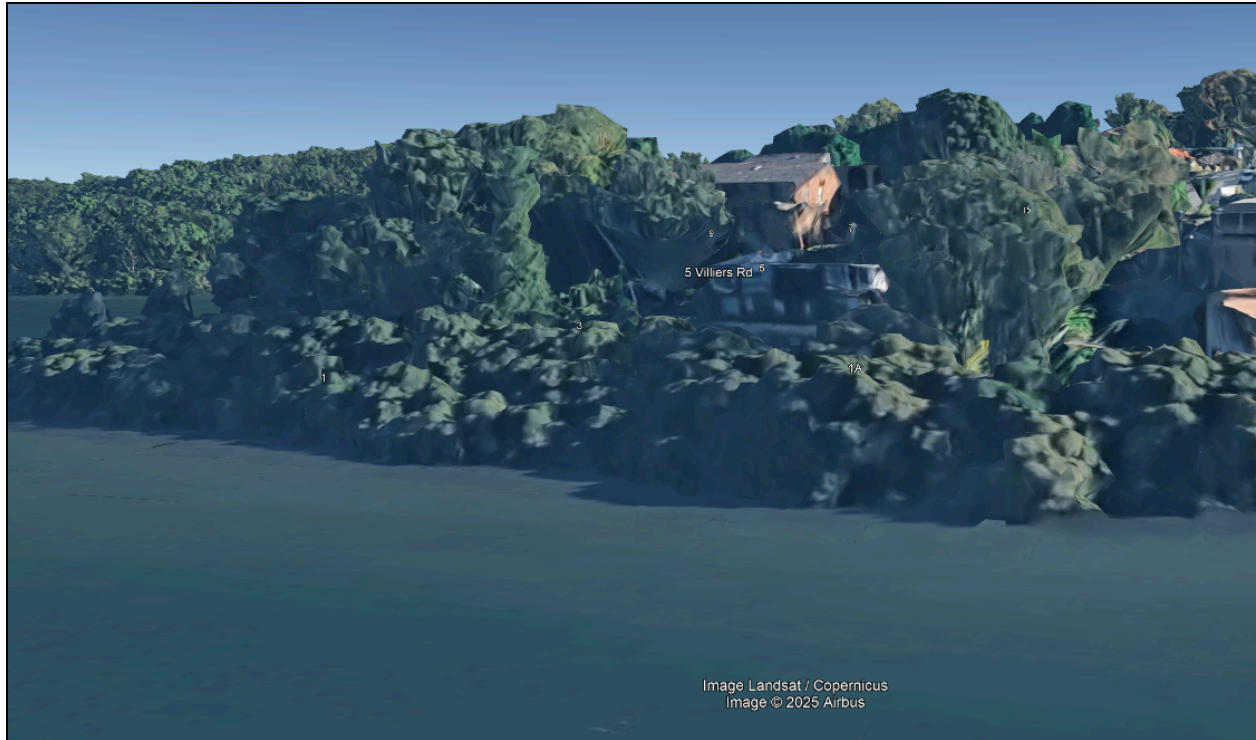
Plate 2.1: 3D Satellite Rendering of the Site and its Surroundings (Google Earth Pro)

The site is surrounded by similar residential dwellings to the south and east of the site, with notable elevation differences at their respective common boundaries. Plate 2.1 shows a 3D satellite image that was generated using Google Earth Pro, which visually demonstrates the steep terrain between the site, the neighbouring properties and the nearby Georges River.
