## Form 1 – Declaration and certification made by geotechnical engineer or engineering geologist in a geotechnical report.

GEOTECHNICAL ASSESSMENT - PROPOSED STAIR REFURBISHMENT & BIKE STORAGE CAGE

13 BOBUCK LANE, THREDBO, NSW

**SPECIALIST ADVICE TO  
MUNJARRA CO-OP SKI LODGE LIMITED**

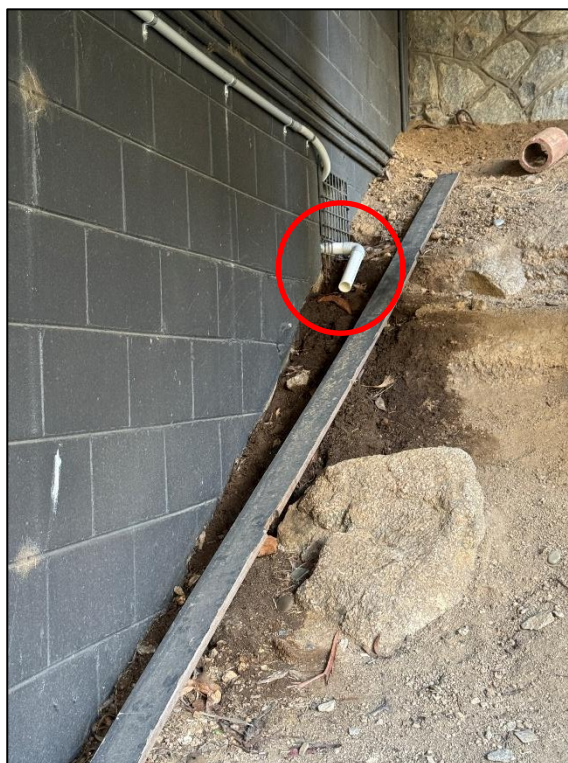
Plate 2: View looking south showing PVC pipe.

We observed what appeared to be a small diameter PVC drainage pipe emanating from the wall, adjacent to the proposed bike storage cage location, which appeared to allow water to discharge over the slope. Refer to Plate 2 below.

- 7.4.1 Any existing subsoil drainage or surface drainage measures disturbed as part of the proposed works must be reconstructed or diverted around the new staircase, so that the current site drainage is maintained. Any surface water drains around the lodge must be regularly checked and cleared of debris. We recommend this forms part of an annual maintenance plan to be carried out by the owners.

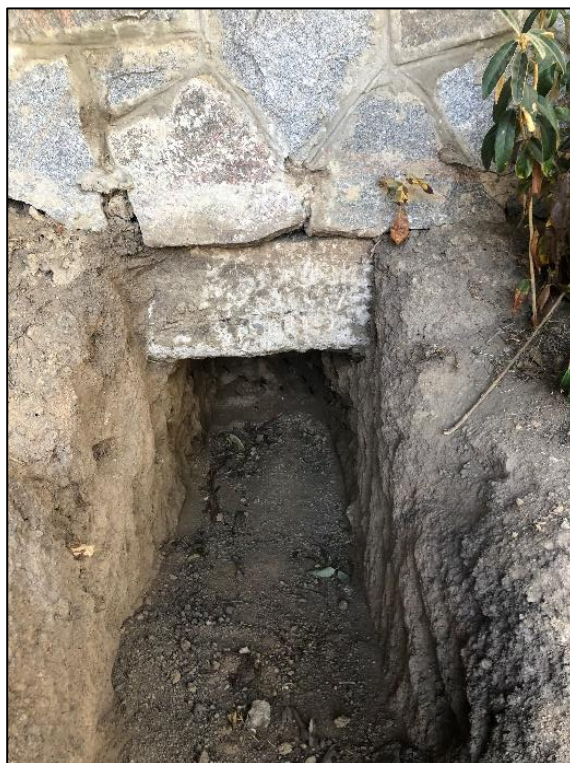
Plate 3: TP1 (Looking south).

Weathered granite was exposed in the sides and base of the test pits below about 0.2m depth, as well as at the ground surface on the western side of the staircase over the lower portion of the site. Refer to Plates 3 and 4 below.

The granite was generally extremely weathered and of hard (soil) strength, but locally was assessed to be highly weathered and of very low rock strength. In TP2, some granite cobbles and boulder sized 'corestones' (less than about 0.3m size) were observed in the western side of the test pit. Hand penetrometer readings in the sides and base of the test pits were greater than 600kPa.
