Site Classification Summary Report

Client	The Trustee for Elmerino Investments Trust	Project No.	216804.00
Project	Proposed Extensions	Date	22 Aug 2023
Address	20 Candle Heath Road, Perisher Valley	Doc No.	R.001.Rev1

Proposed Development

STRUCTURAL ENGINEERING DESIGN FOR PROPOSED ALTERATIONS AND ADDITIONS AT CANDLE HEATH RD, PERISHER VALLEY SNOWY MOUNTAINS NSW 2624

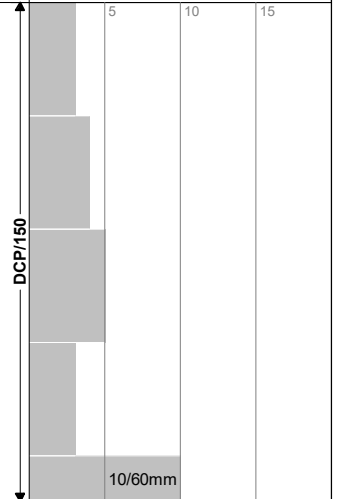
0.7-1.0m: some anthropogenics observed, possible trench within pit							P		0.9						
		1.1	(CL-CI) Gravelly Sandy CLAY; grey brown; clay fraction low to medium plasticity; gravel fraction fine, sub-angular to sub-rounded; sand fraction fine to coarse; trace cobbles to 100mm		RES	(F TO ST)		=PL to >PL				1

1.3	Test pit discontinued at 1.30m depth Auger & bucket refusal on cobbles and boulders

METHOD: 600mm wide toothed bucket to 1.0m, then 100mm diameter auger to 1.3m

Pit 1: Low plasticity silty clay topsoil fill to 0.1 m depth, low plasticity sandy gravelly clay fill to 0.4 m depth, then silty sandy gravel (possible fill) to 1.1 m depth overlying low to medium plasticity gravelly sandy clay to the auger/bucket refusal depth of 1.3 m. It is noted that some anthropogenic inclusions were observed between 0.7 – 1.0 m depth, indicative of either a fill layer or a possible backfilled trench within the greater test pit.

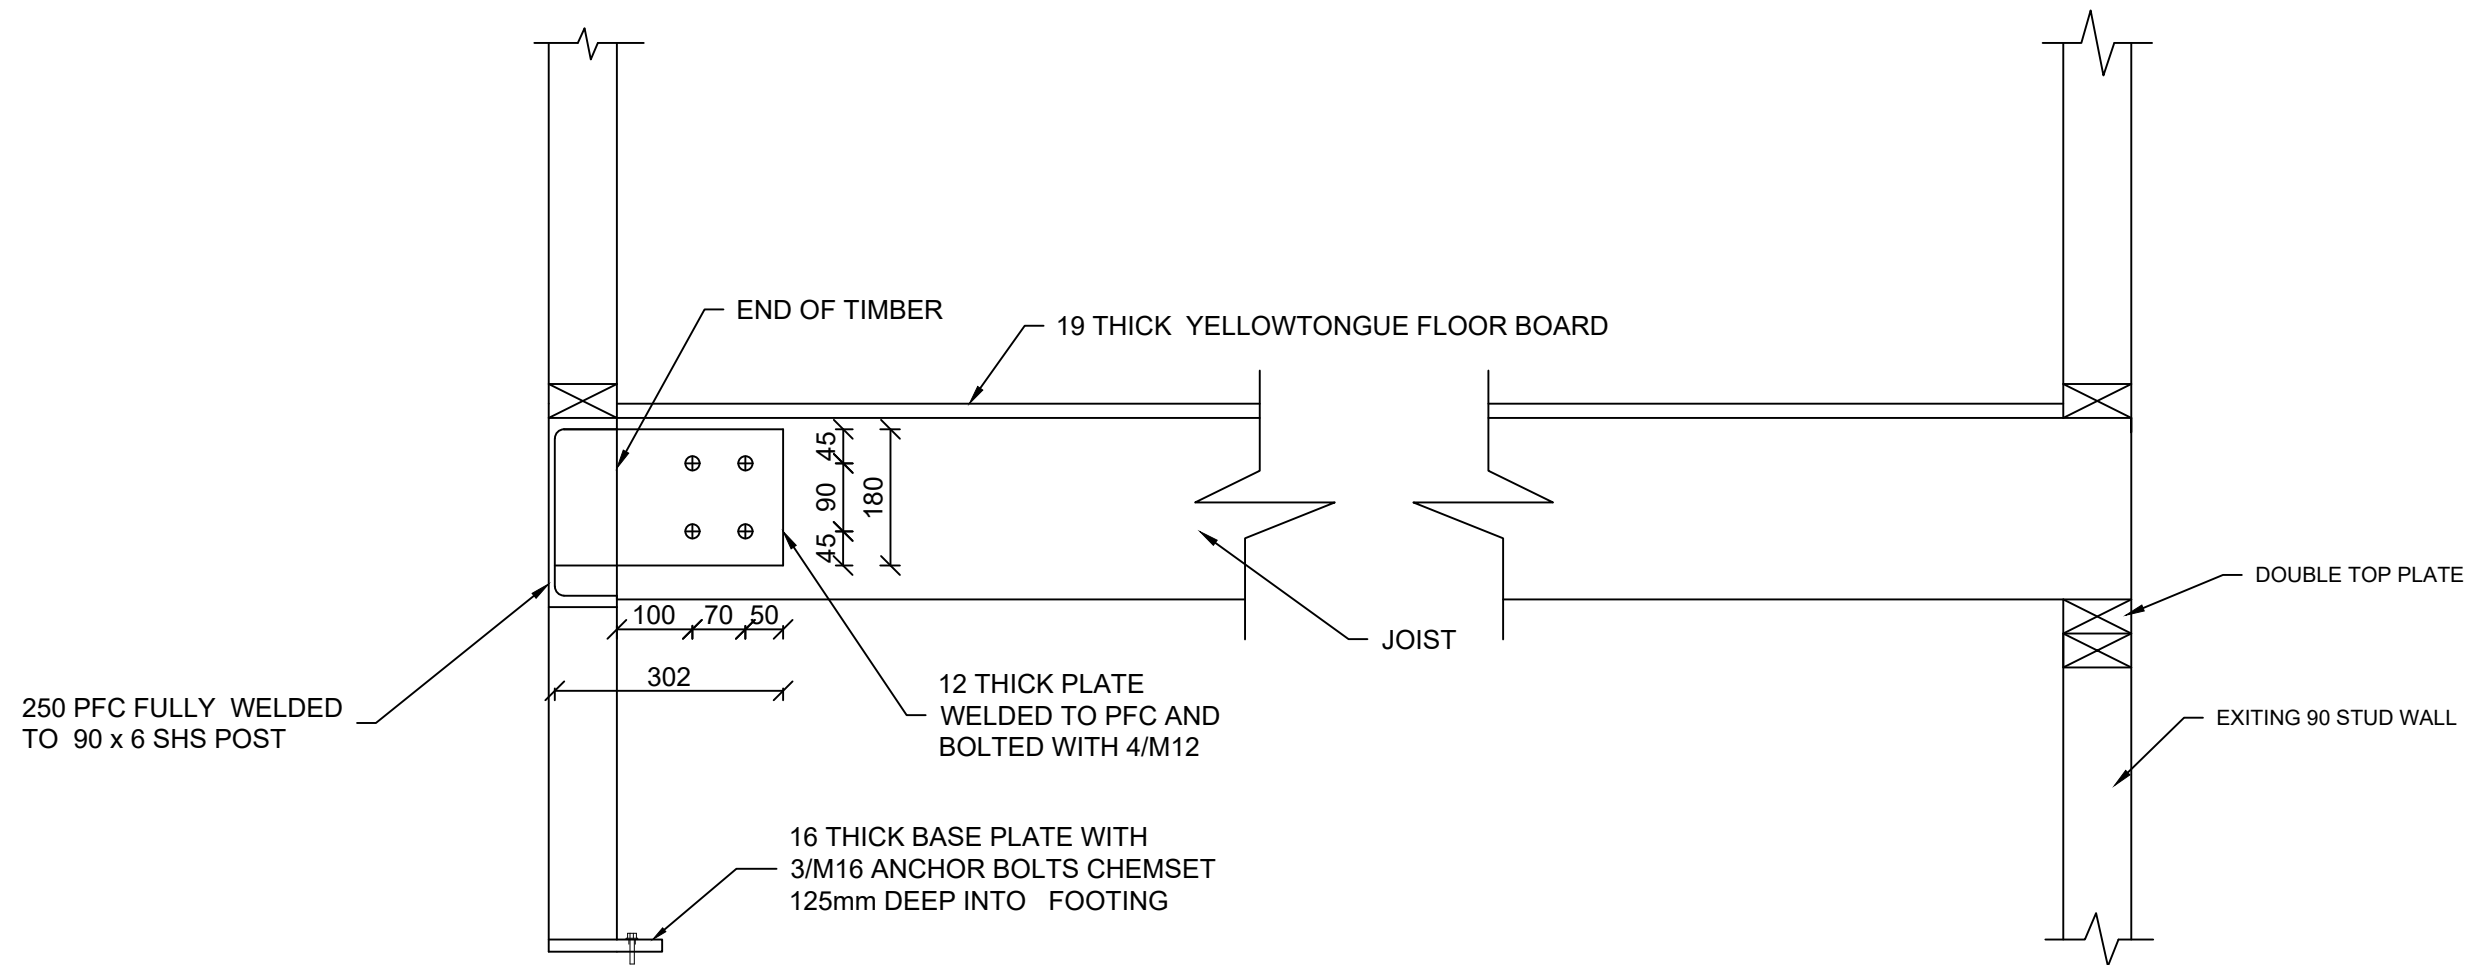
SECTION B-B
SCALE 1:10

DATA SPECIFICATIONS		
SYMBOL	SPECIFICATIONS	MAX SPAN
B1	250 PFC	4m
J1	240 x 58 LVL@450 CRS	3.5m
P1	90 x 6 SHS	
L1	150PFC OR 150 x 35 LVL	1m
