Our Reference: 21091 Riverbank Rehabilitation approval and design  
Via: Email & NSW planning portal

**Environmental protection works – proposed rock rip rap and associated revegetation works along the Murray Riverbank**

**Lot 4&5 of DP560393, 131 Merool Road Moama NSW 2731**

| | | | | | | DOCUMENTS ISSUED DO NOT BEAR ORIGINAL SIGNATURES. EVIDENCE OF VERIFICATION AND APPROVAL MAY BE OBTAINED FROM THE COMPANY. | Name | | Date | Client: | | | Project:<br>MEROOL RIVER BANK REHABILITATION | Drawing Status:<br><div>FOR REVIEW</div> | | | |

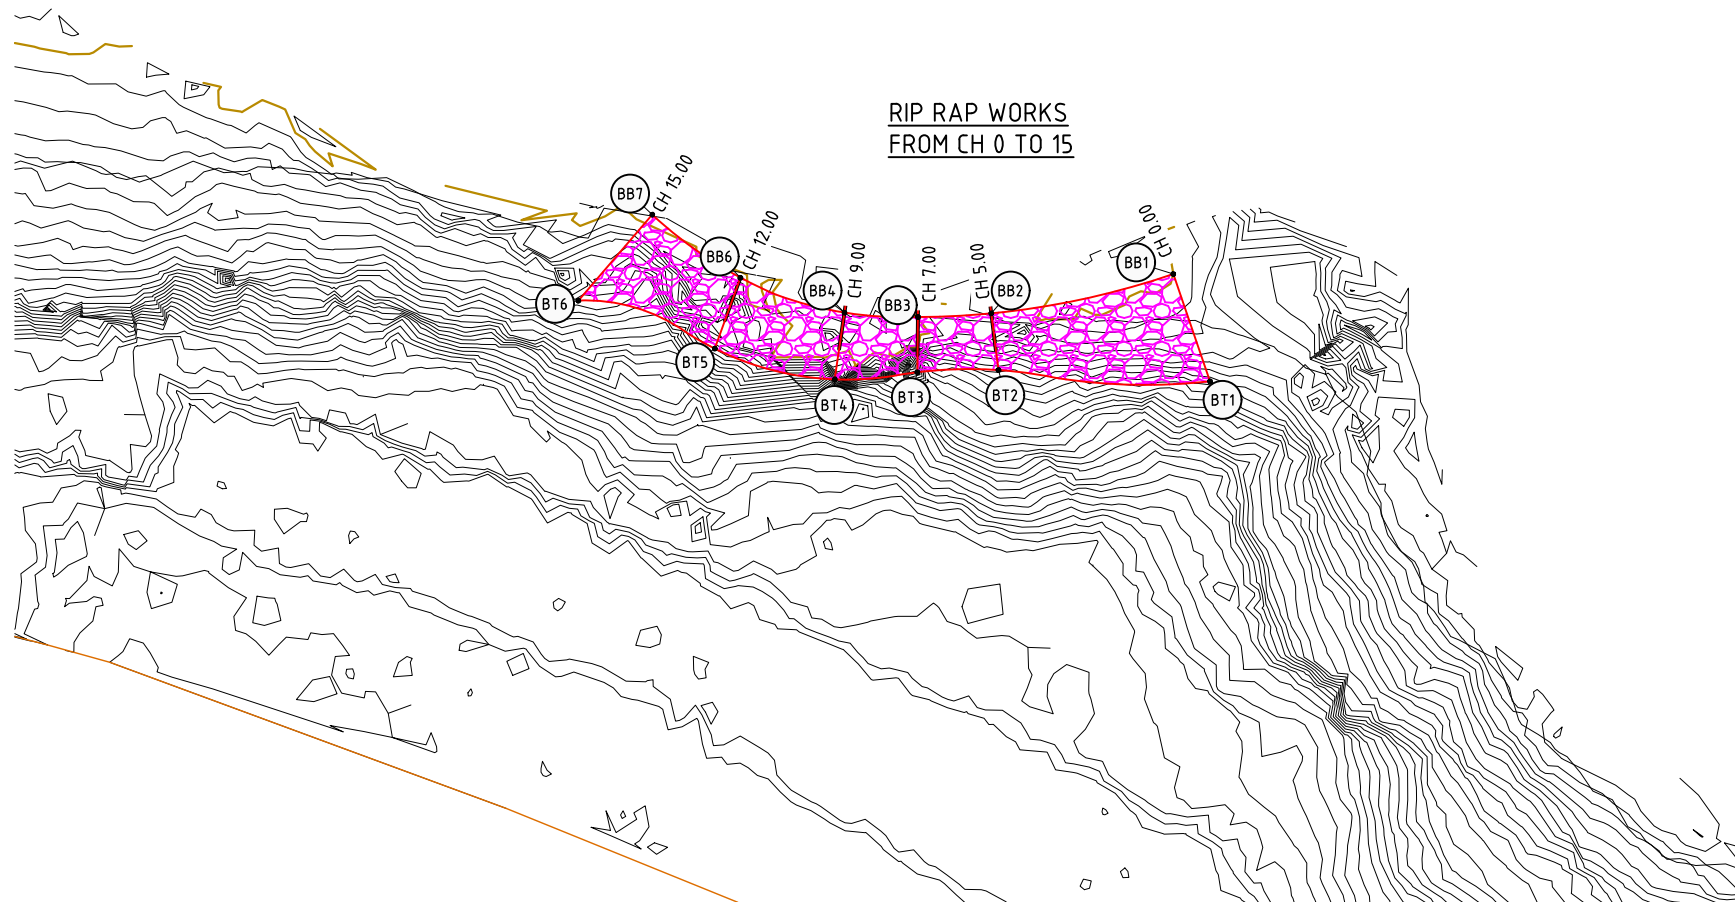
SITE 1  
SCALE 1:200

RIP RAP WORKS  
FROM CH 0 TO 15

1. Proposed site plan
  - Amended proposed site plans are required
    - Site 1- Plan and Cross Section; Drawing No 21091-02; Sheet 02 of 07 – total length of the proposed rock rip rap has been added. Please refer to updated drawing attached.
