Statement of Environmental Effects

Thredboland and Freeriders Beginner Zone

Thredbo Alpine Resort
Kosciuszko National Park, NSW
September 2022

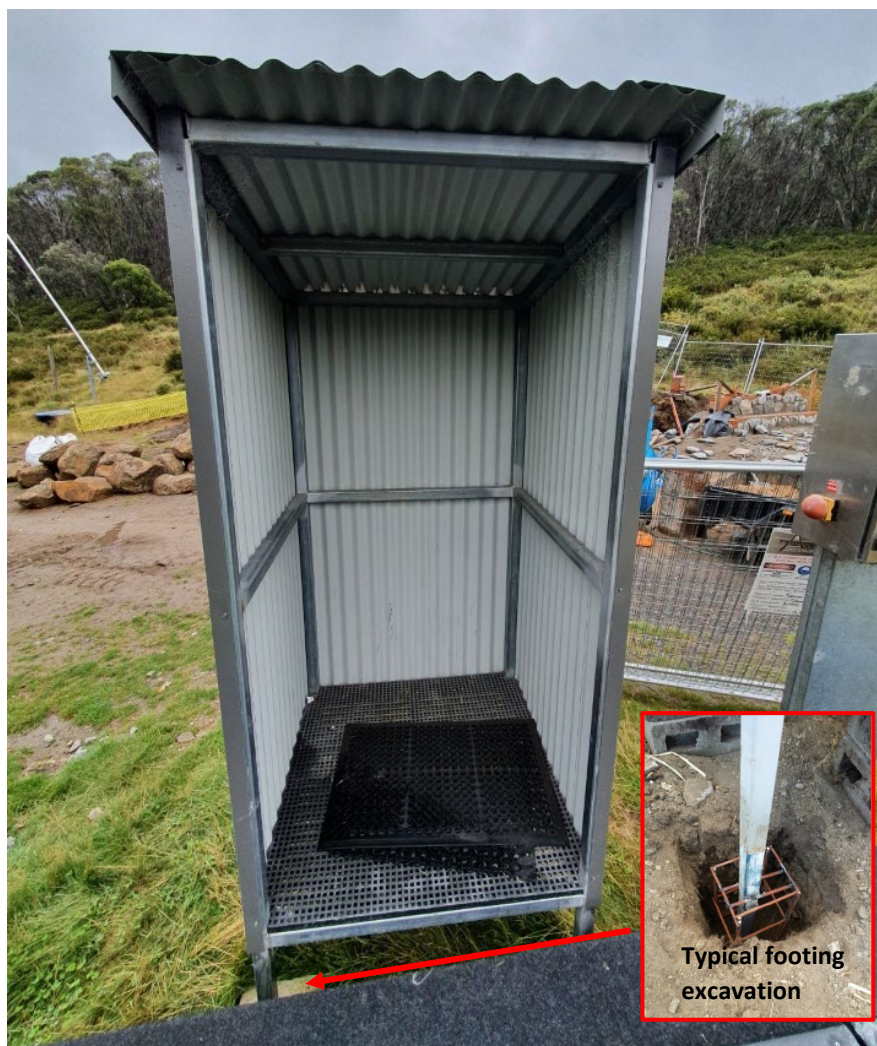
Figure 8: Example of Operator Hut

Two (2) operator huts (top and bottom of snowrunner) (**Figure 8**) will also be installed. The huts are approximately 1100 mm x 1100 mm x 2850 mm high. The hut footings (short concrete piers) require minimal excavations. Design plans are provided in **Appendix B**.

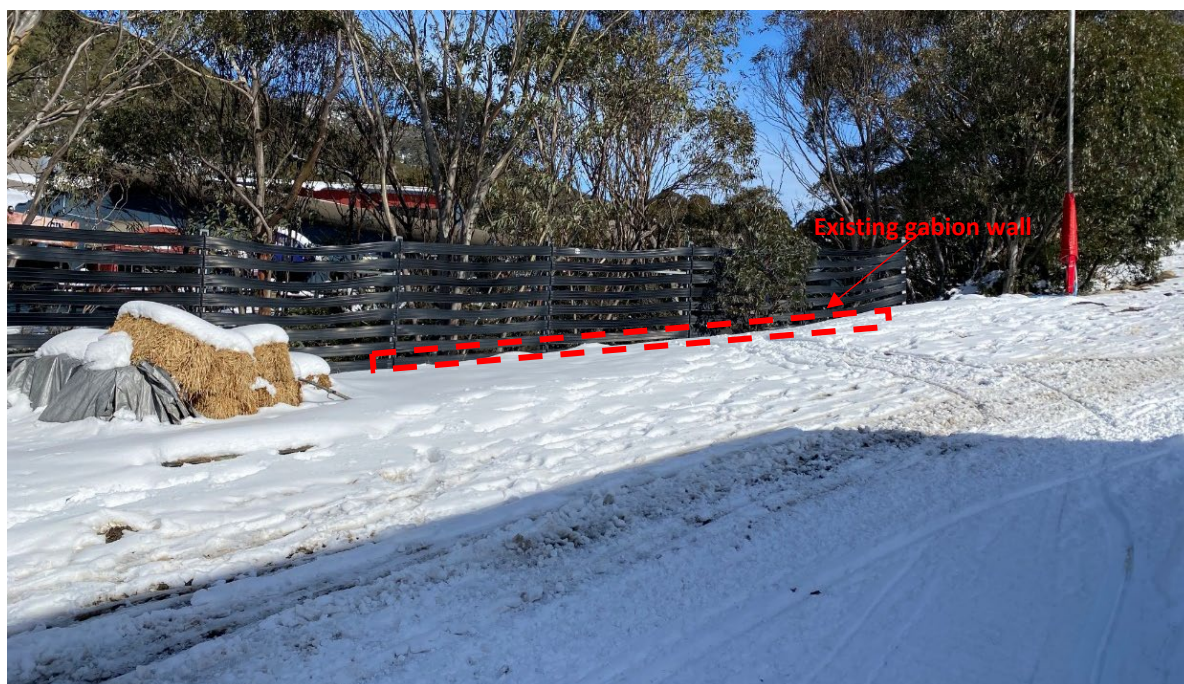
Figure 9: Proposed Stairway Location

A set of low angled stairs (approx. 16 m long x 1.8 m wide) will be constructed adjacent to the Mountain access road (refer **Figure 9**). The stairway will comprise timber sleepers and gravel to blend in with the landscape. The existing gabion wall at this location will also be extended as a rock wall.

After the stairs, guests will turn right across the Mountain access road toward the check-in location. Barrier nets will be installed along the southern end of Gunbarrel bottom station to guide guests to the check-in location.

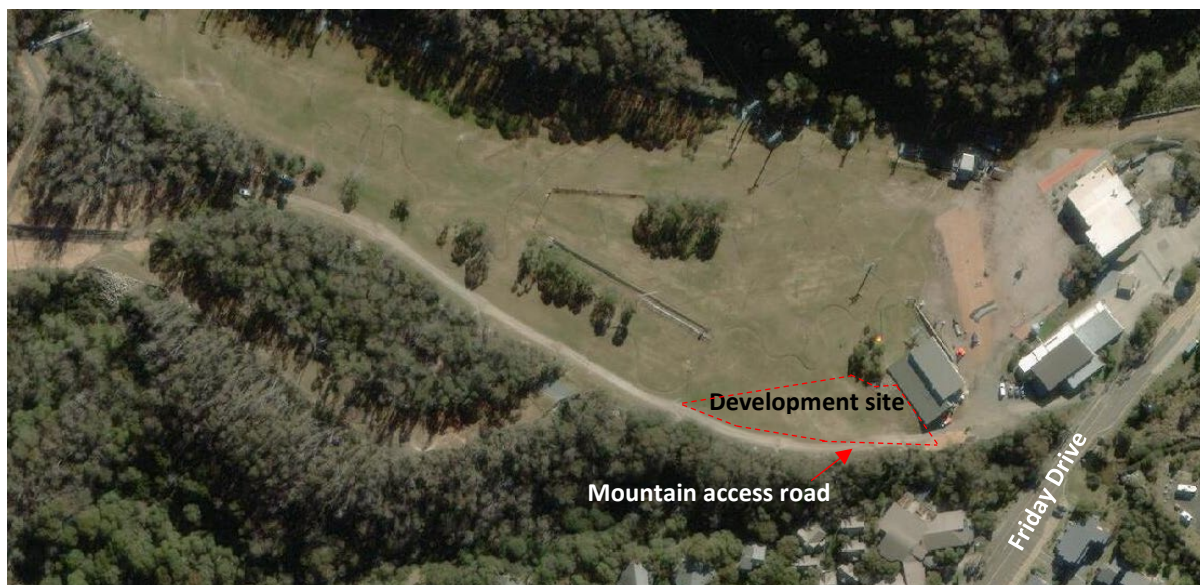
Figure 10: Construction Site Access (Source: NSW Government 2021d)

During operation, staff and guests will be directed to access the Snowsports operations building and check-in via Thredboland and the southern end of Gunbarrel bottom station / Mountain access road. The route will be marked with signage and temporary fencing (refer site plans in **Appendix B**).

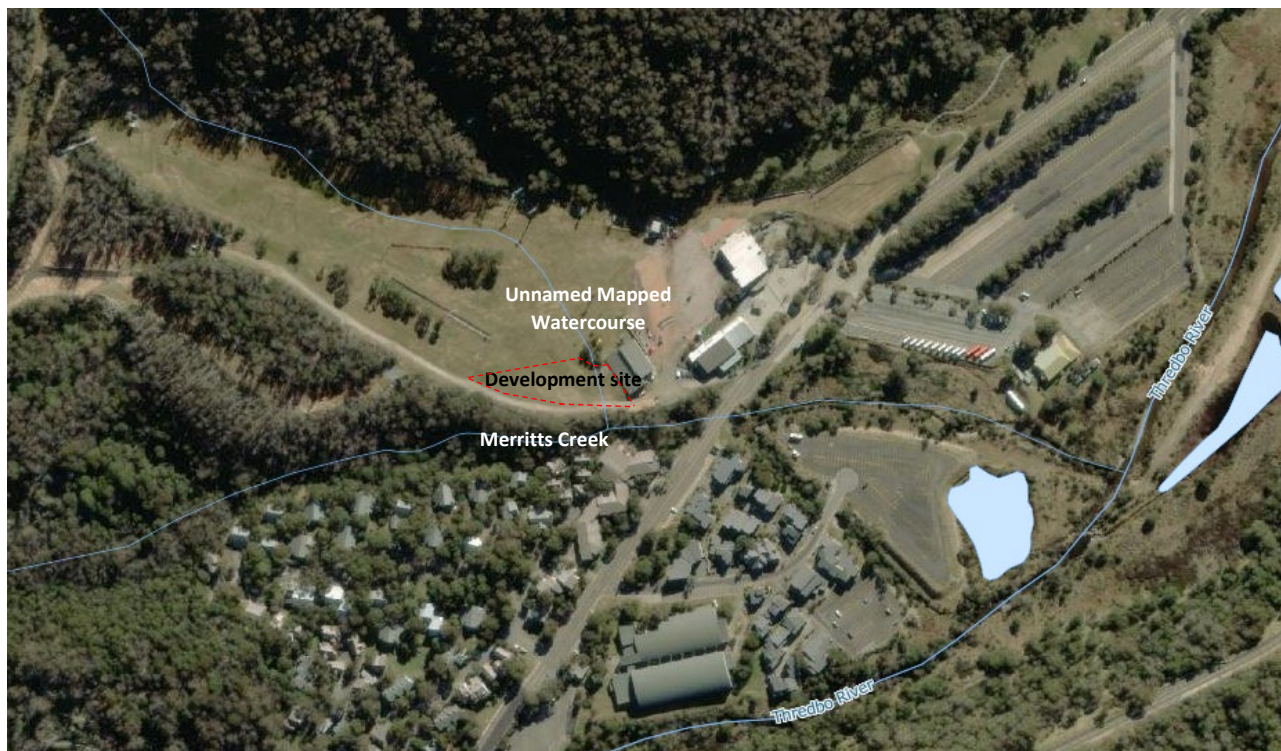
Figure 11: Mapped Watercourses (Source: NSW Government 2022c)

As shown on the *Water Management (General) Regulation 2018 hydroline spatial data 1.0* map (NSW Government 2021c), two mapped watercourses are located within close proximity of the site (Figure 11).

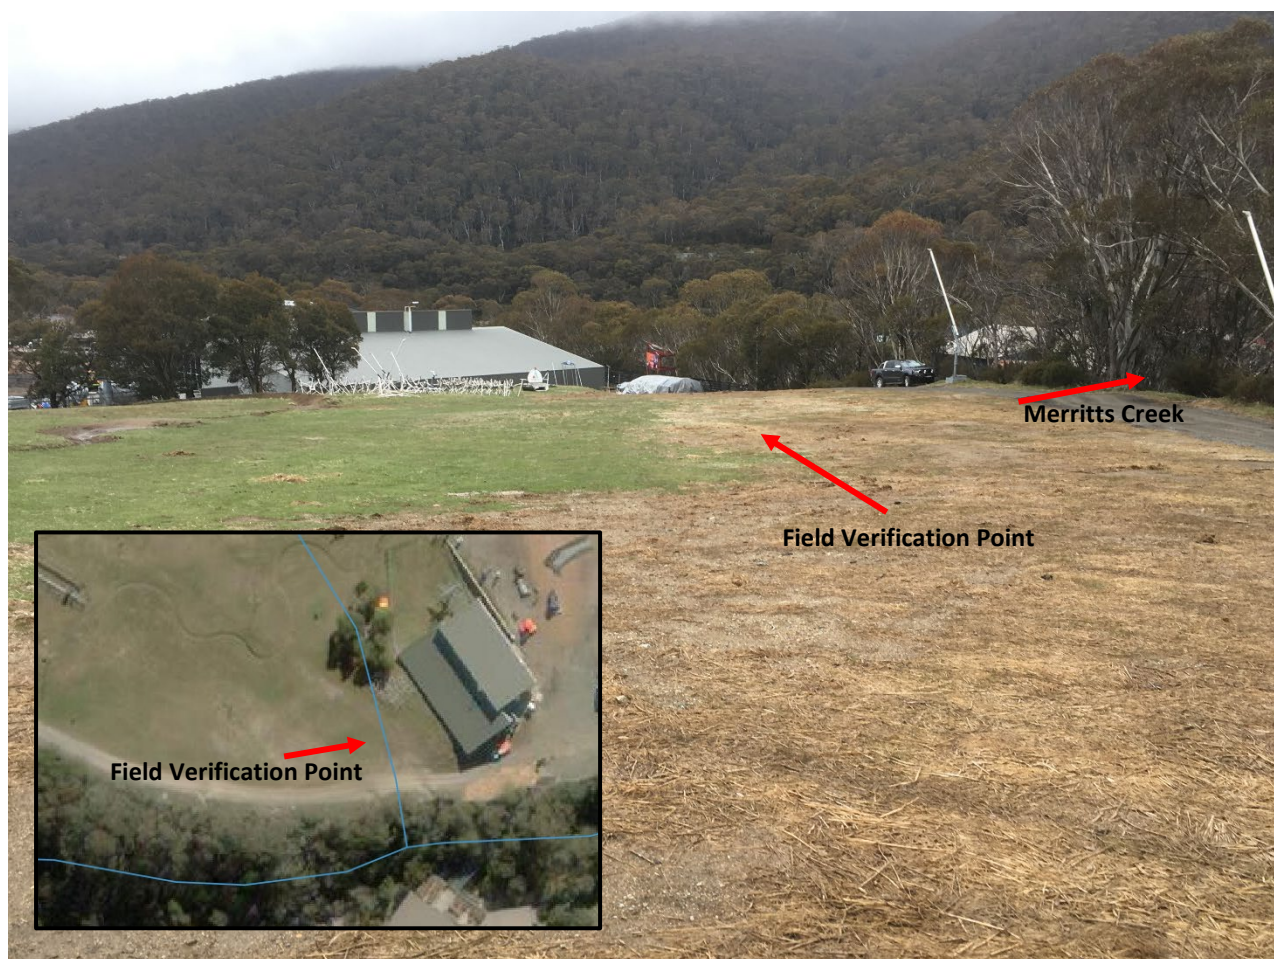
Figure 12: Unmapped Watercourse Field Verification

The portion of the unnamed mapped watercourse which traverses the Development site does not exhibit the features of a defined channel with bed and banks, as shown on **Figure 12**. This drainage line was diverted in the 1980s when Friday Flat was first developed. The diversion resulted in the drainage line being diverted around the ski slope area (approximately halfway down the slope), below the Easy Does It Quad lift (to the north-north-east) into a network of underground pipes, including several inlets/drains (refer **Figure 13** and **Figure 14**). As such, it is determined the mapped watercourse is not waterfront land for the purposes of the WM Act. Therefore, no further assessment is required.

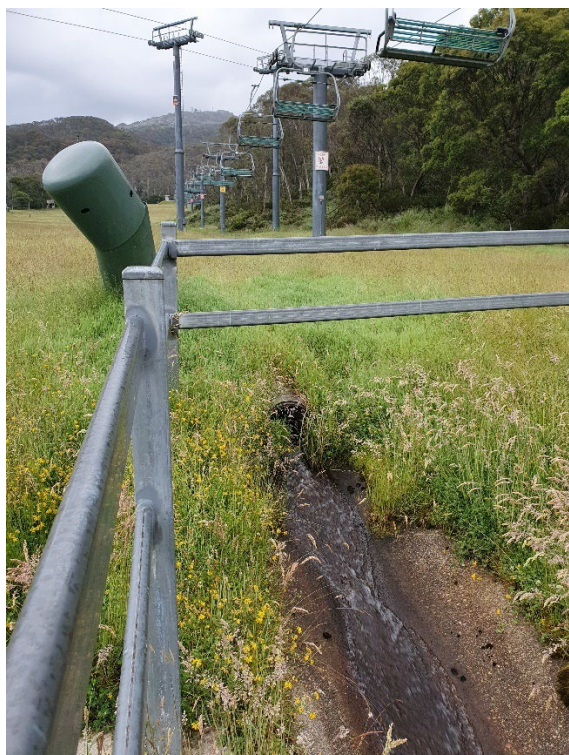
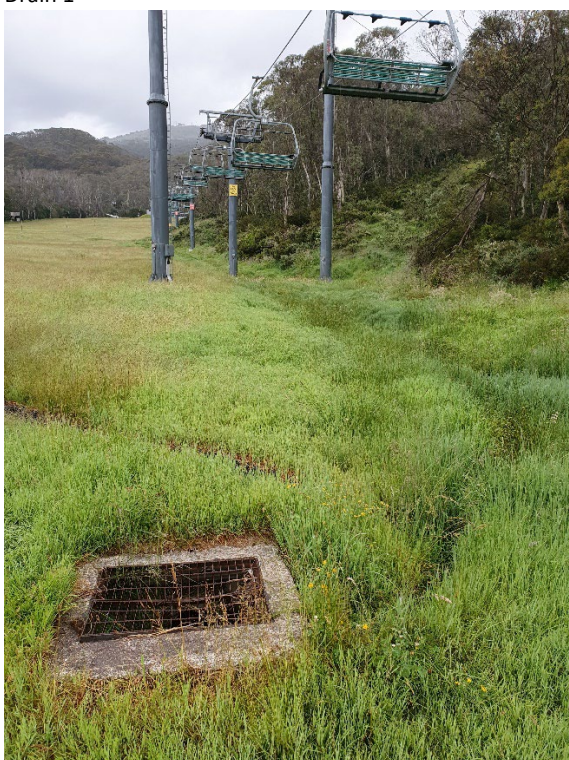
Figure 14: Inlets within diverted drainage line below Easy Does It Quad Lift

Drain 1

Drain 3

Drain 2

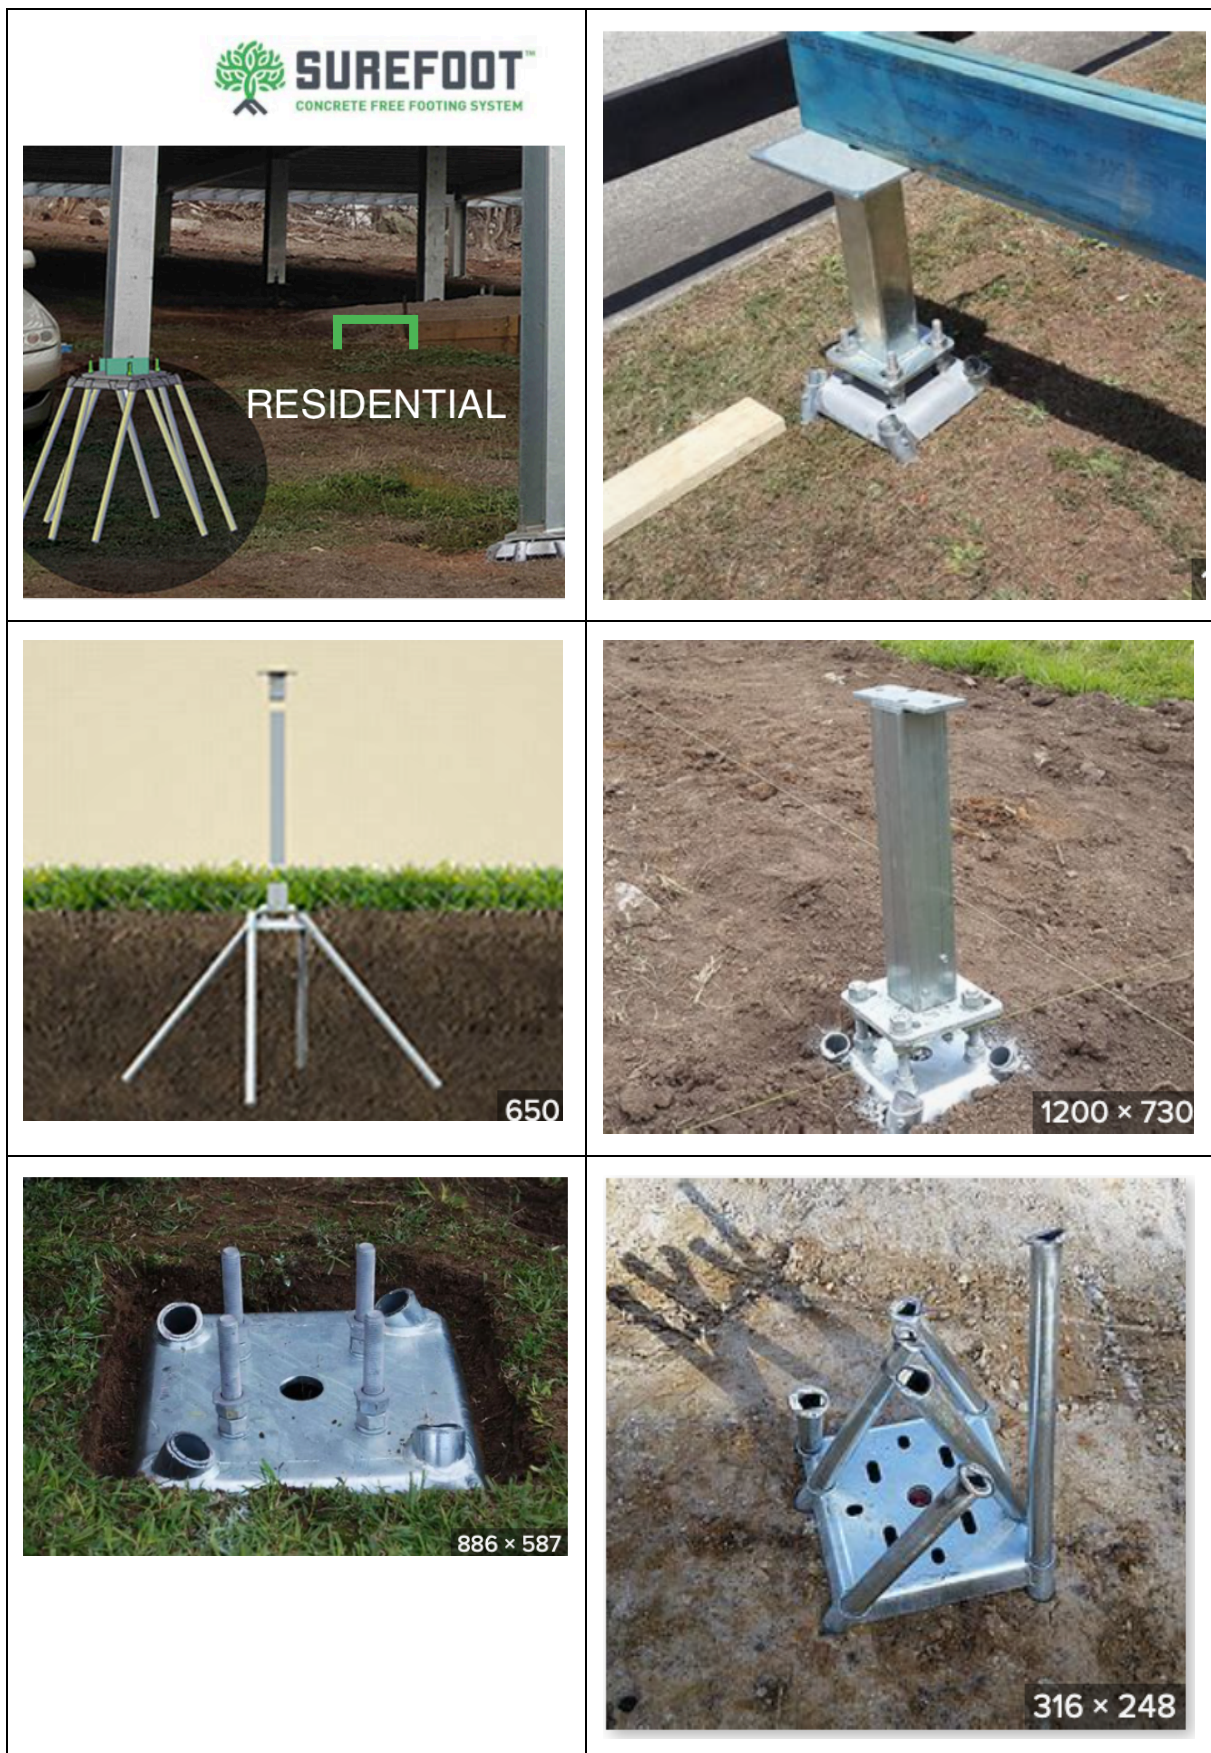
Typical Operators Hut

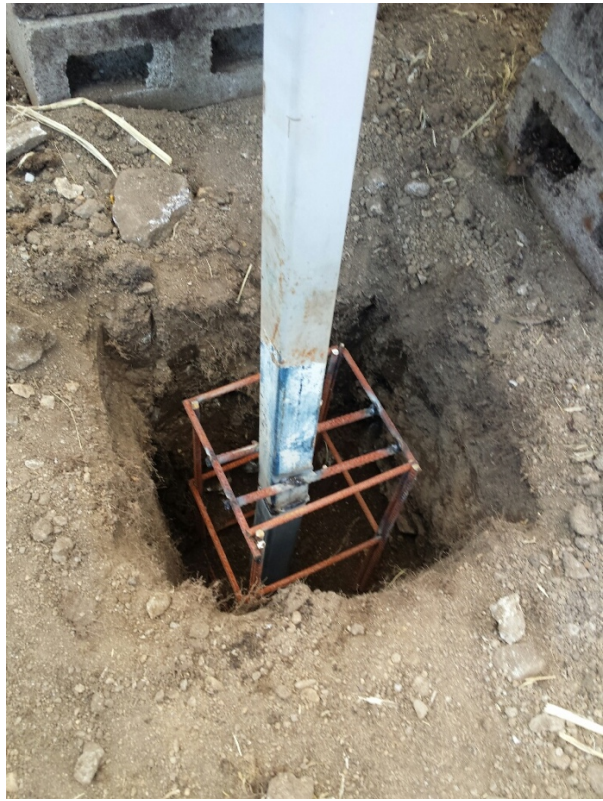
Typical footing excavation for Operators Hut
