4–10 and 14 Cooper Street, Strathfield

Heritage Assessment Report

Prepared for Burwood Council
December 2022

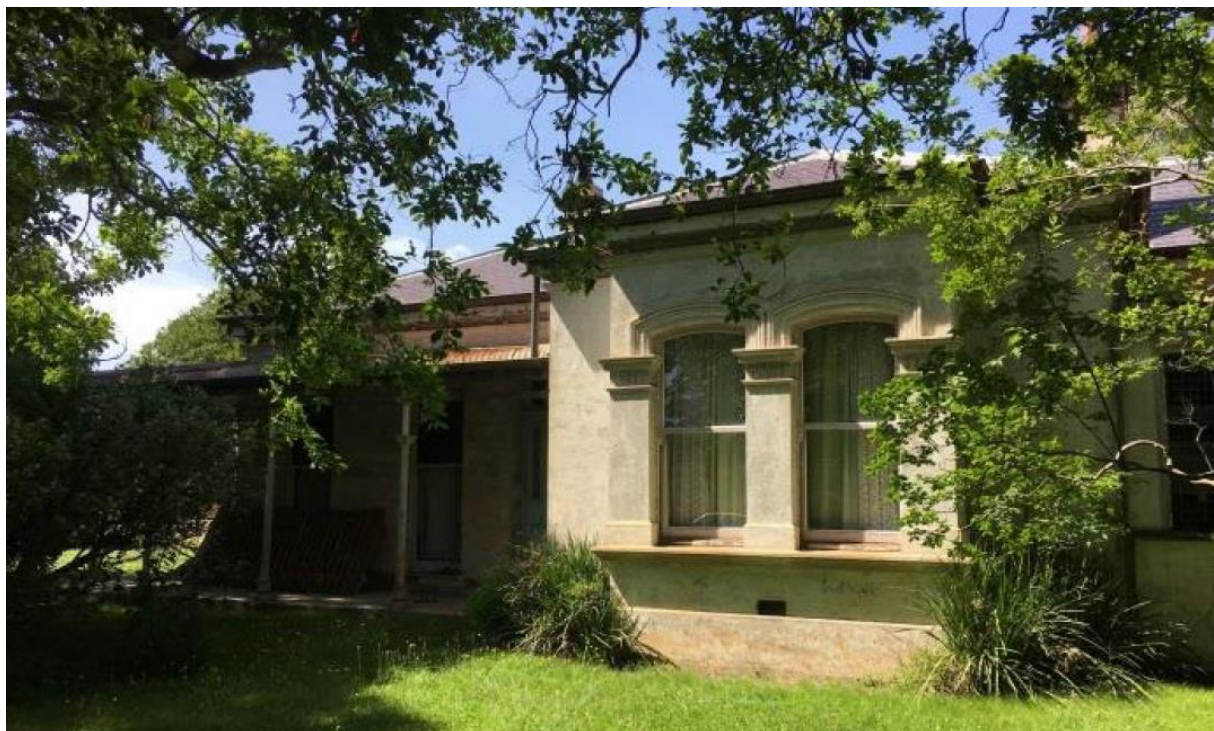
Figure 6.6 No. 2 Cooper Street. (Source: Urbis 2020)

Single storey c.1870s -1880's Victorian Free Classical house with a slate tiled hipped roof and decorative rendered chimneys. The front facade is asymmetrical and constructed of a rendered brick base with rendered brickwork facades and features a projecting bay with indented eaves brackets and rendered cornice moulds, timber framed double hung windows with flat arched top sashes and decorative rendered sill, pilaster mouldings and label moulds. The eastern side has an open return verandah with concrete base and cast iron and timber posts supporting a bullnosed steel roof. The western side verandah is enclosed with fibre cement sheeting and louver windows. Other features include a wide timber and glass panelled front door with sidelights and fanlight, an eastern side verandah addition, double hung windows and single wide timber and glass panelled doors with fanlights.

There is a large front garden with lawn, plants and trees and a brick paved driveway adjacent to the eastern side boundary. A low brick edge is on the street boundary with timber posts and gates across the driveway.

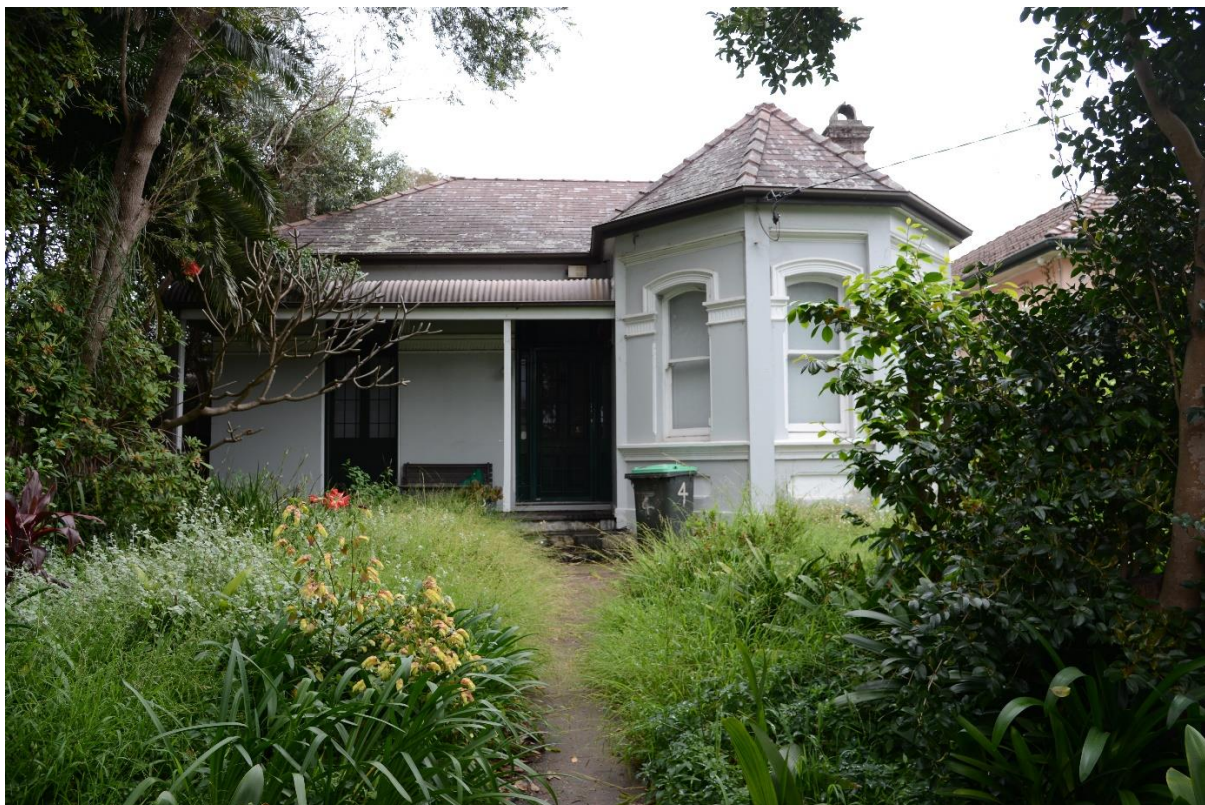
Figure 6.7 4 Cooper Street.

The house is a detached single-storey building constructed of smooth rendered and painted masonry. It has a steep hipped roof of slate tiles and terracotta ridge capping. The original gutters have been replaced with Colorbond. The building retains three identical chimneys, two located on the western elevation behind the projecting faceted bay and the third on the east. The painted masonry chimneys are decorated with plaster mouldings and an arched concrete cap.

No. 4 Cooper Street has a fair degree of integrity and is in good condition. Externally, the façade and detailing are well maintained. The dwelling remains in its original allotment. The original features that have been removed or replaced include the timber or cast iron verandah posts, the brackets to the eaves along the projecting faceted bay and the original name plate. The rear extension is modest in scale, separate from the original house, and does not impact the legibility of the original form of the dwelling.

A detailed assessment of the condition of the dwelling has not been carried out due to limited visibility from the public domain. The original slate roof and bullnose verandah roof show signs of wear, but the dwelling appears to be sound.

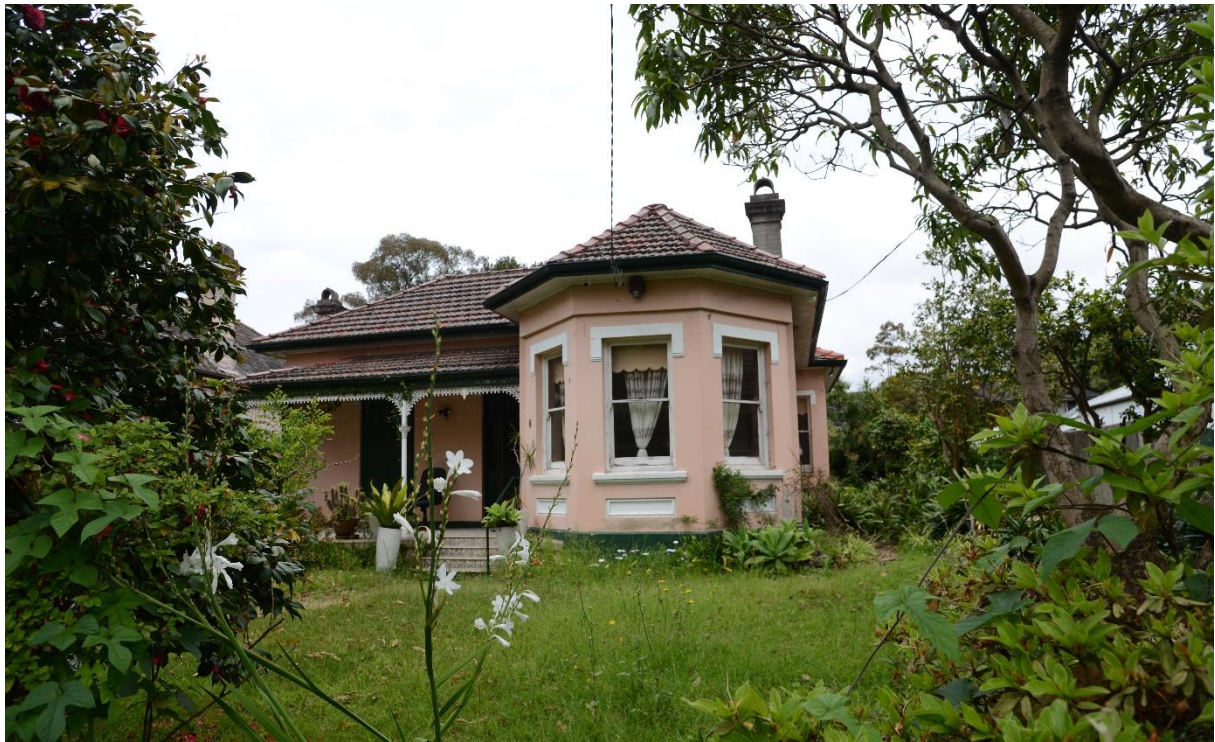
Figure 6.8 Northern façade of 6 Cooper Street, viewed from Cooper Street.

was covered with slate rather than terracotta tiles. The original gutters have been replaced with Colorbond. The building retains three identical chimneys, two located on the west elevation behind the projecting faceted bay and the third on the east. The painted masonry chimneys are decorative, adorned with plaster mouldings and an arched concrete cap.

No. 6 Cooper Street has a good degree of integrity externally. The dwelling remains in its original allotment. Original features that have been removed or replaced include the verandah tiles and the brackets to the eaves along the projecting faceted bay. The rear extension is modest in scale and is separate from the original house, and does not impact the legibility of its original form.

A detailed assessment of the condition of the dwelling has not been carried out due to limited visibility from the public domain. There is some structural cracking evident in the projecting faceted bay and peeling paint.

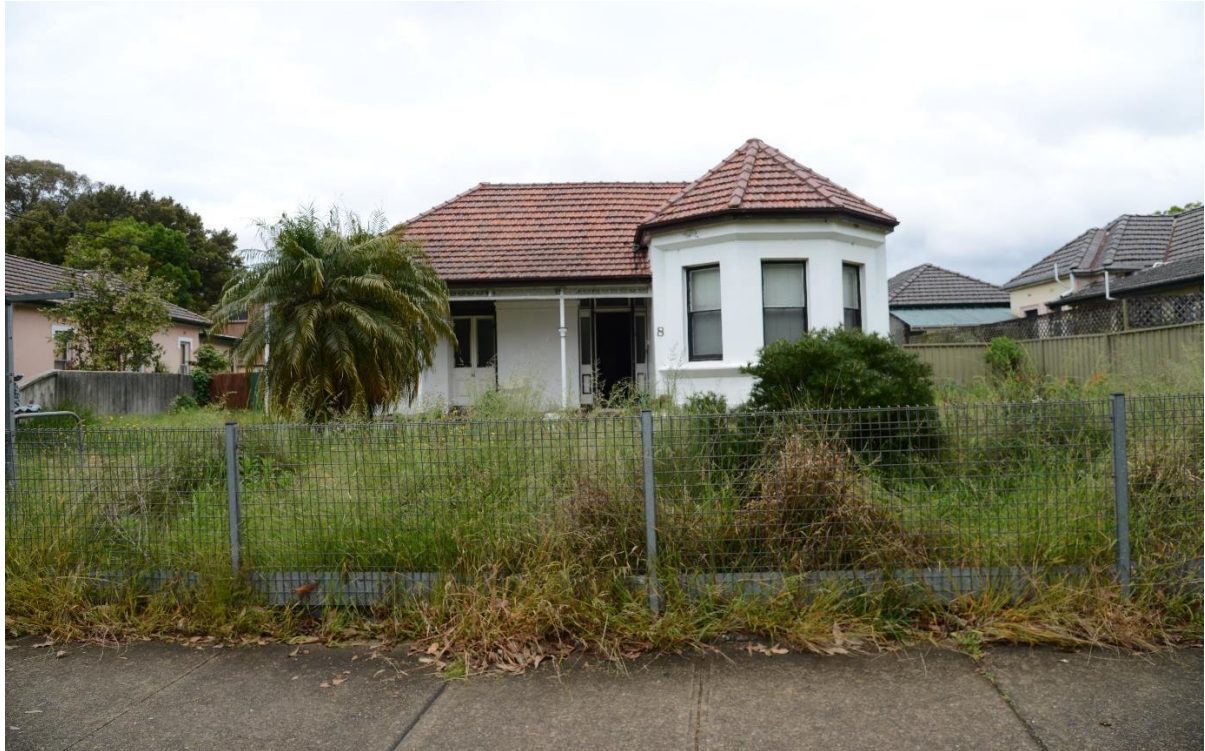
Figure 6.9 8 Cooper Street.

No. 8 Cooper Street has a fair degree of integrity externally. The dwelling remains in its original allotment. While the original form of the dwelling is evident, some original features have been removed or replaced, including the chimneys, verandah tiles, mouldings around the bay windows, and the eaves brackets along the projecting faceted bay. The rear extension is modest in scale and is separate from the original house, and does not impact the legibility of the original form of the dwelling. The east and west elevations were not closely inspected due to obscured views, although they also appear to be stripped of ornamentation.

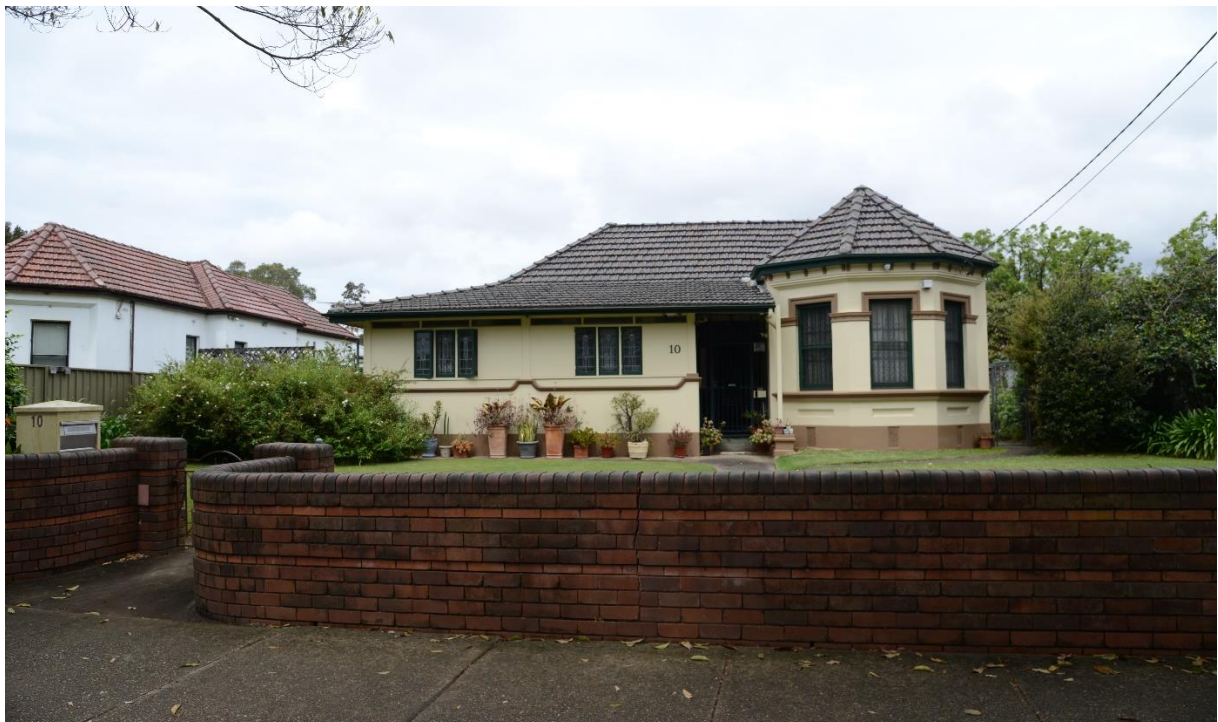
Figure 6.10 10 Cooper Street.

No. 10 Cooper Street is in good condition with various degrees of integrity due to its additions and alterations. The dwelling remains in its original allotment. The projecting faceted bay is intact and demonstrates the original features to Nos 6 and 8 Cooper Street. The enclosed verandah detracts from the Victorian Italianate styling but is sympathetic due to the use of material and references to the faceted bay through the pattern and ornamentation.

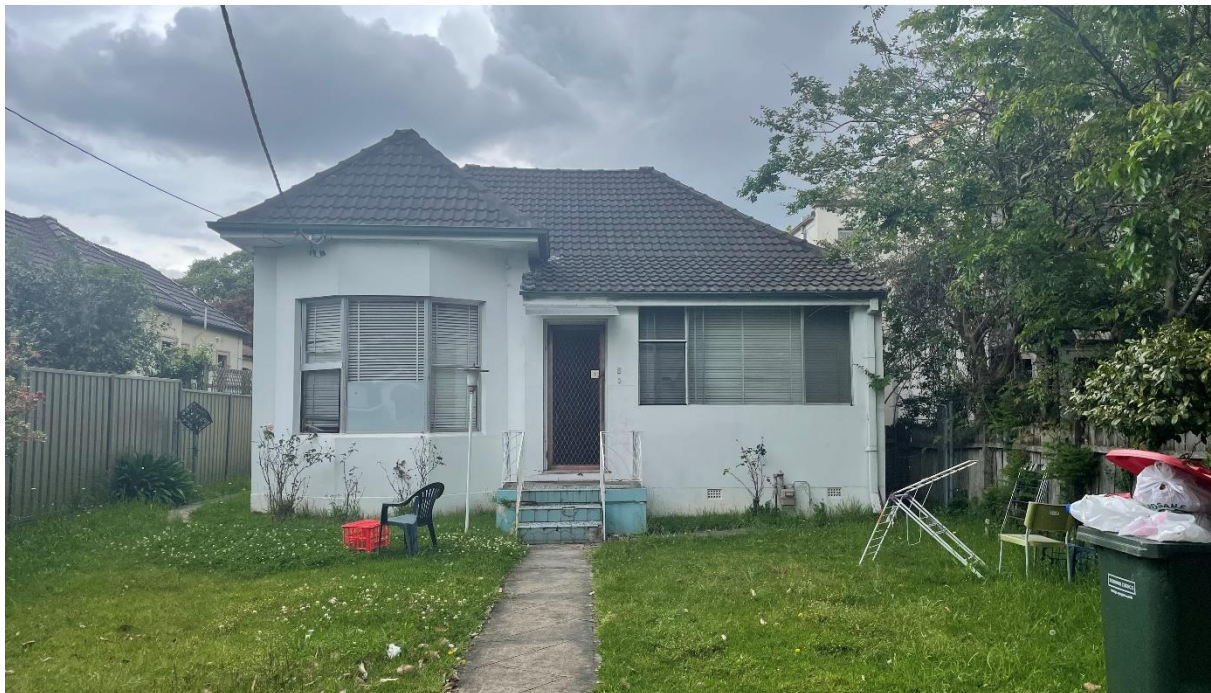
Figure 6.11 No.12 Cooper Street.

No. 12 Cooper Street is a detached single-storey Victorian Italianate dwelling set on a narrow lot. The building is modest, and its size and form are comparable to No. 4 Cooper Street. It is constructed of rendered and painted masonry and comprises a hipped and tiled concrete roof, a faceted bay, a small, elevated entrance and aluminium-framed openings.

There have been significant modifications to the original construction, including alterations to the roof form, enclosure of the front verandah, alteration of the arrangement of windows, replacement aluminium-framed windows and the removal of decorative mouldings to the façade.

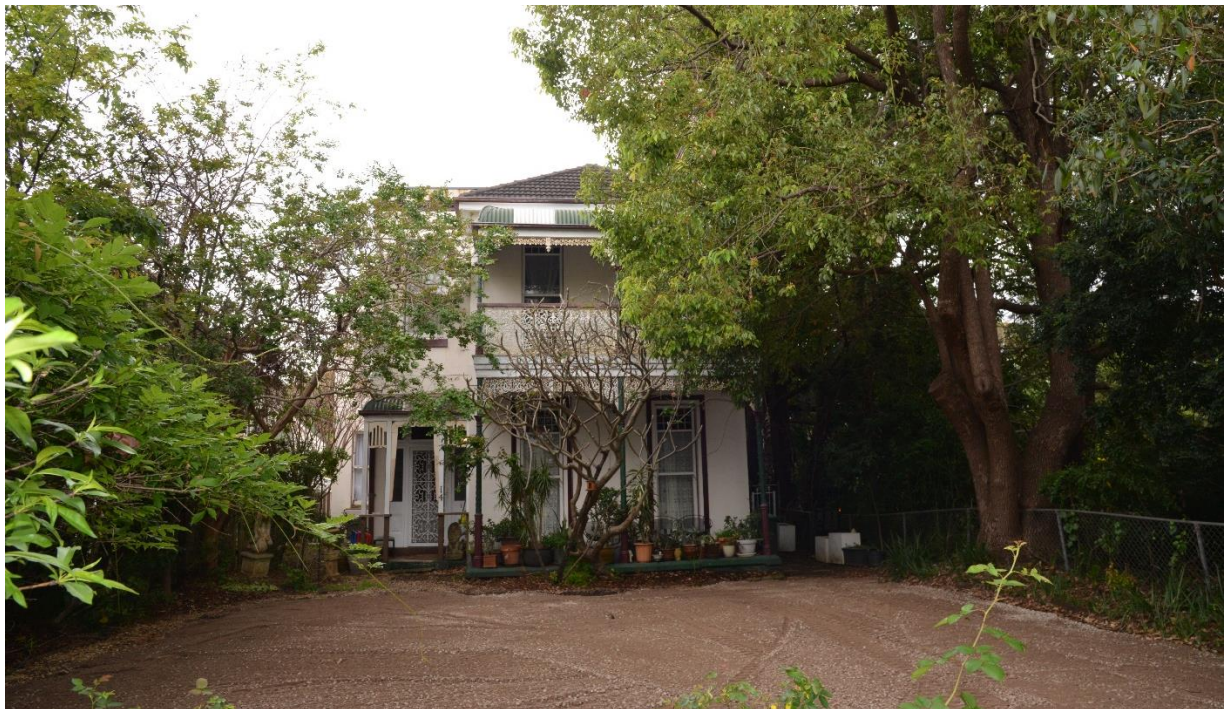
Figure 6.12 14 Cooper Street.

The front verandah has tessellated tiles on a masonry foundation, three decorative cast iron posts and filigree brackets. There are two floor-to-ceiling windows set equally apart on the verandah. They are timber-framed, double-hung sash windows with two large glass panels. The top third of the windows feature a grid of coloured glass panes.

The dwelling shows a high degree of intactness externally. It is a good example of a two-storey Victorian villa. Although there are some Federation additions to the entry porch, including ornate timber posts and brackets, they are sympathetic to the character of the Victorian dwelling.

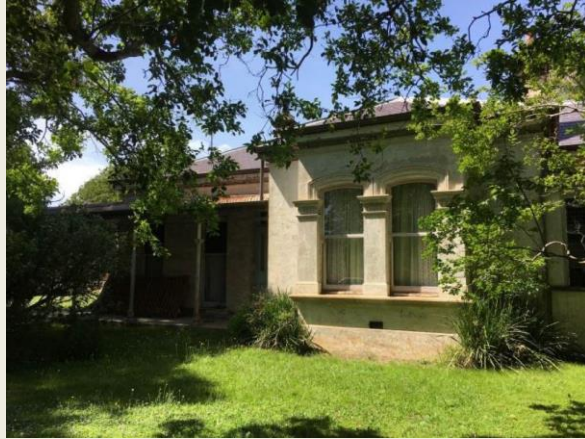
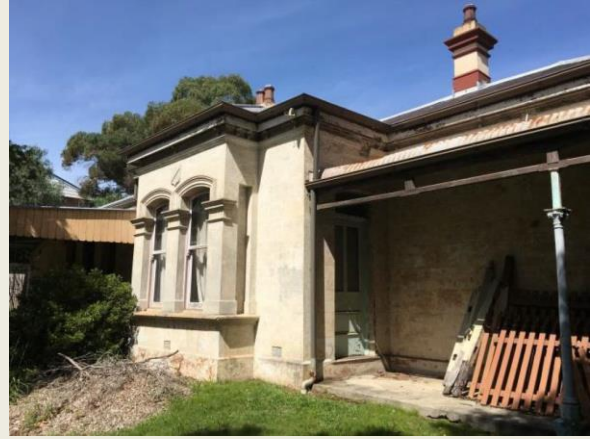
Figure 7.1 Northern elevation of 2 Cooper Street. (Source: Urbis 2021)

Figure 7.2 Northern elevation of 2 Cooper Street. (Source: Urbis 2021)

As outlined in the 2021 Urbis report, 2 Cooper Street, though in poor condition, demonstrates an unusually high degree of integrity internally. The subject properties that have publicly available photographs are understood to have a fair to high degree of intactness within the front section of the dwellings. The internal layout and key features such as the plaster ceilings, fireplaces, timber flooring, skirtings and internal doors are generally intact in the subject dwellings.

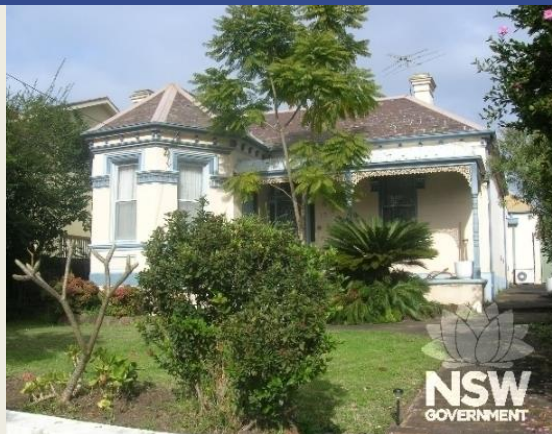
Figure 7.3 Primary elevation of 12 Belgrave Street, Burwood, July 2020. (Source: NSW SHI)

While the SHI listing does not assess the internal fabric, real estate photographs suggest that the front section of 12 Belgrave Street has retained its original configuration and many key features such as the timber flooring and skirting, arched hallway, fireplaces, plaster cornices and plaster mouldings along the wall. A similar degree of internal integrity is seen in real estate photographs of 4 and 6 Cooper Street.

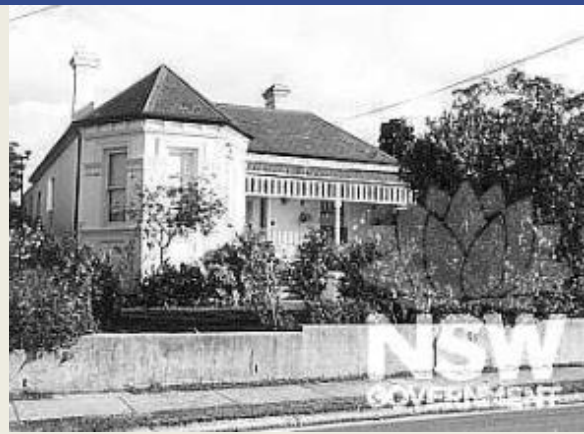
Figure 7.4 Primary elevation of 12 Belgrave Street, Burwood, July 1986. (Source: NSW SHI)

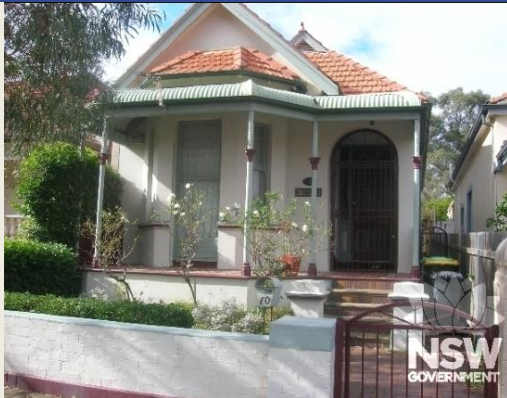
Figure 7.5 Primary elevation of 12 Bold Street, Burwood, July 2020. (Source: NSW SHI)

In comparison to the subject dwellings, 10 Bold Street has stylistic differences and a more modest scale. Despite having some external modifications compared to the subject dwellings, 10 Bold Street demonstrates a relatively higher degree of intactness both internally and externally compared to Nos 8 and 10 Cooper Street. It serves as a good example of a modest Victorian Italianate dwelling. Nos 4 and 6 Cooper Street have similar levels of intactness compared to 10 Bold Street.

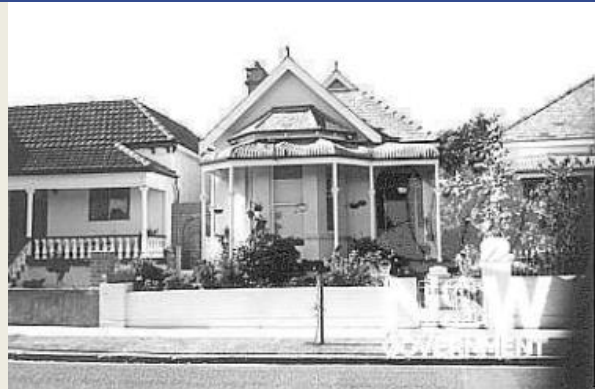
Figure 7.6 Primary elevation of 12 Bold Street, Burwood, July 1986. (Source: NSW SHI)

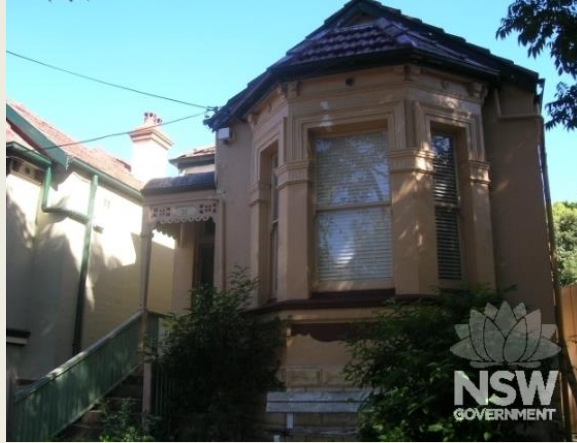
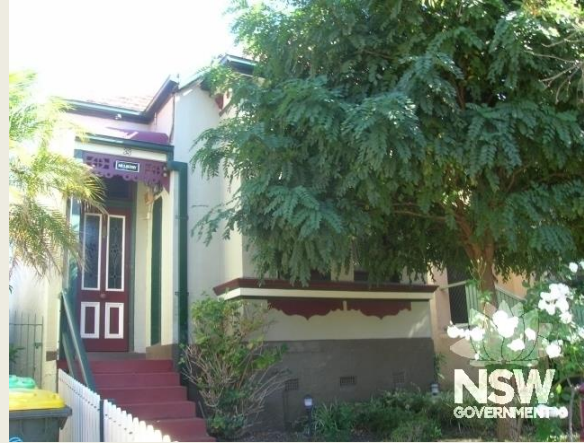
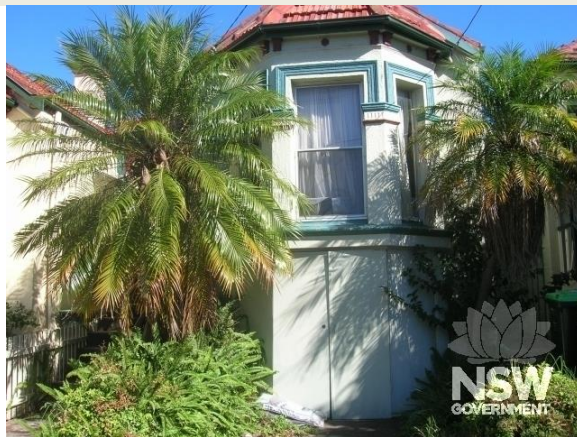
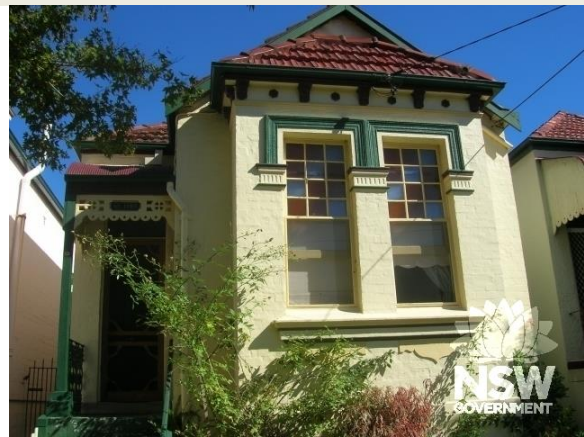
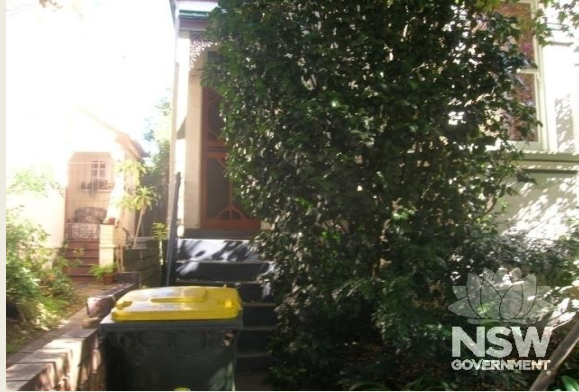
Figure 7.13 Primary elevation of 31 Wallace Street, Burwood, July 2020. (Source: NSW SHI)

Figure 7.14 Primary elevation of 33 Wallace Street, Burwood, July 2020. (Source: NSW SHI)

Figure 7.15 Primary elevation of 35 Wallace Street, Burwood, July 2020. (Source: NSW SHI)

Figure 7.16 Primary elevation of 37 Wallace Street, Burwood, July 2020. (Source: NSW SHI)

Figure 7.17 Primary elevation of 39 Wallace Street, Burwood, July 2020. (Source: NSW SHI)

The most noticeable modifications of the original fabric are the rendering of the sandstone base and the replacement of the front fences.

Comparatively, the dwellings at 4, 6, 8 and 10 Cooper Street demonstrate a single architectural style. However, the individual dwellings have a greater degree of modifications compared to the Wallace Street group. However, overall, both the Wallace Street group and the subject dwellings are collectively visually uniform in their garden settings, consistent setbacks, architectural form and features, which contribute positively to their respective streetscapes and retain their historic settings.
