Geotechnical Assessment

**SPECIALIST ADVICE TO  
THE R.A.N. SKI CLUB LIMITED**

The purpose of the assessment was to carry out a walkover inspection of the site and to assess the subsurface conditions at two borehole locations, as a basis for comments and recommendations on excavation, drainage, shoring design, footing design, exposure classification and the entry and ground floor slabs.

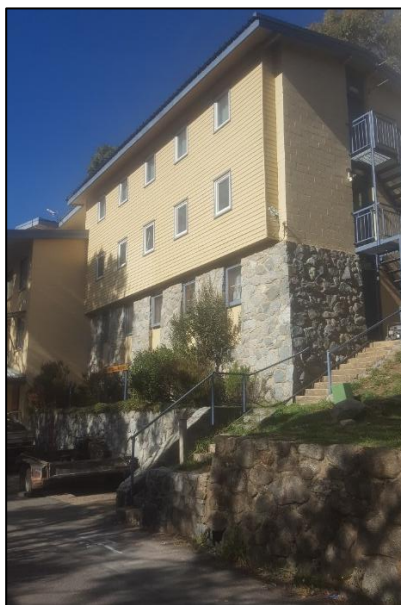
Plate 1: Looking upslope to the south-east showing The R.A.N. Ski Club building.

At the time of our inspections, the site contained a three storey brick and weatherboard lodge building with a ground floor level estimated to be between 1m to 2m higher than Bobuck Lane. The building appeared to be in good external condition, based on a cursory inspection from within the site. A garden was located on the northern side of the building adjacent to its western portion and was supported by a mortared granite

block retaining wall to a height of approximately 2m above Bobuck Lane. A narrow parking lane was located along the toe of the retaining wall. A staircase was located on the western side of the building; refer to Plate 1 below. The rear yard was covered with grass, scattered medium to tall trees and occasional granite cobbles and boulders, up to 0.7m size. A granite block retaining wall supported the lower northern portion of the rear yard to heights between approximately 1.4m to 1.8m. The retaining walls on site appeared to be in good condition. The site appeared to be well drained.

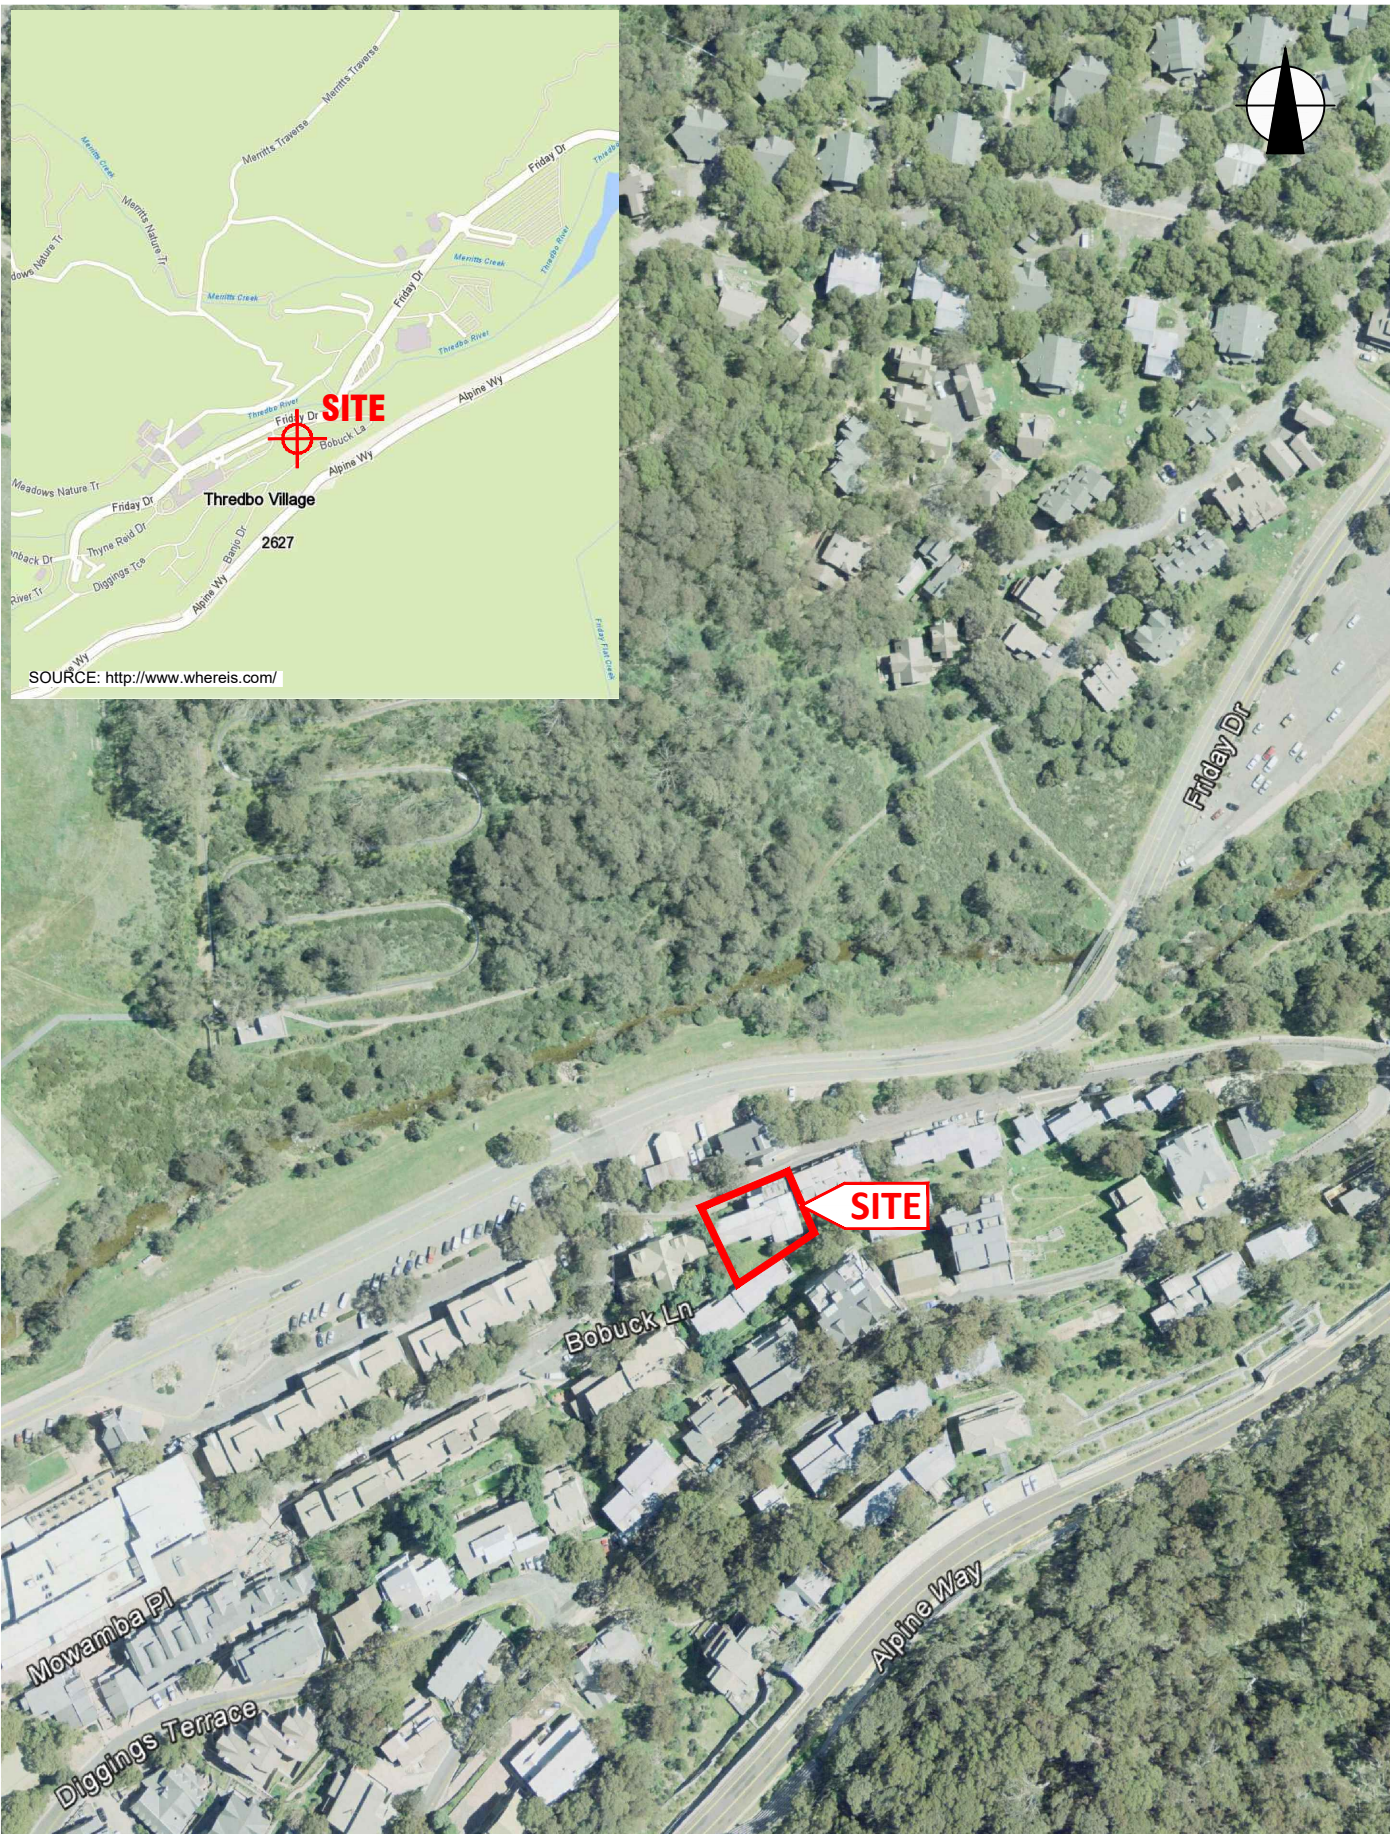
The attached Figure 2 presents a geotechnical site plan and shows the principle geotechnical features observed at the site. Figure 2 is based on the provided survey plan by Peter W. Burns Pty Limited (Job Ref. 5061, Cad File. 5061\_CD\_01\_A, dated 26 April 2018). The slope angles shown on Figure 2 were measured by hand held clinometer and hence are approximate. The heights of retaining walls were recorded using a tape measured. Should any of the features shown on Figure 2 be critical to the proposed development, we recommend they be located more accurately using instrument survey techniques. The geotechnical mapping symbols shown on Figure 2 are presented on the attached Figure 3.
