**Notice of Determination of a  
Development Application**

Development: **5 MW electricity generating works facility (solar farm) and 10 MWh Battery Energy Storage System (BESS)**

Property Description: **Lot 109 DP 751703  
125 Briggs Road, STANBRIDGE NSW 2705**

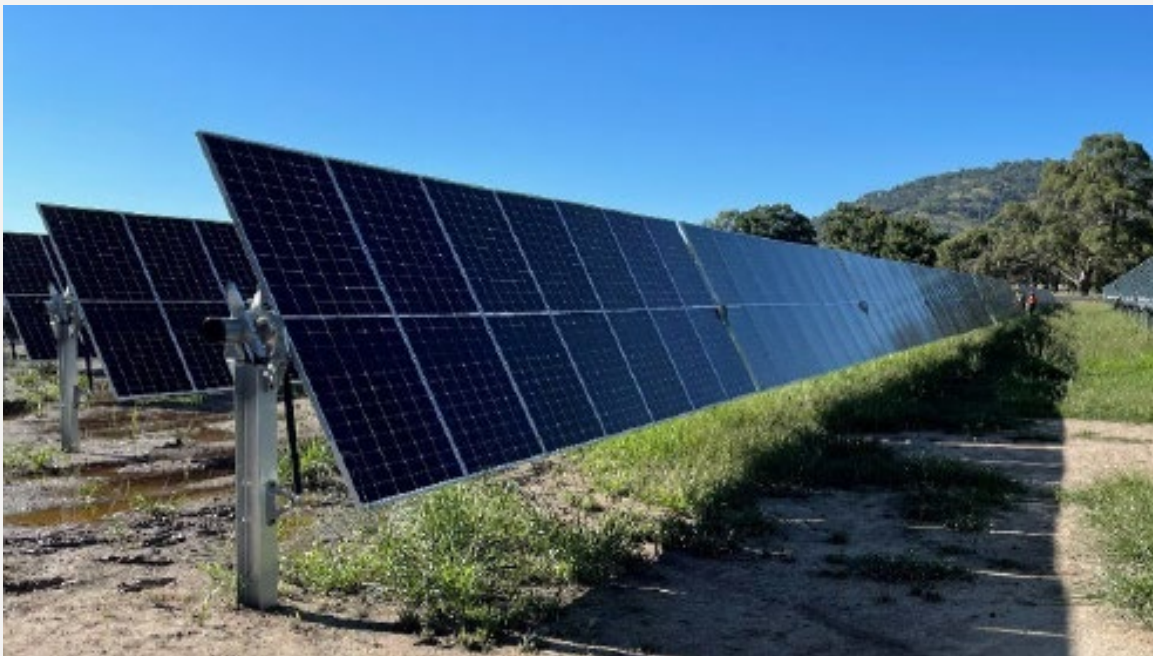
**Figure 9 | Example of a Typical Single Axis Tracker System with PV Modules Mounted in Single Panel Portrait Orientation (1P Configuration)**

Proposed PV Panels will be arranged in 'single portrait' orientation (i.e. end to end). Each proposed PV panel type used in the facility be approximately 2.38 metres x 1.13 metre and will be mounted onto the steel tracking structure.

The final height of the structure, including panels (when at full 60 degree tilt) and allowing for a ground clearance of at least 0.52 metres, will be approximately 2.6 metres from natural ground level. This final height is dependent on the final clearance needed beneath the panels

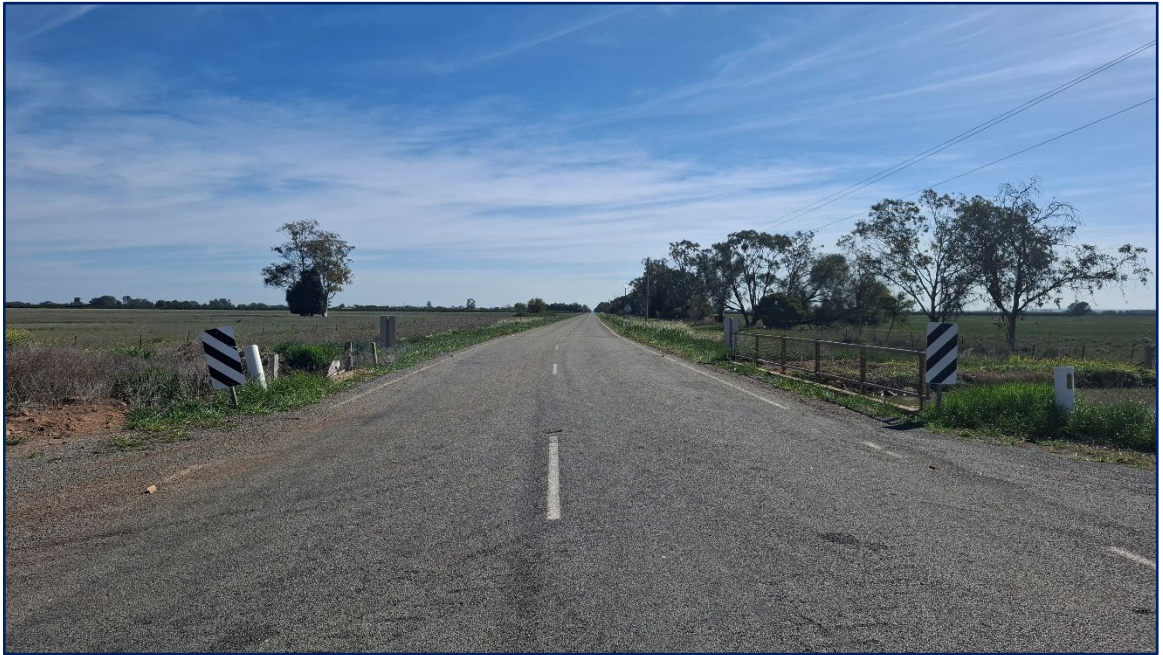
**Figure 2.5: Murrami Road (to the north)**

Murrami Road is classified as a Local Road under the care and management of Council which essentially runs in a north to south alignment between Malcolm Road in the north and Whitton Road in the south. Murrami Road comprises a sealed carriageway of approximately 8 metres in width and accommodates one lane of traffic in each direction. Murrami Road has a default speed limit applicable to a rural area of 100km per hour, and there are no pedestrian or cyclist facilities along Murrami Road.

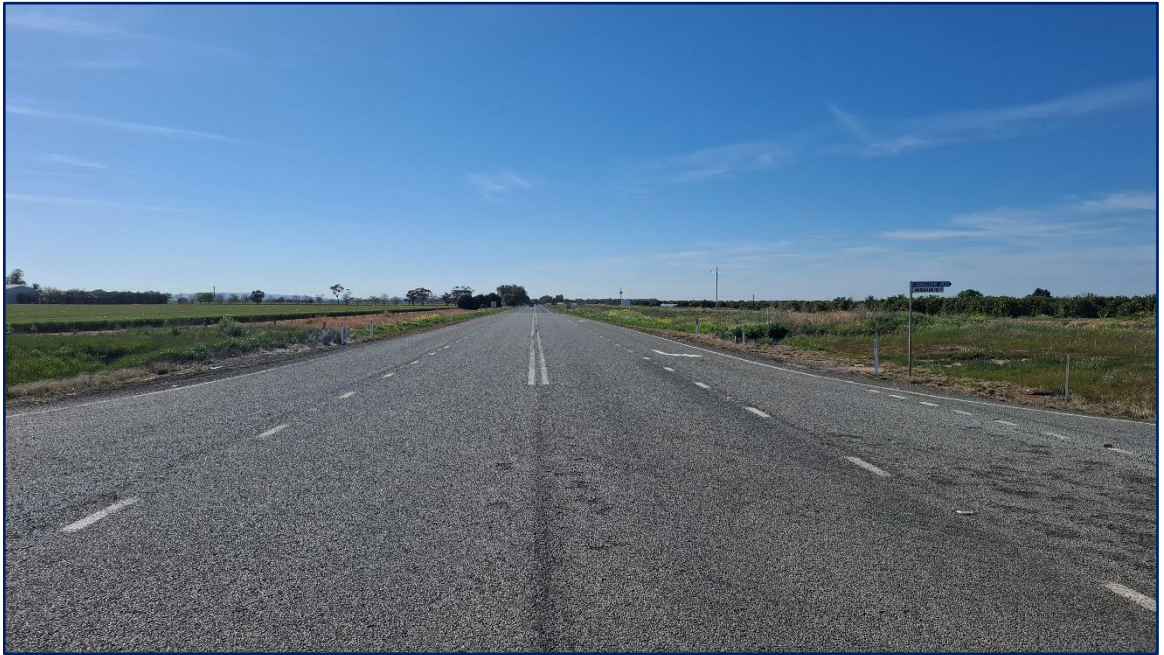
**Figure 2.7: Irrigation Way (to the east)**

Irrigation Way is classified as a State Road under the care and management of Transport for NSW (TfNSW). It essentially runs in an east–west alignment between Wamoon Avenue in the east and MacKay Avenue in the west. In the vicinity of the site, Irrigation Way consists of a sealed carriageway with a typical width of approximately 11 metres, comprising one traffic lane in each direction (each lane approximately 3.5 metres wide) with sealed shoulders on both sides of the road (approximately 2.0 metre wide).

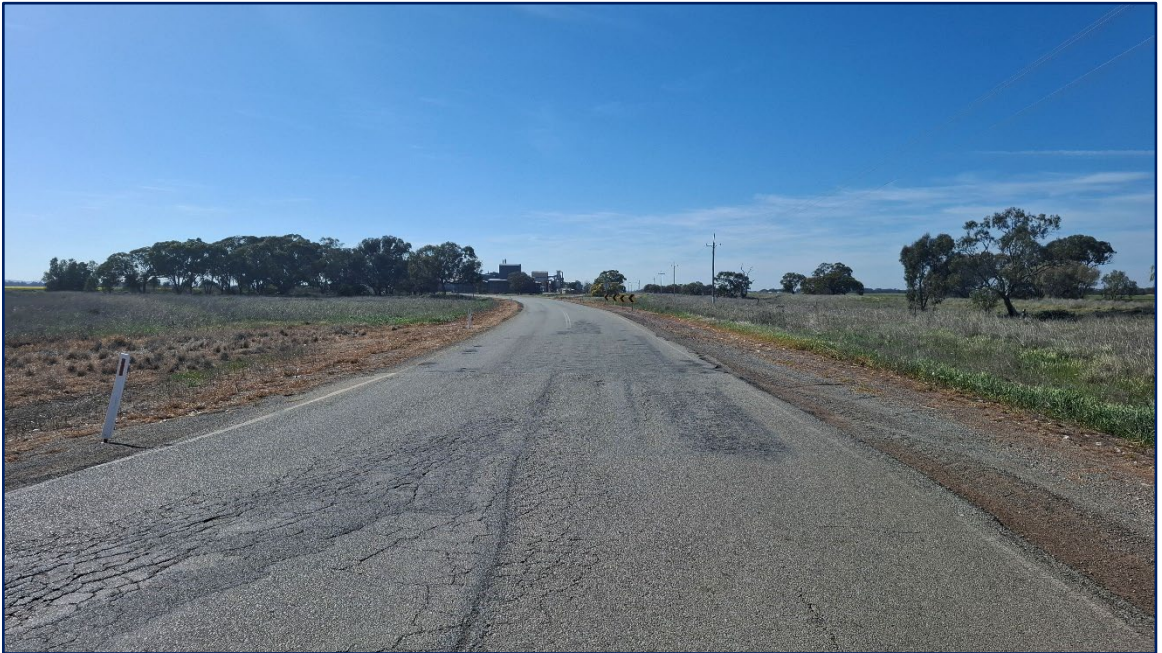
**Figure 2.9: Whitton Road (to the east)**

Whitton Road is classified as a Local Road under the care and management of Council which essentially runs in an east to west alignment between Toorak Road in the east and Binyah Street in the west. Whitton Road comprises a sealed carriageway of approximately 7 metres in width and accommodates one lane of traffic in each direction. Whitton Road has a posted speed limit of 100km per hour, and there are no pedestrian or cyclist facilities along Whitton Road.

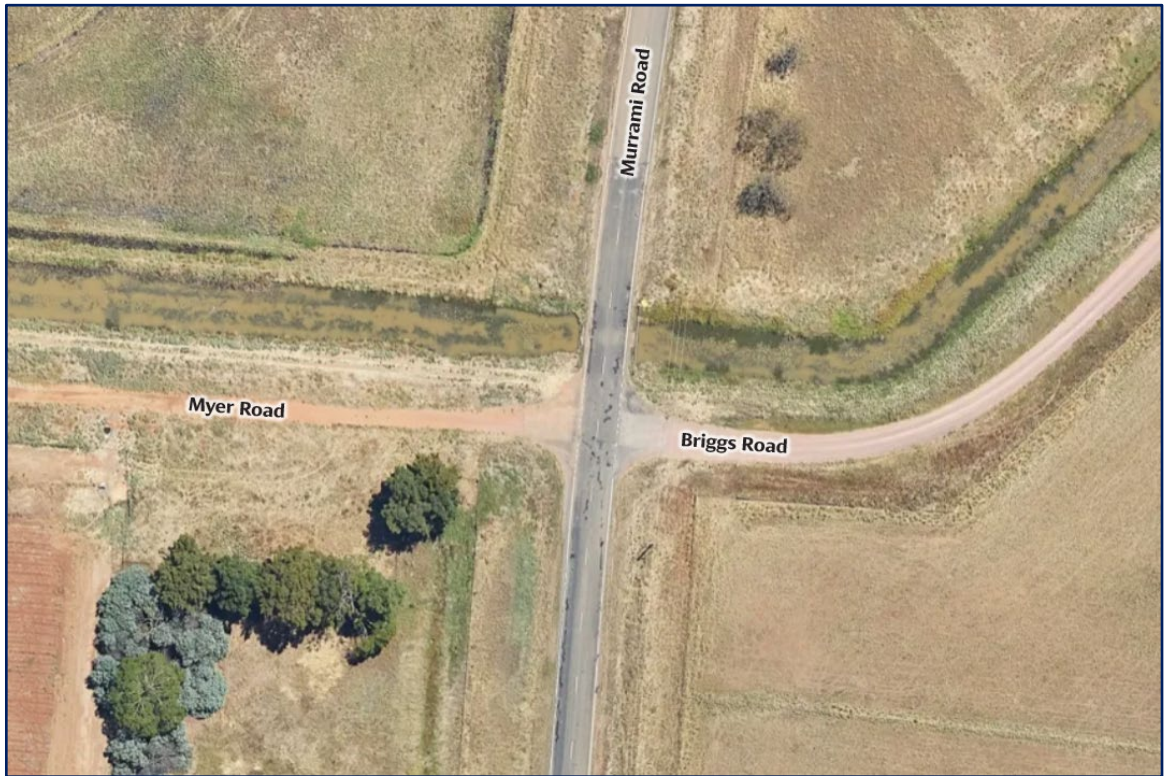
**Figure 2.11: Briggs Road / Murrumbidgee Road / Myer Road Intersection**

The intersection of Briggs Road / Murrami Road / Myer Road is a priority-controlled four-way intersection with priority given to motorists travelling in a north-south alignment along Murrami Road. No auxiliary turn lanes are provided for the intersection. The existing layout of the intersection of Briggs Road / Murrami Road / Myer Road is illustrated in Figure 2.11.

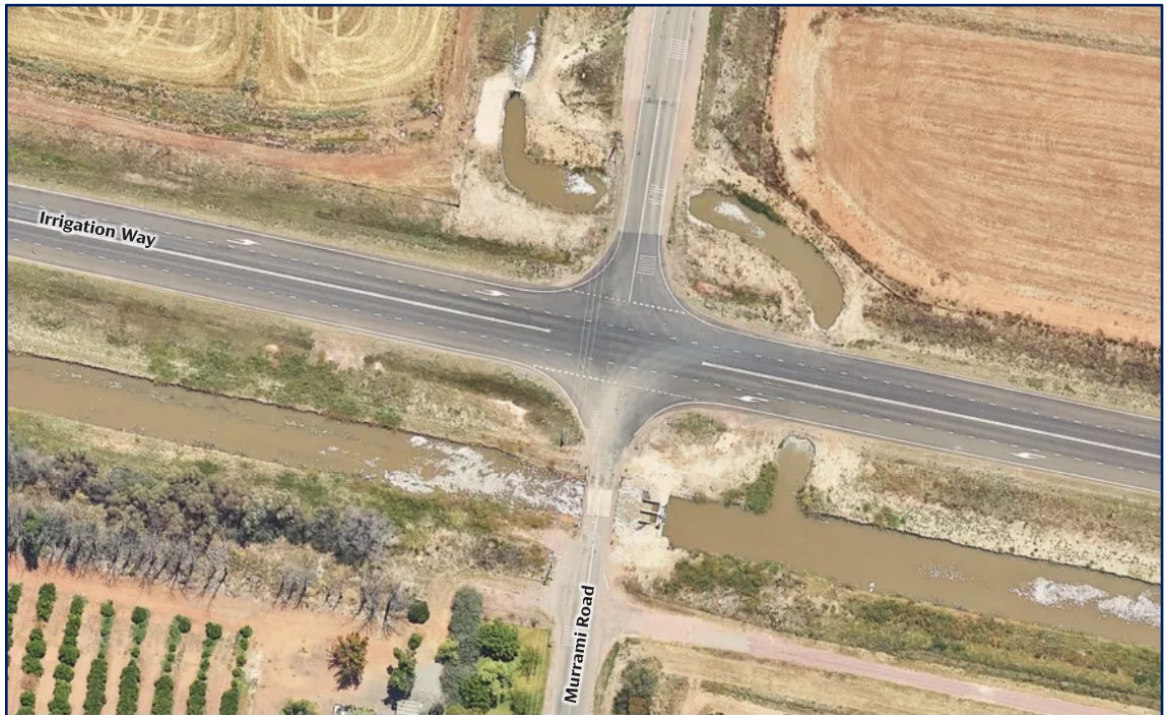
**Figure 2.12: Irrigation Way and Murrami Road Intersection**

The intersection of Irrigation Way and Murrumbidgee Road is a priority-controlled four-way intersection with priority given to motorists travelling in an east-west direction along Irrigation Way. The eastern and western approaches of the intersection provide auxiliary left-turn lanes for vehicles turning left from Irrigation Way into Murrumbidgee Road. The existing layout of the intersection of Irrigation Way and Murrumbidgee Road is illustrated in Figure 2.12.

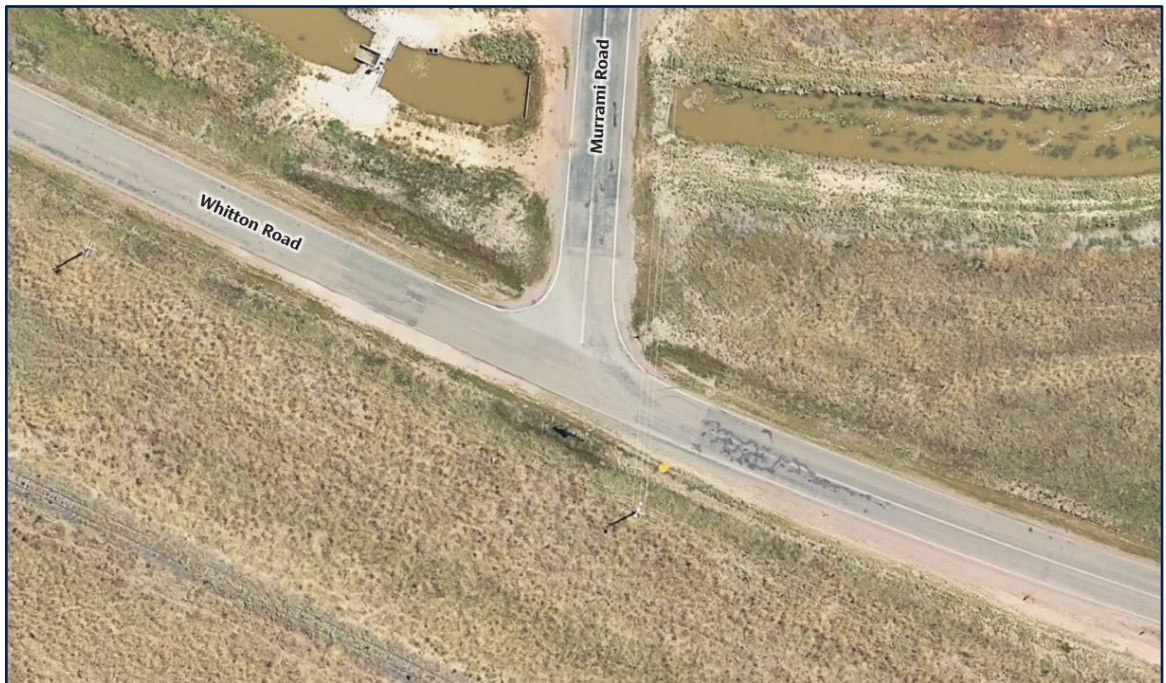
**Figure 2.13: Murrami Road and Whitton Road Intersection**

The intersection of Whitton Road and Murrami Road is a priority-controlled three-way intersection with priority given to motorists travelling in an east-west direction along Whitton Road. No auxiliary turn lanes are provided for the intersection. The existing layout of the intersection of Whitton Road and Murrami Road is illustrated in Figure 2.13.

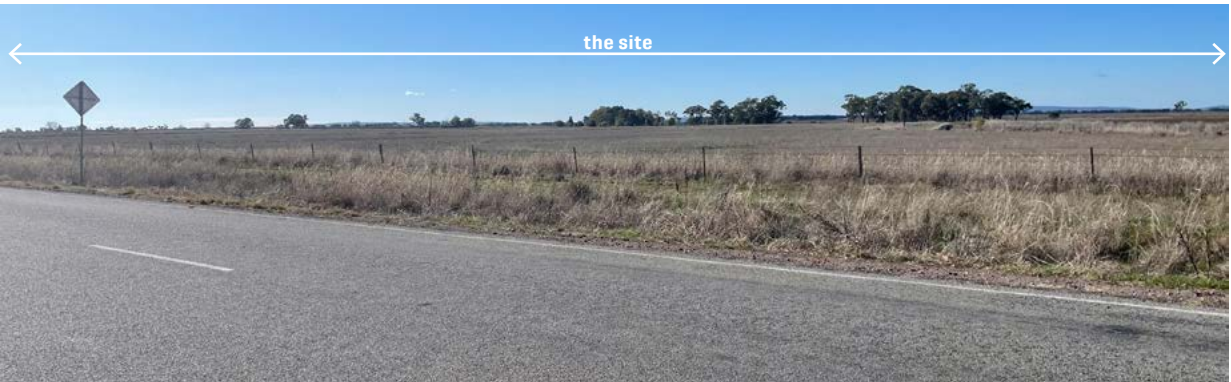
| Photo A: House at 149 Murrami Road. | Moderate | High | Moderate-high |

View to the proposed development from the residence on Murrami Road, immediately opposite to the site.

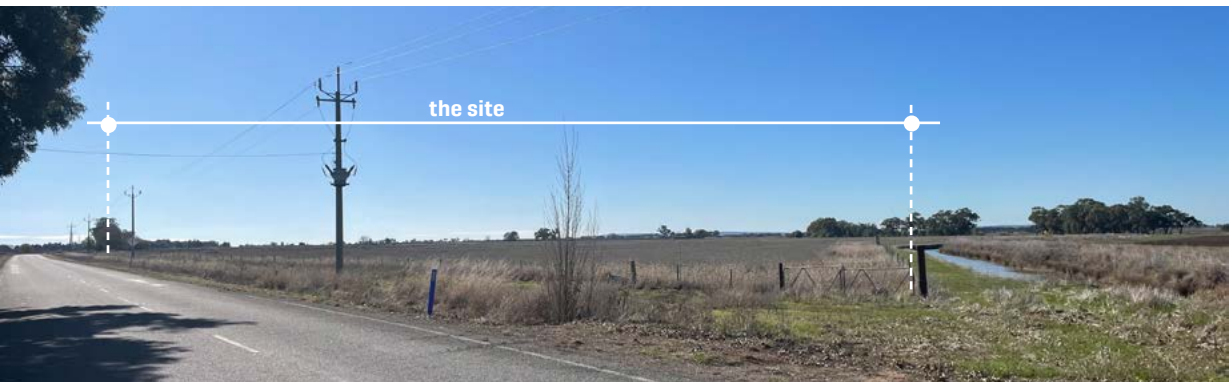
| Photo B: South of house at 149 Murrami Road | Moderate | High | Moderate-high |

View to the proposed development from the channel crossing on Murrami Road, immediately south of the site.

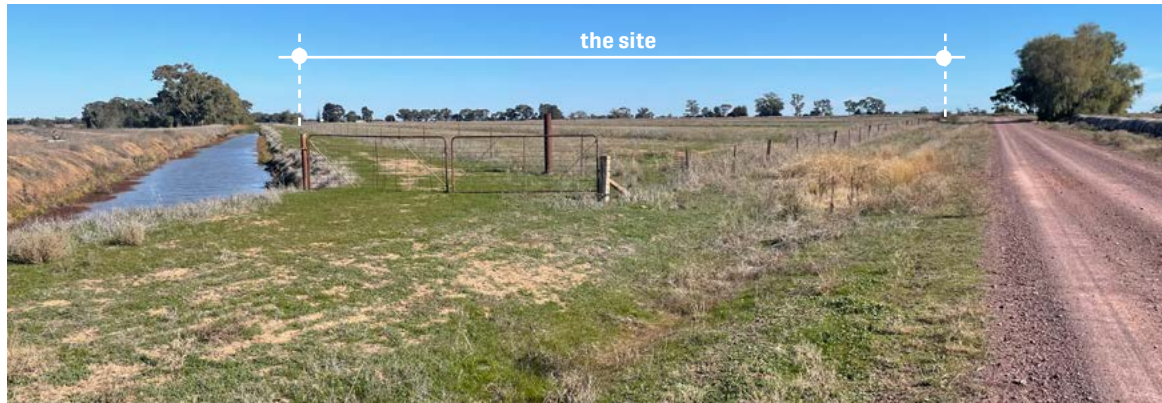
| Viewshed 6 | Sensitivity | Magnitude | Impact |
|---|---|---|---|
| Briggs Road at NE corner of the site | Low | High | Moderate |

View to the proposed development from low traffic unsealed road.

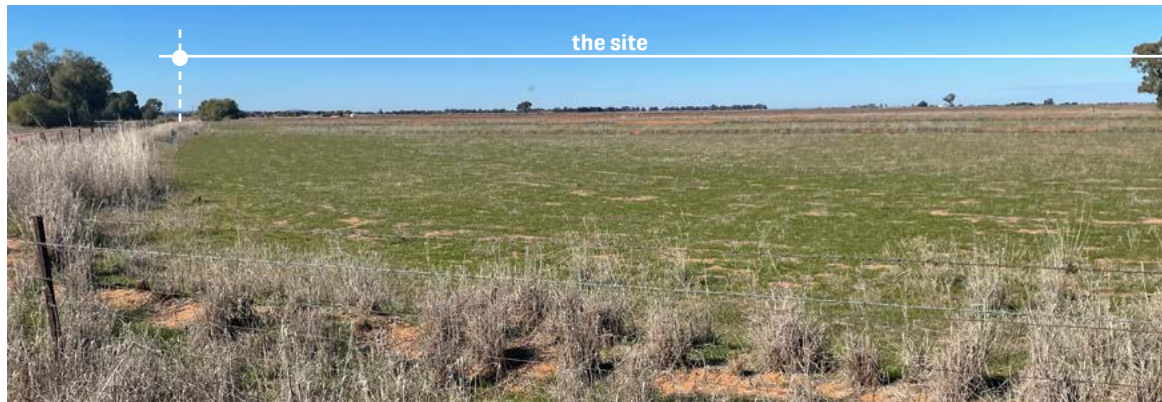
| Viewshed 7 | Sensitivity | Magnitude | Impact |
|---|---|---|---|
| Photo A: Briggs Road at bend of the road. | Low | High | Moderate |

View to the proposed development from low traffic unsealed road, immediately adjacent to the site.

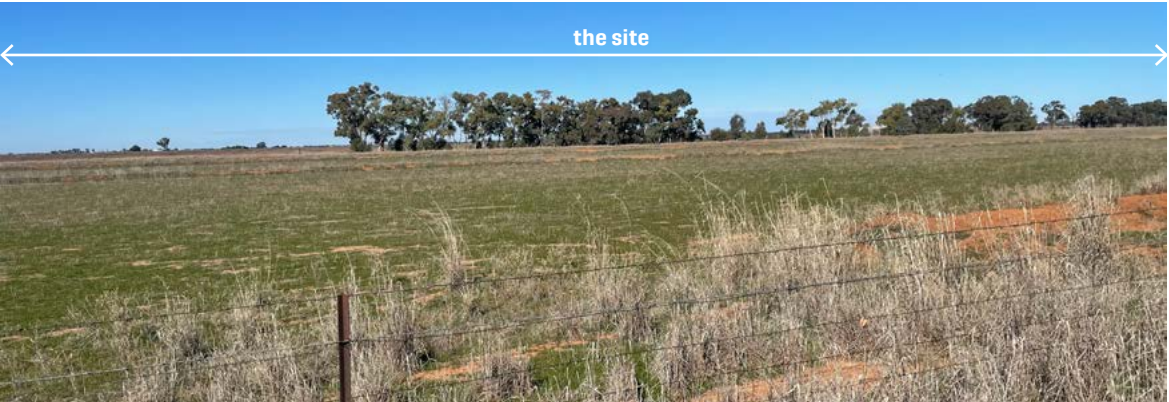
| Viewshed 7 | Sensitivity | Magnitude | Impact |
|---|---|---|---|
| Photo B: Briggs Road at bend in the road. | Low | High | Moderate |

View to the proposed development from low traffic unsealed road, where the channel crosses the road, immediately adjacent to the site.

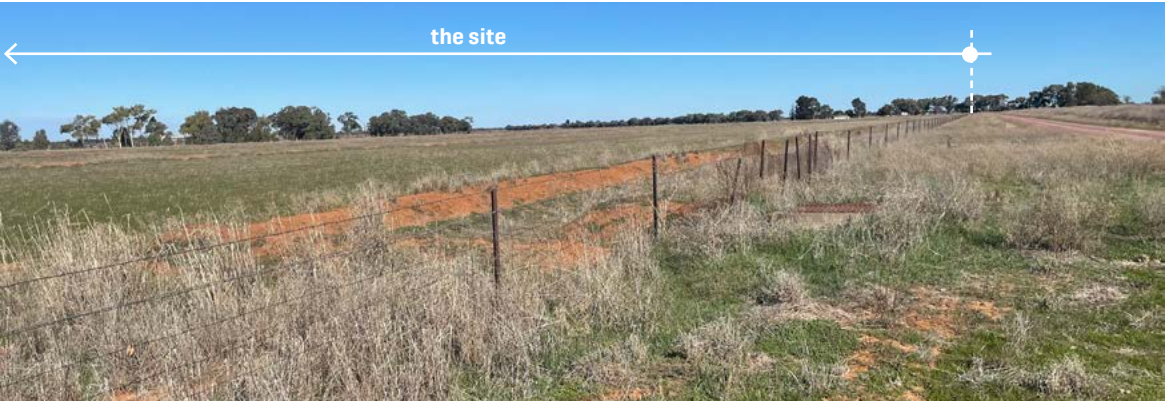
| Viewshed 7 | Sensitivity | Magnitude | Impact |
|---|---|---|---|
| Photo C: Briggs Road at bend in the road. | Low | High | Moderate |

View to the proposed development from low traffic unsealed road, immediately adjacent to the site.

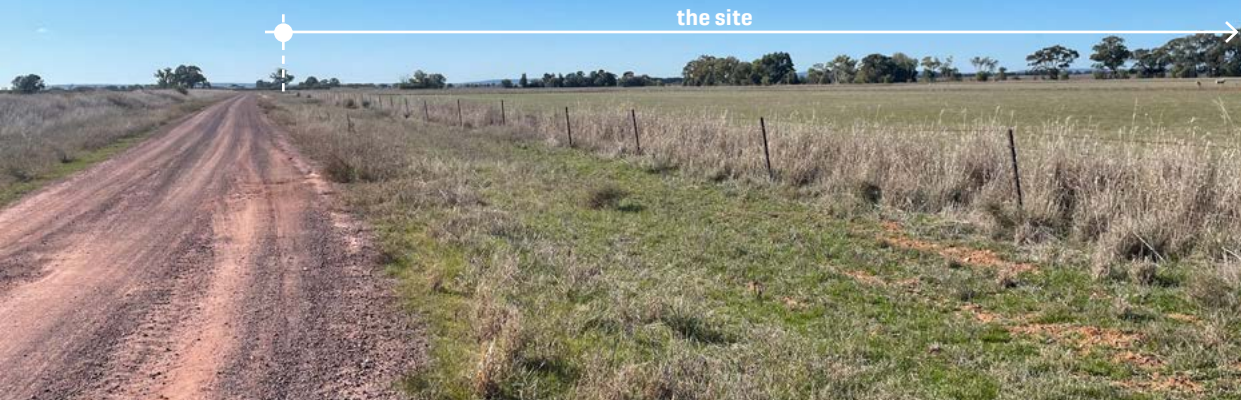
| Viewshed 8 | Sensitivity | Magnitude | Impact |
|---|---|---|---|
| Photo A: Briggs Road 50m east of intersection with Murrami Road. | Moderate | Moderate | Moderate |

View to the proposed development from low traffic unsealed road, immediately adjacent to the site.

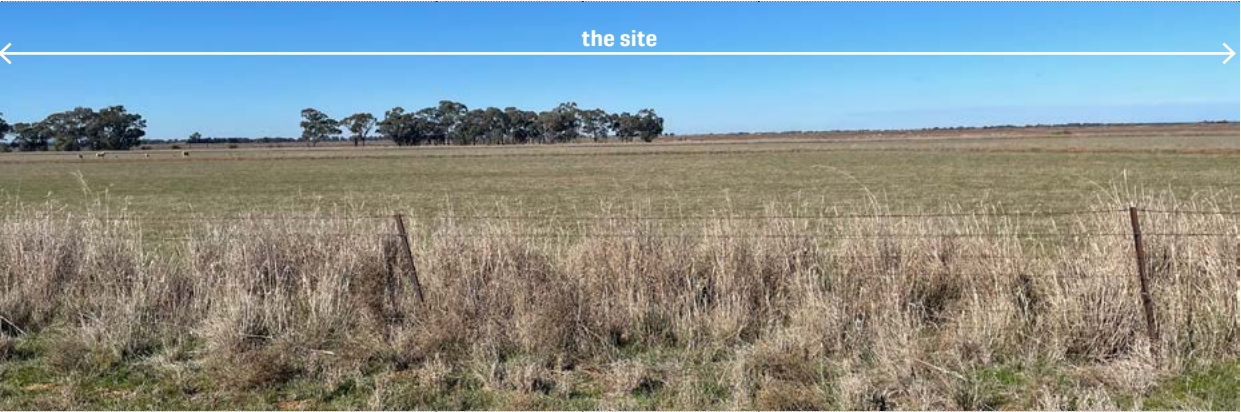
| Viewshed 8 | Sensitivity | Magnitude | Impact |
|---|---|---|---|
| Photo B: Briggs Road 50m east of intersection with Murrami Road. | Moderate | Moderate | Moderate |

View to the proposed development from low traffic unsealed road, immediately adjacent to the site.

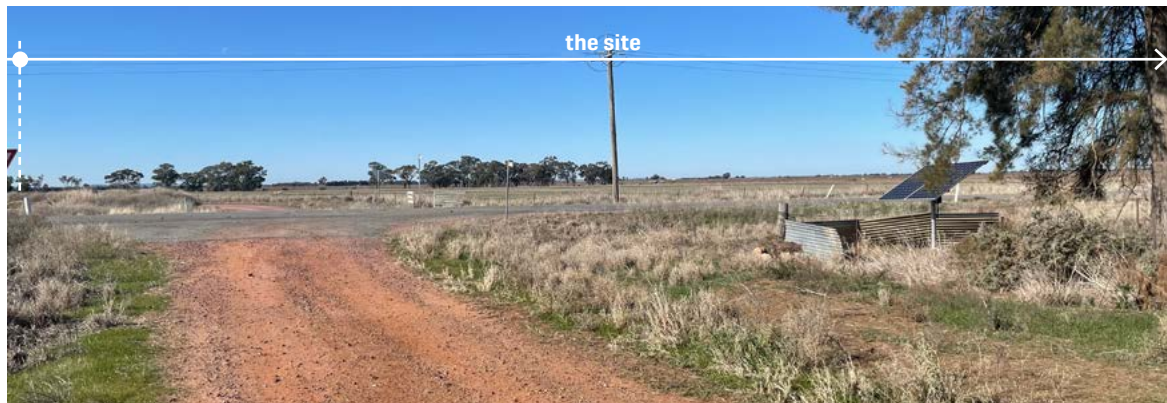
| Viewshed 9 | Sensitivity | Magnitude | Impact |
|---|---|---|---|
| Myer Road. | Low | High | Moderate |

View to the proposed development from low traffic unsealed road, immediately opposite the site

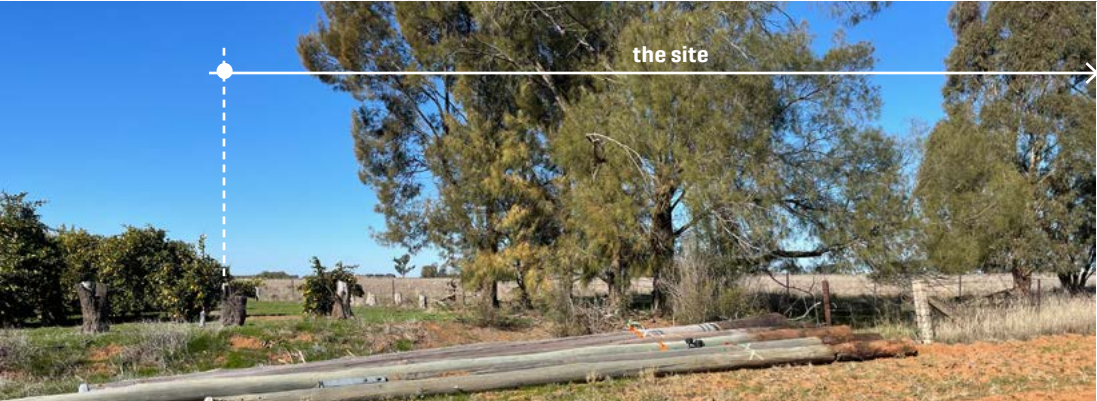
| Viewshed 10 | Sensitivity | Magnitude | Impact |
|---|---|---|---|
| Photo A: 800m from the site at Murrami Road. | Low | Low | Low |

Distant view to the site obscured by vegetation and topography.

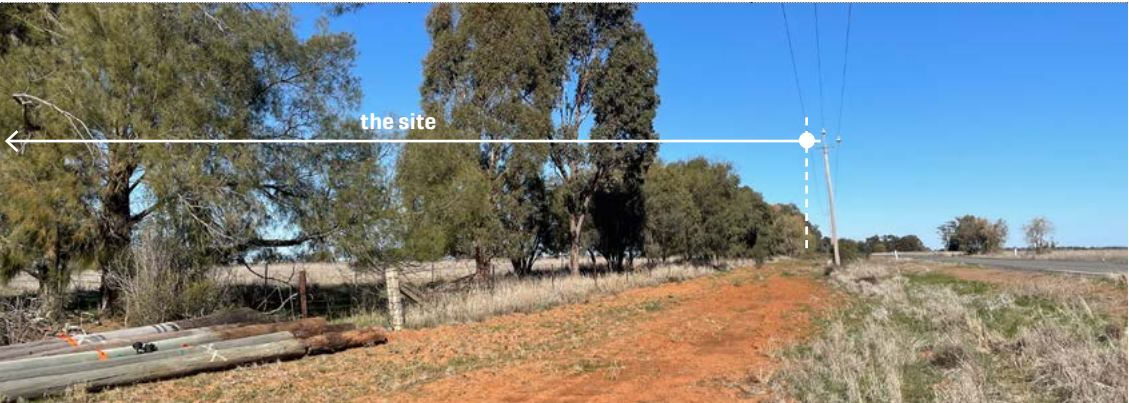
| Viewshed 10 | Sensitivity | Magnitude | Impact |
|---|---|---|---|
| Photo B: 600m from the site at Murrami Road | Low | Low | Low |

Distant view to the site obscured by vegetation and topography.

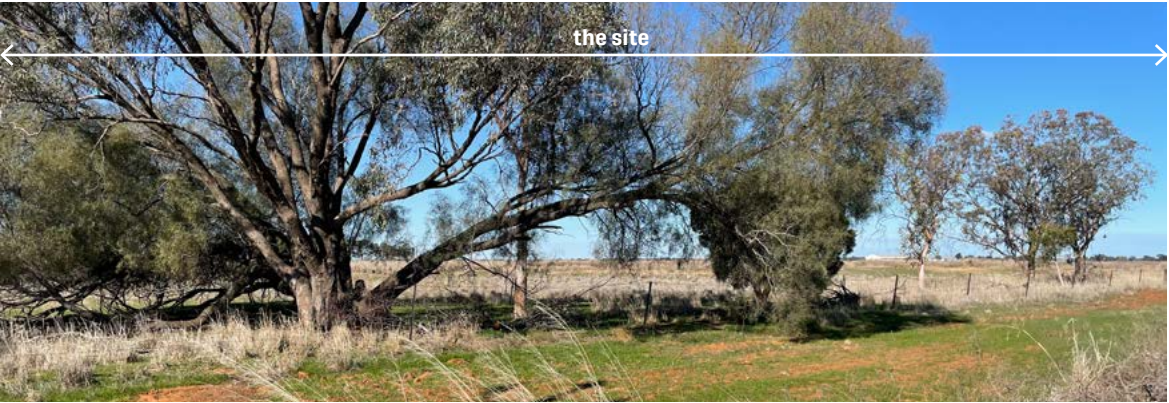
| Viewshed 11 | Sensitivity | Magnitude | Impact |
|---|---|---|---|
| Photo A: 150m from the site on Murrami Road. | Moderate | Low | Moderate-low |

View to the site partially obscured by vegetation and topography

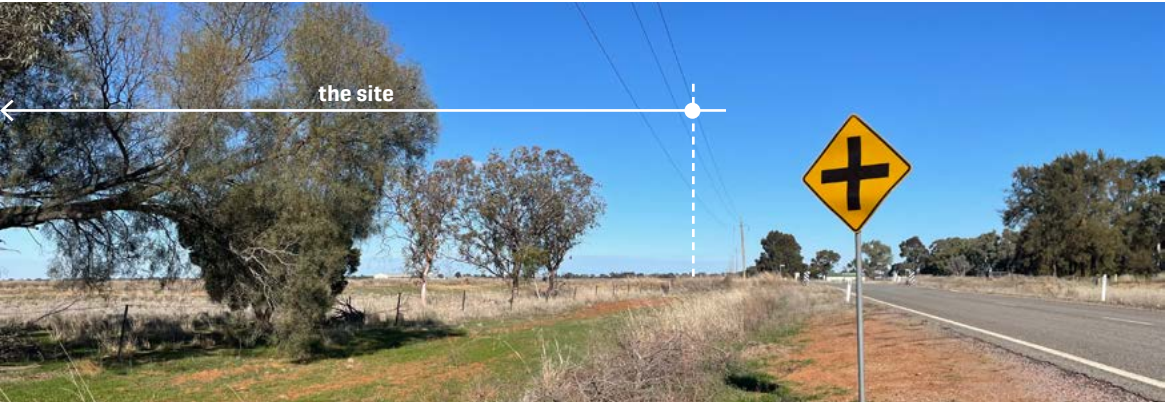
| Viewshed 11 | Sensitivity | Magnitude | Impact |
|---|---|---|---|
| Photo B: 150m from the site on Murrami Road. | Moderate | Low | Moderate-low |

View to the site partially obscured by vegetation and topography

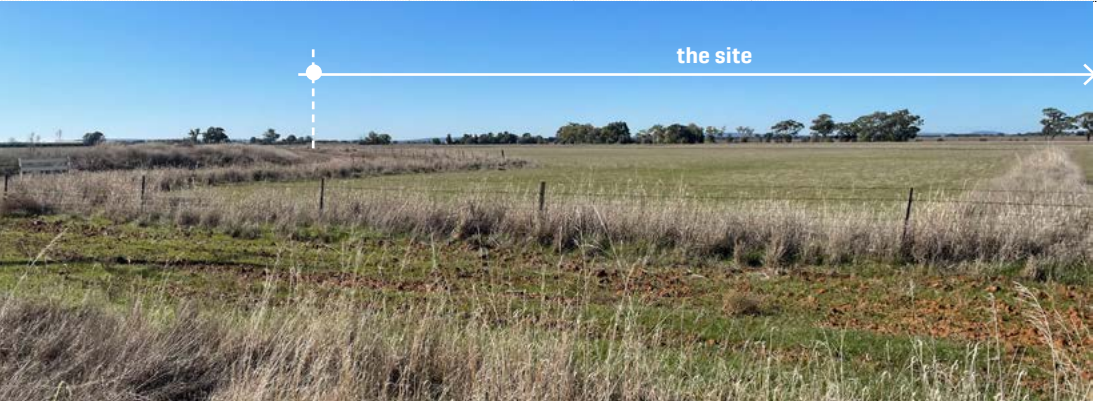
| Viewshed 12 | Sensitivity | Magnitude | Impact |
|---|---|---|---|
| Photo A: Murrami Road immediately adjacent to the site | Moderate | High | Moderate-high |

View to the proposed development from moderate traffic sealed road, immediately adjacent to the site

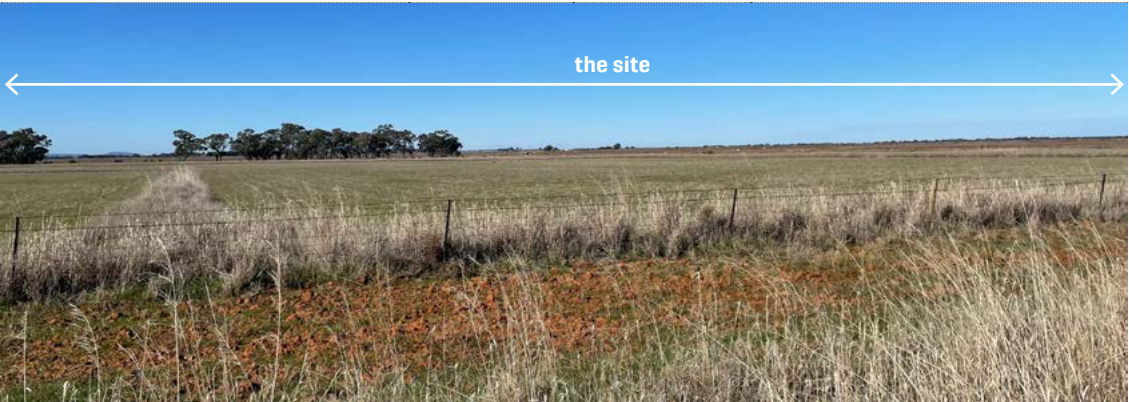
| Viewshed 12 | Sensitivity | Magnitude | Impact |
|---|---|---|---|
| Photo B: Murrami Road immediately adjacent to the site | Moderate | High | Moderate-high |

View to the proposed development from moderate traffic sealed road, immediately adjacent to the site

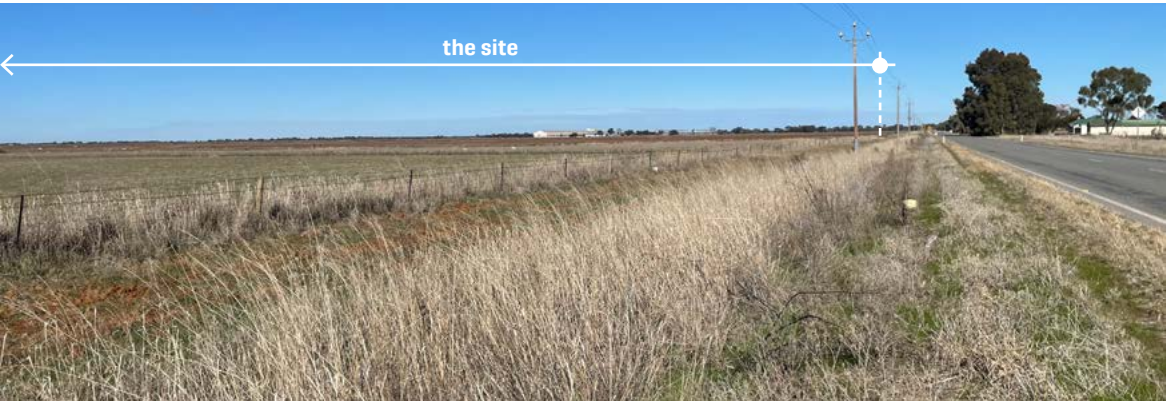
| Viewshed 12 | Sensitivity | Magnitude | Impact |
|---|---|---|---|
| Photo C: Murrami Road immediately adjacent to the site | Moderate | High | Moderate-high |

View to the proposed development from moderate traffic sealed road.

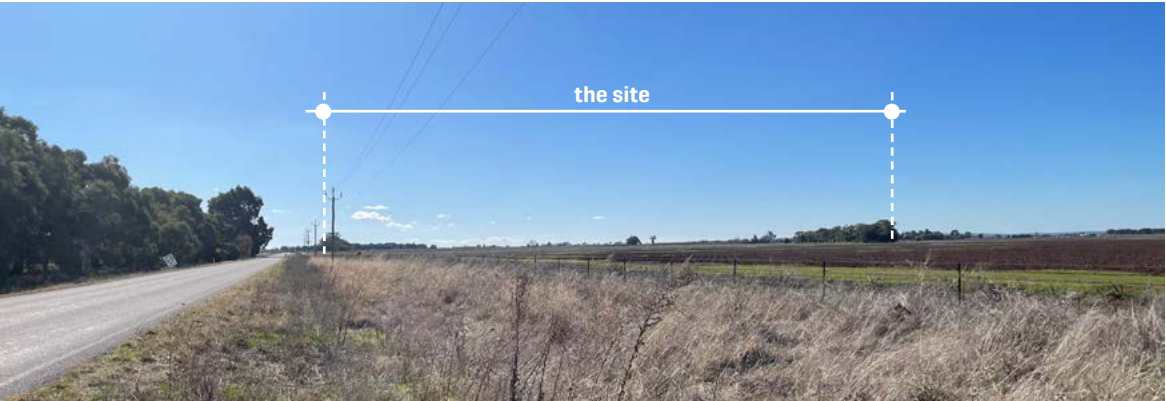
| Viewshed 13 | Sensitivity | Magnitude | Impact |
|---|---|---|---|
| 300m south of the site on Murrami Road. | Moderate | Moderate | Moderate |

View to the proposed development from moderate traffic sealed road, south of the site.

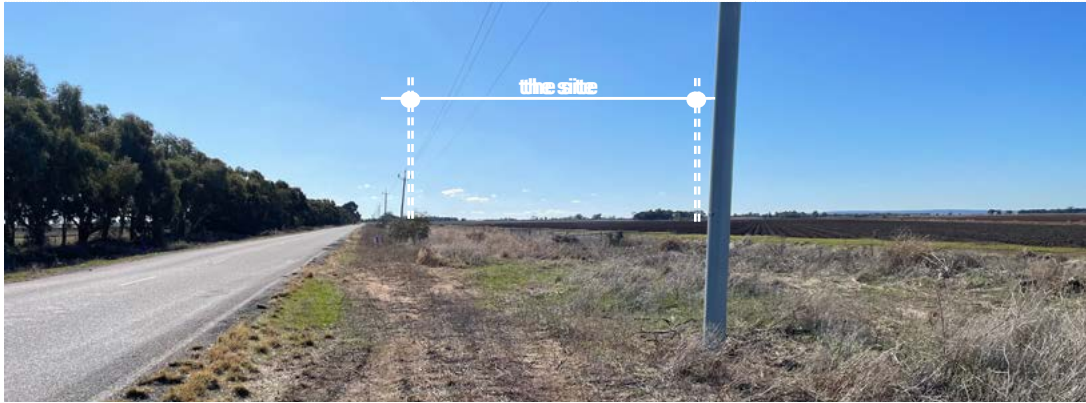
| Viewshed 14 | Sensitivity | Magnitude | Impact |
|---|---|---|---|
| 950m south of the site at the intersection of Murrami and Blythe Roads | Low | Low | Low |

Distant view to the proposed development from moderate traffic sealed road south of the site

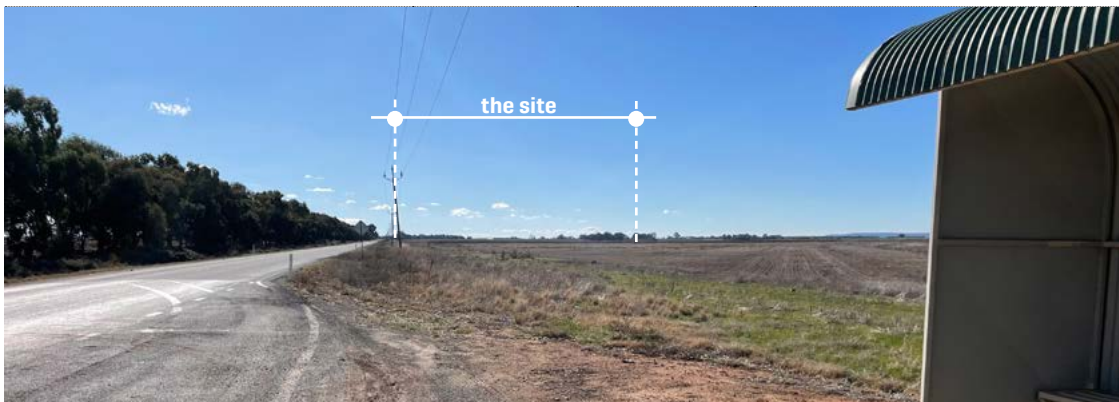
| Viewshed 15 | Sensitivity | Magnitude | Impact |
|---|---|---|---|
| 400m south of the site at the existing bus stop | Low | Low | Low |

Distant view to the proposed development from moderate traffic sealed road south of the site.

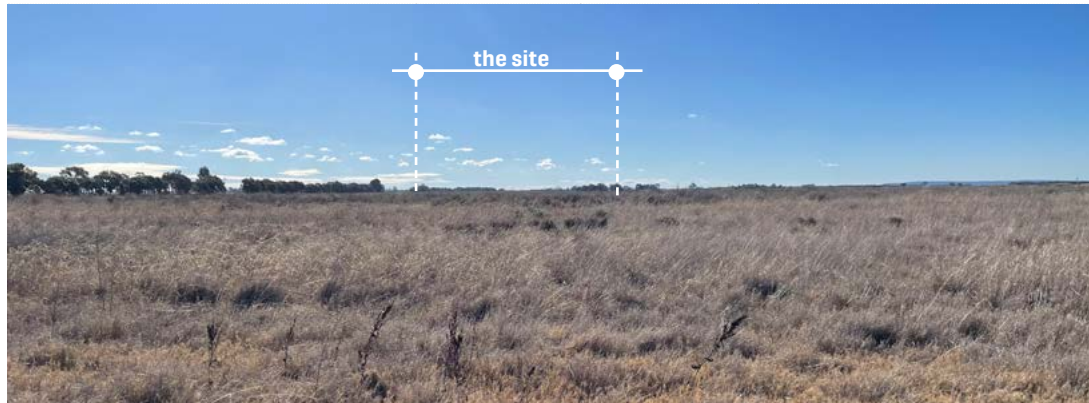
| Viewshed 16 | Sensitivity | Magnitude | Impact |
|---|---|---|---|
| 1600m south of the site at Whitton Road. | Negligible | Negligible | Negligible |

The site is not visible due to vegetation, topography and distance.

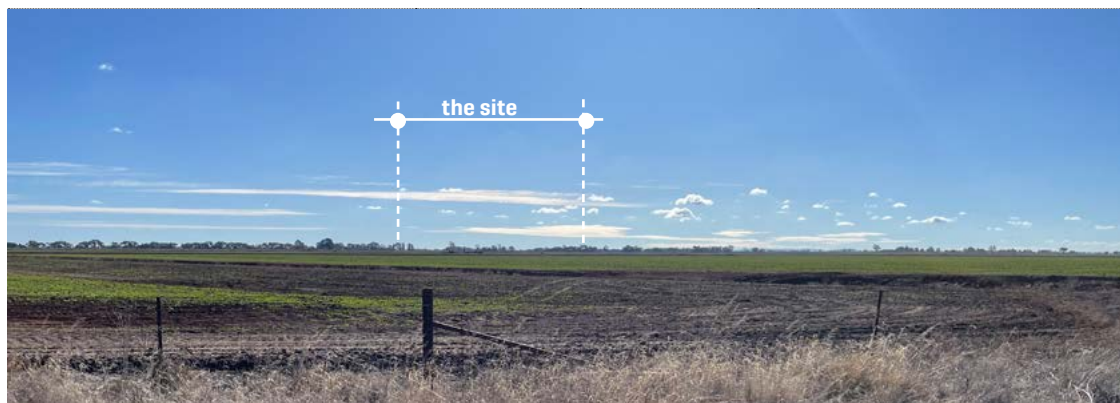
| Viewshed 17 | Sensitivity | Magnitude | Impact |
|---|---|---|---|
| 1650m south of the site at Whitton Road. | Negligible | Negligible | Negligible |

The site is not visible due to vegetation, topography and distance.

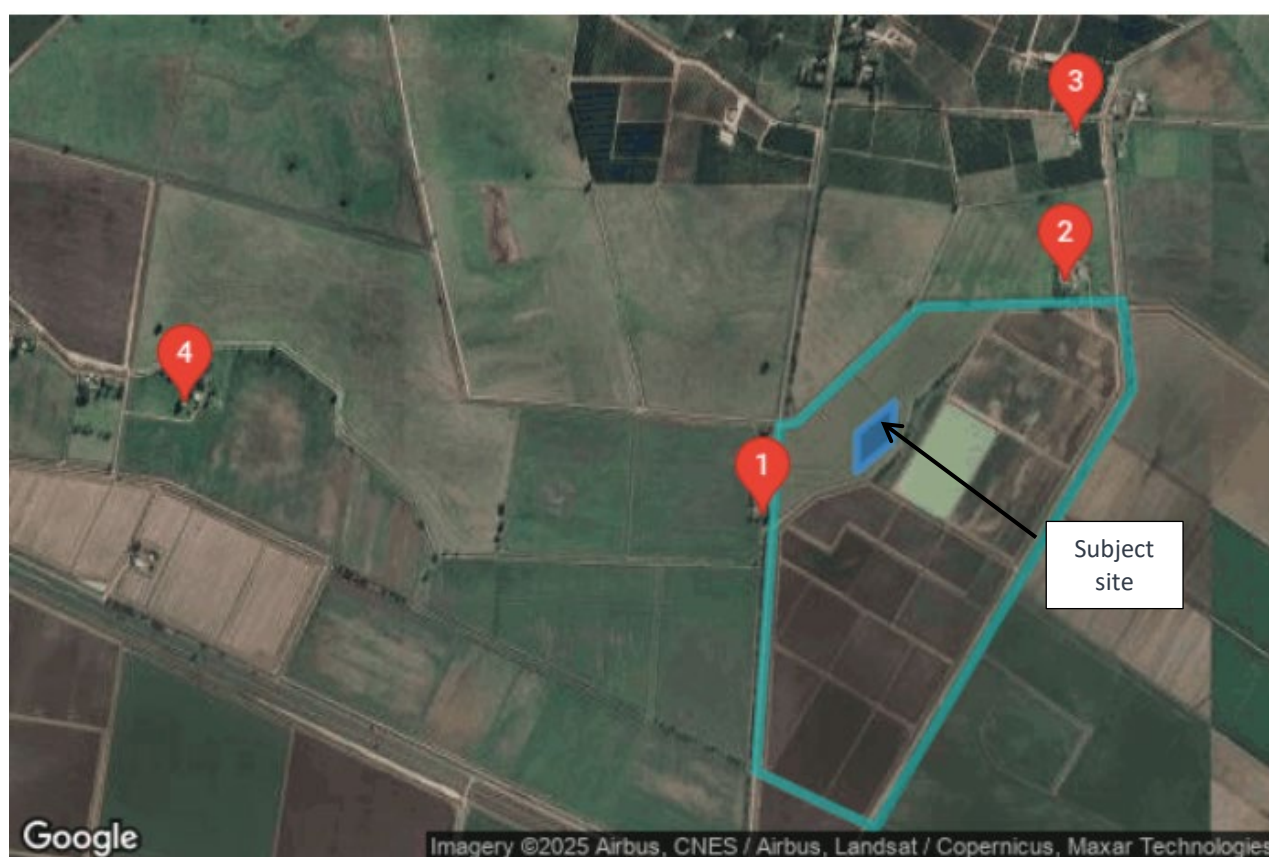
**Figure 5: Observation Points Assessed for Glint and Glare Within the Immediate Context of the Subject Site**

A number of Observation Points (OPs) were identified within proximity to the site. These OPs consisted entirely of surrounding dwellings and were measured from a height of 1.5 metres above the ground for a typical viewing angle.

**Figure 5** below illustrates the location of the OPs within proximity of the site, identified as the red pinpoints.

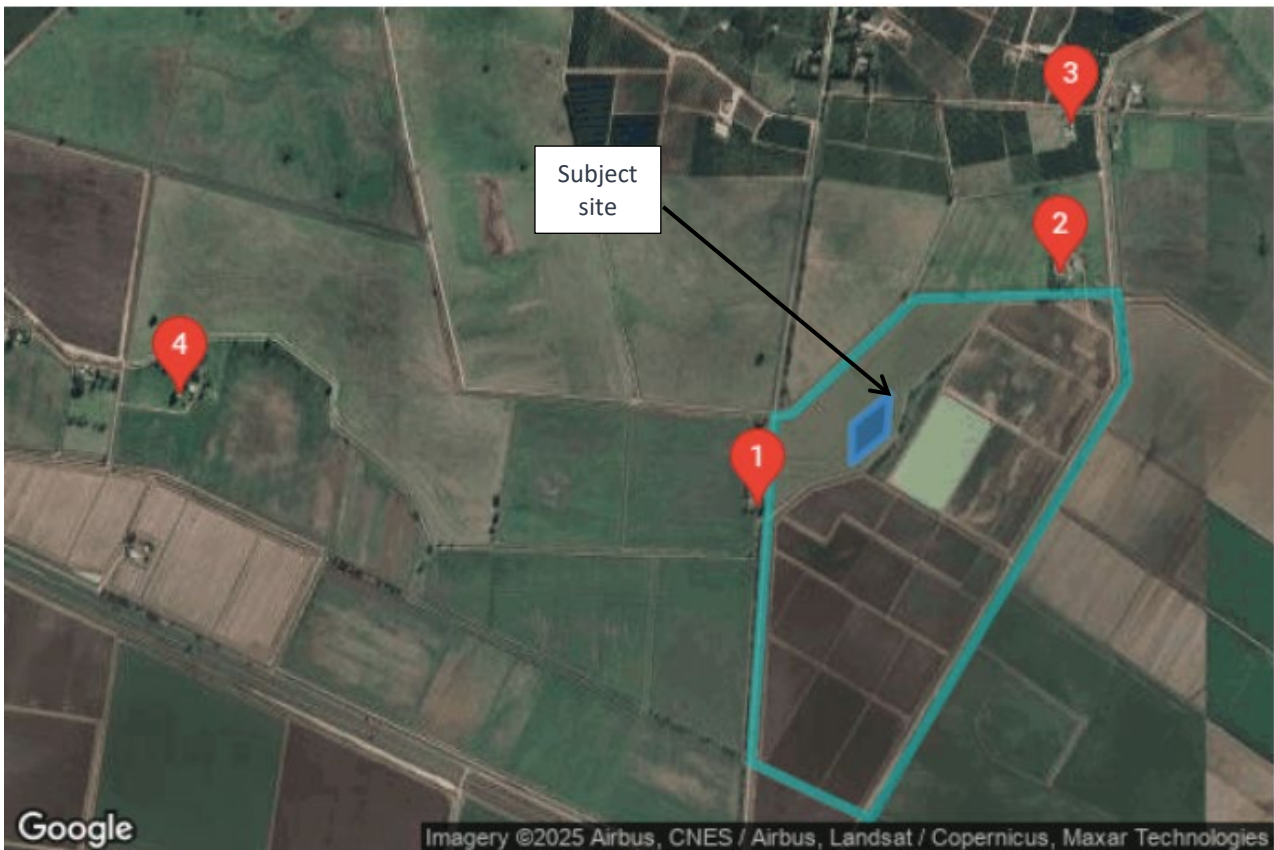
**Figure 6 Routes assessed for glint and glare within the immediate context of the subject site**

All surrounding routes were recorded for input into the GlareGuage tool similar to the OP's. The height above ground was input as 2.4 metres, which represents the eye height of drivers in larger trucks, being the most susceptible to potential glare. The input height was determined in accordance with the criteria set out in the *Austrroads, Guide to Road Design Part 3: Geometric Design*.

The routes are indicated below in **Figure 6**, identified as the teal line.

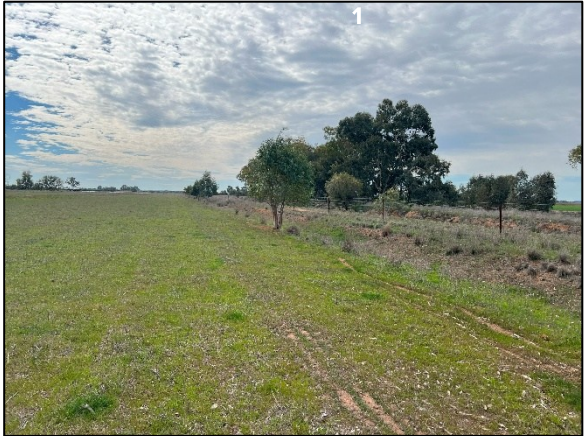
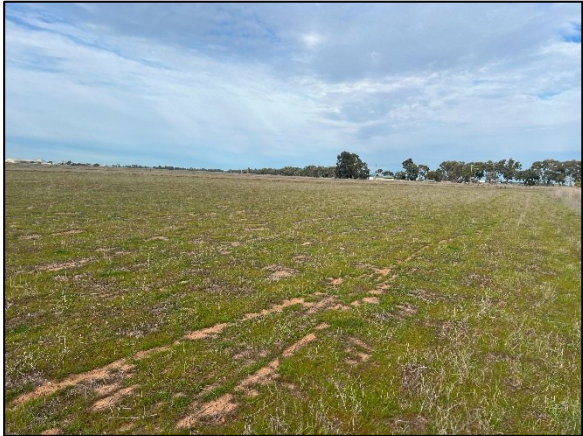
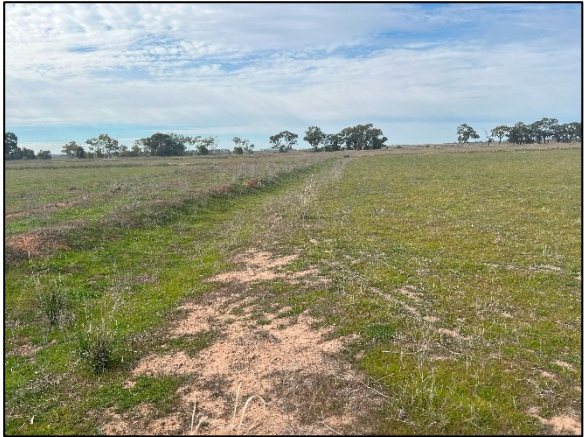
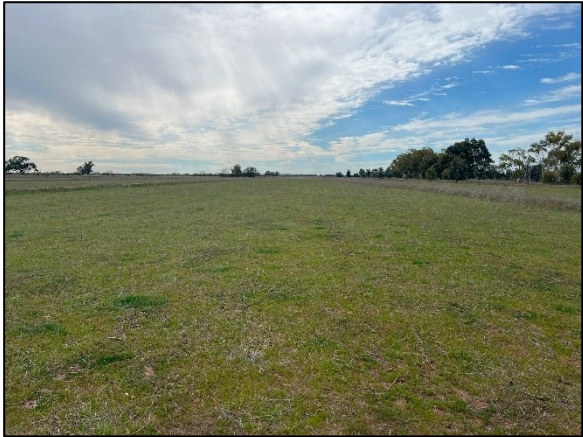
60 - 65

| Representative photographs of the Subject Land | |
|---|---|
| Representative photographs of Subject Land illustrating native grassland outside of Development Footprint | Representative photographs of Subject Land illustrating scattered trees within Development Footprint |
