## PRELIMINARY CONTAMINATED SITE INVESTIGATION

“STRATHEDEN”

815 Manilla Road, Tamworth NSW 2340

September 2022

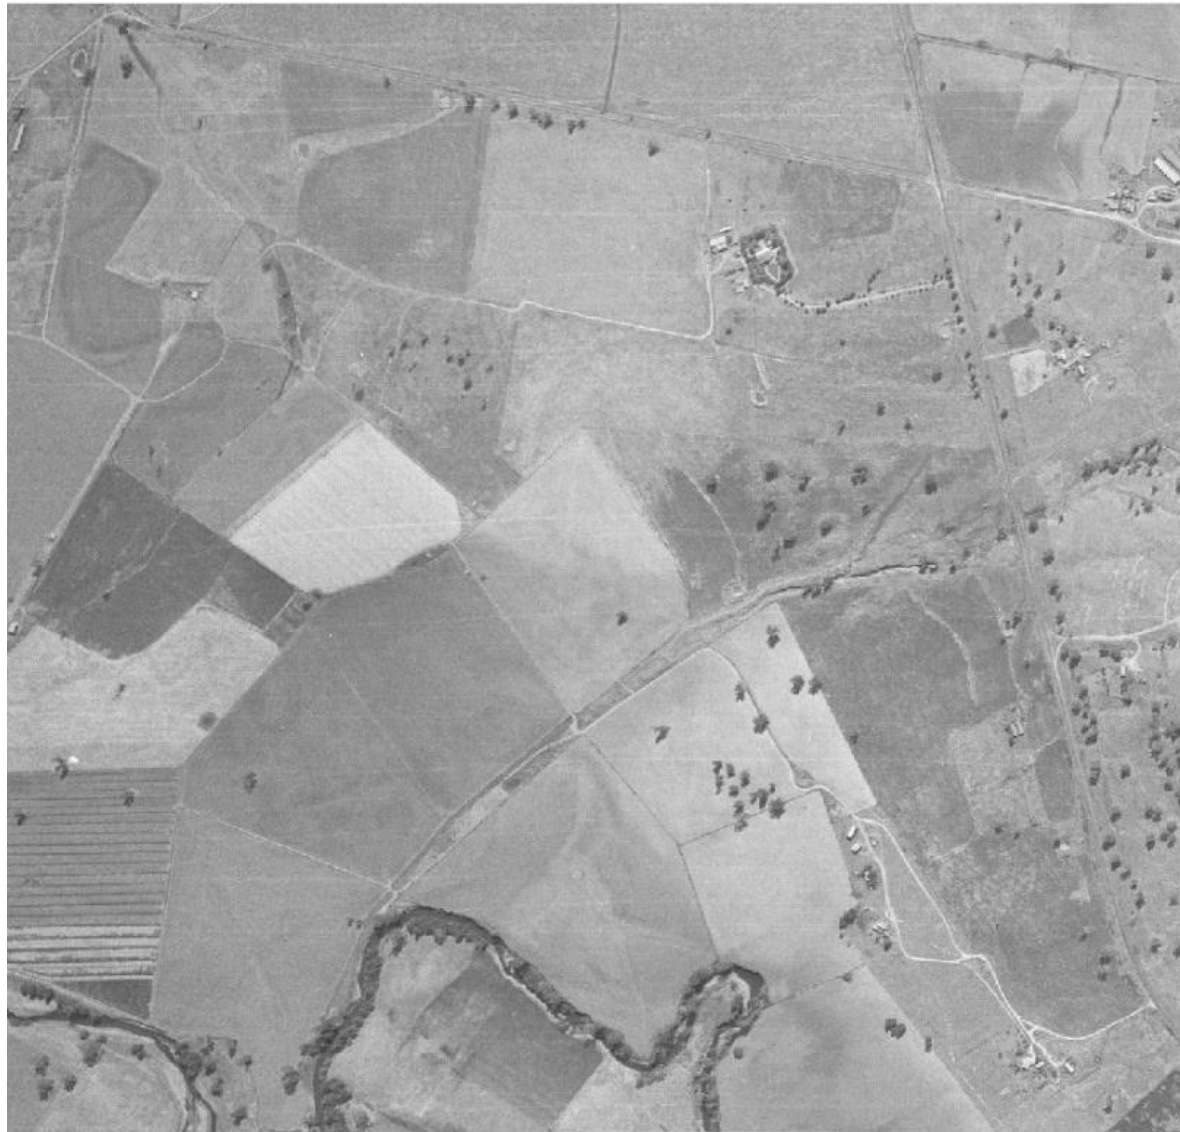
**Figure 3: 1976 Aerial image of Stratheden**

Historical aerial images were accessed to review historical development on the property. The images available start in 1976. This image presented in figure 4 shows the main homestead and surrounding horse related infrastructure. Paddocks contain a few horse shelters and self-feeders. Only one small shed is present in the western part of the property. Approximately one third of the property was cultivated. The remainder appears as natural or improved pasture. The buildings in this photo remain in place.

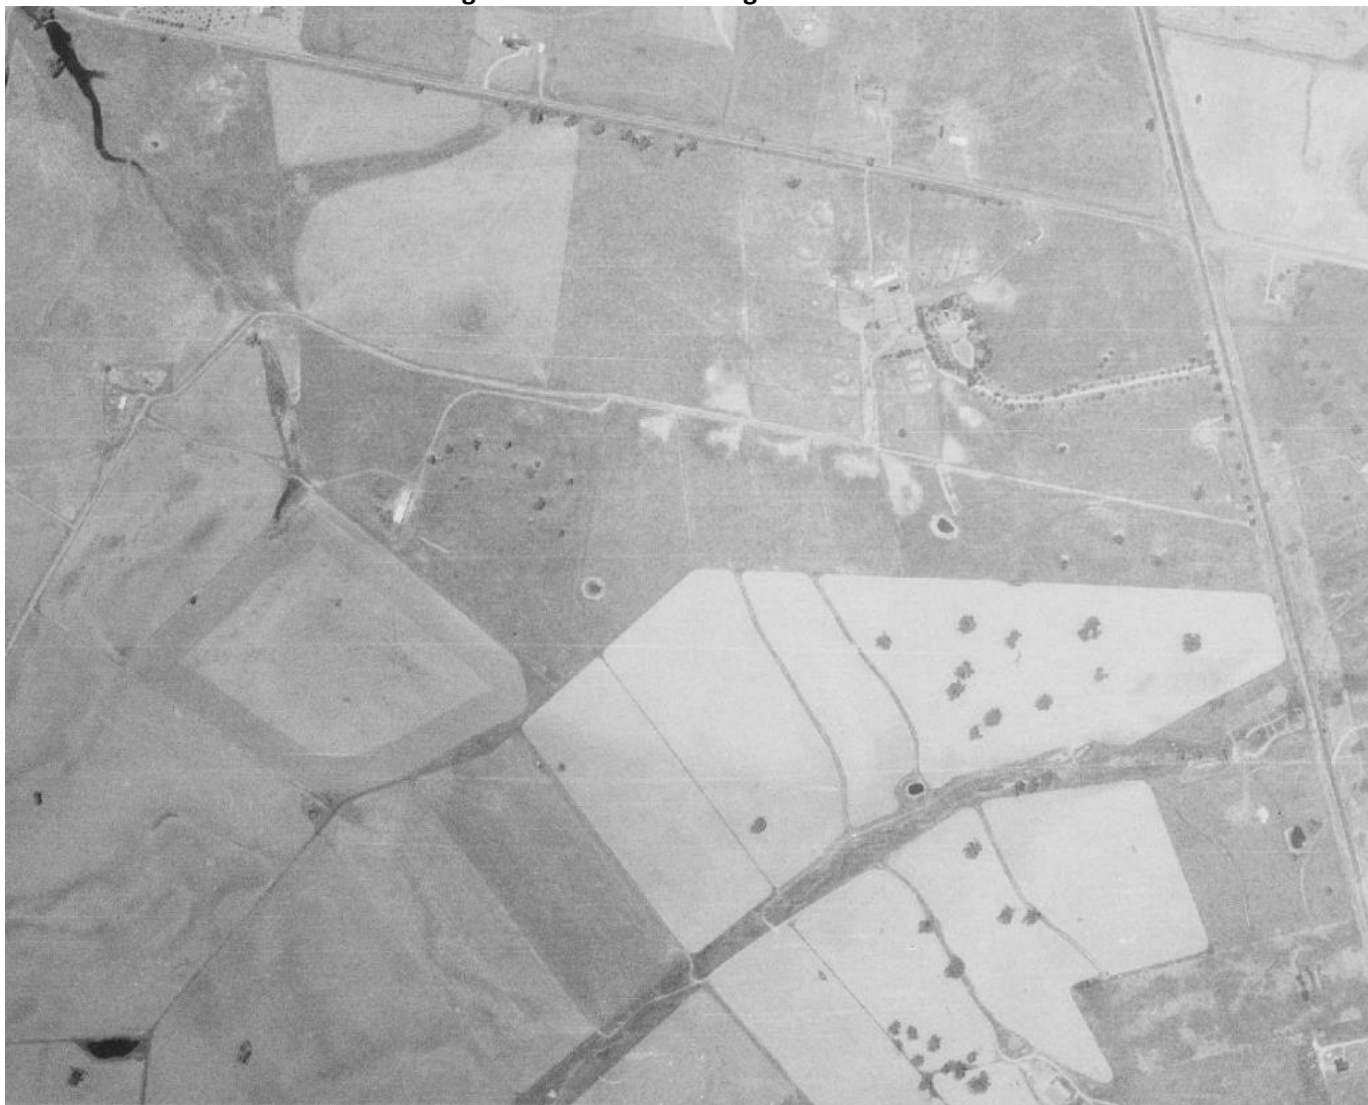
**Figure 4: 1984 Aerial image of Stratheden**

A 1984 aerial image shows some minor expansion of the horse facilities and hay storage. The second house and main hay shed appear in this image. All ground disturbance can be related to grazing animals, roads, cultivation and old stock dams. No structures of concern are present.

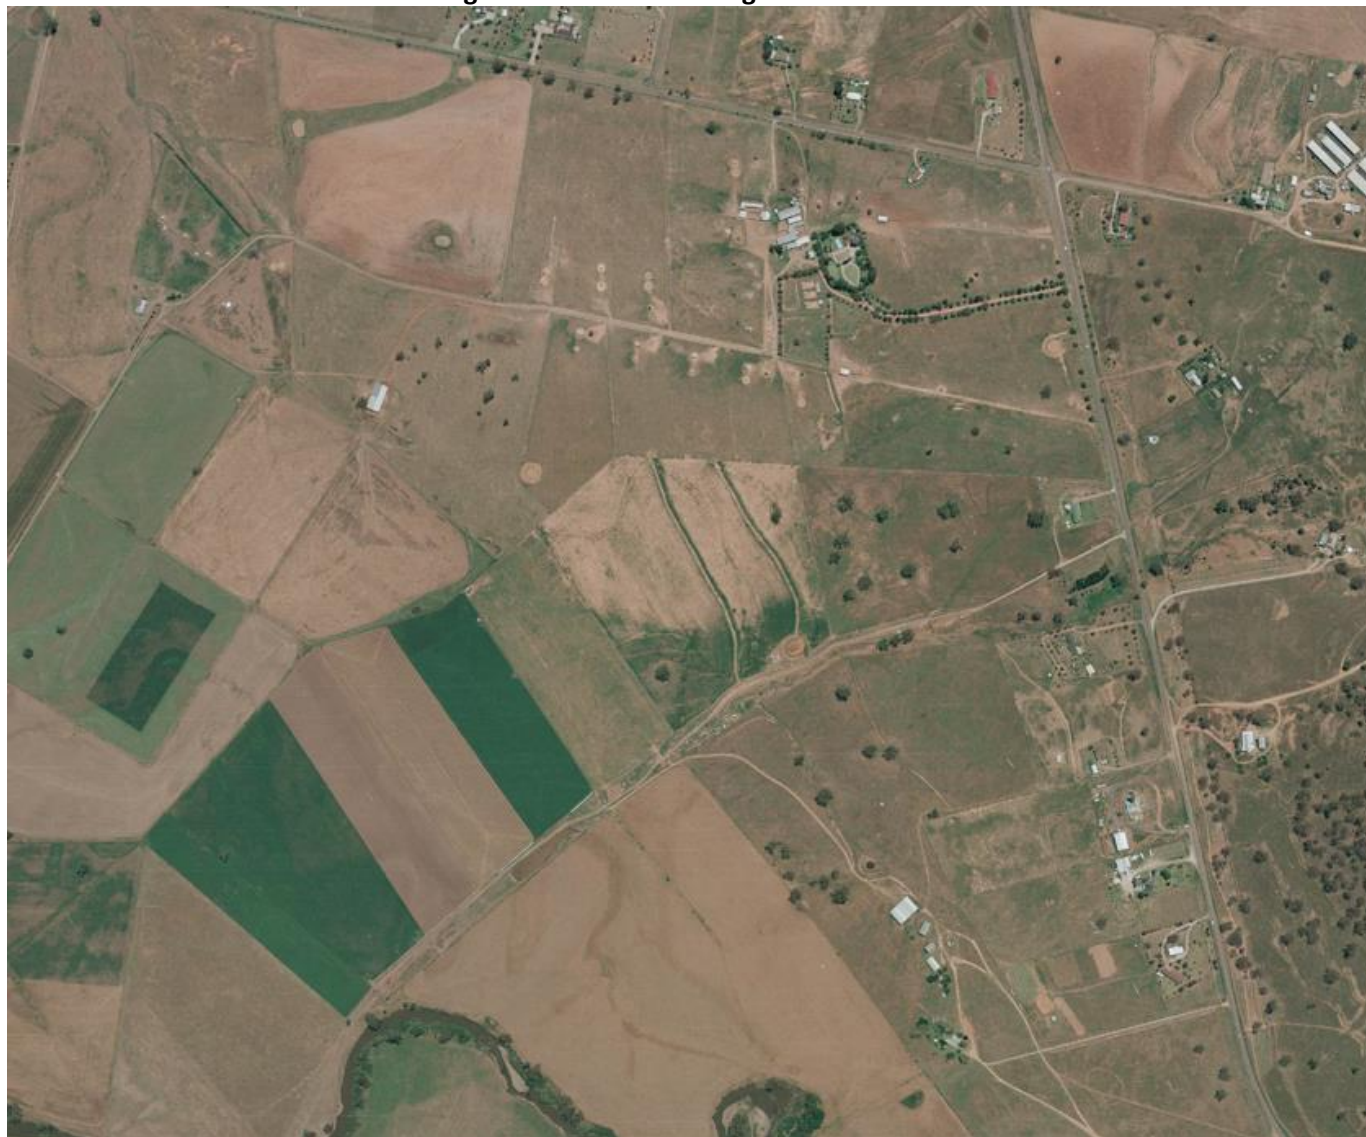
**Figure 5: 1993 aerial image of Stratheden**

The 1993 aerial image shows further expansion of the horse related infrastructure including additional stables, horse shelters and self-feeders. All additions relate to the horse enterprise.

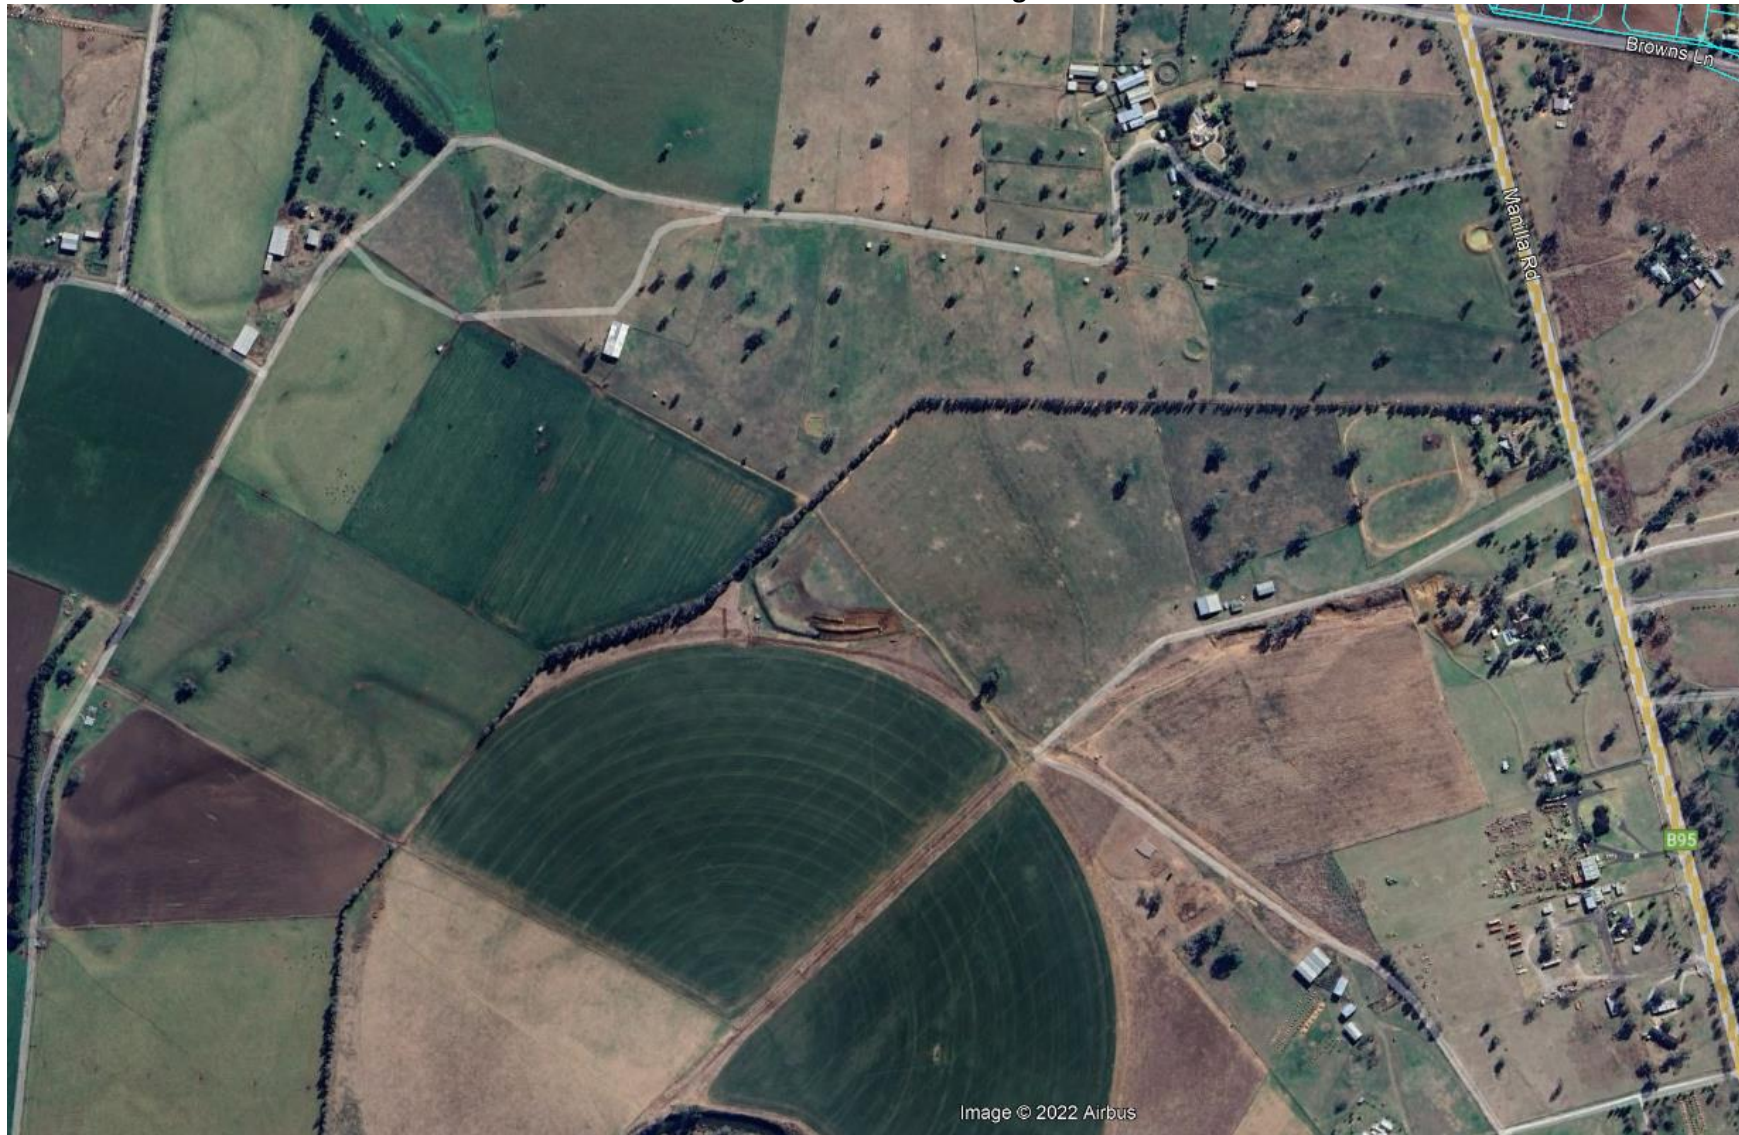
Figure 8: 2022 Aerial image

A 2022 image shows minor changes. Additional training facilities have been added to the structures around the homestead.

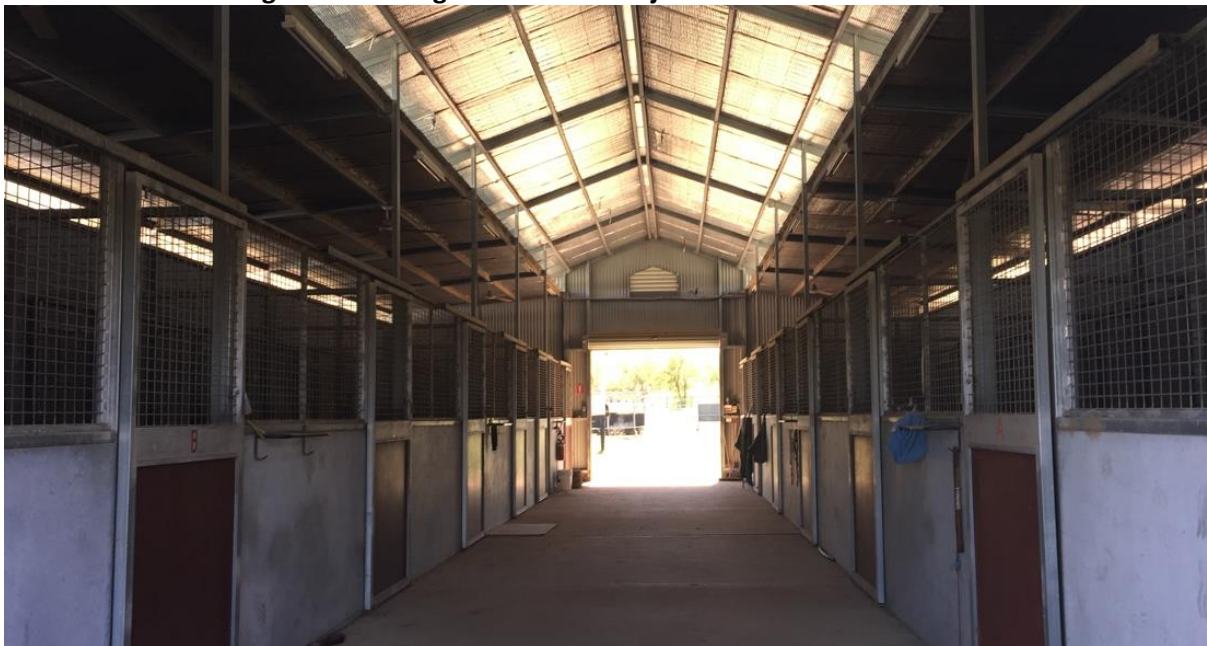
**Figure 9: Existing horse stables adjacent to main homestead**

The breeding of horses does not require the use of chemicals that may present a long-term risk of ground contamination.
