# GEOTECHNICAL INVESTIGATION

# NSW LAND & HOUSING CORPORATION

*680-688 East & 165 Alexandria Streets, East Albury (BGXPC)*

*Report No: 21/0682*

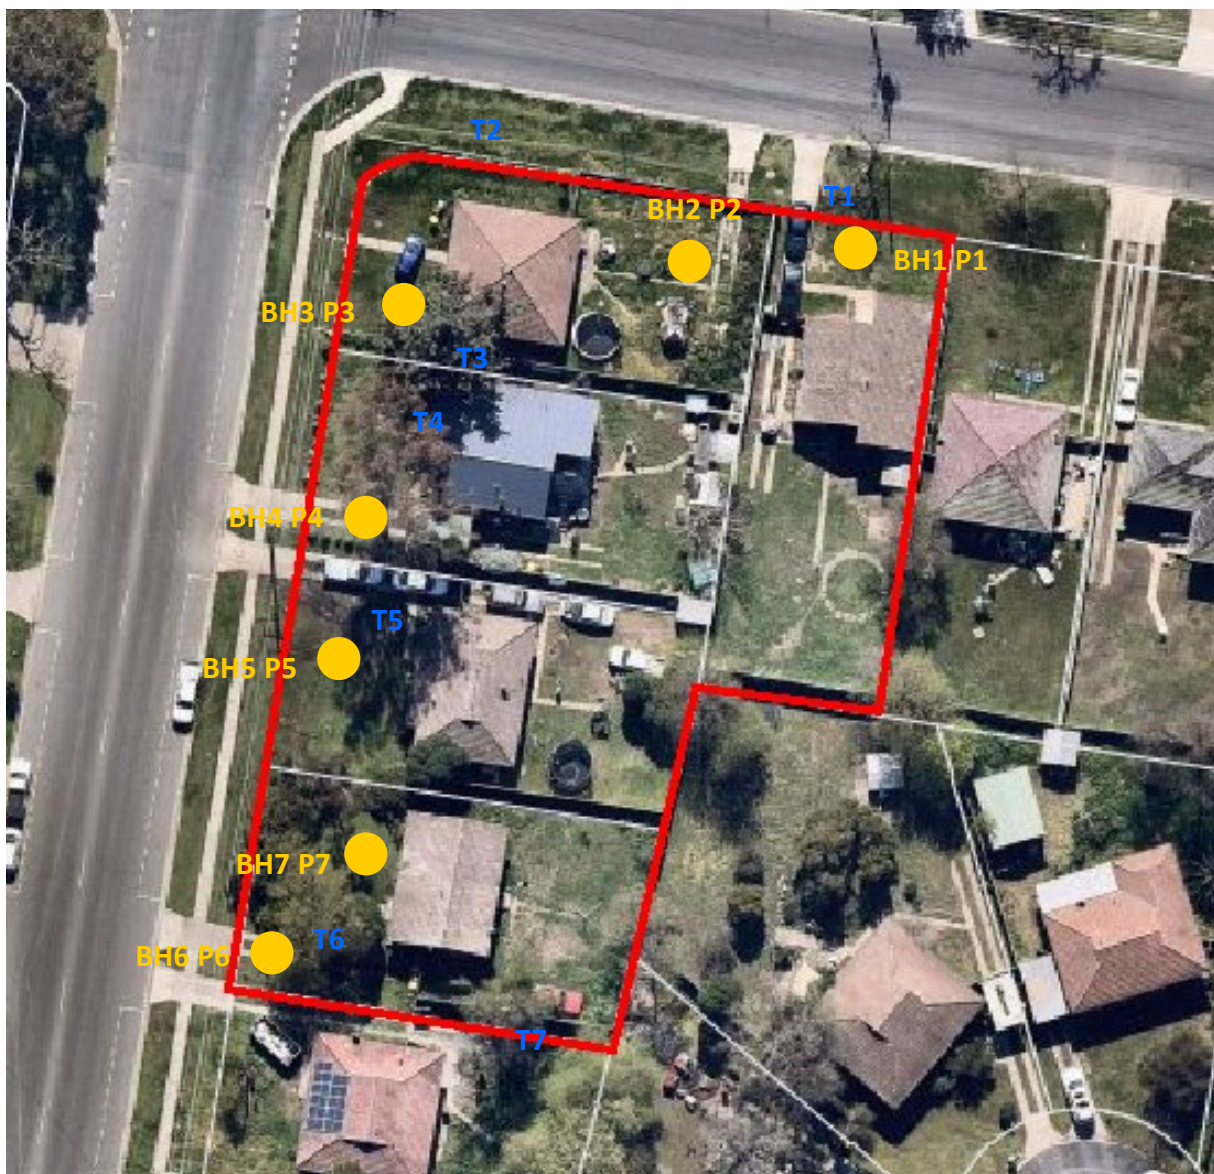
Drawing No: 21/0682

GEOTECHNICAL INVESTIGATION  
680-688 EAST & 165 ALEXANDRIA STS, EAST ALBURY  
BOREHOLE AND PENETROMETER LOCATIONS

The fieldwork consisted of drilling seven (7) boreholes numbered BH1 to BH7, at the locations shown on Drawing No. 21/0682. Except for BH7, the boreholes were drilled using a utility mounted Edson RP70 drilling rig owned and operated by STS. ***Because there was no access for the drilling rig, BH7 was drilled using a hand auger.*** Soils were drilled using rotary solid flight augers. Soil strengths were determined by undertaking Dynamic Cone Penetrometer (DCP) tests at each borehole location.
