ARBORICULTURAL IMPACT ASSESSMENT

Demolition of Existing Structures and Construction of a Seniors Development comprising of three (3) Double Storey Buildings, Carparking Area and Associated Works

26 Rose Crescent & 69-73 Bourke Street,
North Parramatta NSW 2151

Date: 10th June 2022

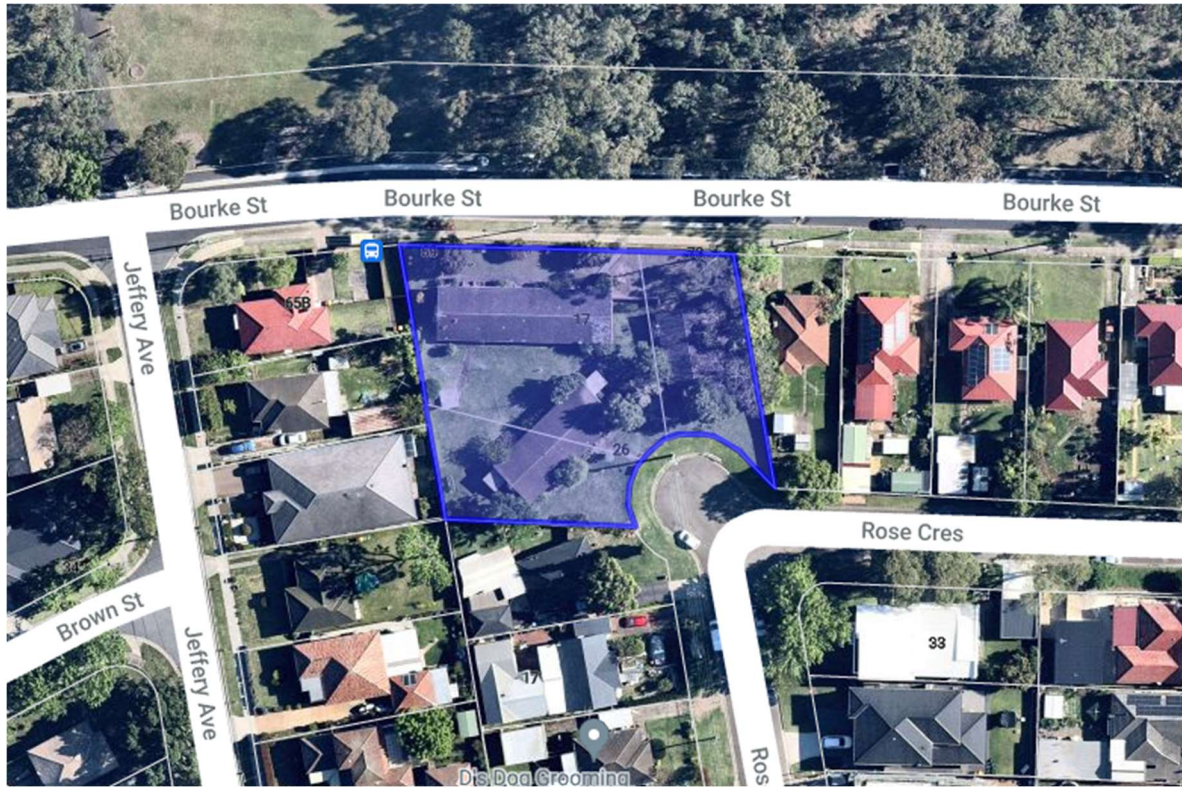
Figure 1 – Aerial image indicating subject site (highlighted blue) Source: Nearmap 2022

This Arboricultural Impact Assessment (AIA) was commissioned by Barry Rush & Associates on the 14th of February 2022 to evaluate the potential impacts that proposed development works will have on existing trees located on and adjacent to the subject site at 26 Rose Crescent & 69-73 Bourke Street, North Parramatta (refer to **Figure 1**).

The site is known as 26 Rose Crescent & 69-73 Bourke Street, North Parramatta and is legally described as Lot 2 in DP 215342 (the site). The site is located to the northeast side of Rose Crescent and south of Bourke Street. The site currently contains three (3) single storey buildings accommodating thirteen (13) units with open landscaped garden areas. An existing 1.83 metre wide easement to drain water is located along the eastern boundary. (Refer to **Figure 1** below).

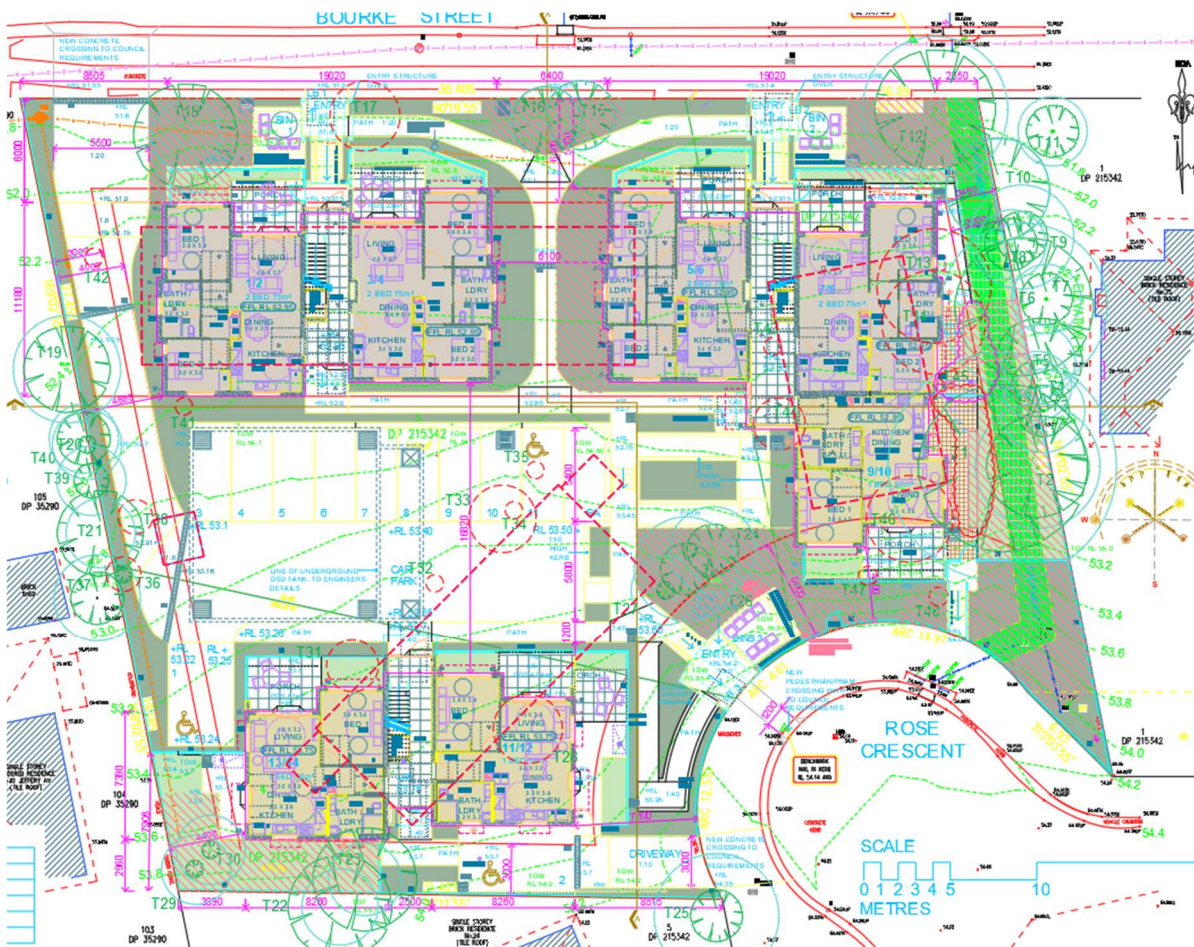
Figure 2 – Site/Ground Floor Plan extract showing the proposed layout of the development

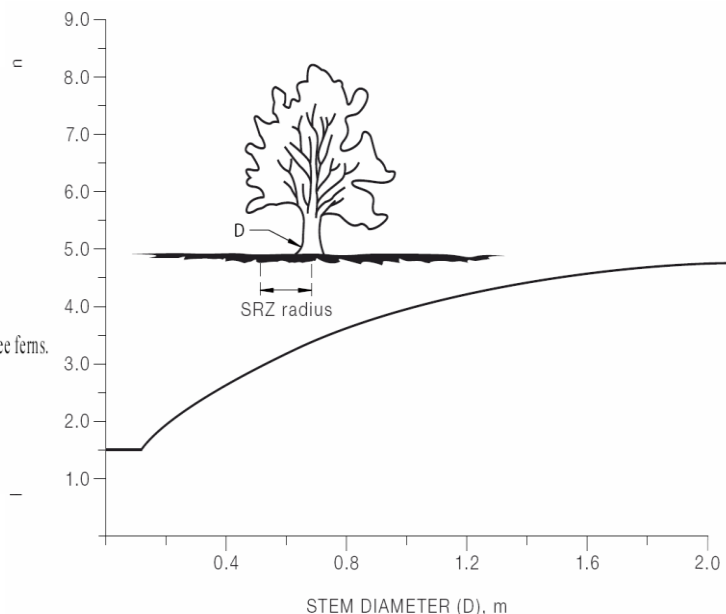
FIGURE 1 STRUCTURAL ROOT ZONE

- 1 R_{SRZ} is the structural root zone radius.
- 2 D is the stem diameter measured immediately above root buttress.
- 3 The SRZ for trees less than 0.15 m diameter is 1.5 m.
- 4 The SRZ formula and graph do not apply to palms, other monocots, cycads and tree ferns.
- 5 This does not apply to trees with an asymmetrical root plate.

SRZ (Structural Root Zone)
The SRZ is a radial area extending outwards from the centre of the trunk. This area contains the majority of the structural woody roots. This area is responsible primarily for stability. Root damage or root loss within this zone greatly increases the opportunity for decay fungi to ingress into the heartwood, causing internal decay in addition to destabilising the trees structural integrity. The SRZ is calculated as follows (This calculation is taken from the Australian Standard 4970 – 2009 Protection of Trees on Development Sites): (D x 50)/0.42 x 0.64
