REPORT TO
NSW HEALTH INFRASTRUCTURE

ON
DETAILED (STAGE 2) SITE INVESTIGATION

FOR
PROPOSED GUNNEDAH HOSPITAL
REDEVELOPMENT

AT
MARQUIS STREET, GUNNEDAH, NSW

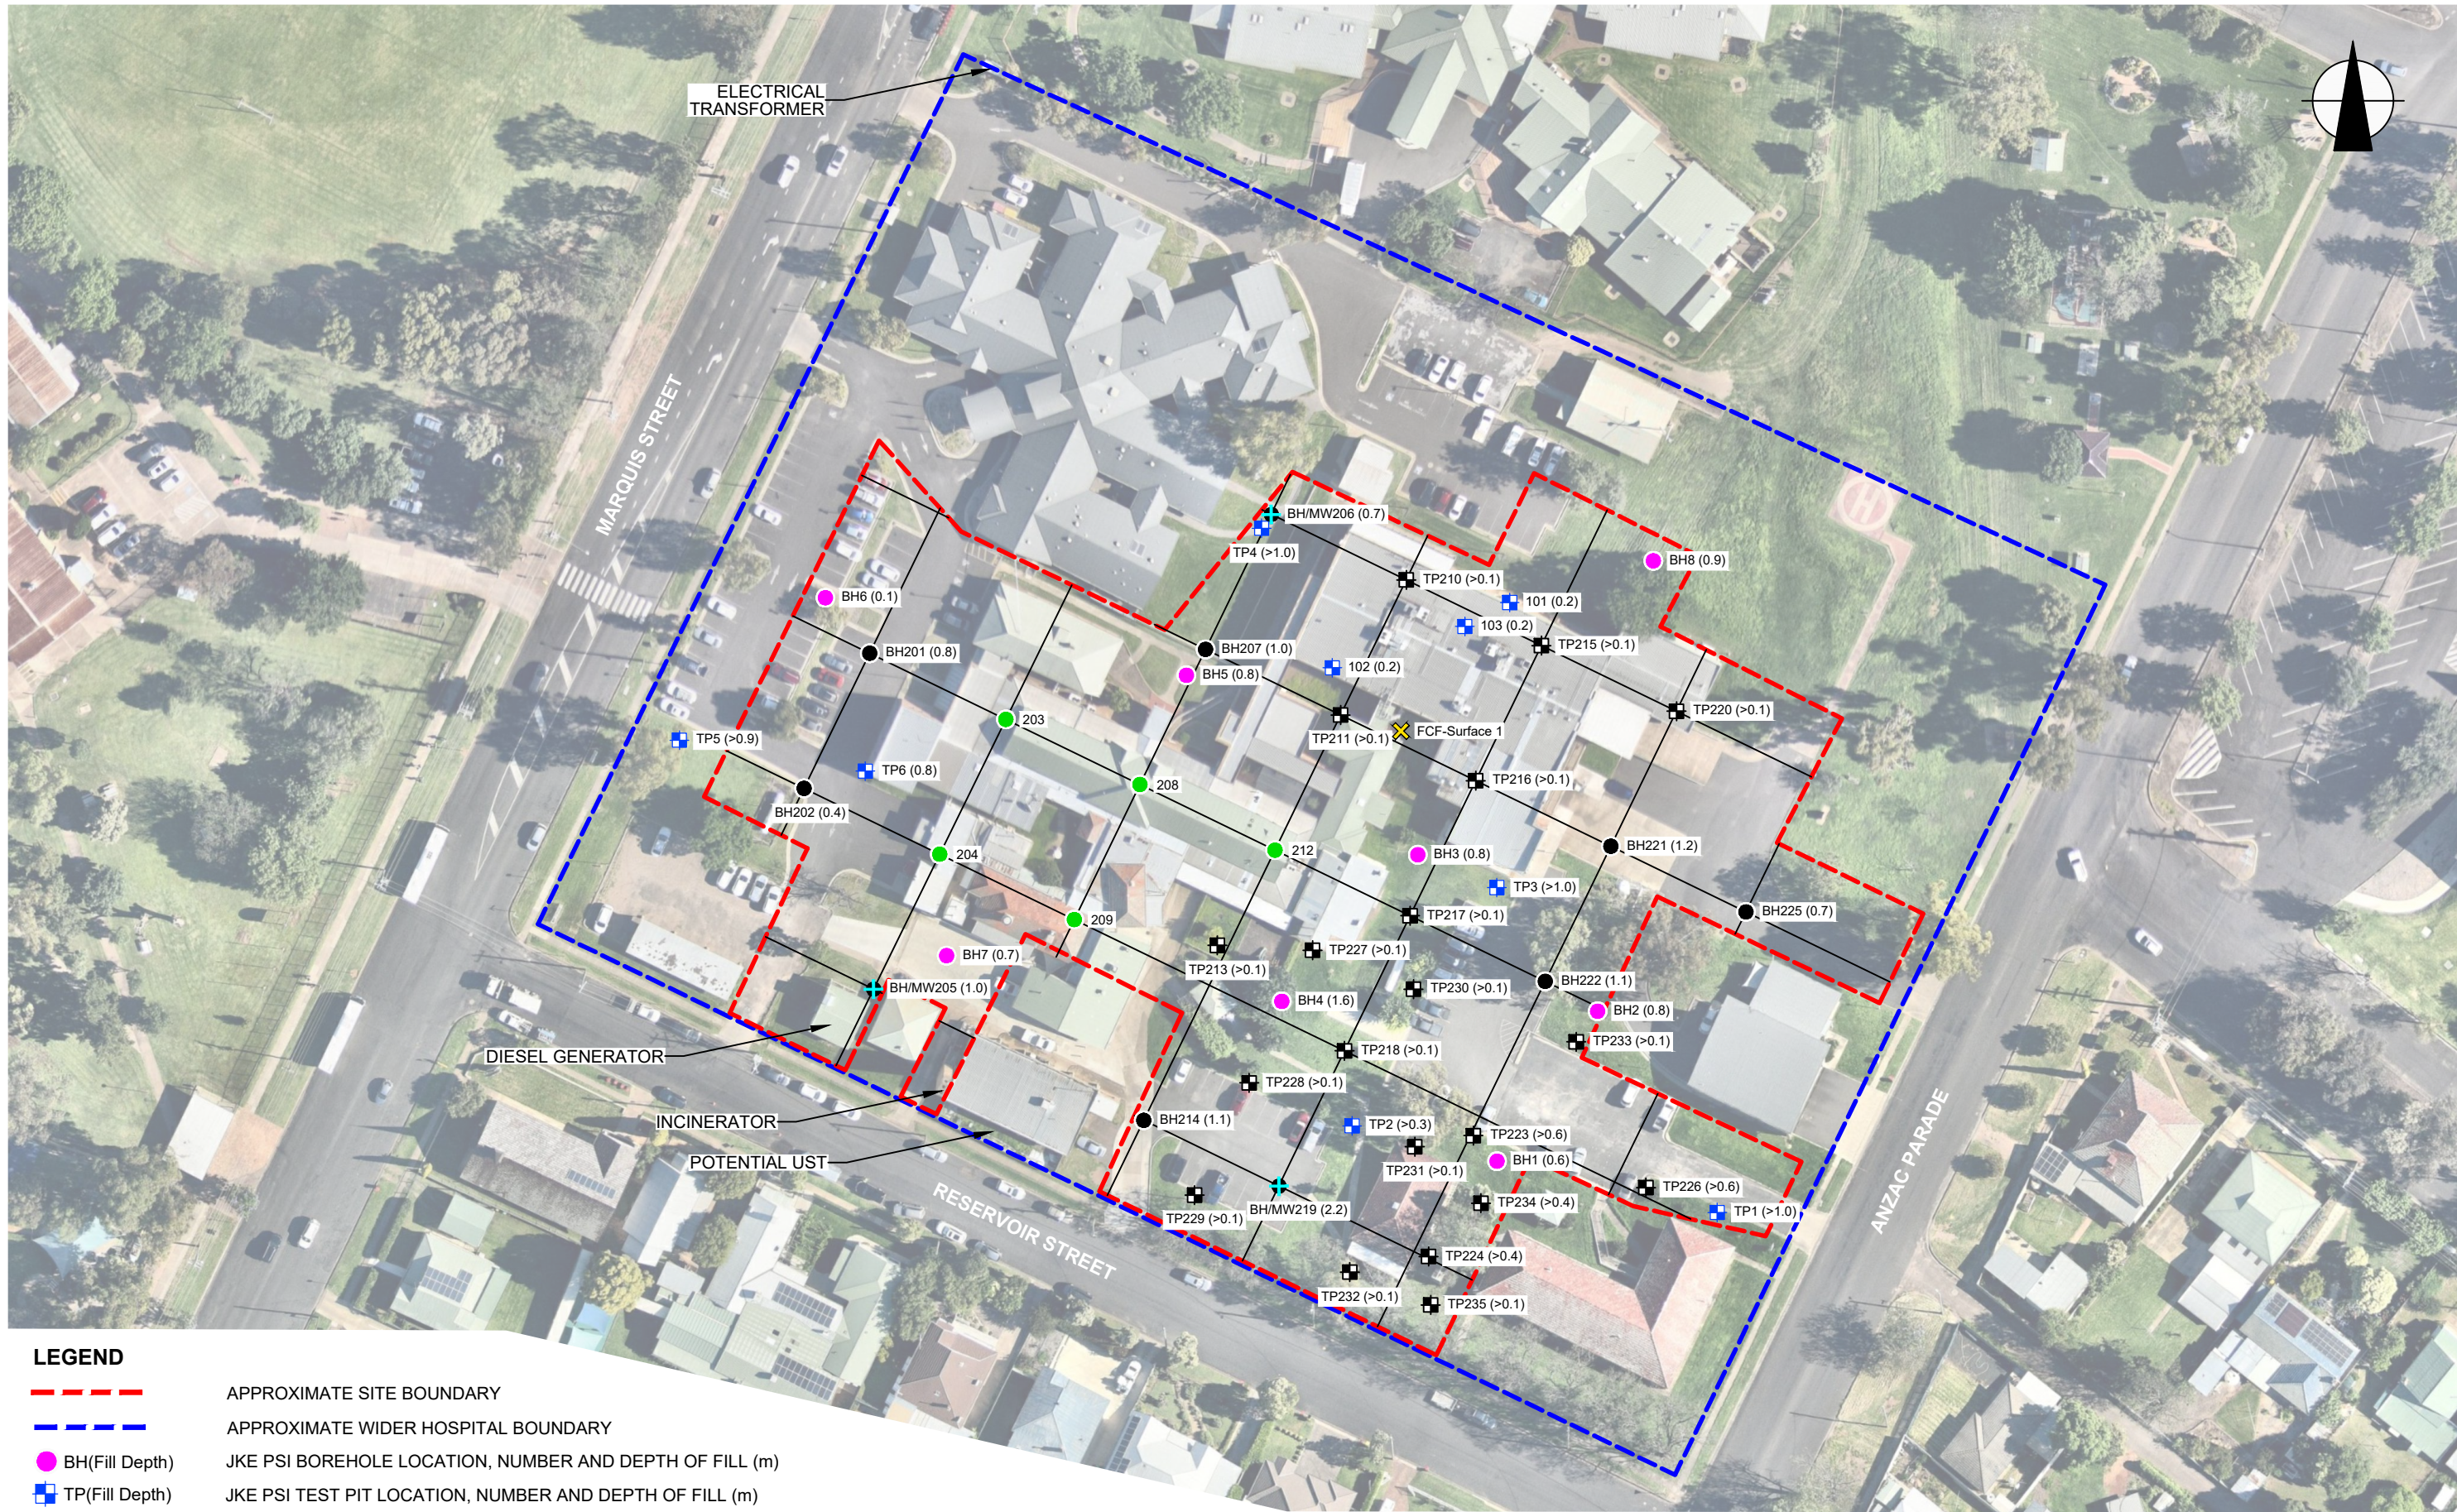
- APPROXIMATE SITE BOUNDARY
- APPROXIMATE WIDER HOSPITAL BOUNDARY
- BH(Fill Depth) JKE PSI BOREHOLE LOCATION, NUMBER AND DEPTH OF FILL (m)
- TP(Fill Depth) JKE PSI TEST PIT LOCATION, NUMBER AND DEPTH OF FILL (m)
- TP101(Fill Depth) JK GEOTECHNICAL TEST PIT LOCATION, NUMBER AND DEPTH OF FILL (m)
- 201 BOREHOLE LOCATION, NUMBER AND DEPTH OF FILL (m) (JKE, DSI)
- BH/MW205 BOREHOLE AND GROUNDWATER MONITORING WELL LOCATION, NUMBER AND DEPTH OF FILL (m) (JKE, DSI)
- TP210 TEST PIT LOCATION AND NUMBER AND DEPTH OF FILL (m) (JKE, DSI)
- 203 SAMPLING LOCATION INACCESSIBLE, PROPOSED TO BE COMPLETED POST-DEMOLITION
- ✕ FCF(Surface) FIBRE CEMENT FRAGMENT LOCATION, NUMBER AND DEPTH (Surface/m)

An above ground diesel generator and an incinerator were identified in the south section of the site (refer to Figure 2 attached). Additionally, what appeared to be a breather vent pipe possibly associated with a petroleum Underground Storage Tank (UST) was observed by JKE from Reservoir Street protruding from the roof of the hospital maintenance/engineering building located to the south of the site (within the wider hospital grounds). There were no other indicators of a potential UST (e.g. gatic cover, fuel bowser etc) there were no visible (e.g. spills, staining) indicators of contamination associated with these features.

Source / AEC	CoPC
accidental spills/leaks to have occurred in this area, most likely during refuelling activities.	
<u>Incinerator</u> – An incinerator is located in the south section of the site and as shown on Figure 2 attached in the appendices. There is a potential for localised impacts from spills/leaks when loading waste into the incinerator or from removing waste ash from the incinerator which could have migrated to the soils in the vicinity, and also from atmospheric fallout from the incinerated waste settling on nearby ground surface.	Heavy metals and PAHs.
<p><u>Off-site UST</u> – Based on the presence of a vent pipe and anecdotal information from a hospital employee, there is likely to be a UST to the south of the maintenance/engineering building (see Figure 2). The UST was understood to have stored diesel associated with former boiler hot water system.</p> <p>The decommissioning details of the UST are unknown and therefore the UST could still contain some form of degraded petroleum. The potential UST is located up-gradient of the site, within the wider hospital property, and is considered to be a potential source of contamination.</p>	TRH, BTEX and naphthalene.

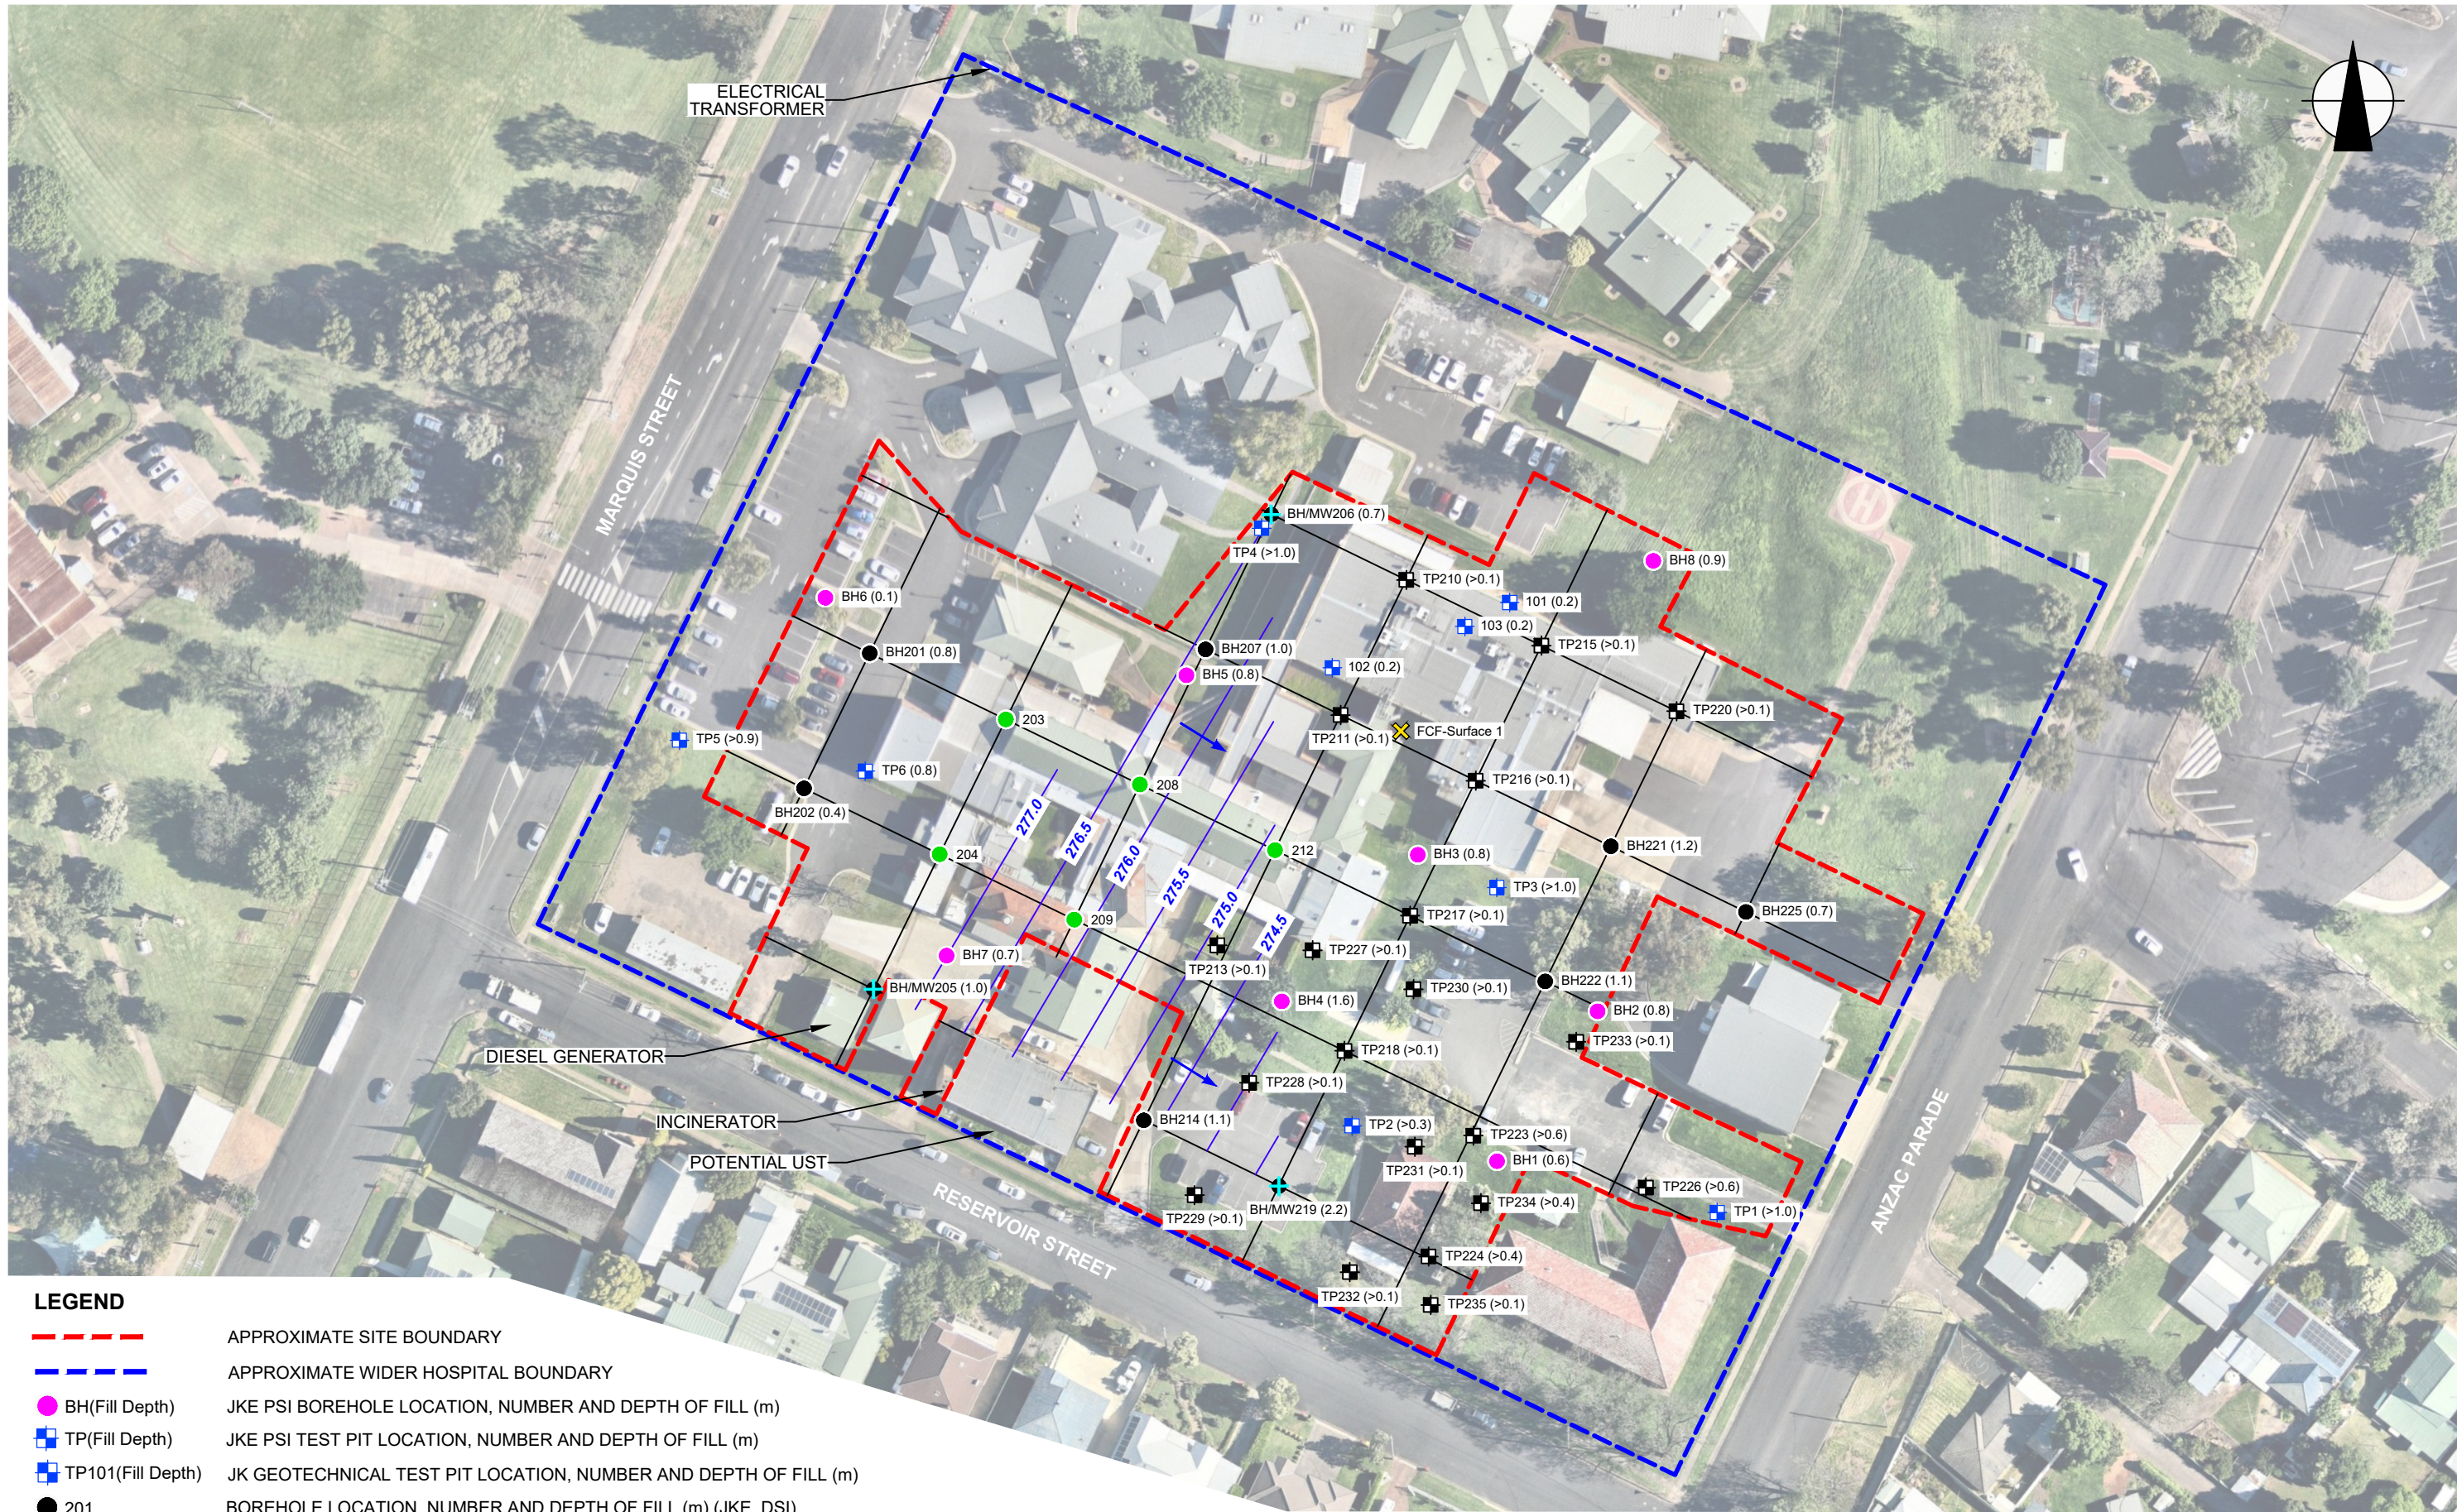
- APPROXIMATE SITE BOUNDARY
 - APPROXIMATE WIDER HOSPITAL BOUNDARY
 - BH(Fill Depth)
 - TP(Fill Depth)
 - TP101(Fill Depth)
 - 201
 - BH/MW205
 - TP210
 - 203
 - ✕ FCF(Surface)
 - 276.5
 -
- JK PSI BOREHOLE LOCATION, NUMBER AND DEPTH OF FILL (m)
- JK PSI TEST PIT LOCATION, NUMBER AND DEPTH OF FILL (m)
- JK GEOTECHNICAL TEST PIT LOCATION, NUMBER AND DEPTH OF FILL (m)
- BOREHOLE LOCATION, NUMBER AND DEPTH OF FILL (m) (JKE, DSI)
- BOREHOLE AND GROUNDWATER MONITORING WELL LOCATION, NUMBER AND DEPTH OF FILL (m) (JKE, DSI)
- TEST PIT LOCATION AND NUMBER AND DEPTH OF FILL (m) (JKE, DSI)
- SAMPLING LOCATION INACCESSIBLE, PROPOSED TO BE COMPLETED POST-DEMOLITION
- FIBRE CEMENT FRAGMENT LOCATION, NUMBER AND DEPTH (Surface/m)
- GROUNDWATER CONTOUR INTERVALS (m)
- INFERRED GROUNDWATER FLOW DIRECTION

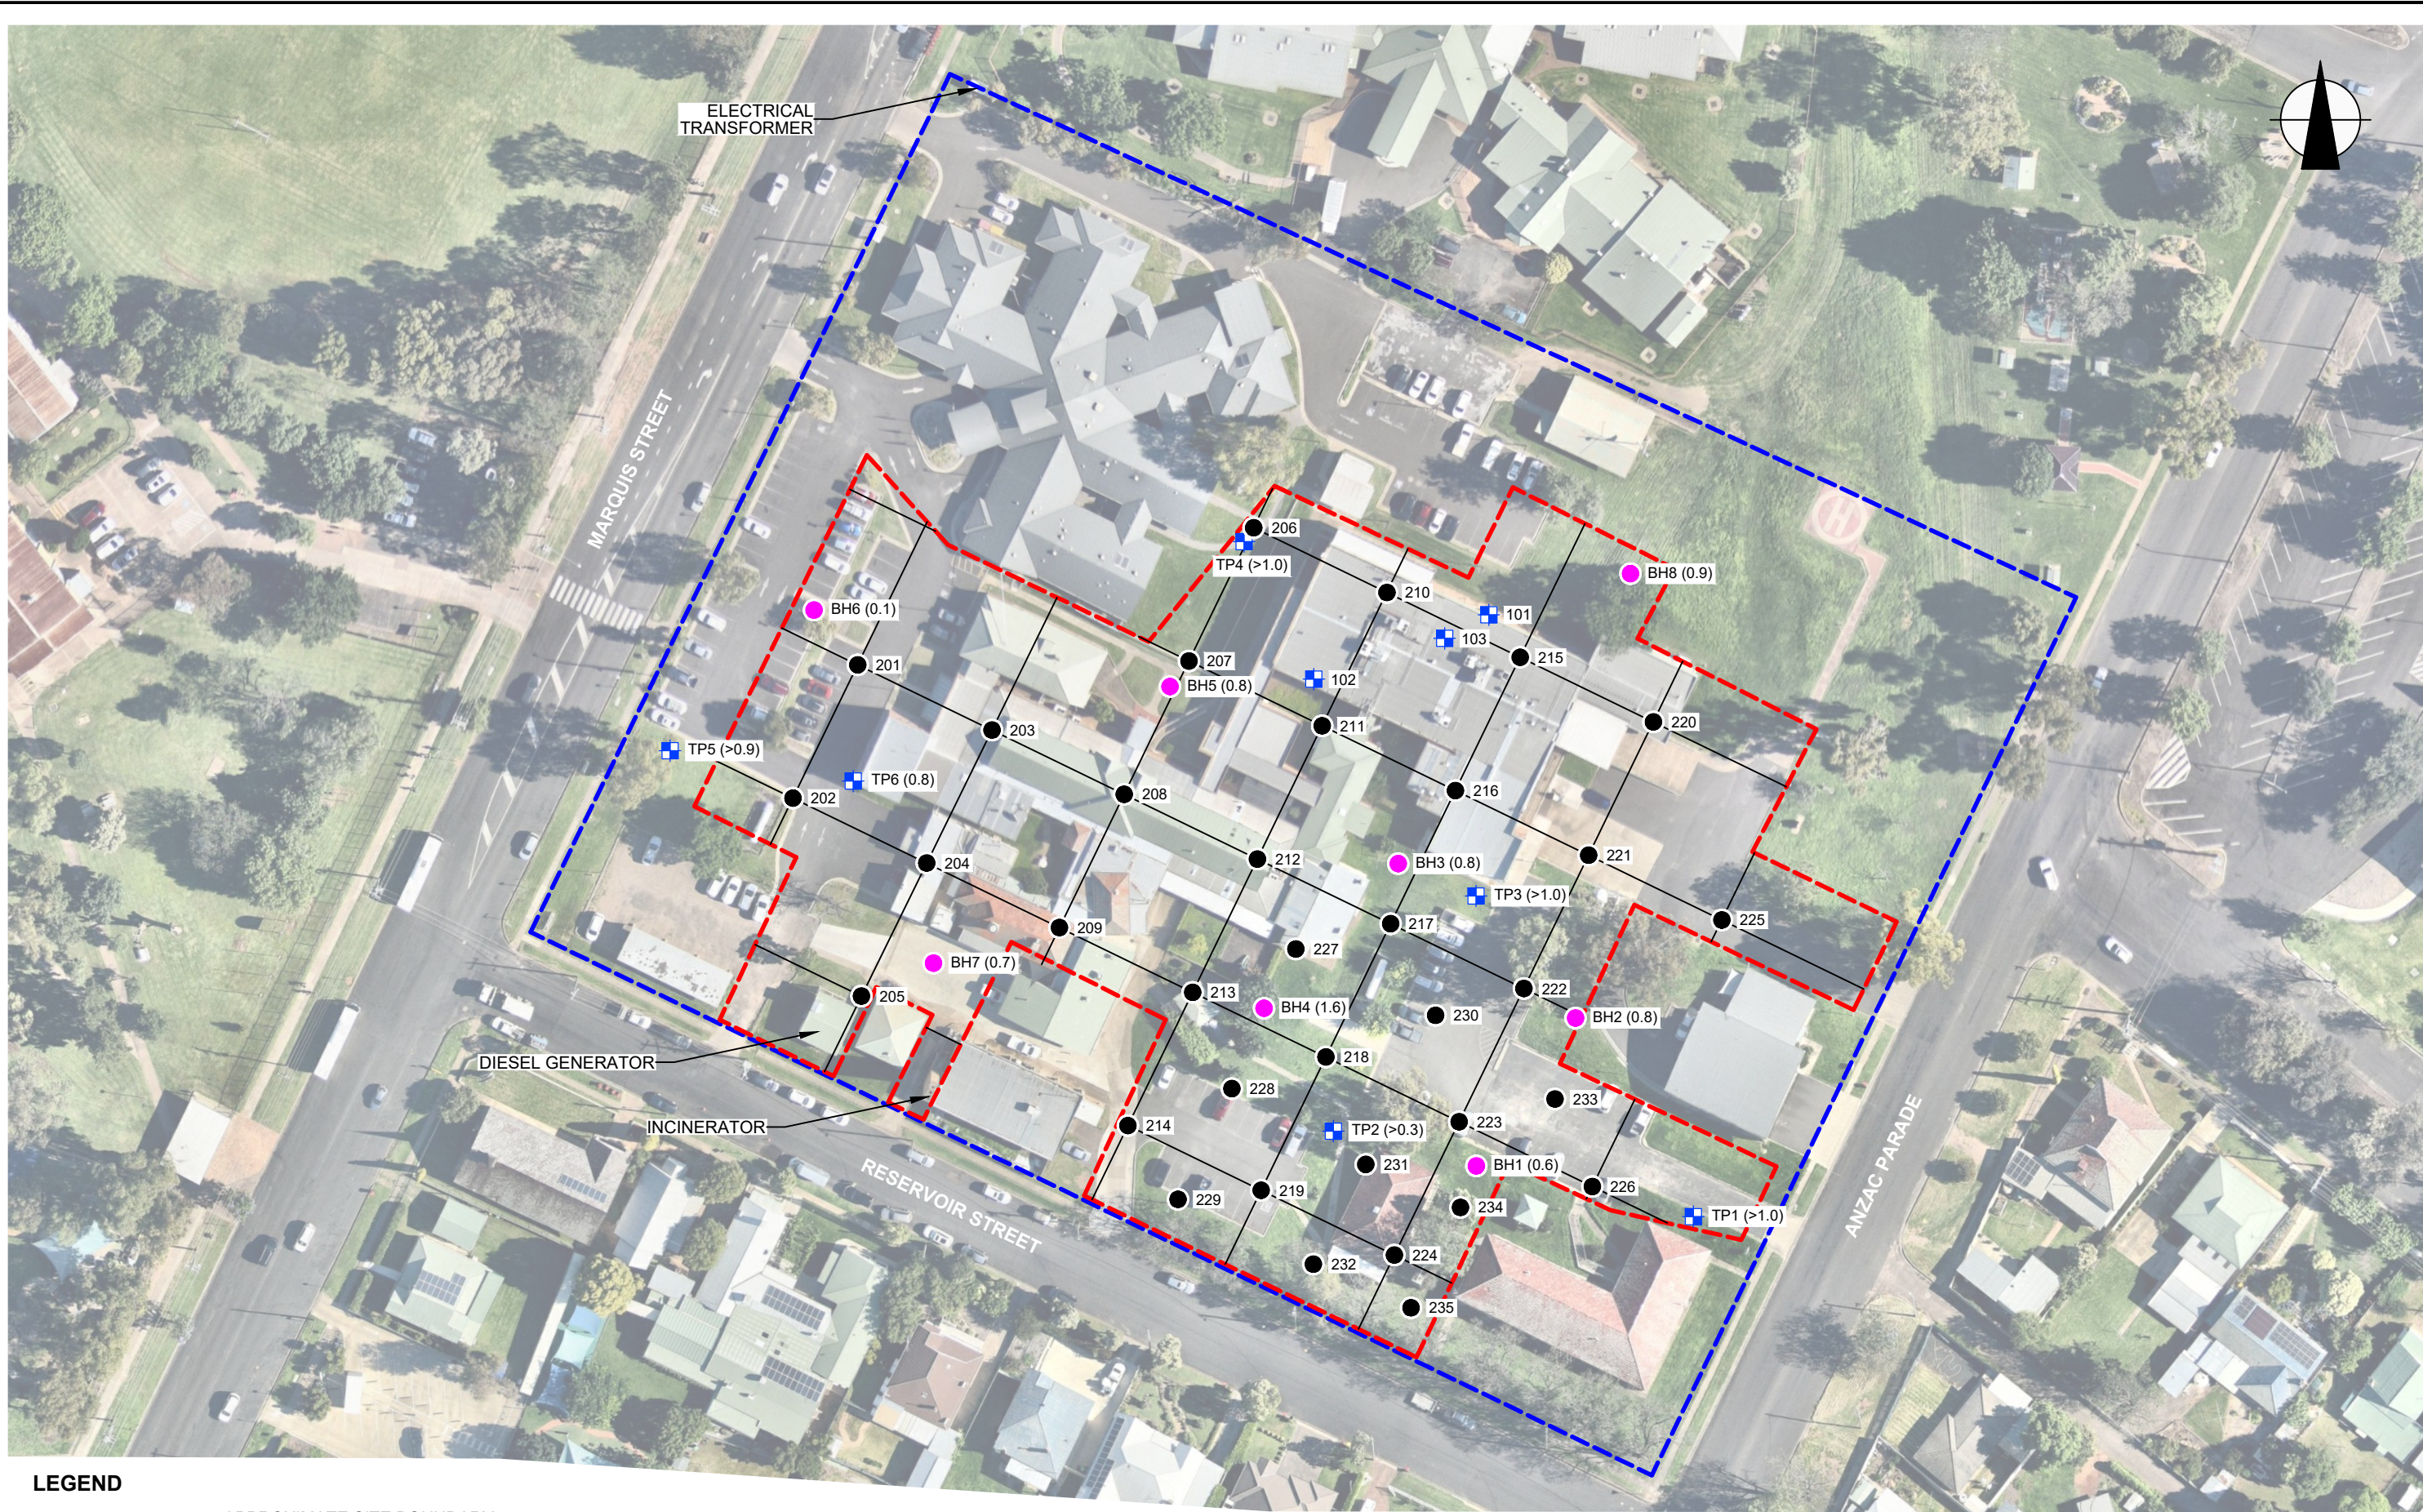
- APPROXIMATE SITE BOUNDARY
- APPROXIMATE WIDER HOSPITAL BOUNDARY
- BH(Fill Depth)
- TP(Fill Depth)
- TP101
- 201
- JKE PSI BOREHOLE LOCATION, NUMBER AND DEPTH OF FILL (m)
- JKE PSI TEST PIT LOCATION, NUMBER AND DEPTH OF FILL (m)
- JK GEOTECHNICAL TEST PIT LOCATION AND NUMBER AND
- PROPOSED DSI SAMPLING LOCATION NUMBER
