## **ABORIGINAL DUE DILIGENCE ASSESSMENT REPORT**

### **GUNNEDAH HOSPITAL UPGRADE**

GUNNEDAH, NSW

JUNE 2023

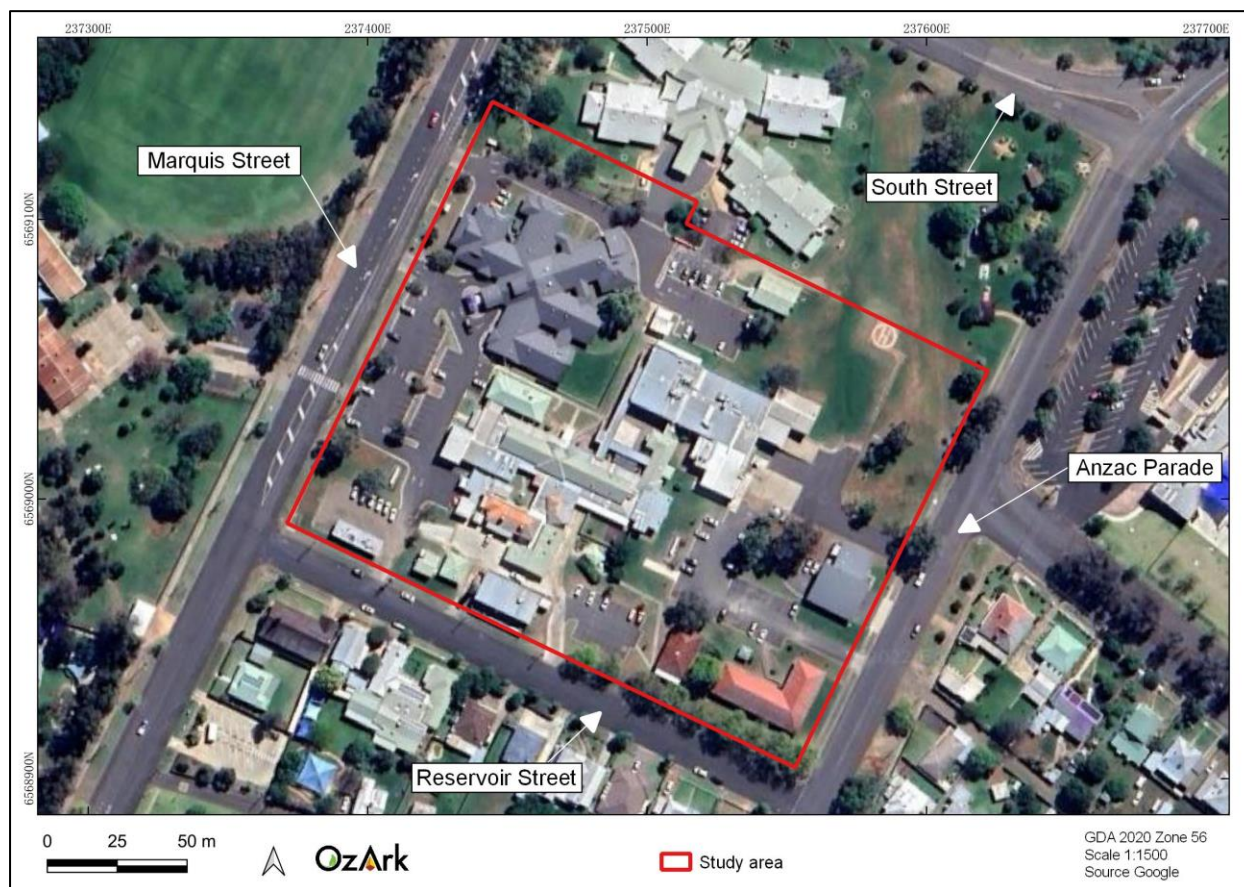
**Figure 1-2: Aerial showing the study area.**

The study area for the assessment is the existing Gunnedah Hospital site, located at Lot 3 DP 792209. The main entrance is on Marquis Street, but the study area also fronts Anzac Parade and Reservoir Street. The study area is shown on **Figure 1-2**.

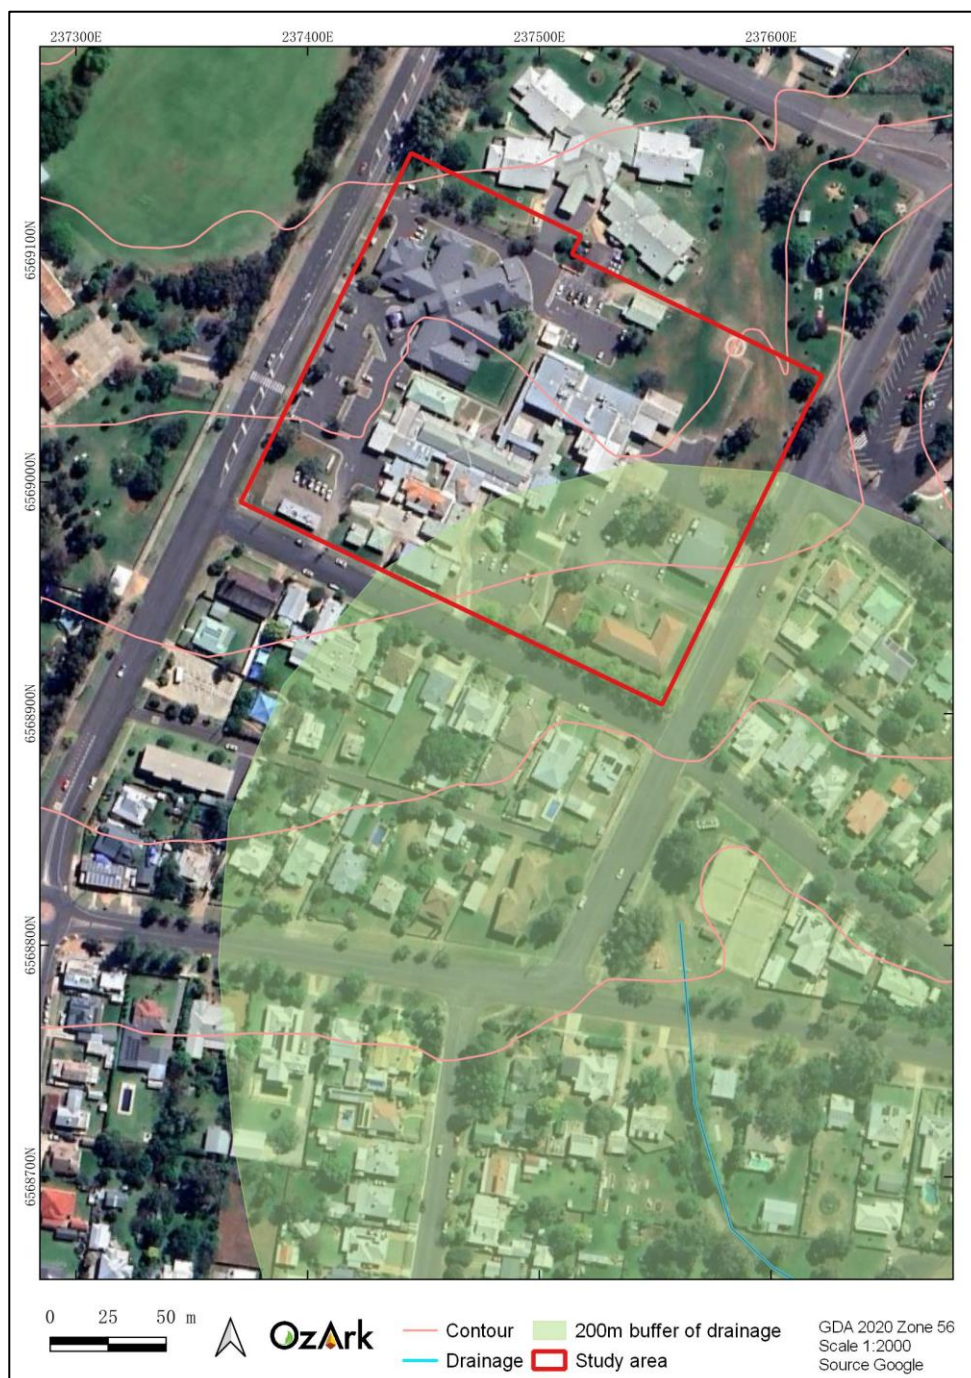
**Figure 2-2: Contours and waterways at the study area.**

The closest waterway to the study area is an unnamed drainage line, located approximately 100 m south of the study area (**Figure 2-2**). This unnamed drainage line has been substantially modified along its length near the Gunnedah Hospital however it was likely a former tributary of the Namoi River. As part of the study area is located within 200 m of ‘waters’, it is considered to have increased potential to contain Aboriginal objects under the Due Diligence Code of Practice. However, this does not include landforms that have been disturbed. As outlined in **Section 2.2.2**, the entire study area includes ‘disturbed land’, and visual inspection is not required.

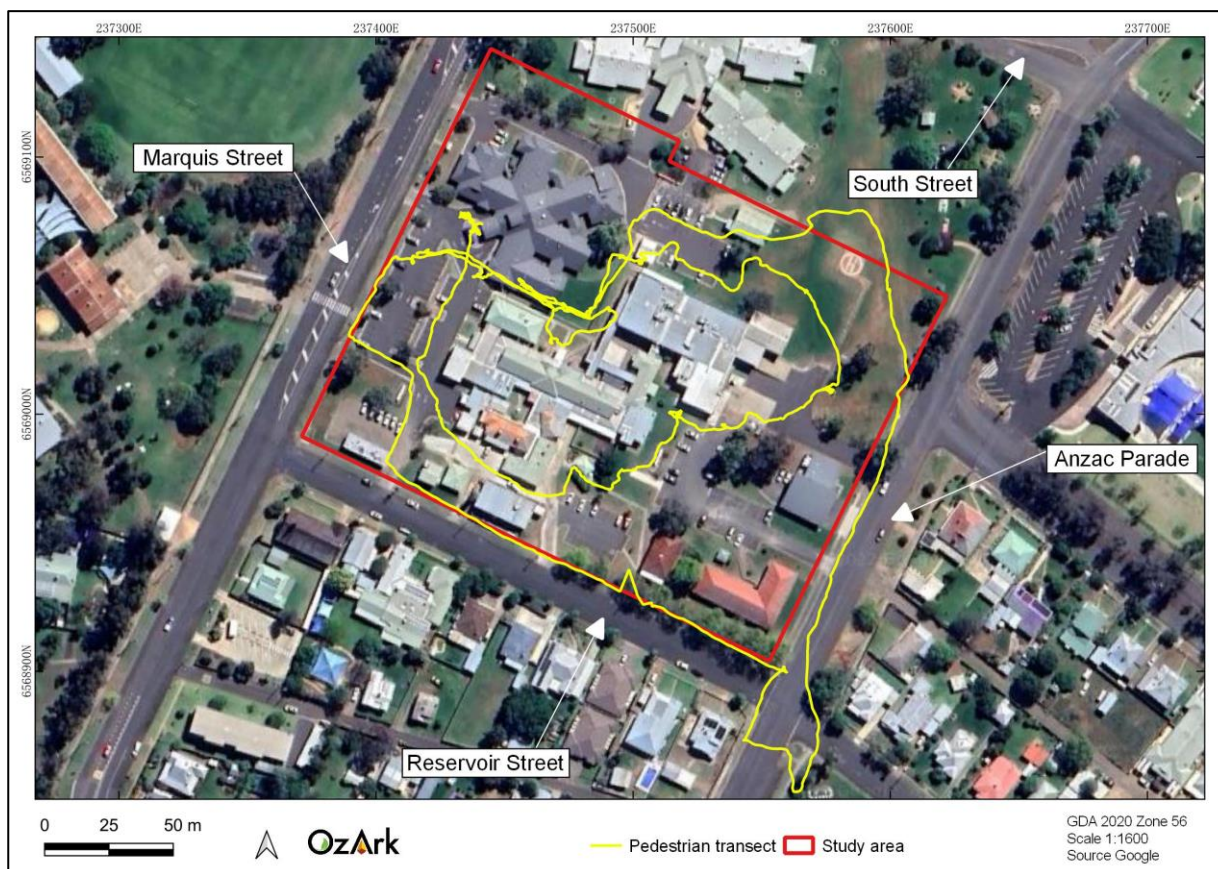
Figure 2-3: Survey coverage within the study area.

The visual inspection of the study area was undertaken on 25 July 2022 by OzArk Archaeologist, Harrison Rochford. The pedestrian coverage of the inspection team is shown on **Figure 2-3**.

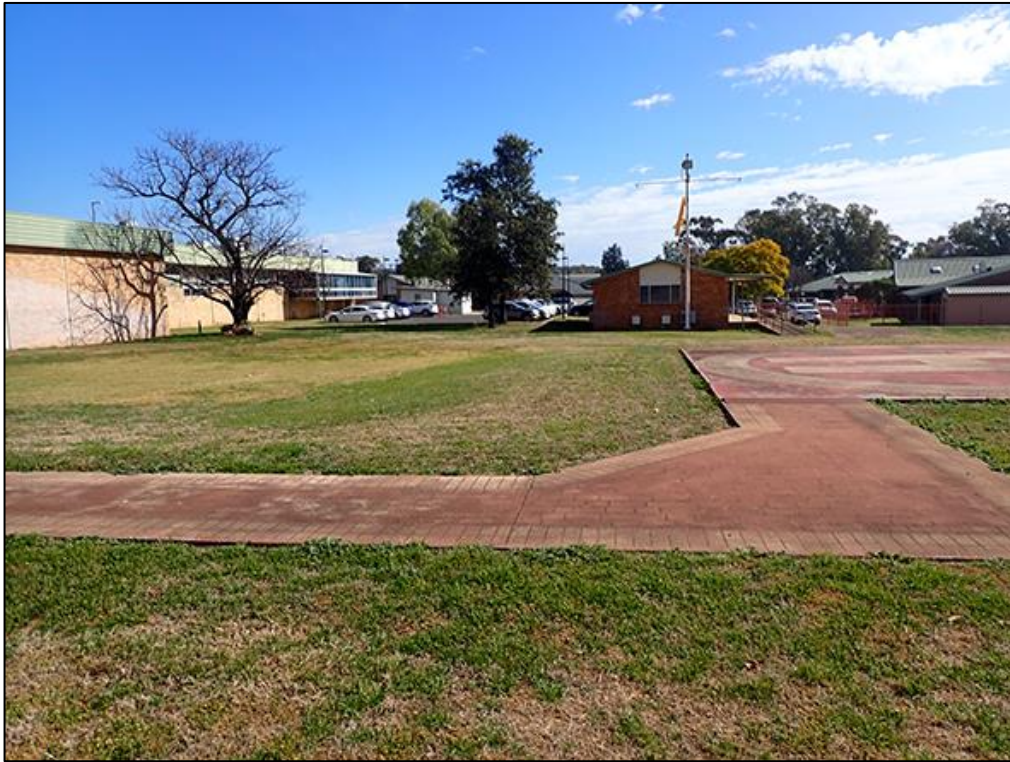
The levels of disturbance from the development of the hospital were confirmed and the potential for archaeological evidence to remain at the site was assessed as low (**Plate 1** and **Plate 2**).

Plate 1: View southwest to the existing Gunnedah Hospital infrastructure.

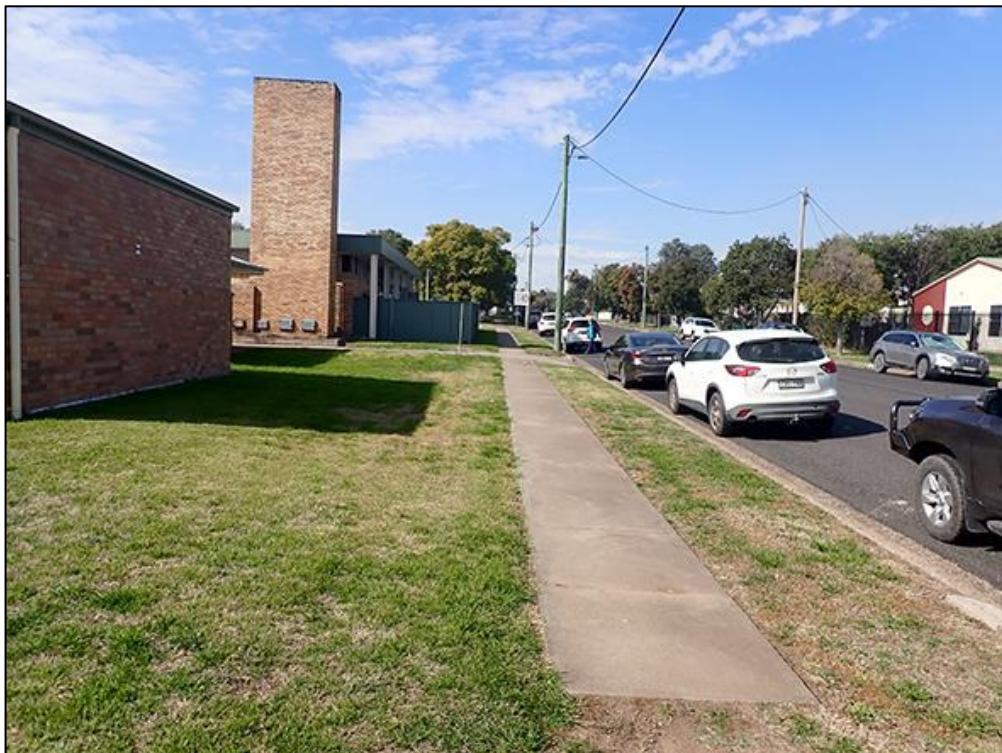
Plate 2: View east along the southern boundary of the study area on Reservoir Street.
