REPORT TO
NSW HEALTH INFRASTRUCTURE

ON
REMEDIATION ACTION PLAN

FOR
PROPOSED GUNNEDAH HOSPITAL
REDEVELOPMENT

Date: 19 May 2023
Ref: E35091UPDrpt3-RAP

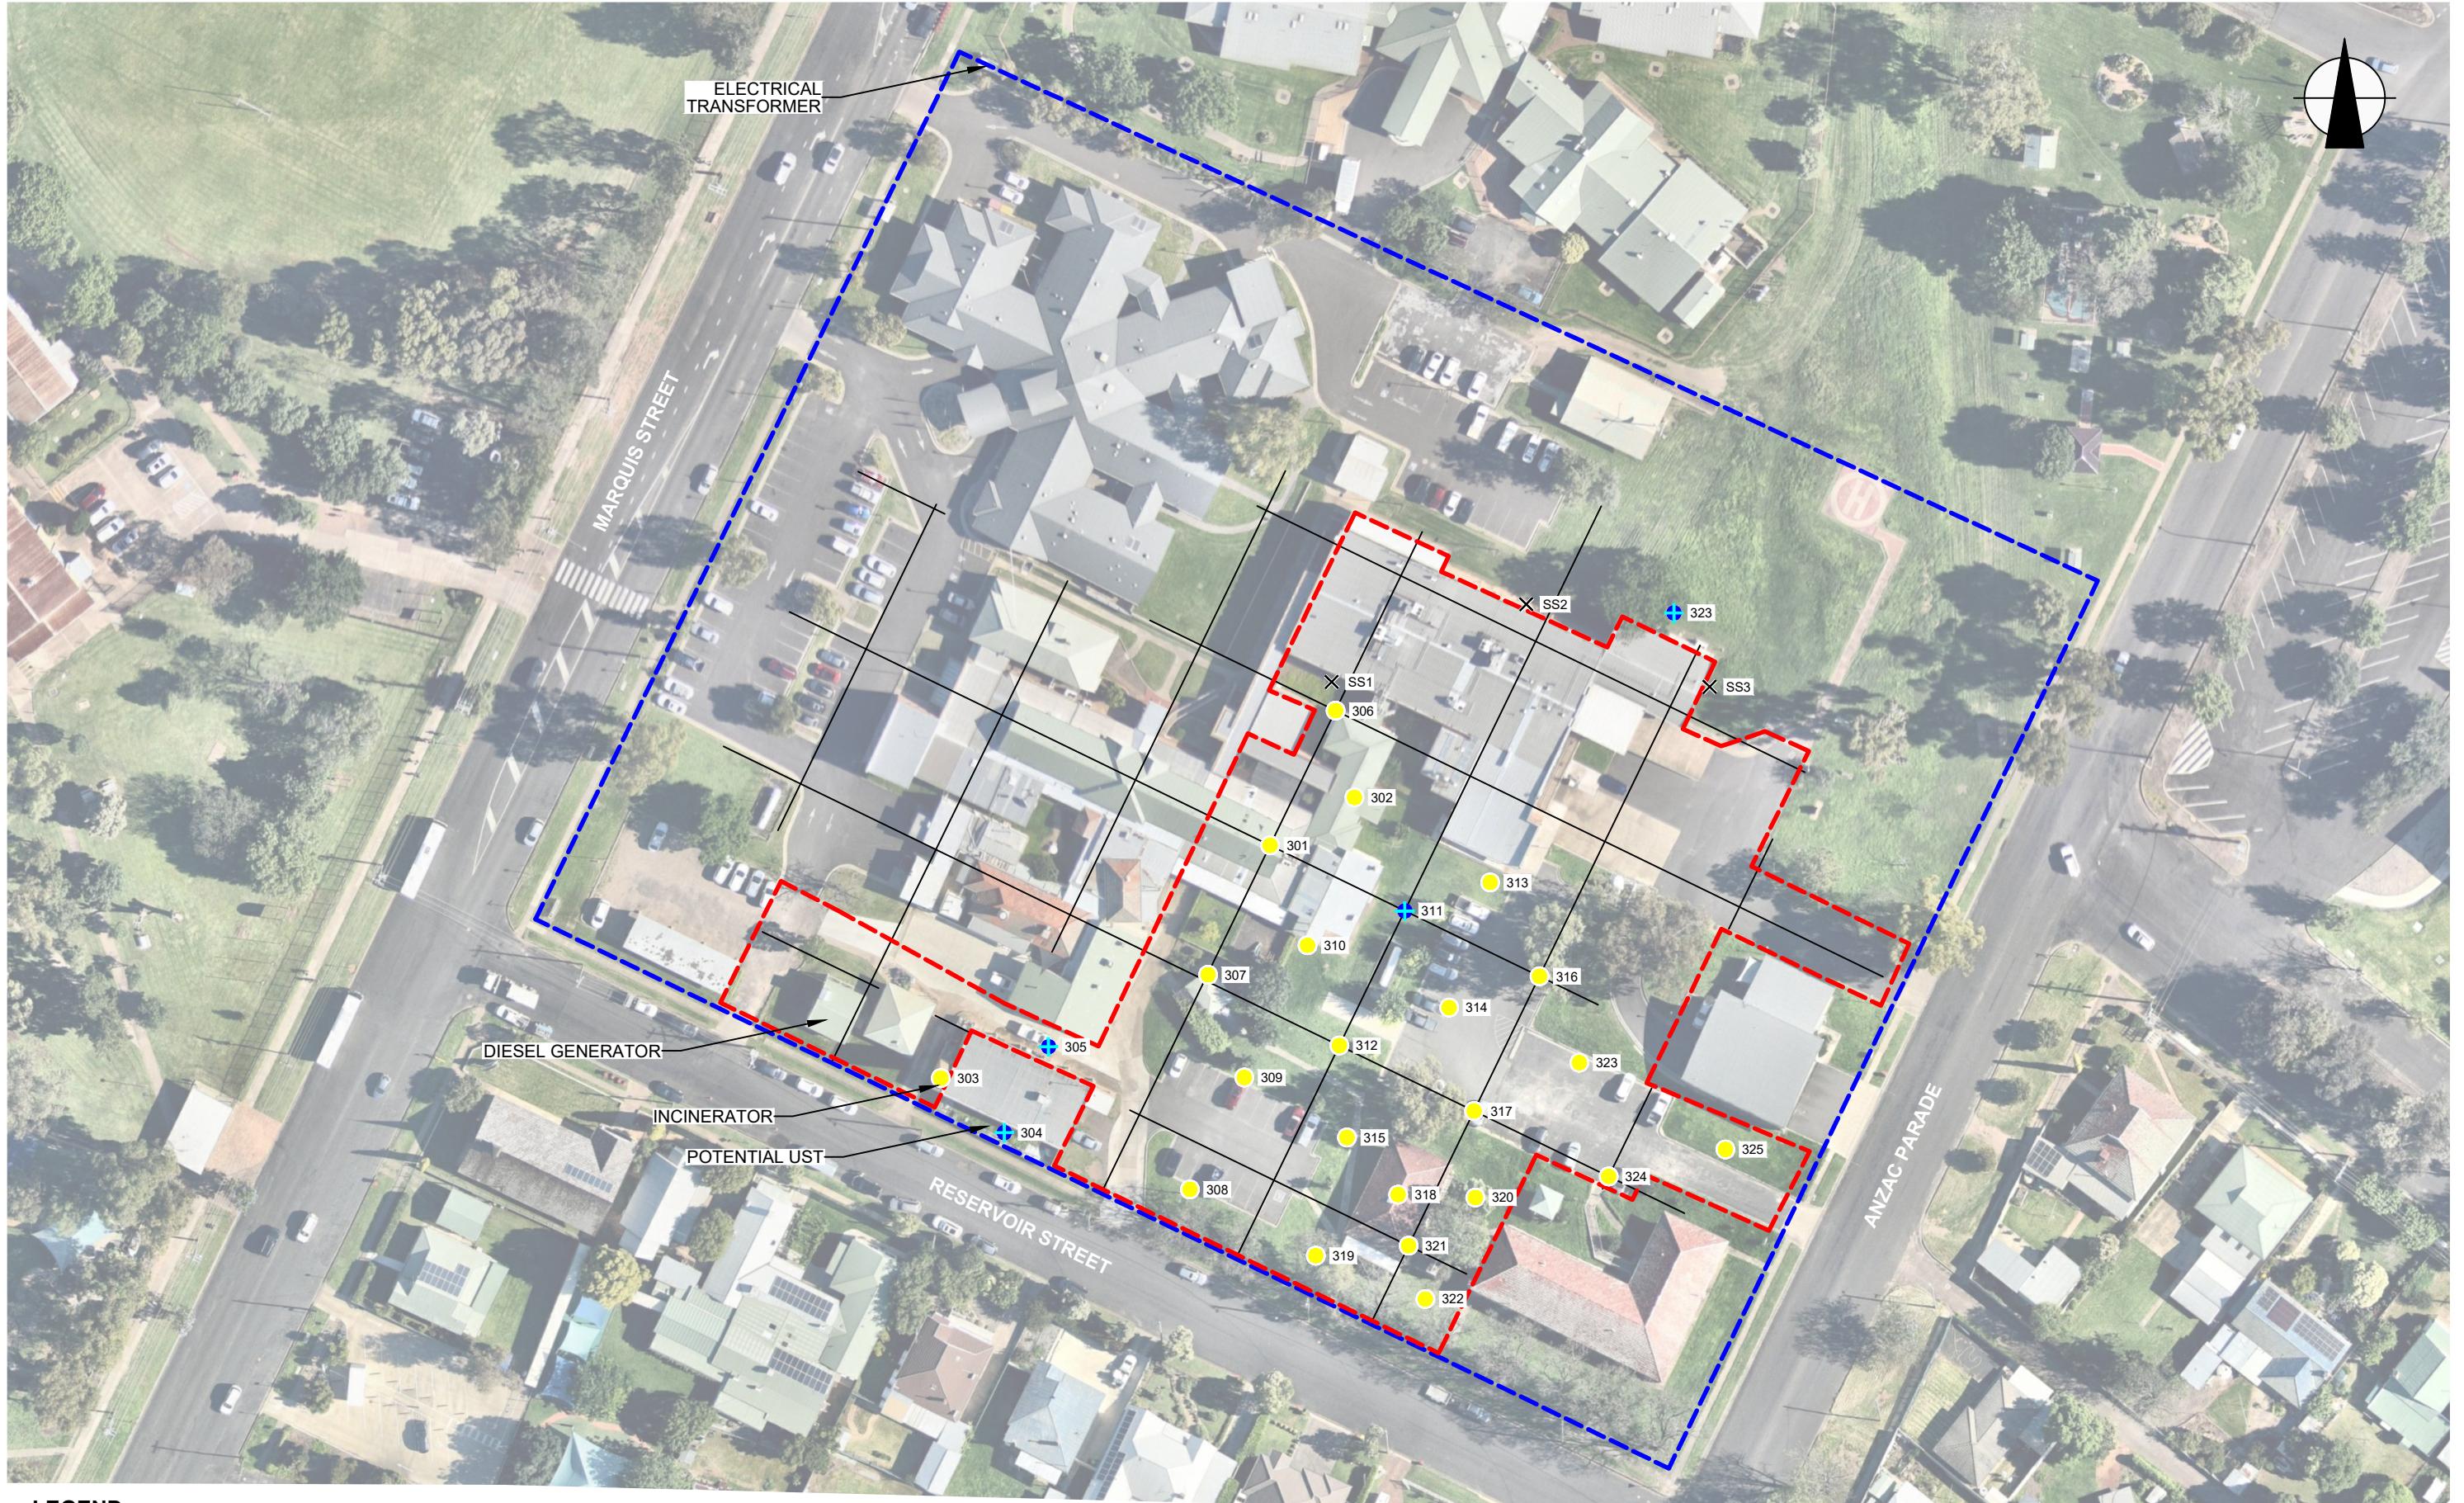
- APPROXIMATE SITE BOUNDARY
- APPROXIMATE WIDER HOSPITAL BOUNDARY
- PROPOSED SOIL SAMPLING LOCATION
- + PROPOSED SOIL SAMPLING AND GROUNDWATER MONITORING WELL LOCATION
- X PROPOSED SURFACE SOIL SAMPLING LOCATION
SS1

Prior to the commencement of remediation, and following establishment of a contractor works area and demolition of the required buildings, an investigation is to occur to further characterise the soil and groundwater conditions and facilitate a more comprehensive and complete assessment of the risks driving the remediation. The additional pre-remediation investigation requirements are outlined in Section 5 and an amended/updated RAP is to be prepared where necessary following this investigation.

Prior to the commencement of remediation, and following establishment of a contractor works area and demolition of the required buildings, an investigation is to occur to further characterise the soil and groundwater conditions and facilitate a more comprehensive and complete assessment of the risks driving the remediation.

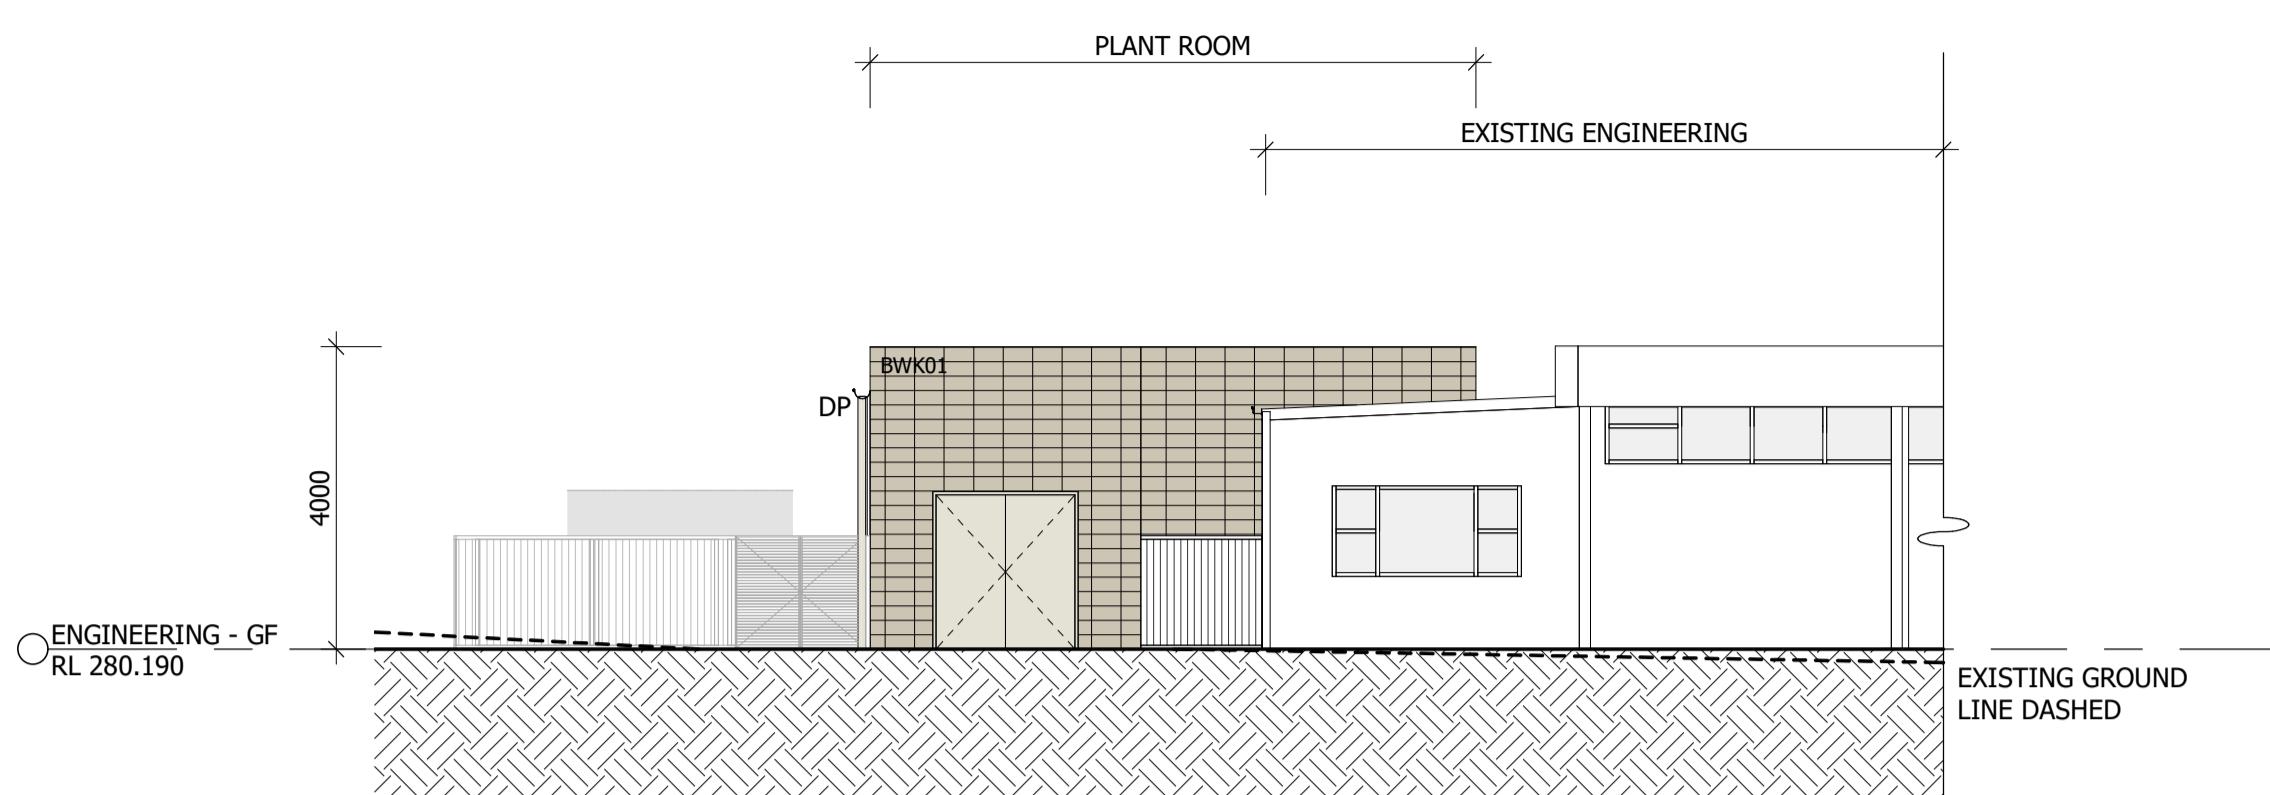
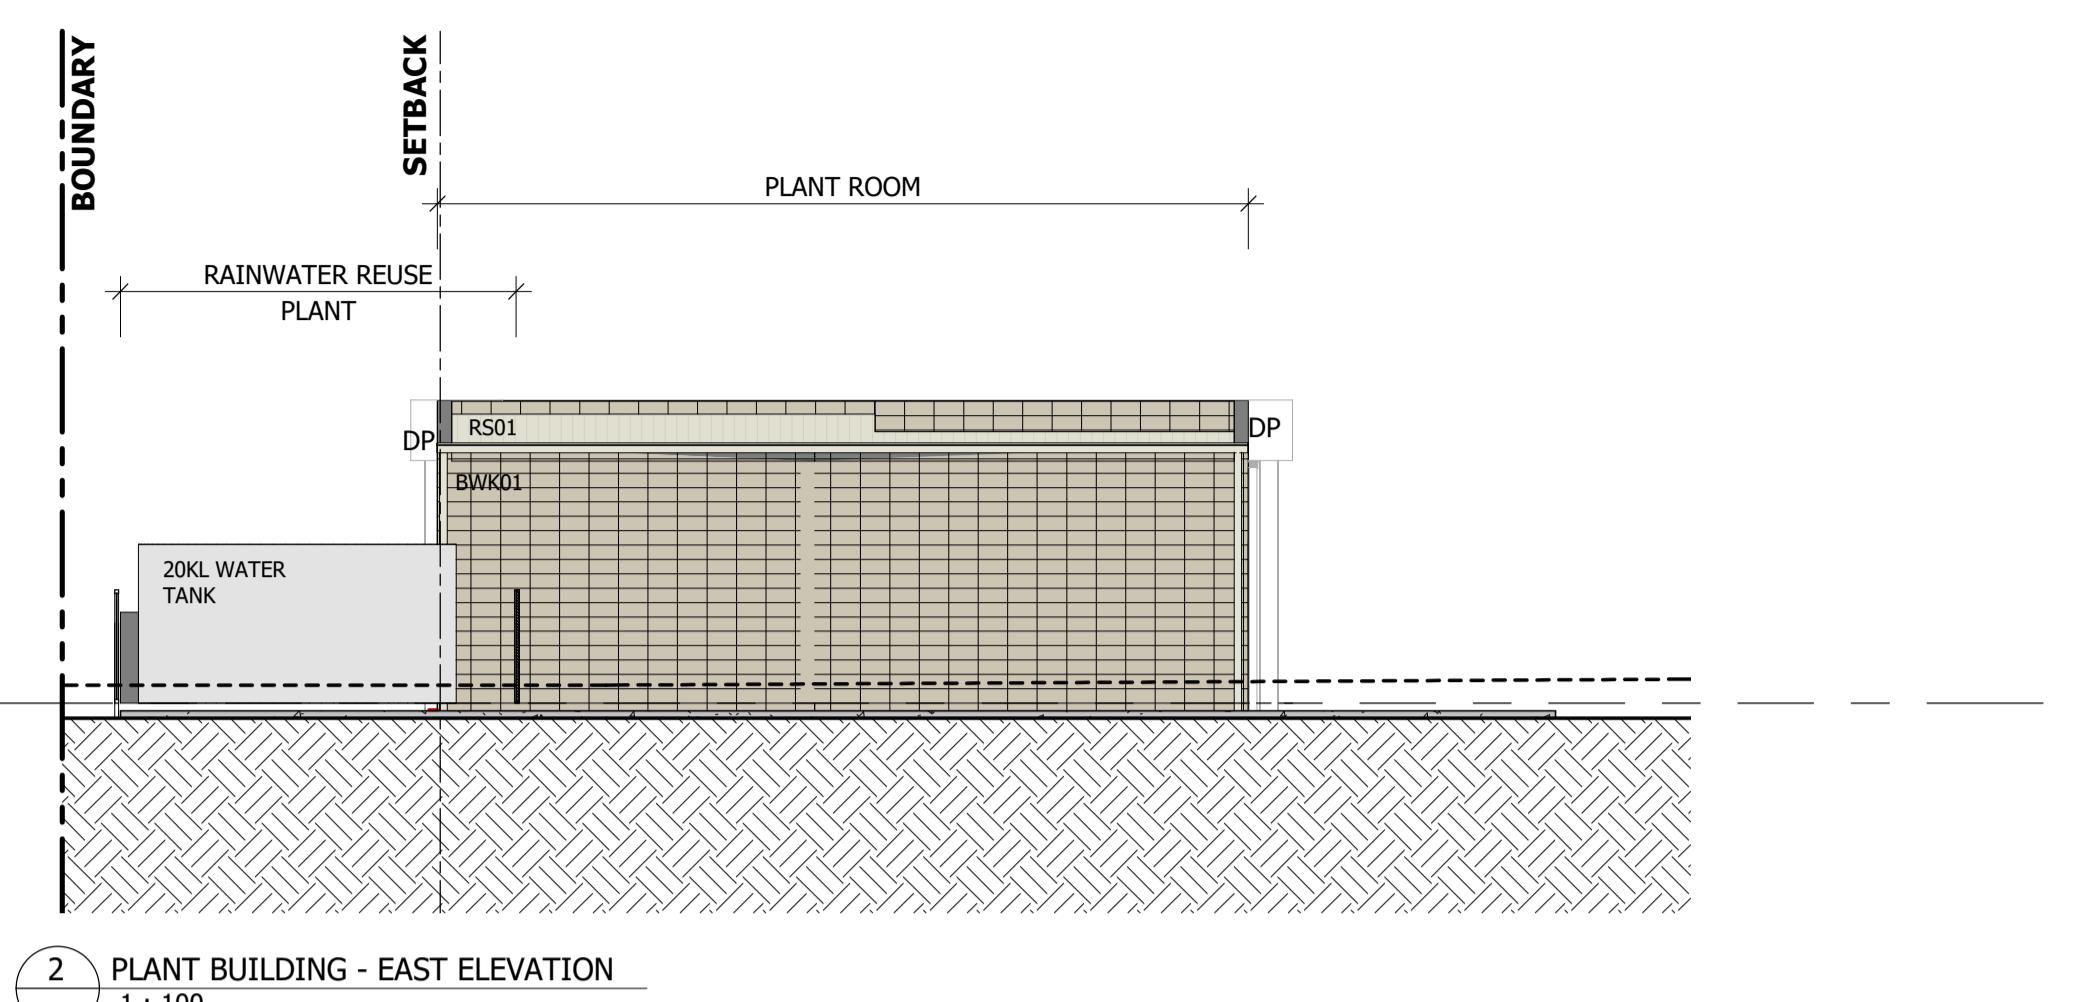
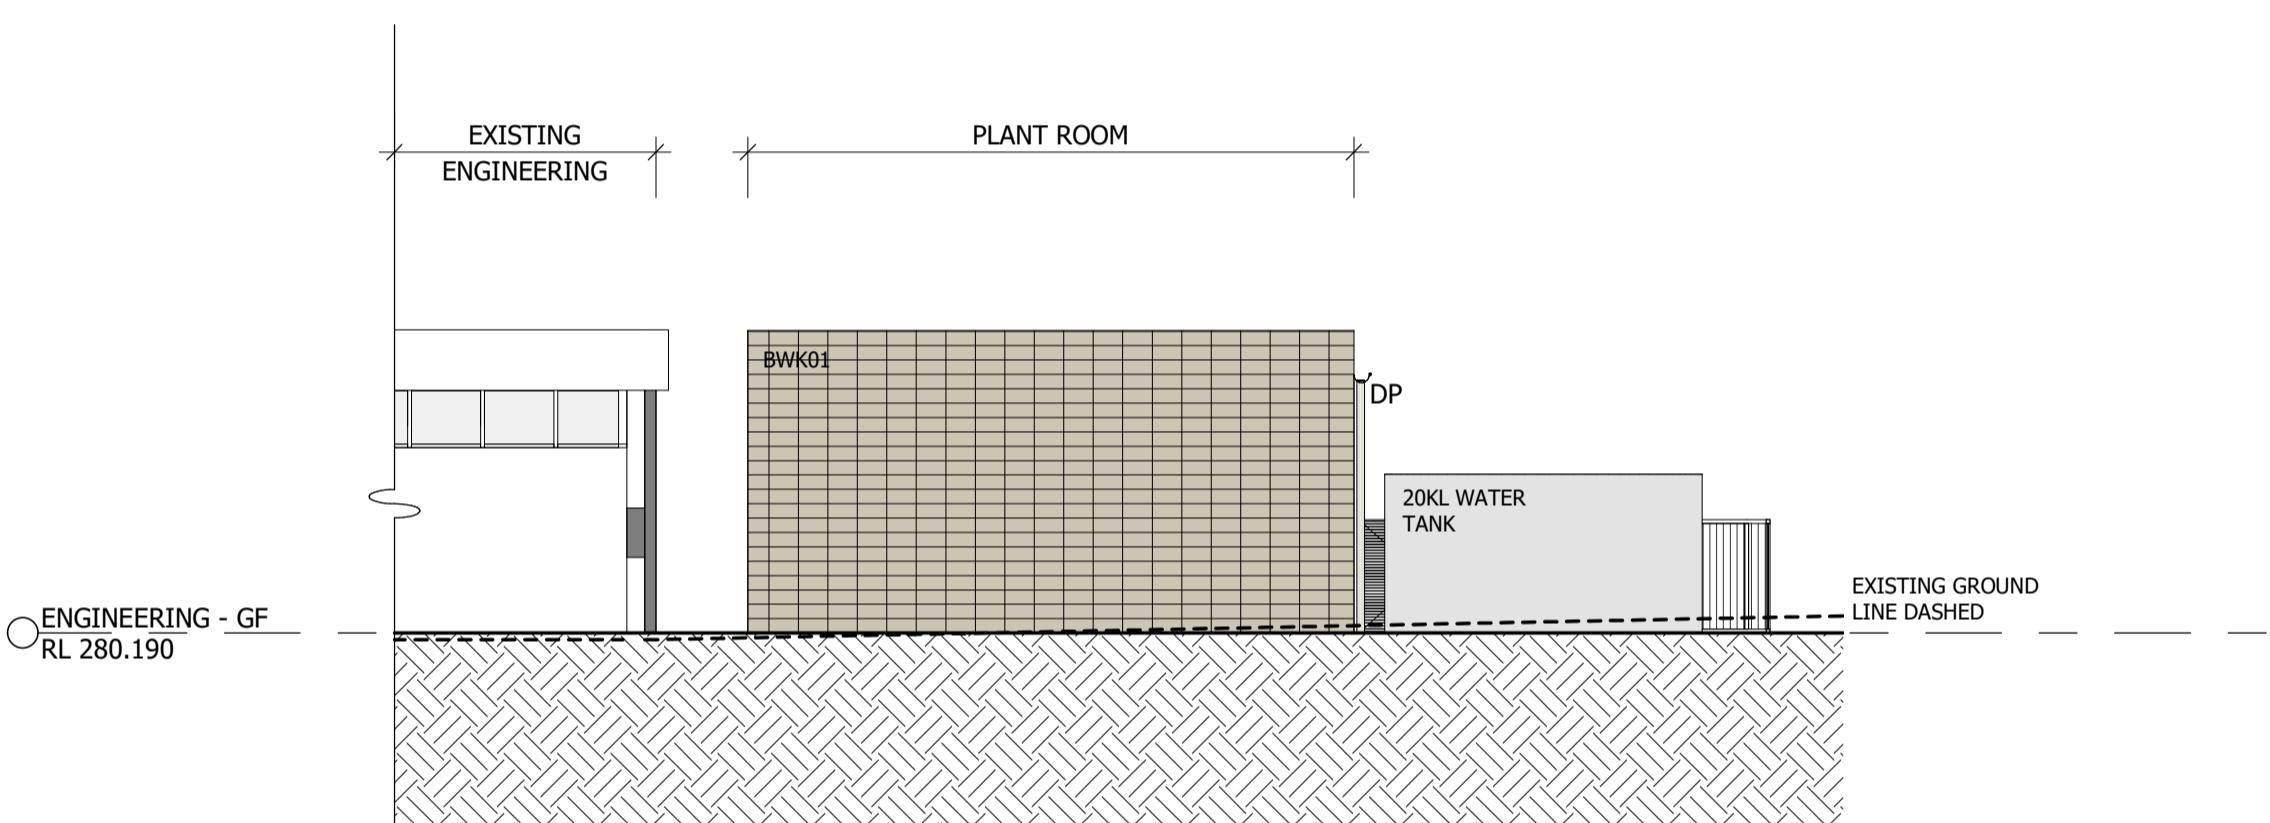
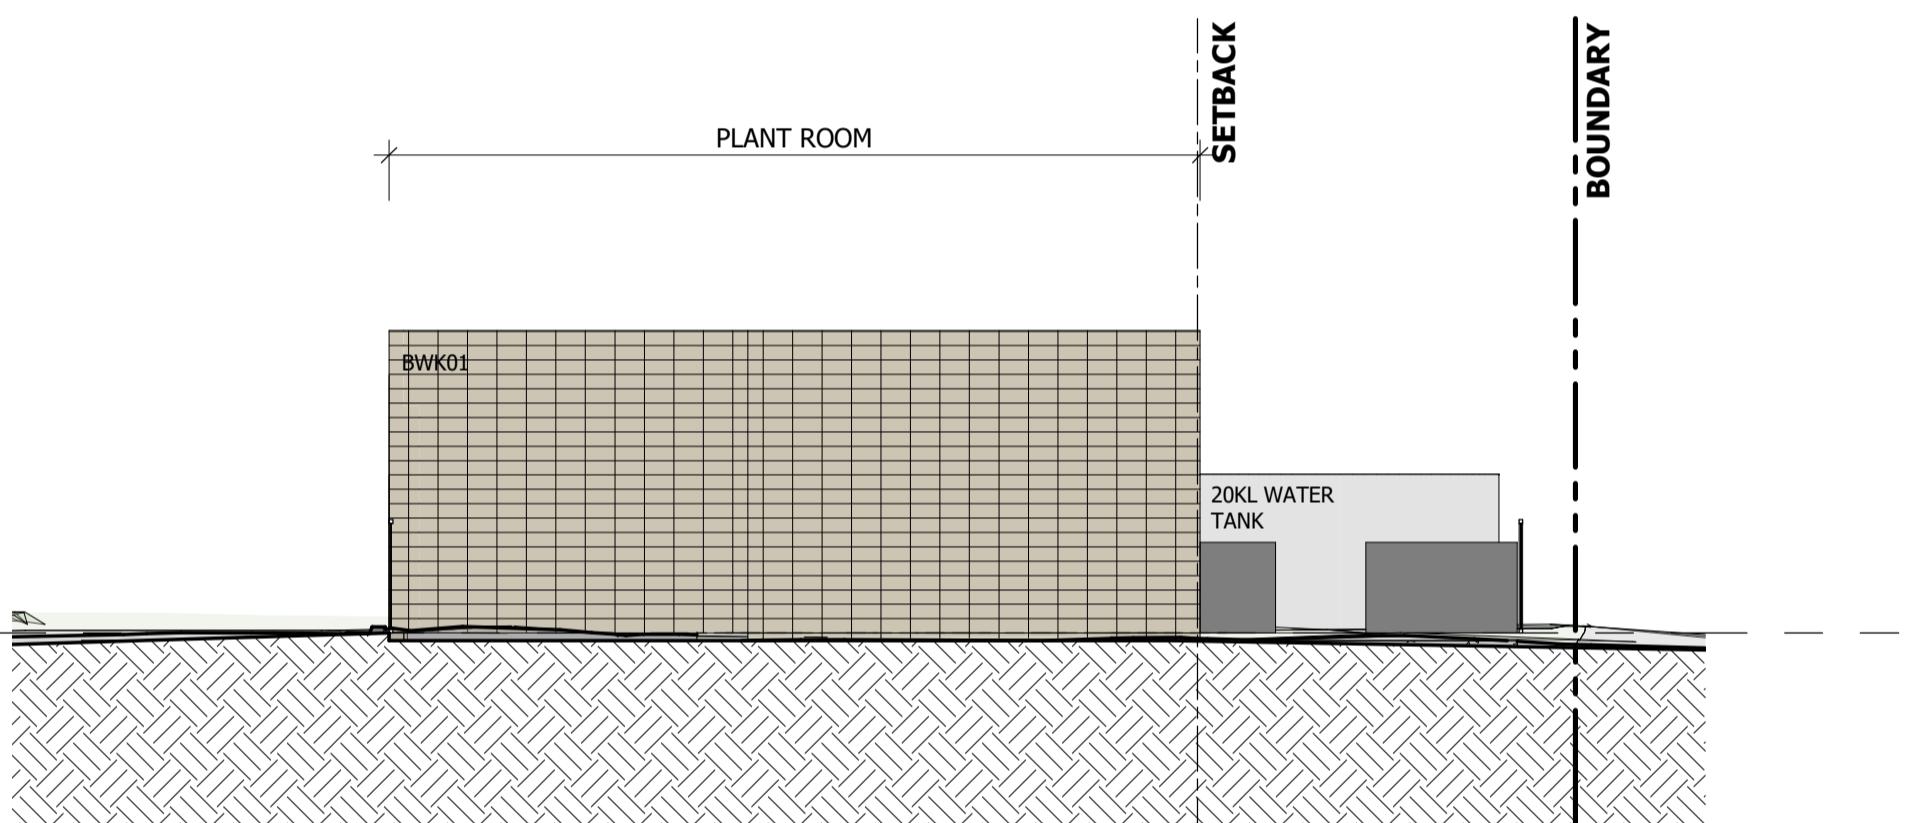
1 PLANT BUILDING - NORTH ELEVATION
1 : 100

2 PLANT BUILDING - EAST ELEVATION
1 : 100

3 PLANT BUILDING - SOUTH ELEVATION
1 : 100

4 PLANT BUILDING - WEST ELEVATION
1 : 100

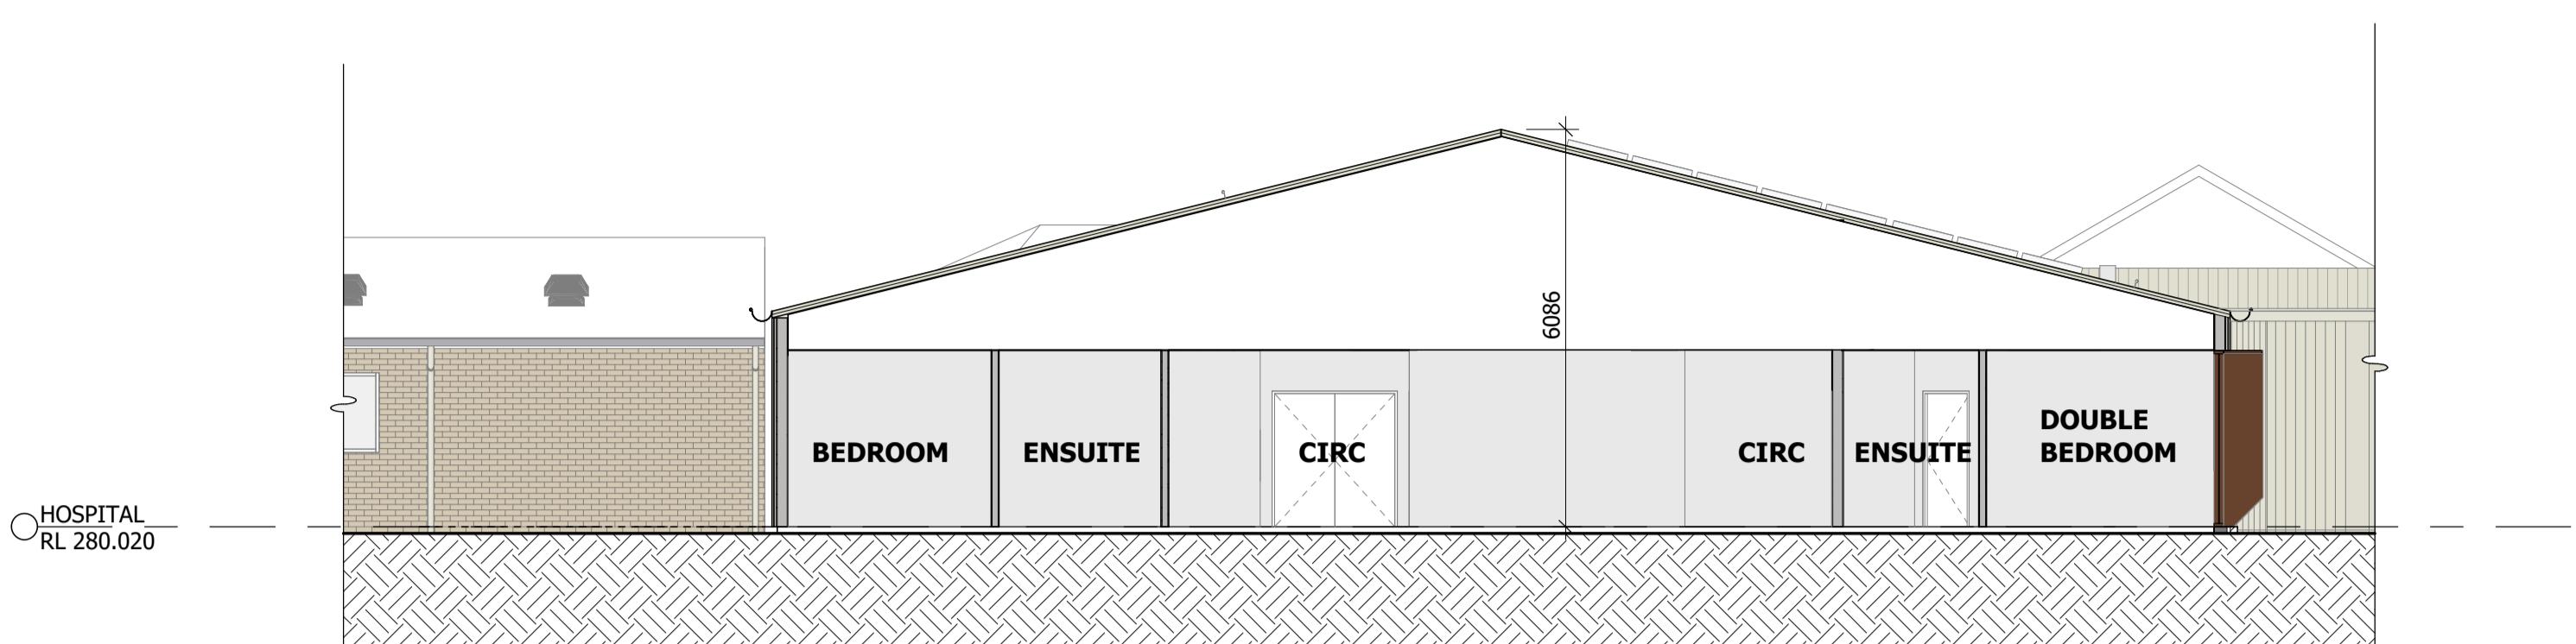
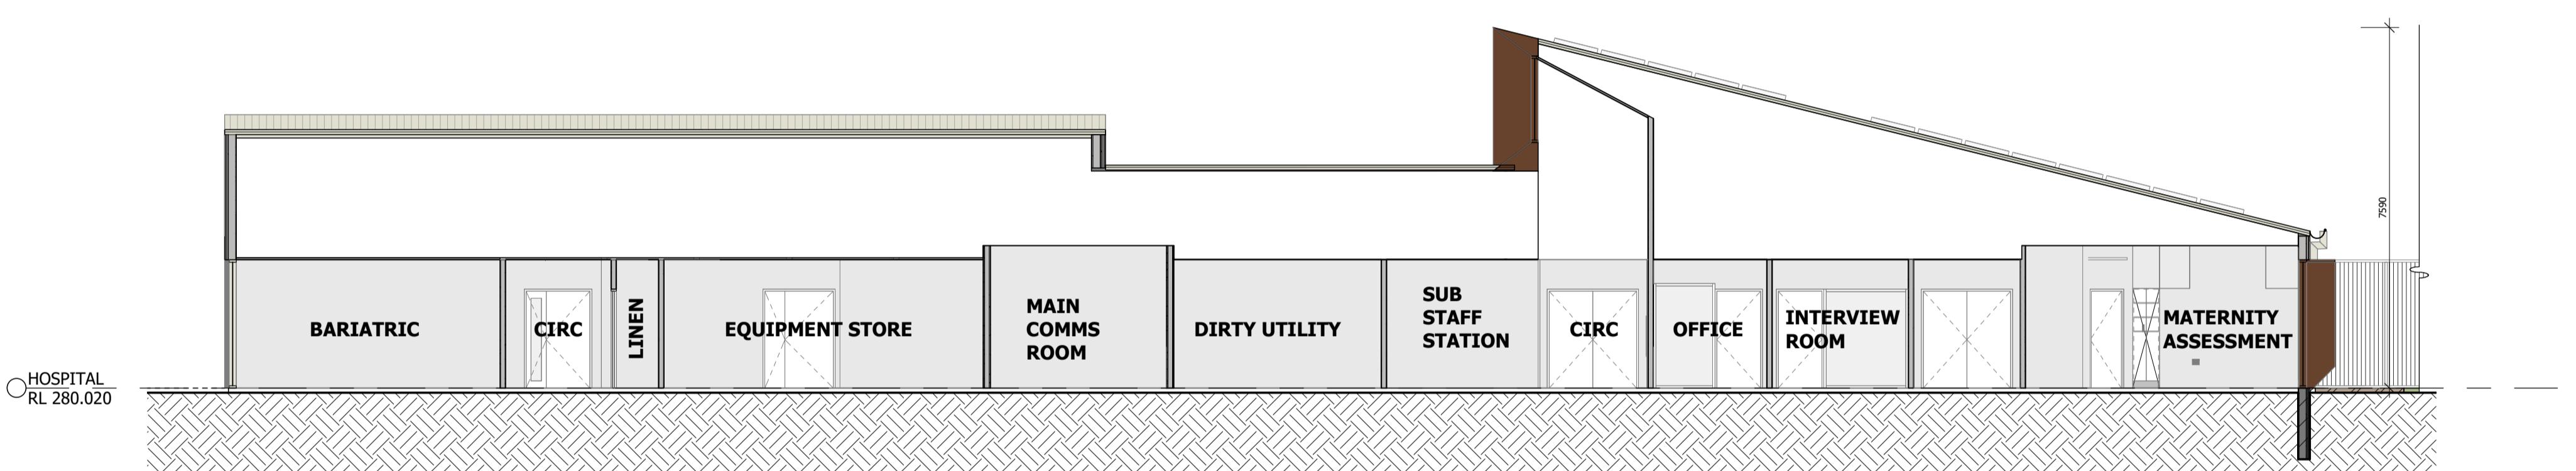
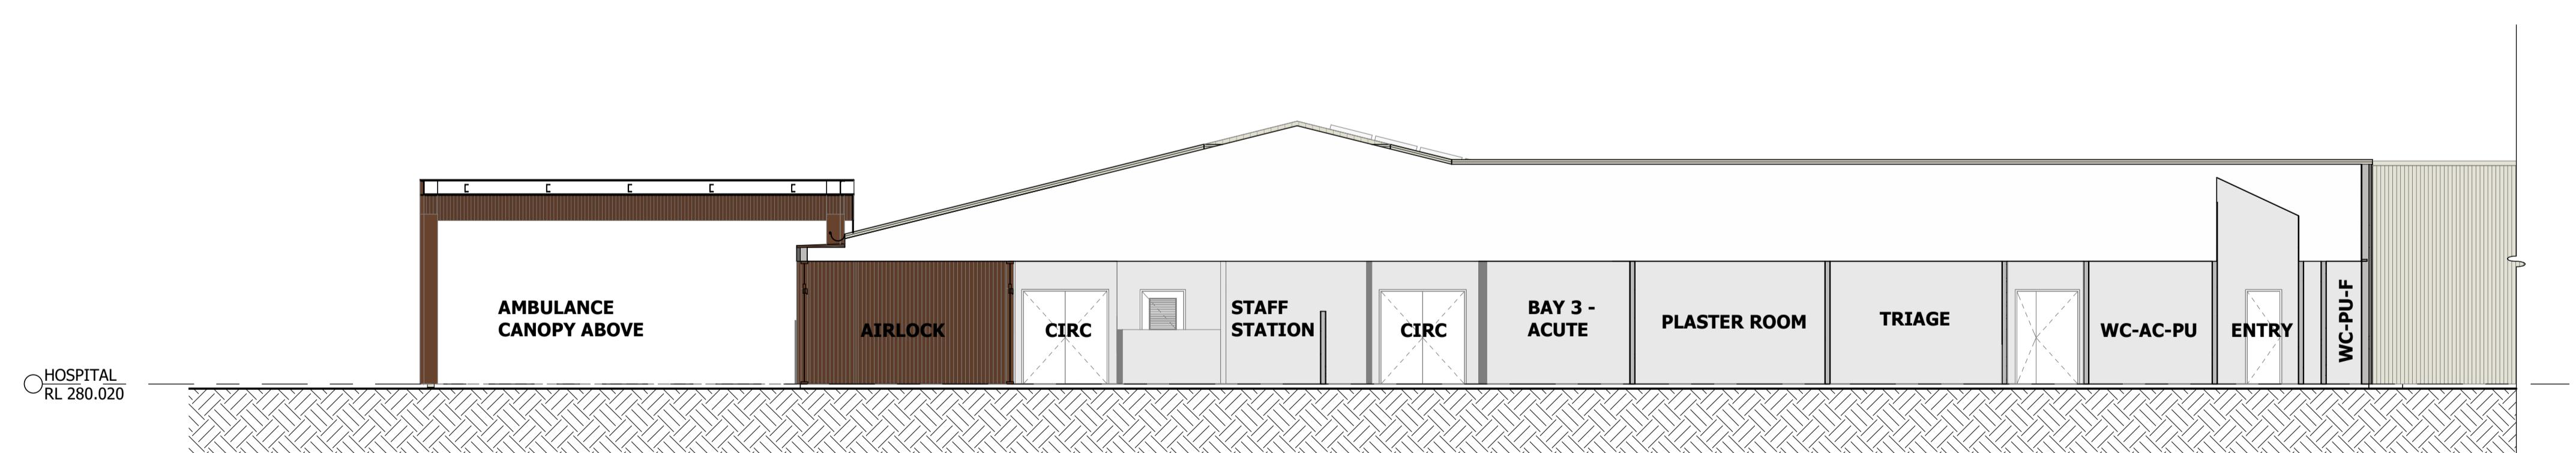
1 INPATIENT UNIT
1 : 100

2 INPATIENT UNIT - HIGHLIGHT WINDOW OVER SUB STAFF STATION
1 : 100

3 AMBULANCE ENTRY & EMERGENCY
1 : 100

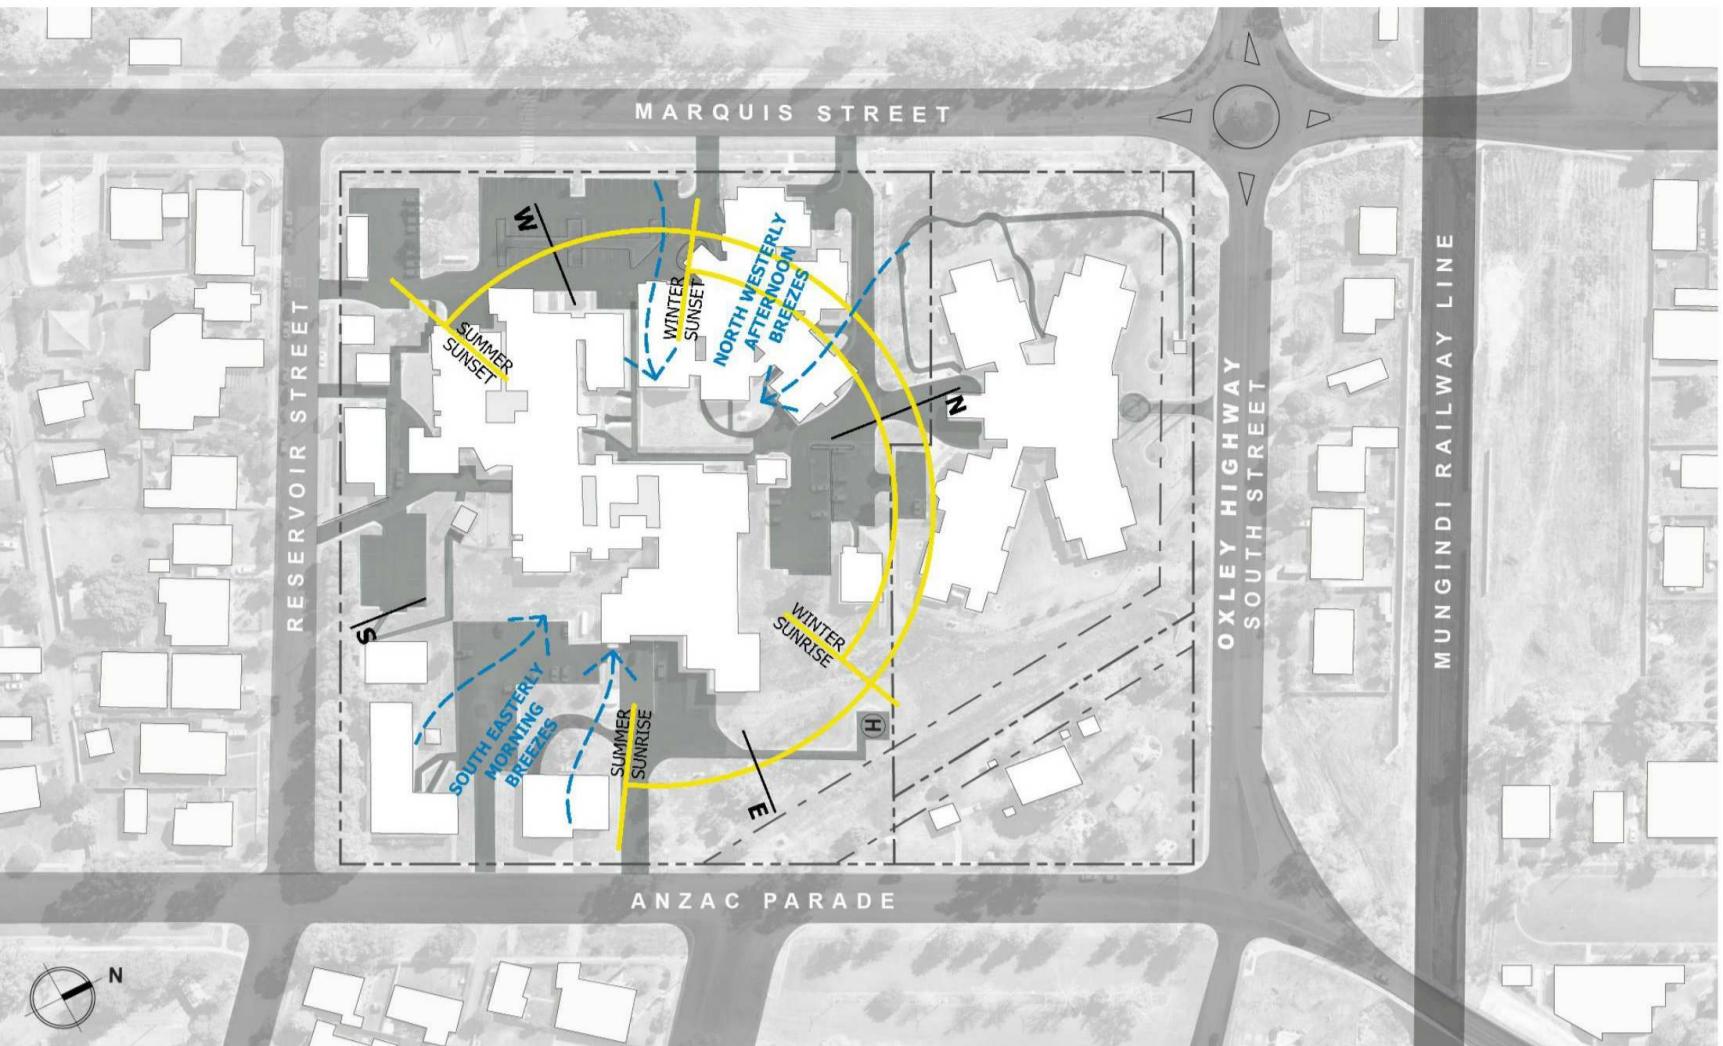
SITE ANALYSIS

Climate:
 Gunnedah is located between the tropical and temperate climate zones.

- Pedestrian access to the site
- Public building access points
- Public circulation
- 1 Rural Health Centre entry
- 2 Community Health entry
- 3 Former Main Hospital entry
- 4 Current Main Hospital and Covid Screening entry
- 5 Emergency & Imaging entry
- 6 Education Centre entry
- 7 Alkira Nursing Home entry
- 8 Clinic entry

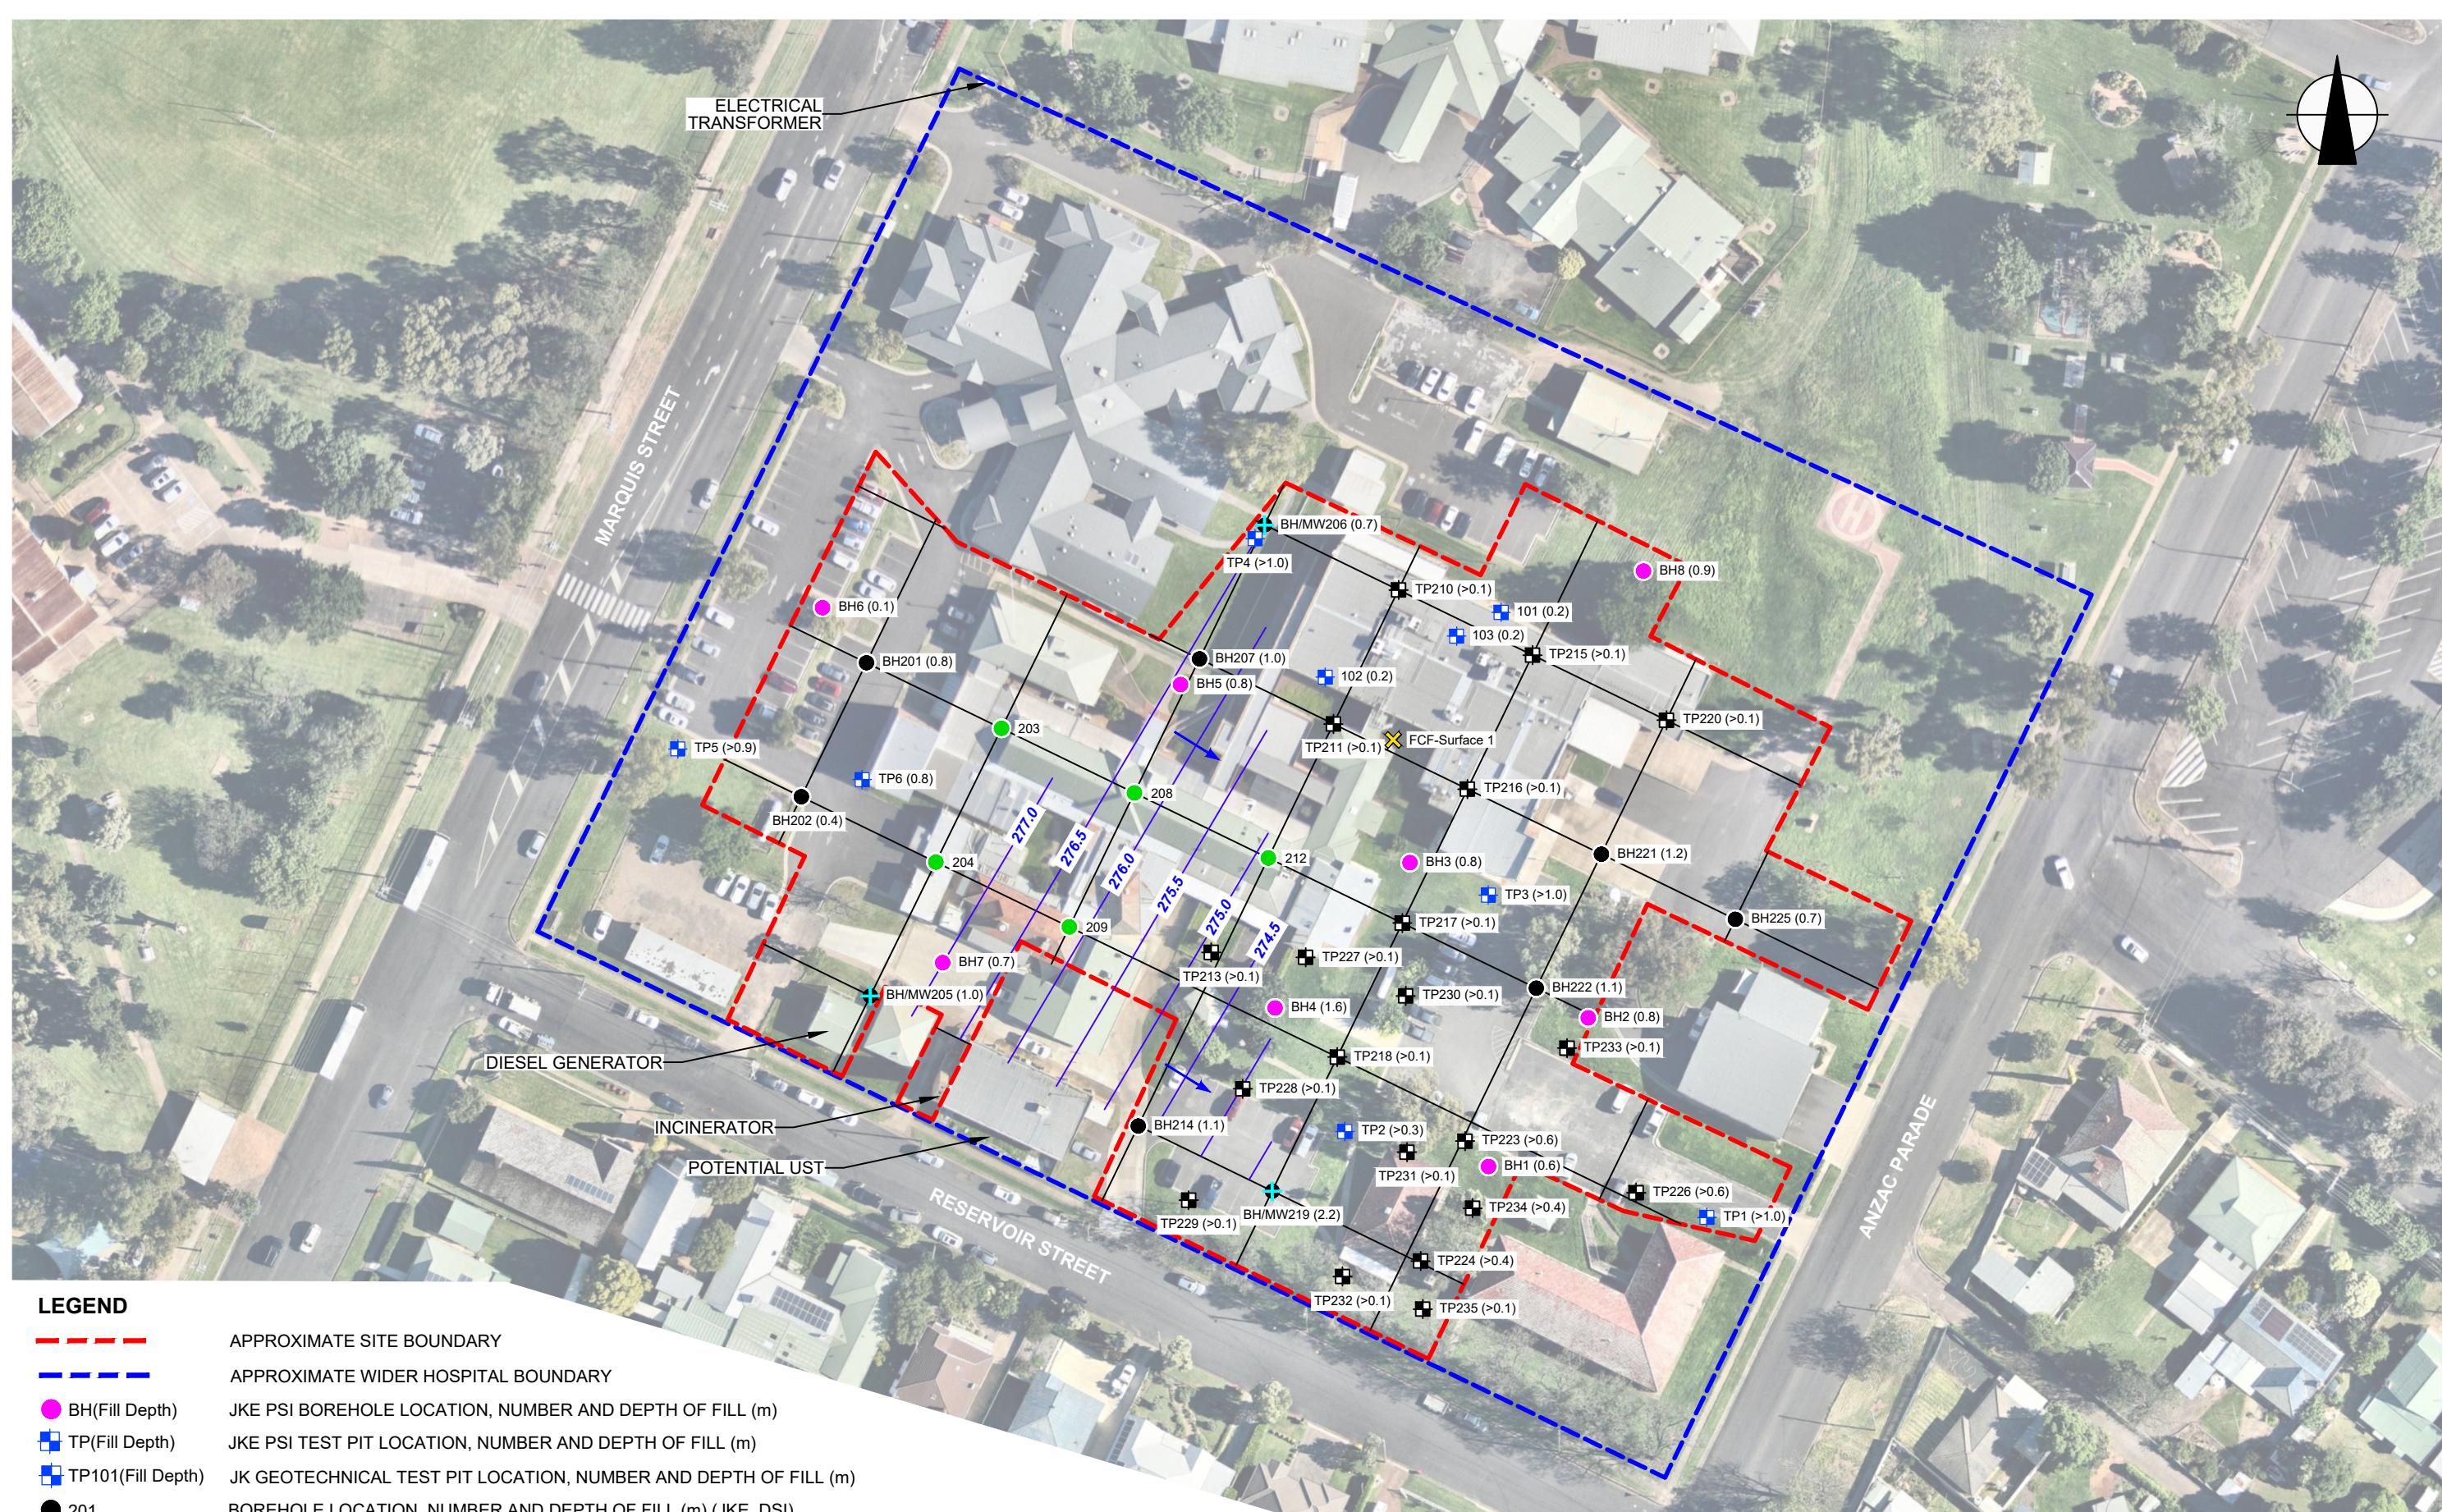
- APPROXIMATE SITE BOUNDARY
- APPROXIMATE WIDER HOSPITAL BOUNDARY
- BH(Fill Depth)
- TP(Fill Depth)
- TP101(Fill Depth)
- 201
- BH/MW205
- TP210
- 203
- FCF(Surface)
- 276.5
- INFERRED GROUNDWATER FLOW DIRECTION

The investigation included a review of historical information presented in the PSI and soil sampling from 30 boreholes or testpits, and groundwater sampling from three groundwater monitoring wells. The AEC identified in the DSI included: fill material; use of pesticides; hazardous building materials; an electrical transformer; a diesel generator; an incinerator and a potential off-site diesel Underground Storage Tank (UST – see Figure 2 in Appendix A). We note that the potential UST is located within the wider hospital area to the south of the maintenance/engineering building and outside of the proposed redevelopment area (i.e. outside the site applicable under the RAP).
