Biodiversity Assessment Report

Tamworth Mental Health Unit

Arboricultural Impact Assessment - TMHU Building

Arboricultural Impact Assessment – Car Parks

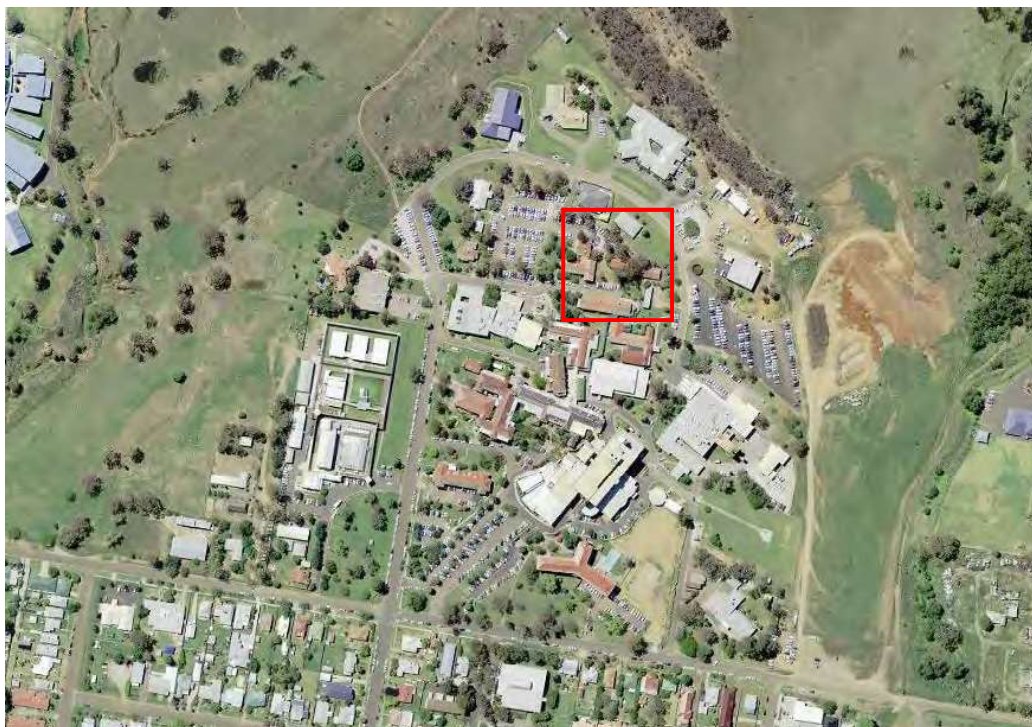
Figure 1. Whole site image (location). The red square identifies the area within the larger Tamworth Hospital complex containing the subject trees that may be impacted by the proposed development. (SEED, n.d.).

- 5.1.1 The site was located within the grounds of the Tamworth Hospital, Dean Street, Tamworth (Figure 1). Specifically, the area designated in this report, was located to the north of the site, immediately to the north of the emergency department.
- 5.1.2 As the proposed development site was within the hospital grounds usage surrounding the area was all hospital related. The Emergency Department was located to the south, carparking to the west and auxiliary hospital buildings to the north and east.
- 5.1.3 The site possessed a level, sloping aspect characterised by a high point located at the north, with the low point to the south.
- 5.1.4 Site soils were expected to differ from natural soil horizon profiles due to extensive and longstanding site development and usage.
- 5.1.5 The site was located within the Tamworth Regional Council Local Government Area (LGA).

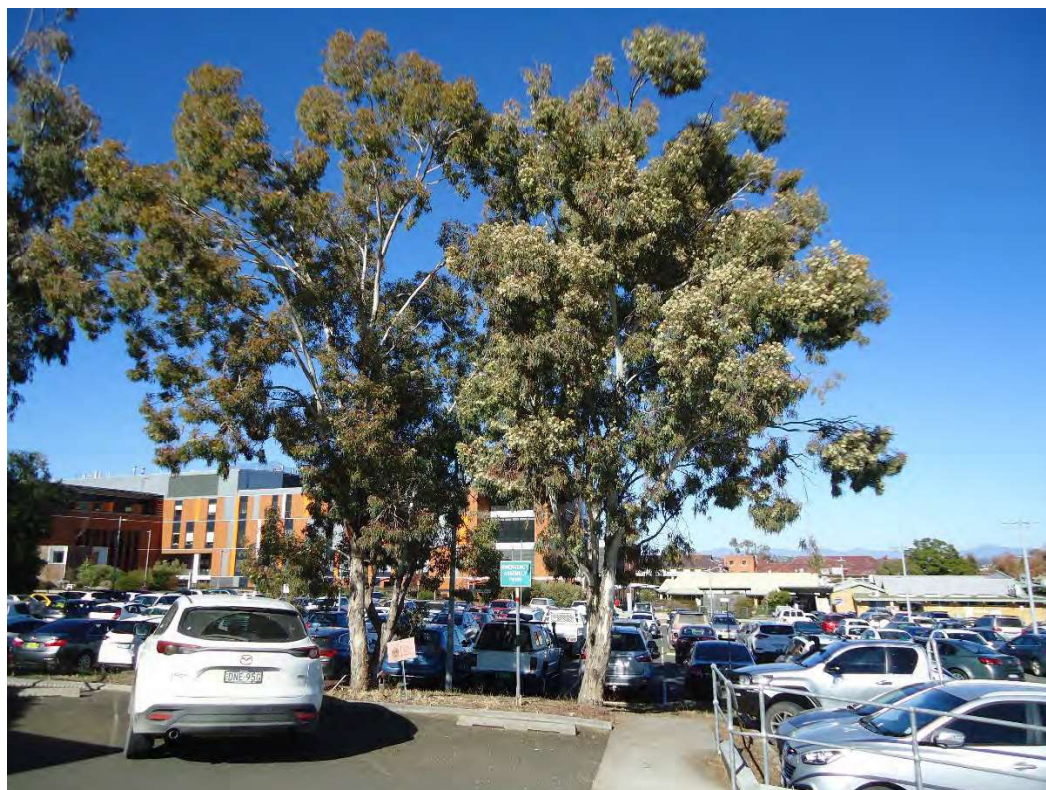
Figure 3. View to south of Trees 1 & 2 *Eucalyptus melliodora* (Yellow Box) in their growing environment. (ArborSafe, May 2021).

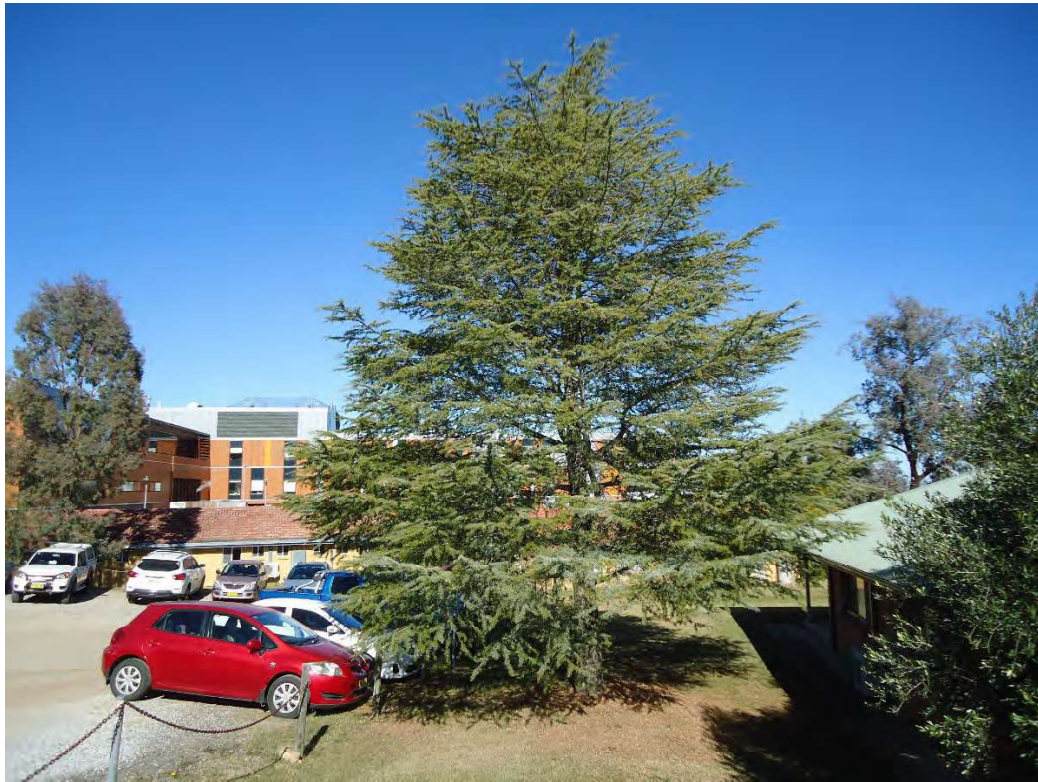
Figure 4. View to south of Tree 7 *Cedrus deodara* (Himalayan Cedar) in its growing environment. (ArborSafe, May 2021).

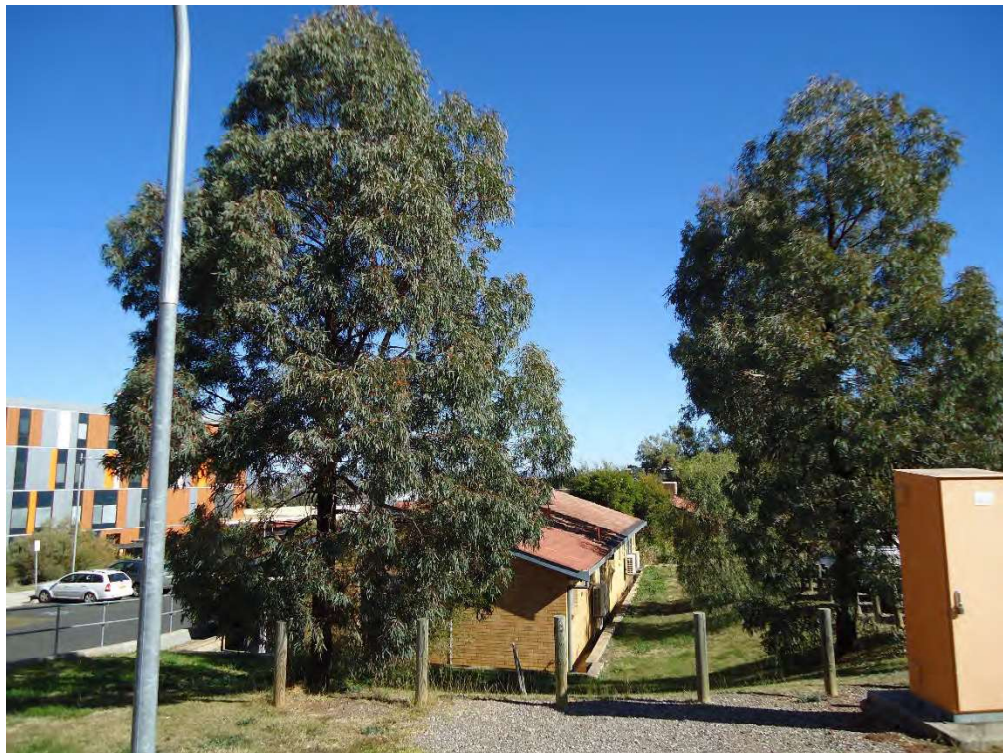
Figure 5. View to west of Trees 8 & 9 *Eucalyptus sideroxylon* (Red Ironbark) in their growing environment. (ArborSafe, May 2021).

- 5.2.3 The dominant species within the site was *Eucalyptus sideroxylon* (Red Ironbark) with a line of juvenile trees having been planted at the eastern end of the area to complement the existing declining mature specimen. The structure within the young trees was not good with multiple included unions observed which would limit future ULE.

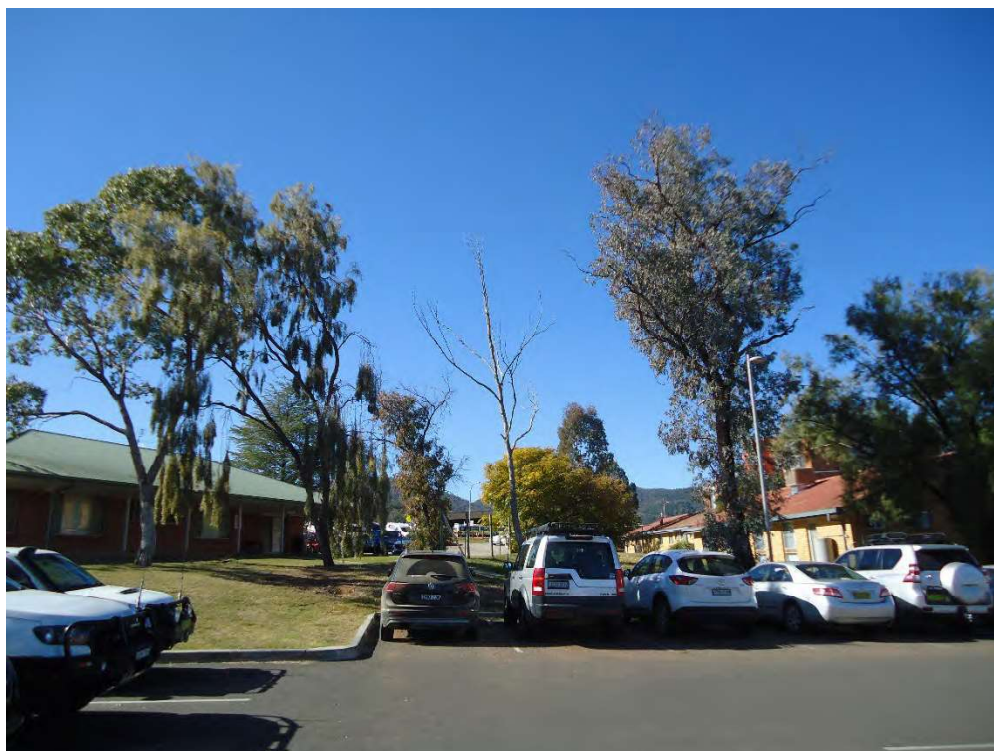
Figure 6. View to south of Trees 13 – 18 in their growing environment. (ArborSafe, May 2021).

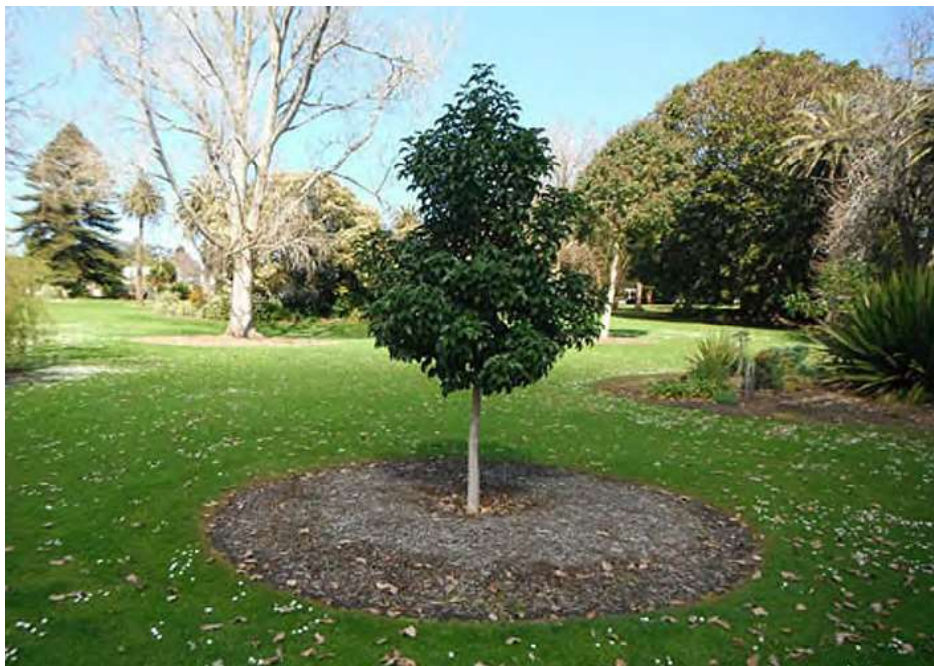
Figure 14. An excellent example of how to mulch a young tree. (Lachlan Andrews, September 2015).

Mulching is a plant health care action which can be undertaken to improve plant and soil health (Figure 14), as well as overall landscape aesthetics. Placing an organic (or sometimes inorganic) material on the soil surface reduces the level of direct sunlight contact. Mulching should not be confused with composting which involves incorporating organic matter such as composts or manures into the soil profile. All plants in their natural ecologies (except for some arid and coastal ecologies) are naturally mulched by the falling of leaves, bark, flowers and other organic material.

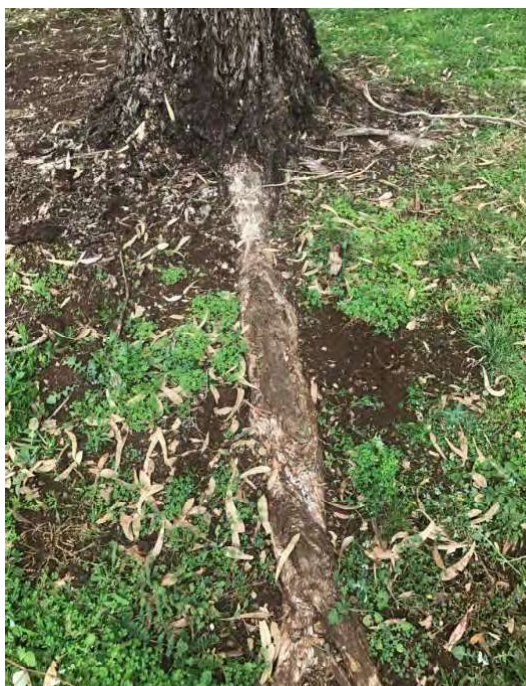
Figure 16. An example of damage to tree roots caused via mowing. (Luke Dawson, June 2017).

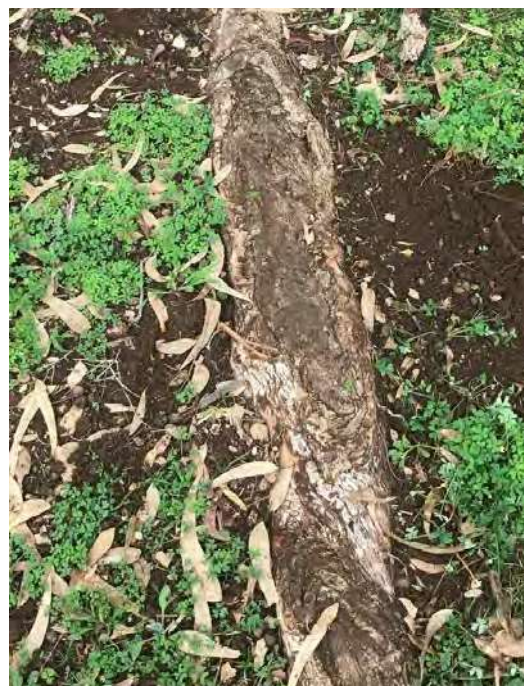
Figure 17. Image showing wound caused to upper portion of surface root by mower. (Luke Dawson, June 2017).

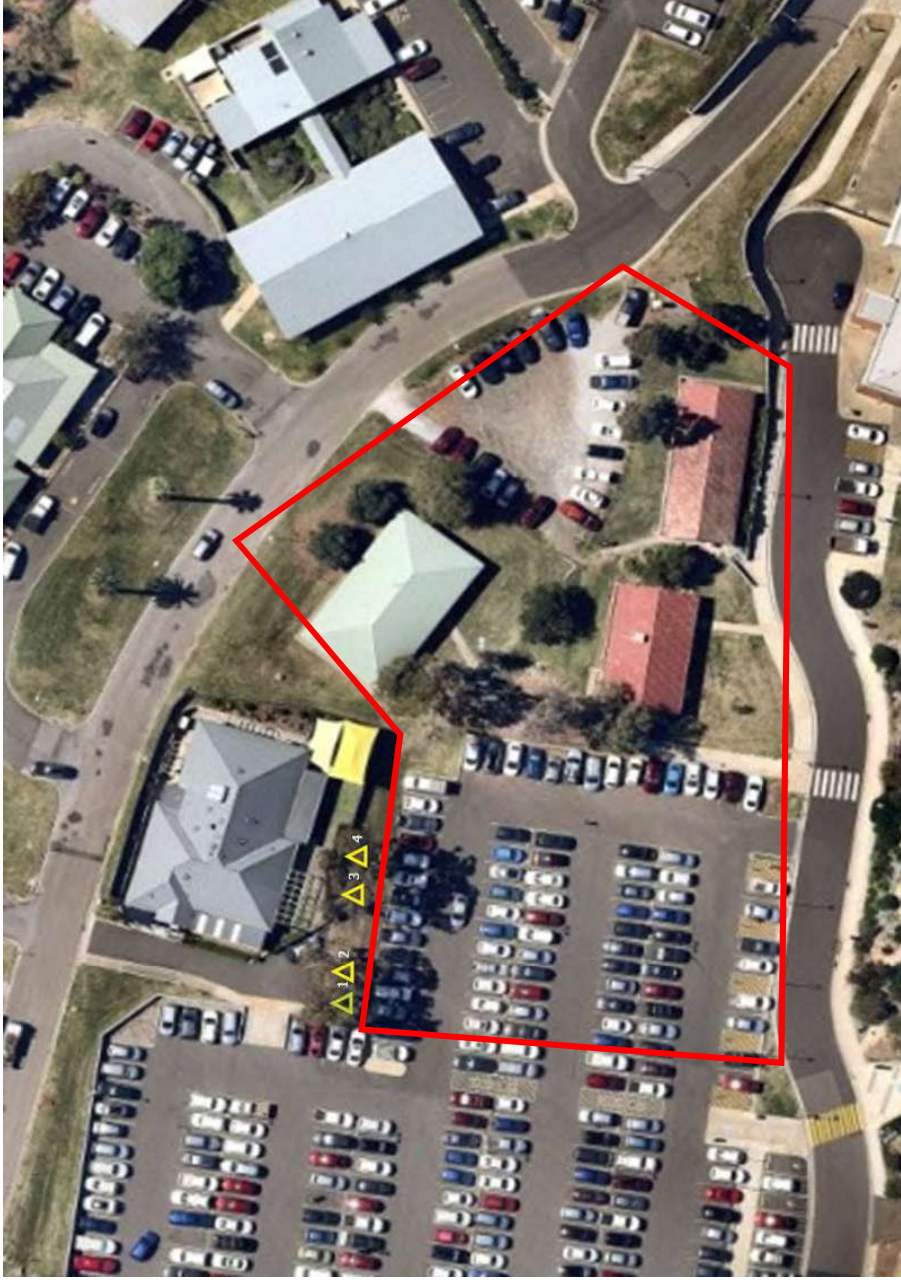
Figure 18. Site map showing retained trees with suggested Tree Protection/Site perimeter Fence locations. (ArborSafe, May 2021).

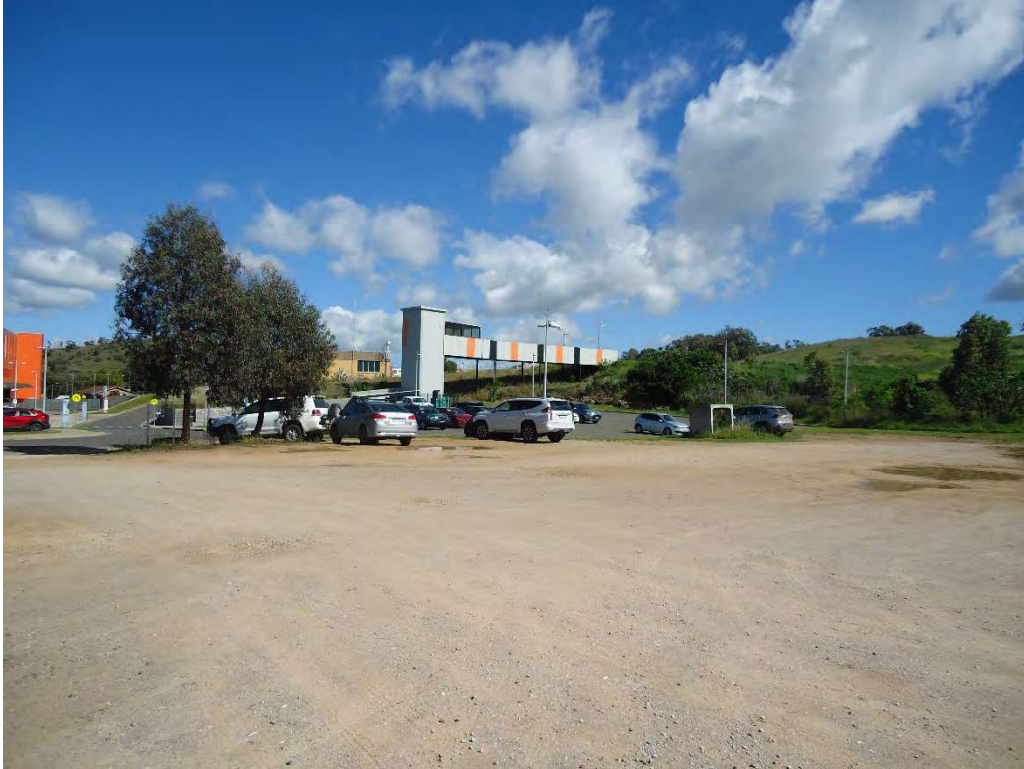
Figure 4. Overview image of carparking Zone 1 with Trees 19 and 20 to the left. (ArborSafe, 28 October 2022).

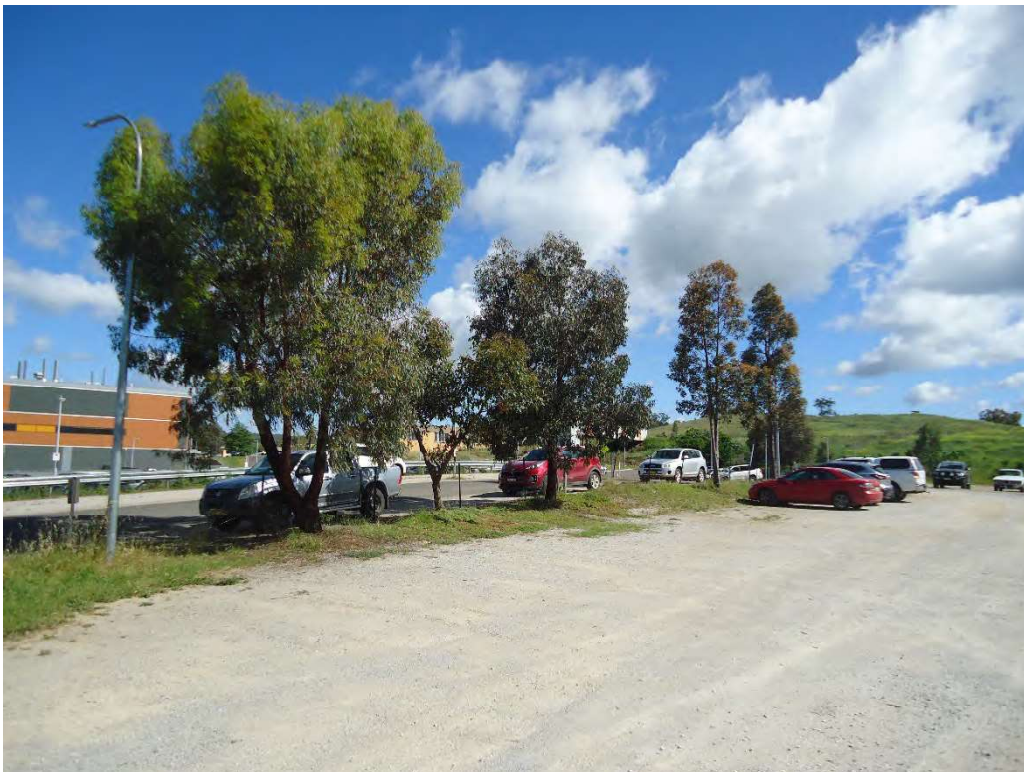
Figure 5. Overview image of the Zone 1 – extension area (refer to Figure 2), showing Trees 22–25. (ArborSafe, 28 October 2022).

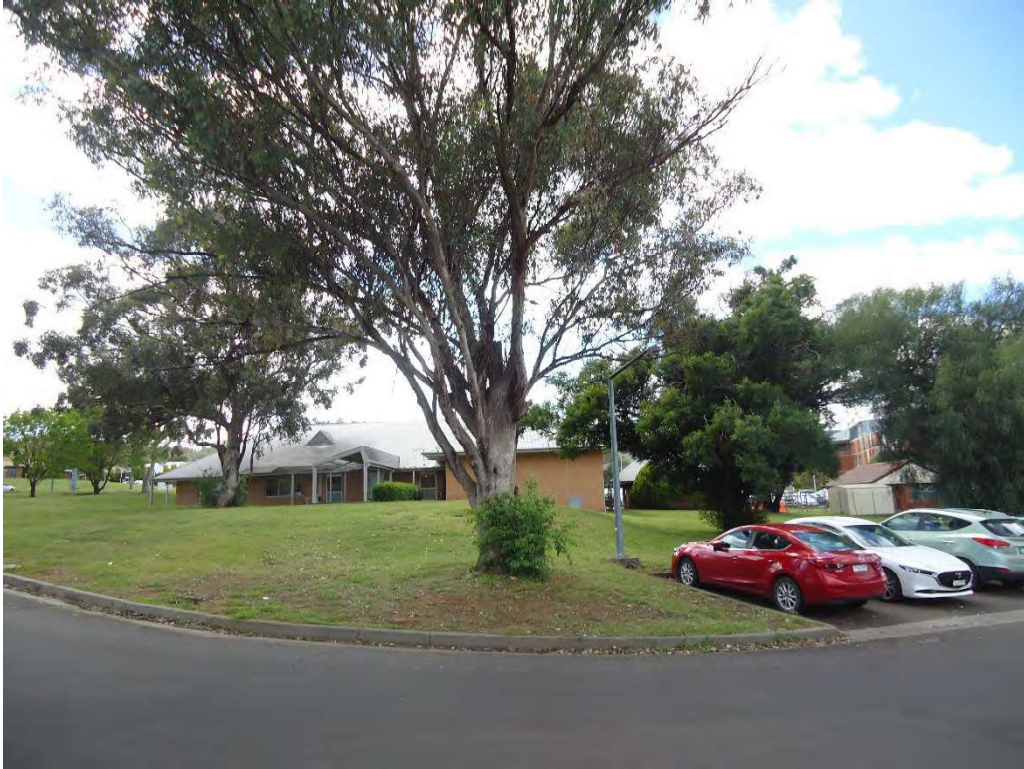
Figure 7. Overview image of carparking Zone 2, with Tree 27 in the foreground. (ArborSafe, 28 October 2022).

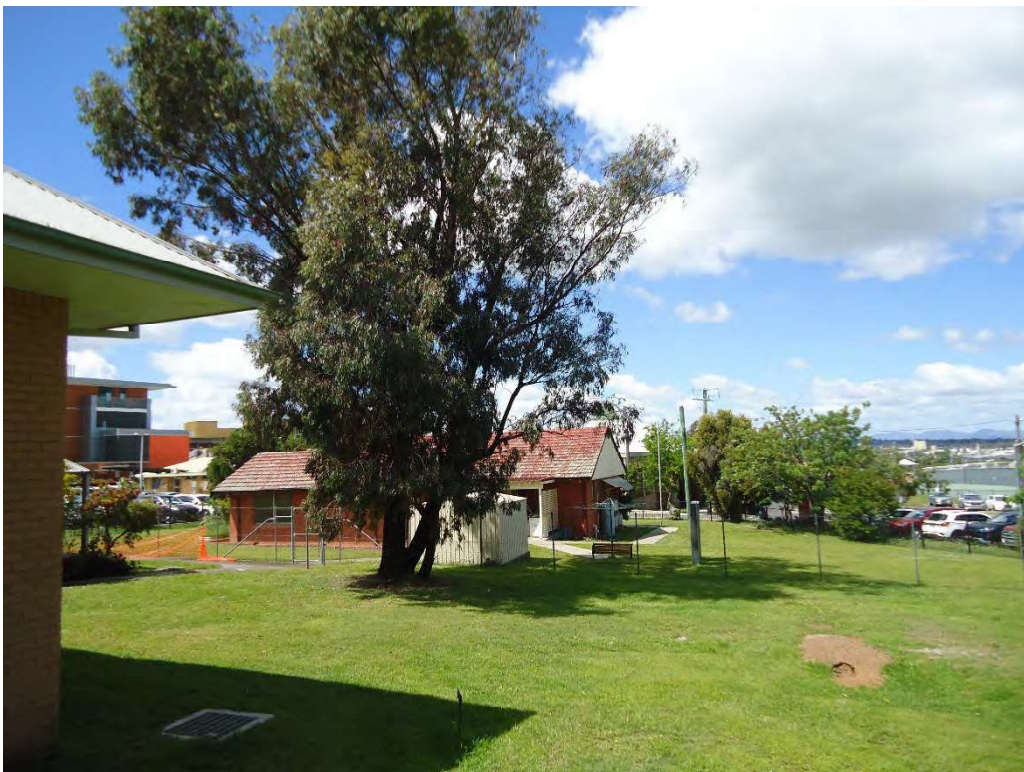
Figure 8. Overview image of carparking Zone 2, with Tree 30 in the foreground. (ArborSafe, 28 October 2022).

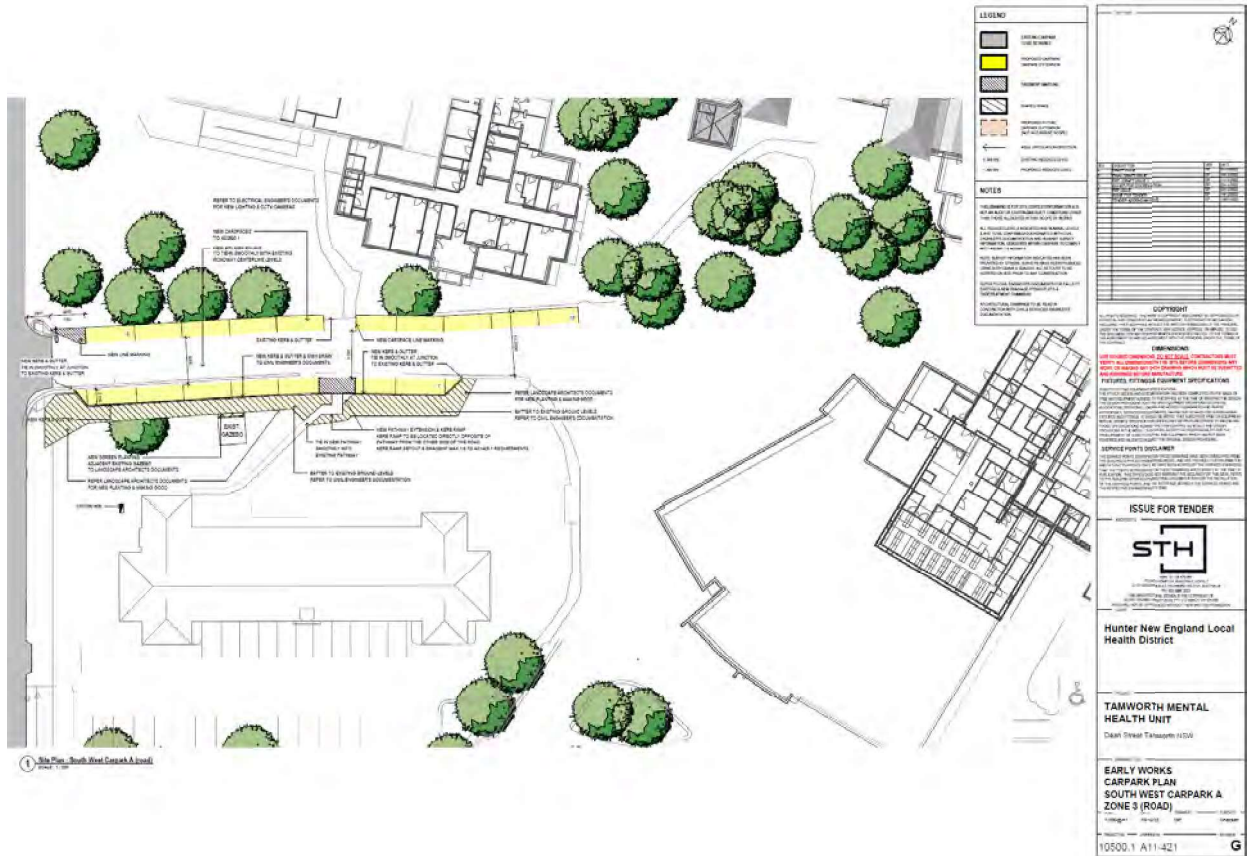
Figure 9. Excerpt from Early Works Carpark Plan South West Carpark A Zone 3 (Dwg. No. A11-421, Rev. G). (STH, 15 February 2023).

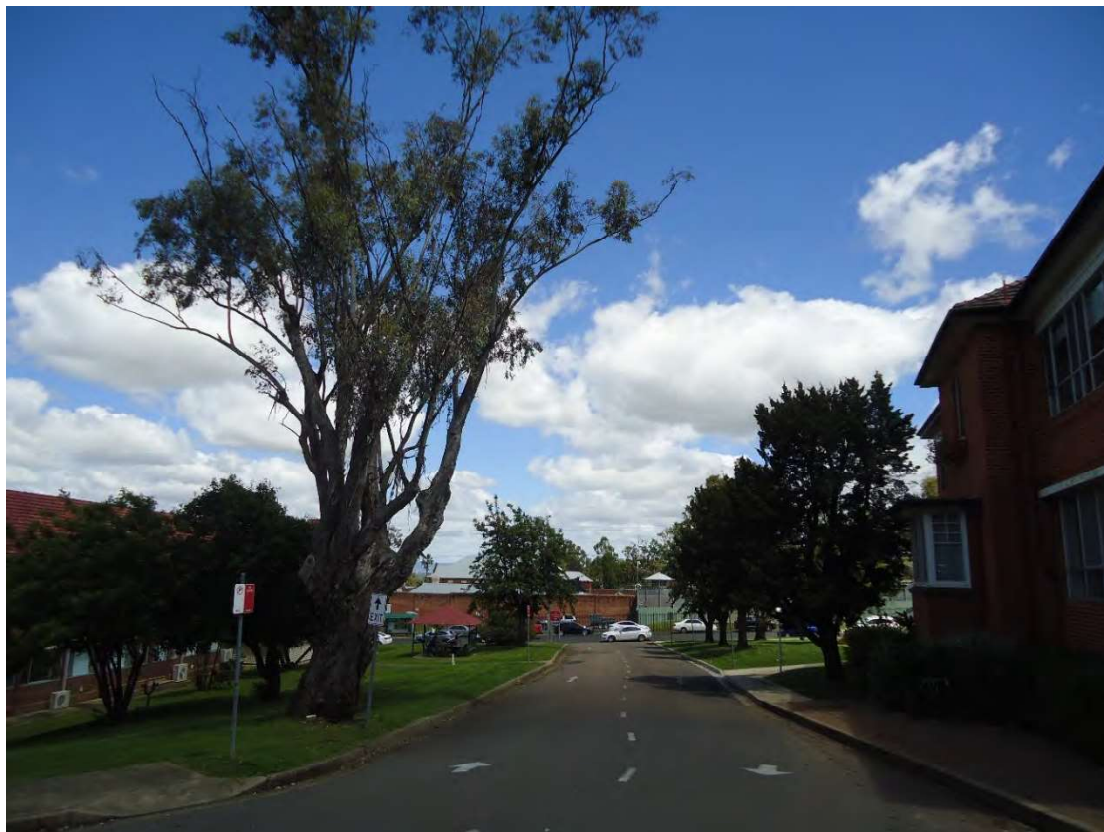
Figure 10. Overview image of carparking Zone 3, with Tree 40 in the left foreground. (ArborSafe, 28 October 2022).

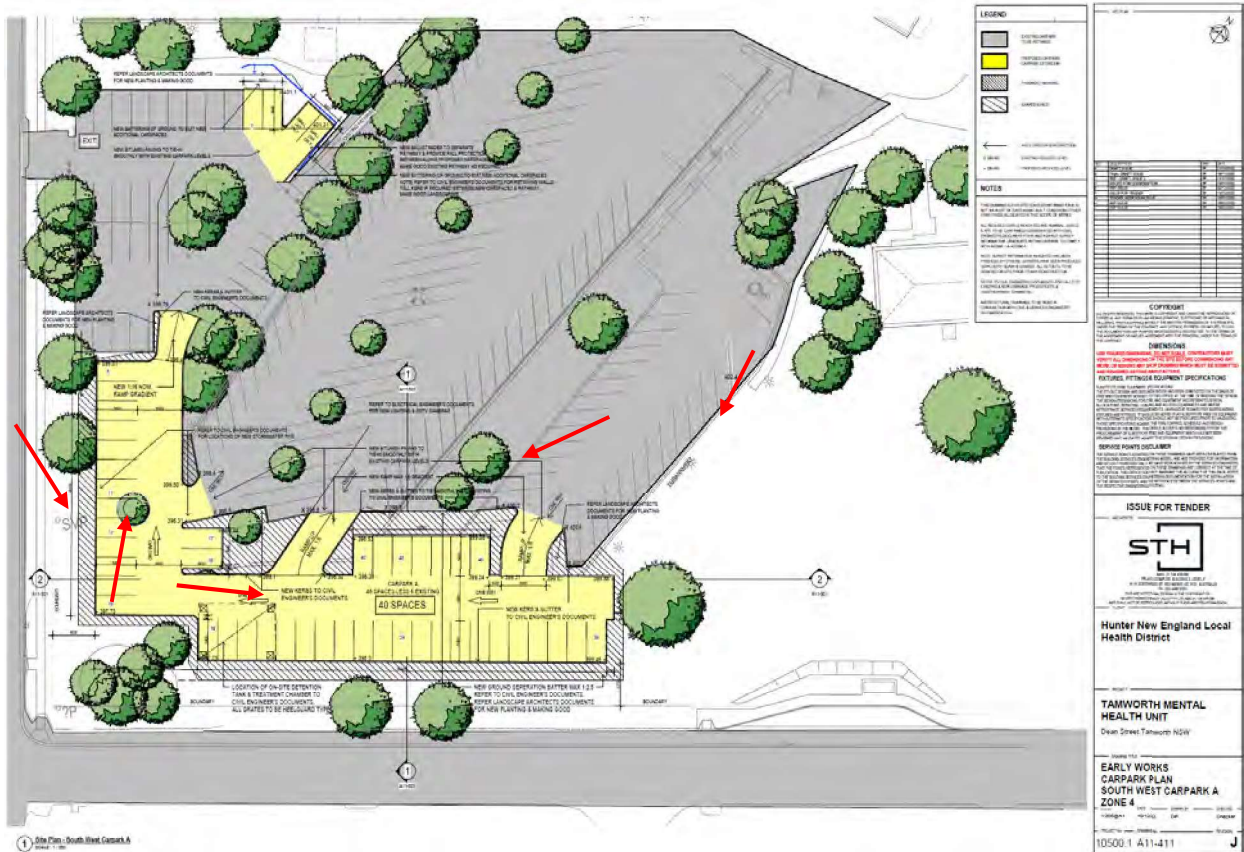
Figure 11. Excerpt from Early Works Carpark Plan South West Carpark A Zone 4 (Dwg. No. A11-411, Rev. J) Red arrows shows direction of Figure 12–15 images. (STH, 15 February 2023).

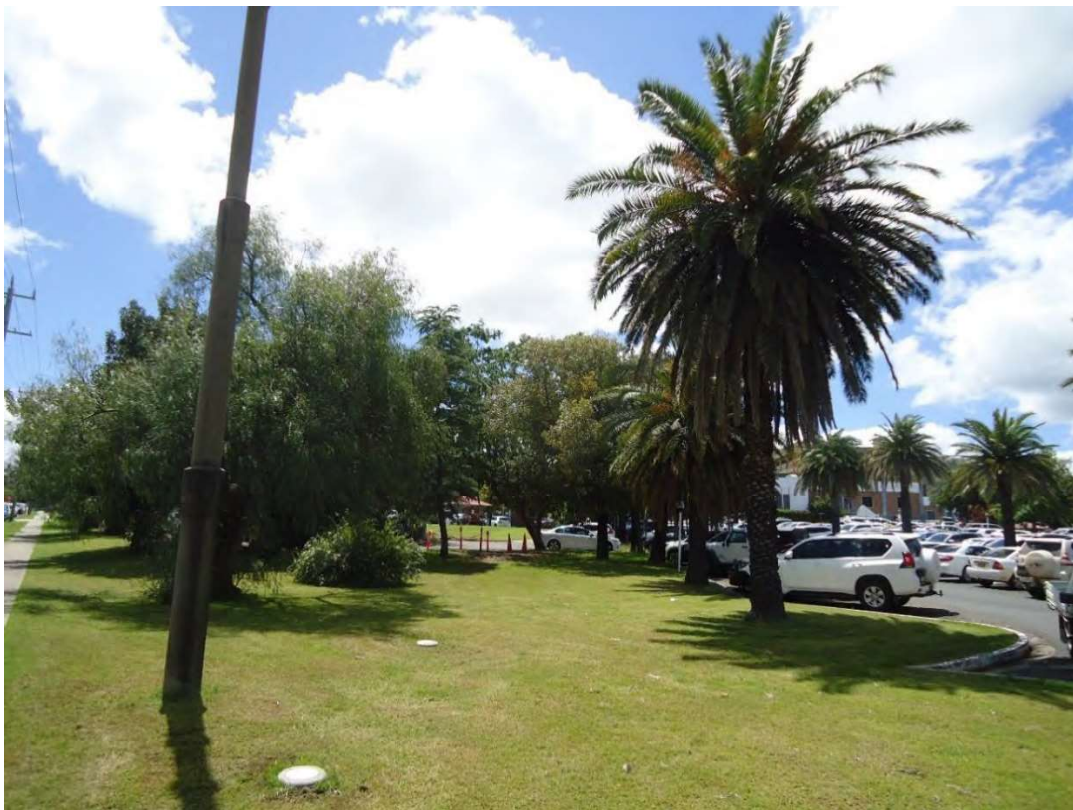
Figure 12. Overview image of carparking Zone 4, with Tree 52 and 46 in the foreground. (ArborSafe, 28 October 2022).

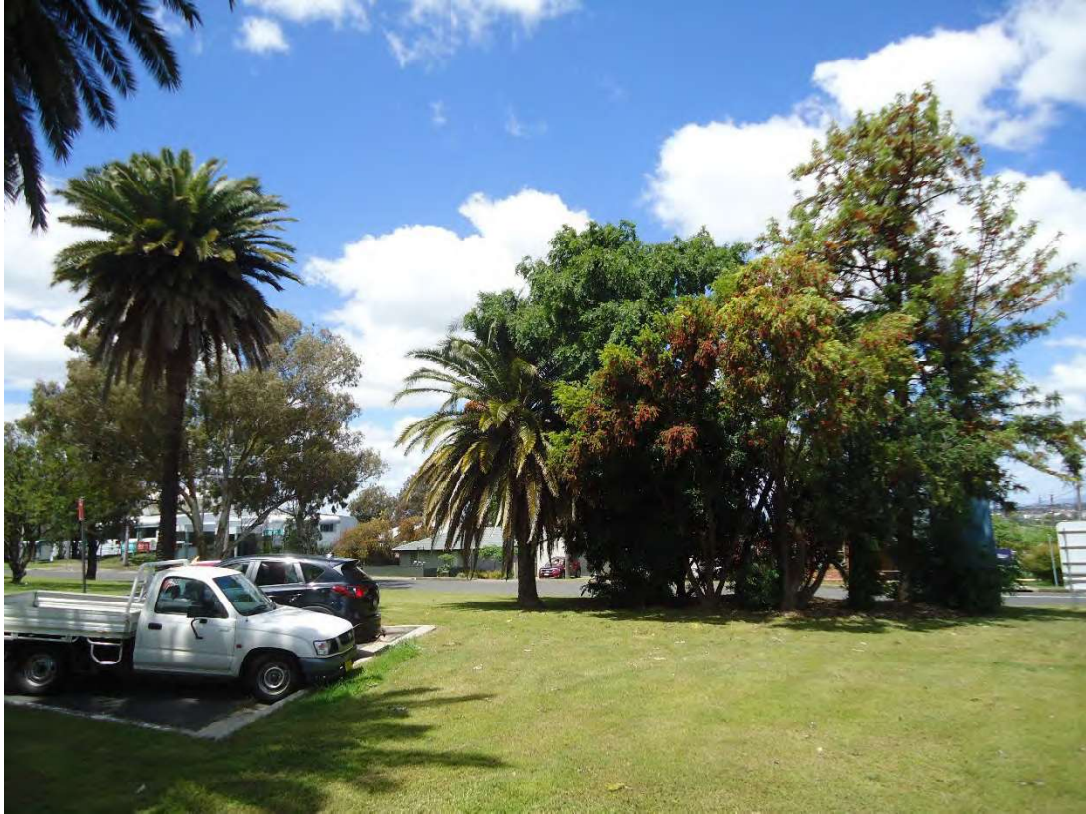
Figure 13. Overview image of carparking Zone 4, with Palm 60 in the left foreground and Trees 53–59 in the group. (ArborSafe, 28 October 2022).

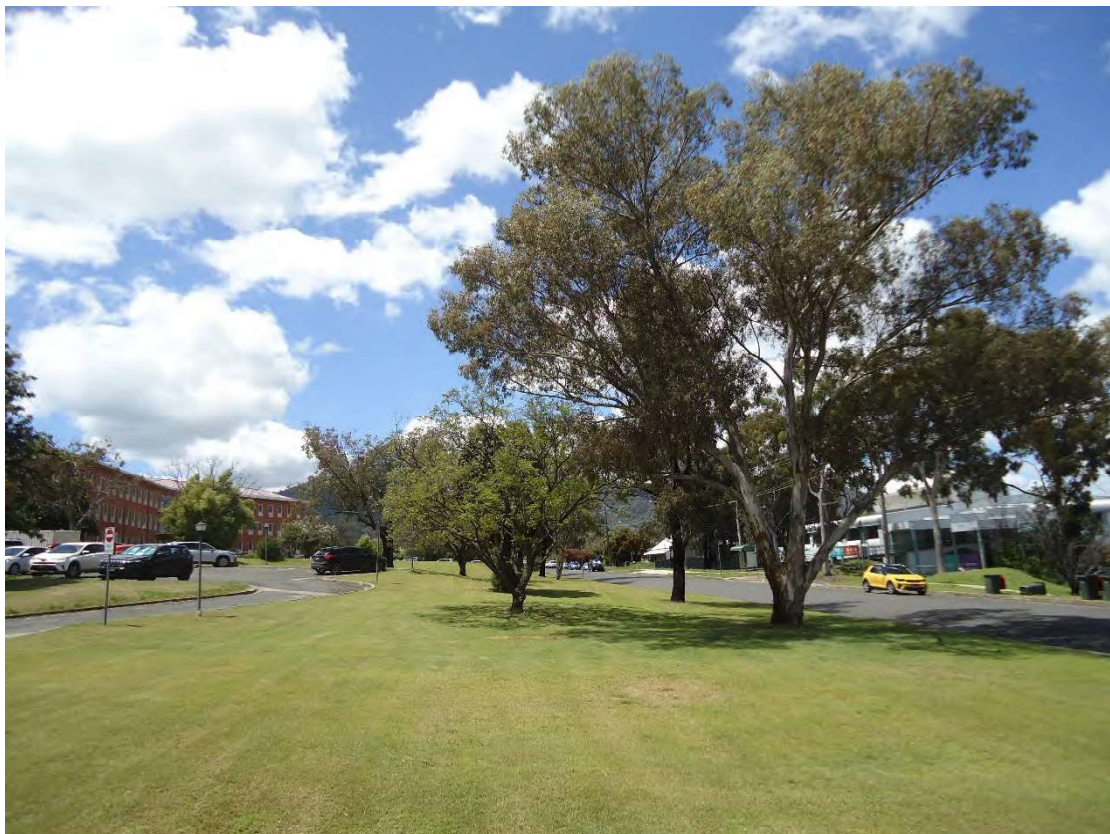
Figure 14. Overview image of carparking Zone 4, with Tree 62 in the right foreground. (ArborSafe, 28 October 2022).

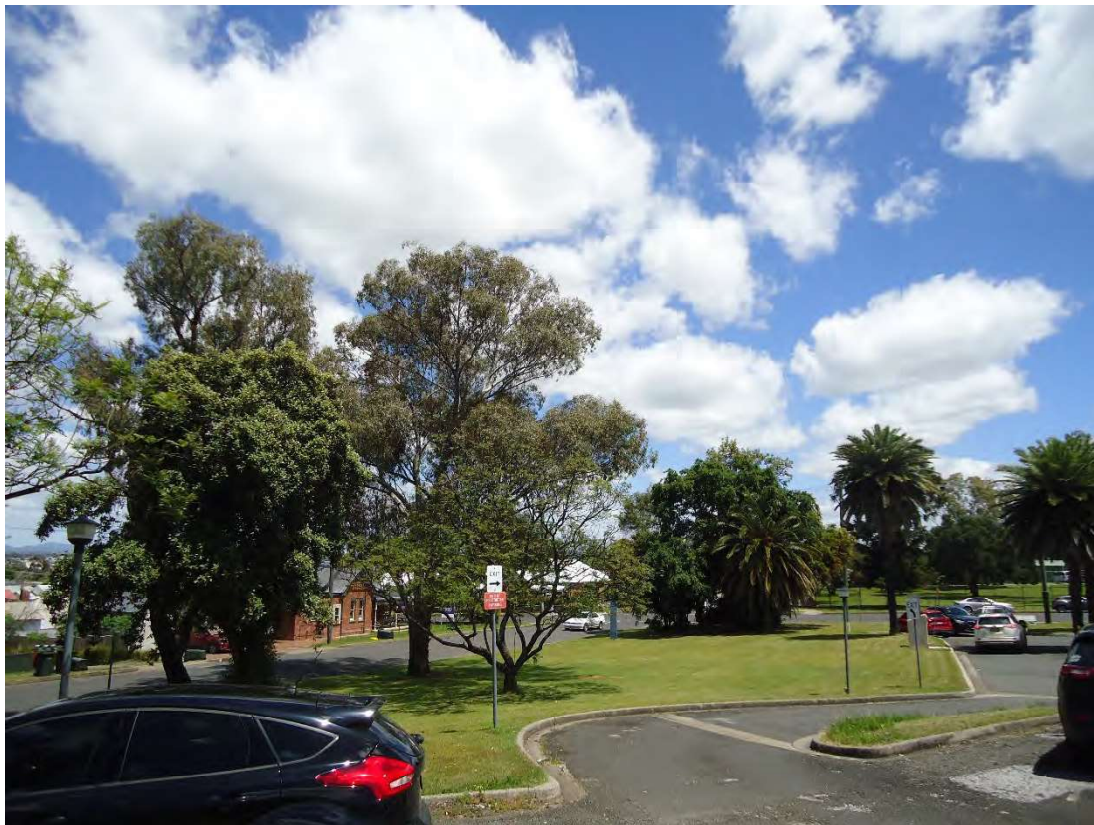
Figure 15. Overview image of carparking Zone 4. (ArborSafe, 28 October 2022).

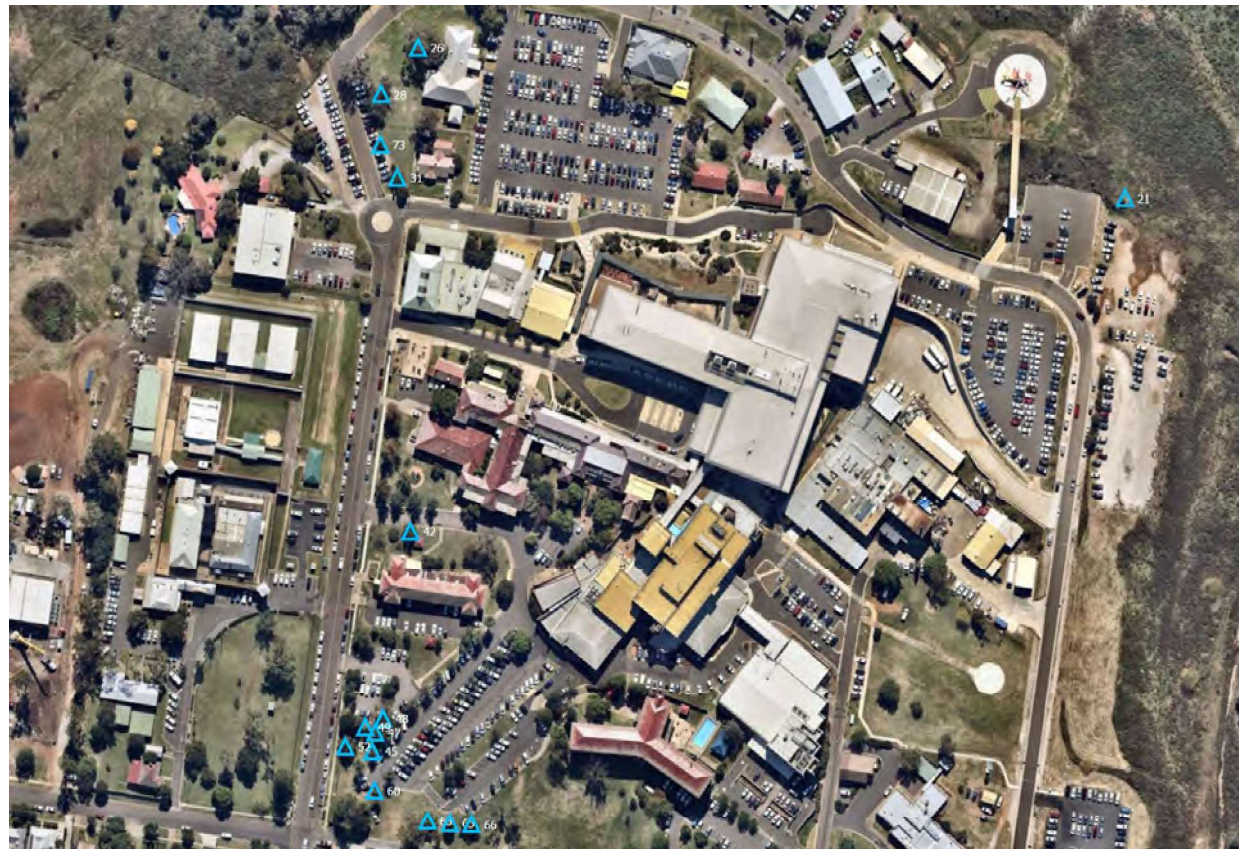
Figure 16. Site map showing trees requiring removal. (ArborSafe, October 2022).

Recommendation	Category A High retention value		Category B Moderate retention value		Category C Low Retention value		Category U No retention value	
	Qty	Tree numbers	Qty	Tree numbers	Qty	Tree numbers	Qty	Tree numbers
Remove for development	0		9	26, 28, 42, 45, 47, 48, 49, 60, 63	6	21, 31, 52, 65, 66, 73	0	
Remove in the context of development	0		0		0		2	29, 50

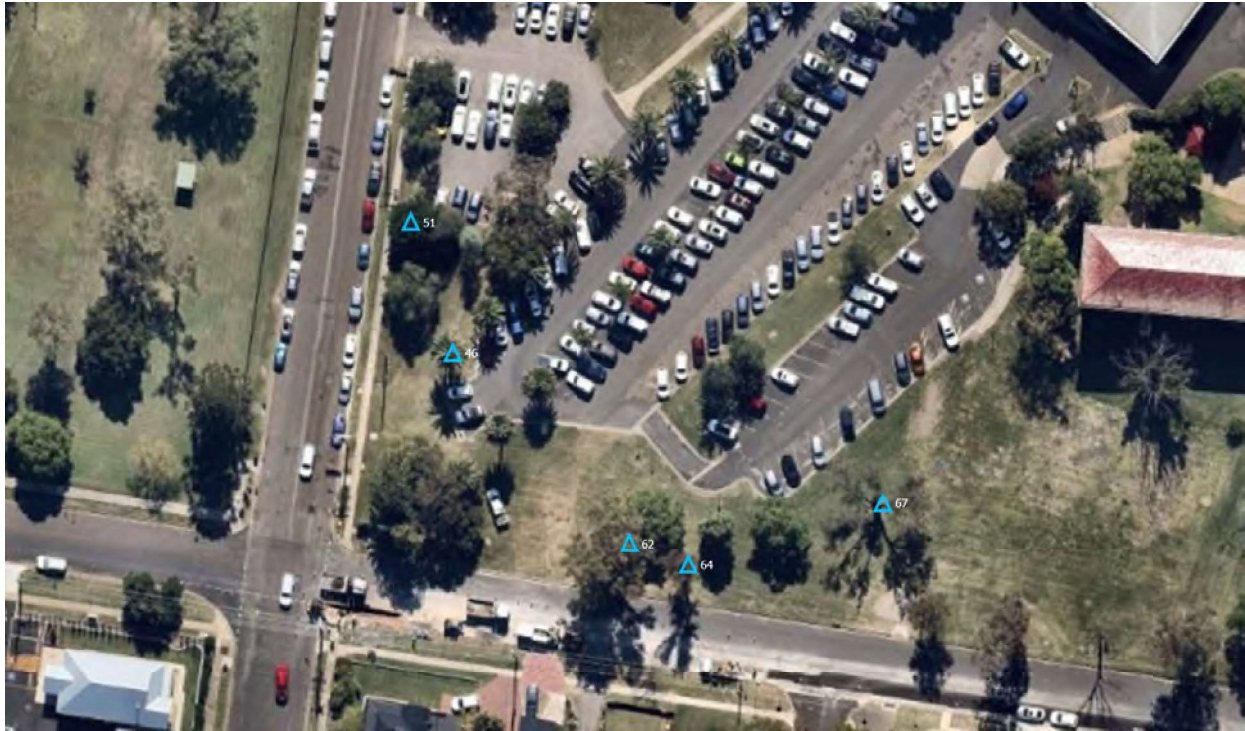
Figure 17. Site map showing trees requiring specific protection measures. (ArborSafe, October 2022).

- Arborist supervision
- The use of machinery should be undertaken from areas of hardstand to avoid potential root compaction
- The proposed excavation should commence at the outer extent of the TPZ and move inwards to minimise root damage to the tree
- No excavation should occur within the SRZ of these trees
- Roots discovered are to be treated with care and minor roots (<40mm diameter) pruned with a sharp, sterile handsaw or secateurs. All significant roots (>40mm diameter) are to be recorded, photographed and reported to the project arborist.

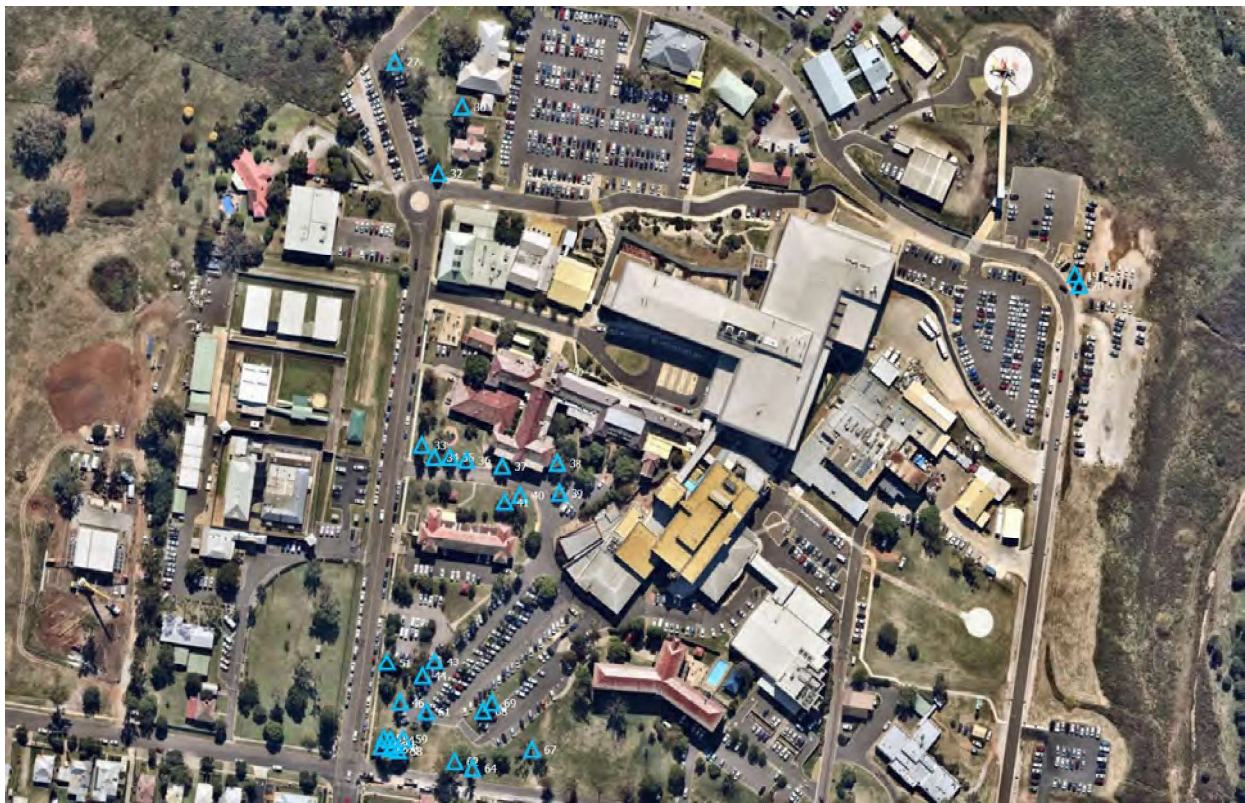
Figure 18. Site map showing tree requiring generic protection measures. (ArborSafe, October 2022).

7.5.1 All retained trees require generic protection measure (Figure 18). Refer to Section 7.6–7.12 for further detail.

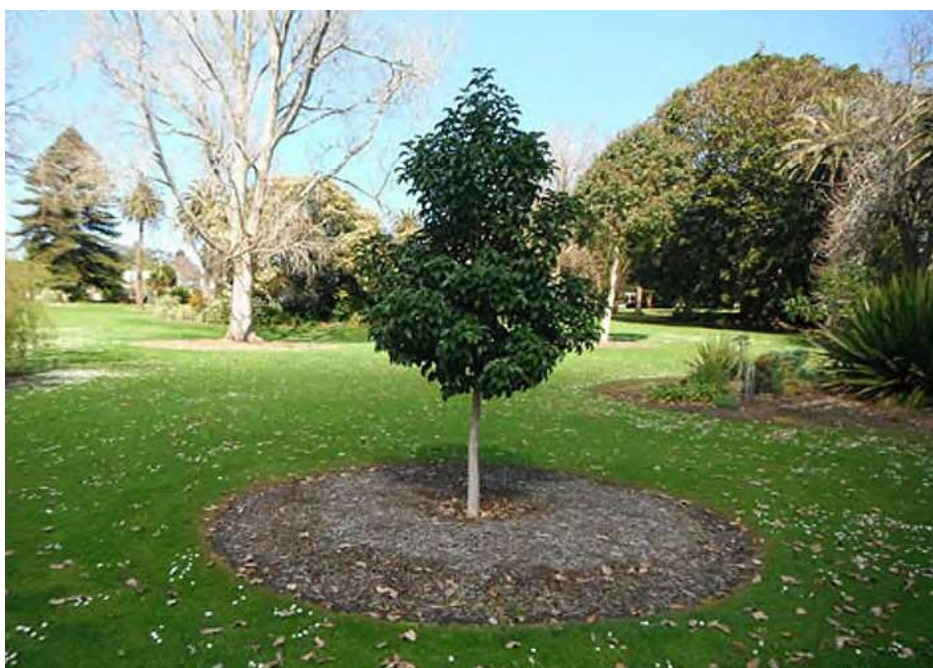
Figure 22. An excellent example of how to mulch a young tree. (Lachlan Andrews, September 2015).

Mulching is a plant health care action which can be undertaken to improve plant and soil health (Figure 22), as well as overall landscape aesthetics. Placing an organic (or sometimes inorganic) material on the soil surface reduces the level of direct sunlight contact. Mulching should not be confused with composting which involves incorporating organic matter such as composts or manures into the soil profile. All plants in their natural ecologies (except for some arid and coastal ecologies) are naturally mulched by the falling of leaves, bark, flowers and other organic material.

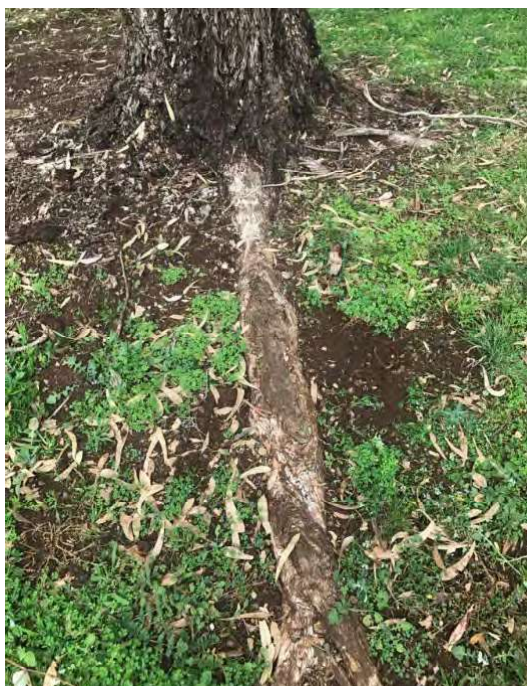
Figure 24. An example of damage to tree roots caused via mowing. (Luke Dawson, June 2017).

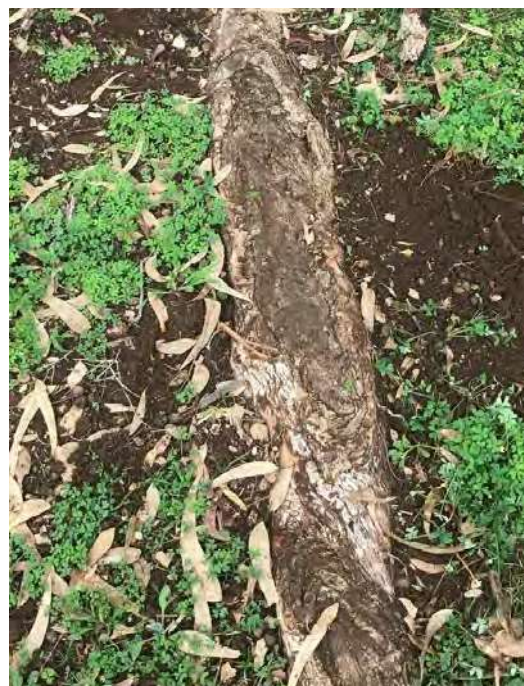
Figure 25. Image showing wound caused to upper portion of surface root by mower. (Luke Dawson, June 2017).
