JBS&G (63097- 153076)

L03 - Wentworth Health Services Pre-Remedial Requirements (Rev A)

L03 – Wentworth Health Services Wentworth Health Services Pre-Remedial Requirements, Wentworth Health Services, Wentworth NSW

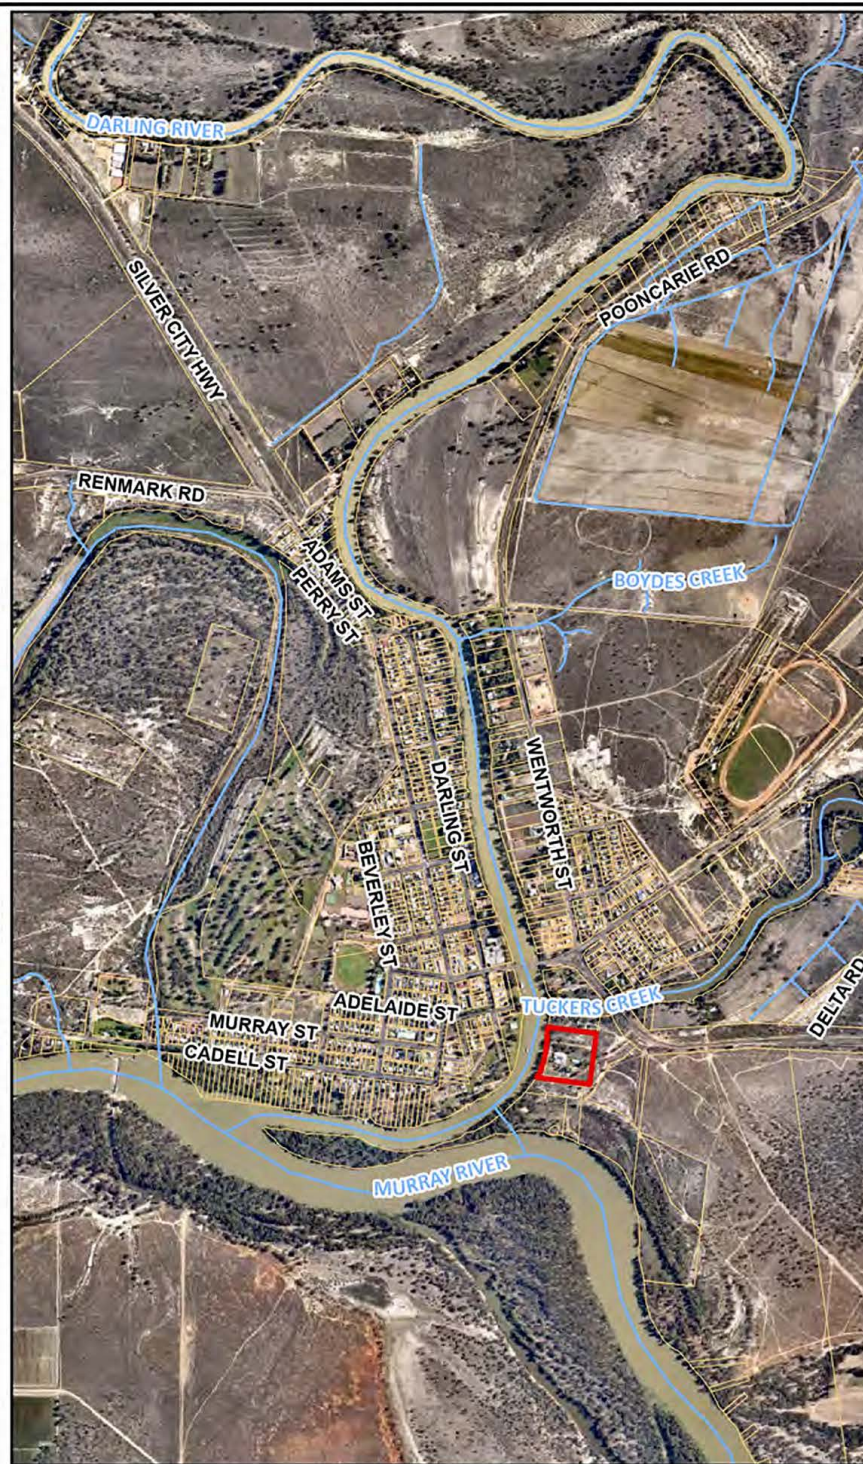
Legend:
 Approximate Site Boundary

JBS&G Australia Pty Ltd (JBS&G) was engaged by Health Infrastructure (HI, the client) to provide environmental consultancy services associated with the proposed redevelopment of the Wentworth Health Services facility in Wentworth, NSW (the site, **Attachment 2, Figure 1 and Figure 2**).

The site has been subject to a Preliminary Site Investigation (PSI) and a Detailed Site Investigation (DSI), which have identified the presence of asbestos on/in soil impacts as a result of historic uses/activities on the site, including fly-tipping and the creation of existing/current site levels using fill materials of unknown origin (PSI, JBS&G 2022¹ and DSI, JBS&G 2023a²). Fill material beneath the existing building footprints and immediately adjacent areas has been assumed to be impacted with asbestos, as such the DSI recommended a pre-remedial assessment to characterise soils in existing building footprints following demolition. Existing building footprints are as shown in **Figure 2**.

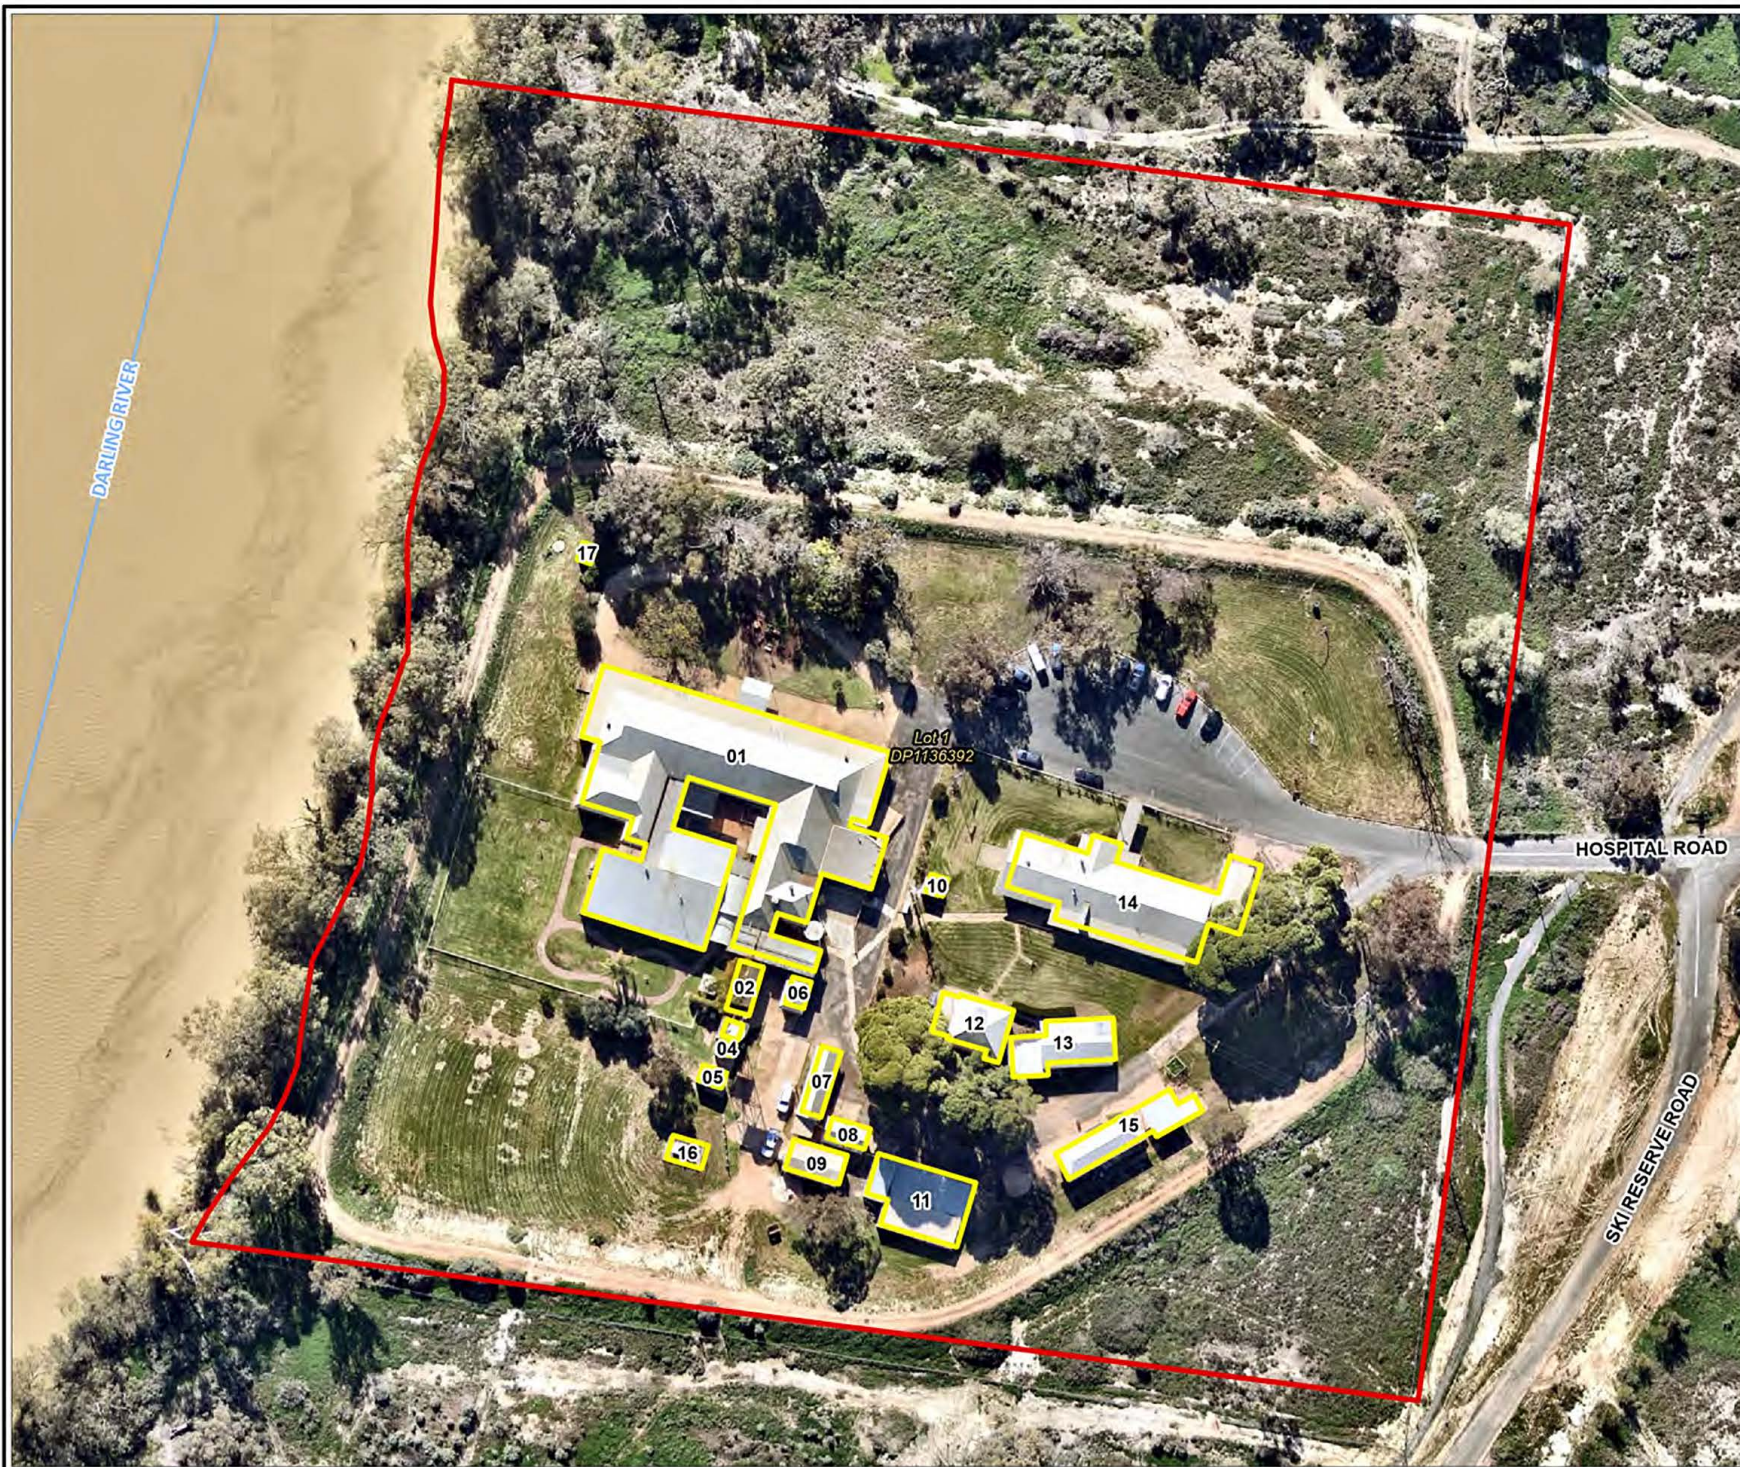
FIGURE 2

- Legend:**
- Approximate Site Boundary
 - Cadastre (DFS, 2021)
 - Building Outline
- Building Usage**
- 01. Wentworth Health Services Building (Hospital)
 - 02. Old Boiler House
 - 03. Old Pump Shed/Room
 - 04. Old Dirty Linen
 - 05. Contaminated Waste
 - 06. Staff Amenities Block
 - 07. Maintenance Storage Shed
 - 08. Infectious Waste/Old Morgue
 - 09. Maintenance Workshop
 - 10. Emergency Generator Shed
 - 11. Carports/Storage Shed
 - 12. Old Nurses Home (Condemned)
 - 13. Uni Staff Quarters/Accommodation/USYD
 - 14. Senior Activity Centre/Physio/Community Centre
 - 15. Staff Accommodation
 - 16. LPG Gas Storage
 - 17. Pump Station (PS07) Control Panel Shed

SITE LAYOUT
