## **HISTORIC IMPACT STATEMENT**

### **WENTWORTH HOSPITAL REDEVELOPMENT**

WENTWORTH, NSW

MAY 2023

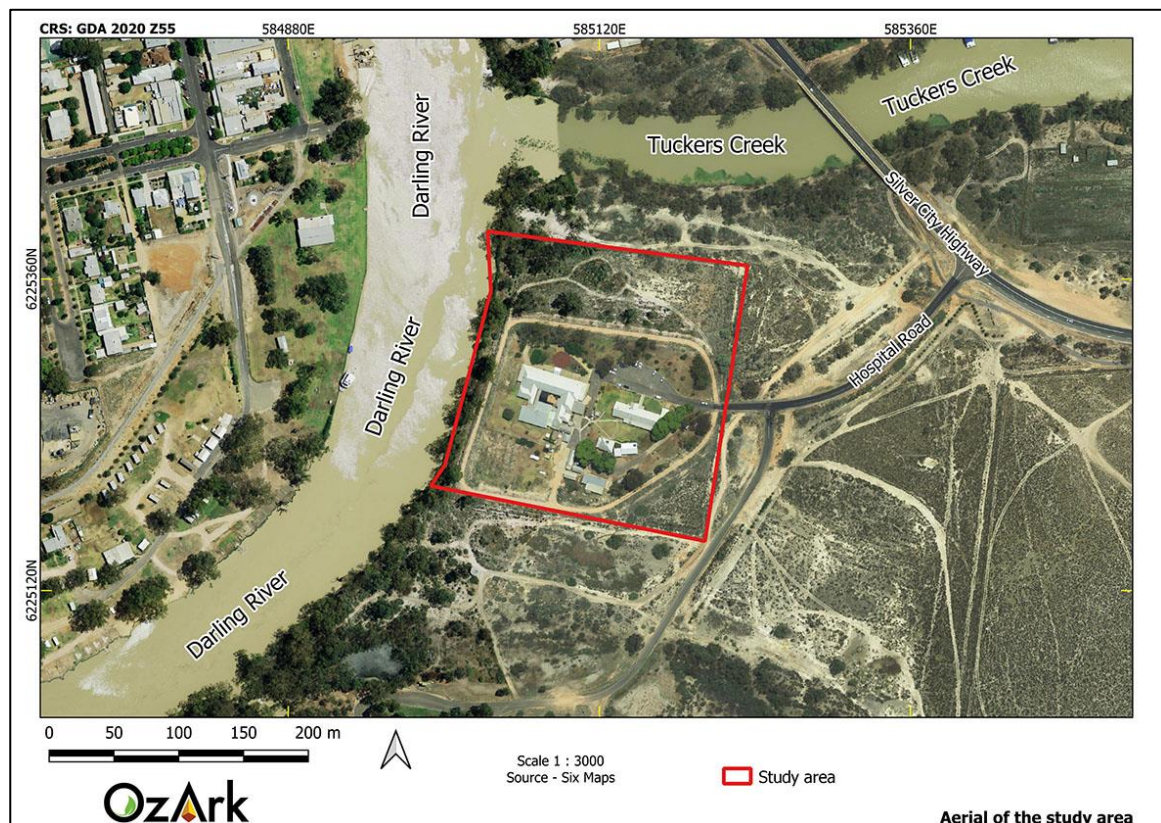
**Figure 1-2: Aerial showing the study area.**

The study area is comprised of approximately 3.8 hectares (ha) of land at the junction of the Murray and Darling Rivers, as well as Tuckers Creek, at Wentworth NSW (**Figure 1-2**). The study area is situated on an elevated terrace associated with these three waterways and has been utilised as a health facility since the late 1800s.

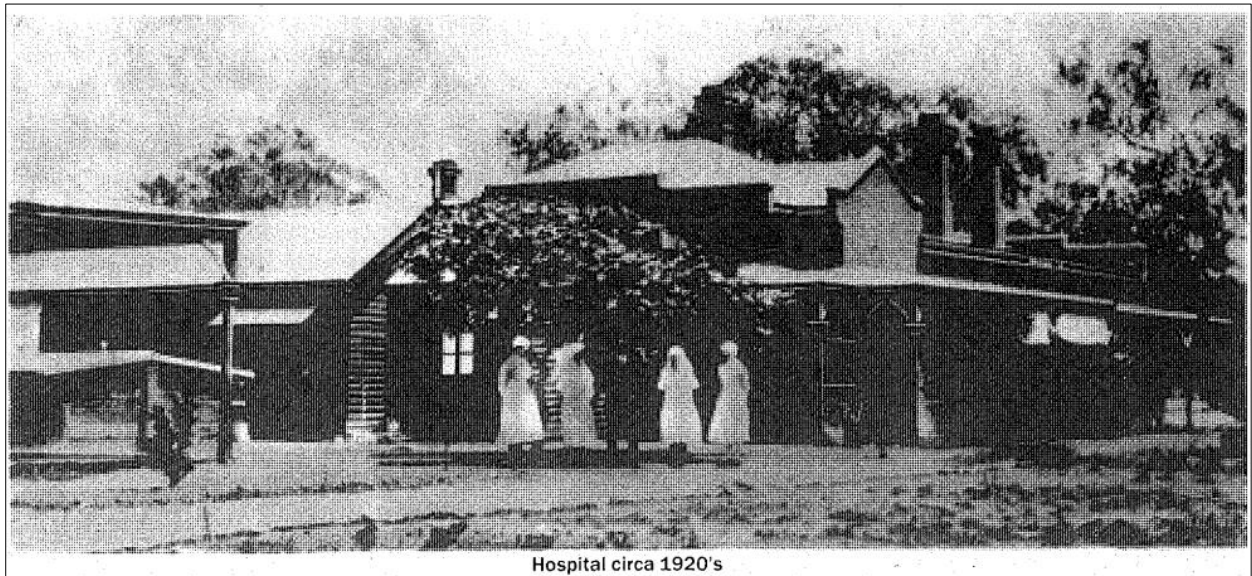
**Figure 2-1: Image of the hospital from 1920 (Robertson 1985:19).**

In rebuilding the Private Ward, assurance had to be made that it was not to be used for private patients and once agreed, two additional wards were added, and their verandahs gauzed in 1920 (**Figure 2-1**). Following this a covered walkway was constructed between the buildings. In 1926, new buildings including a new kitchen were funded, with agreement that as much material from

**Description of site:** The original buildings constructed in 1887/88 are known from images only as seen in **Figure 2-1** and **Figure 2-2**.

**Figure 3-1** shows views of the current buildings on the site. When compared to the images on **Figure 2-1** and **Figure 2-2**, it is clear that the current buildings are not the 'original buildings' on site and that the current buildings are the 'new hospital' illustrated on **Figure 2-3**.

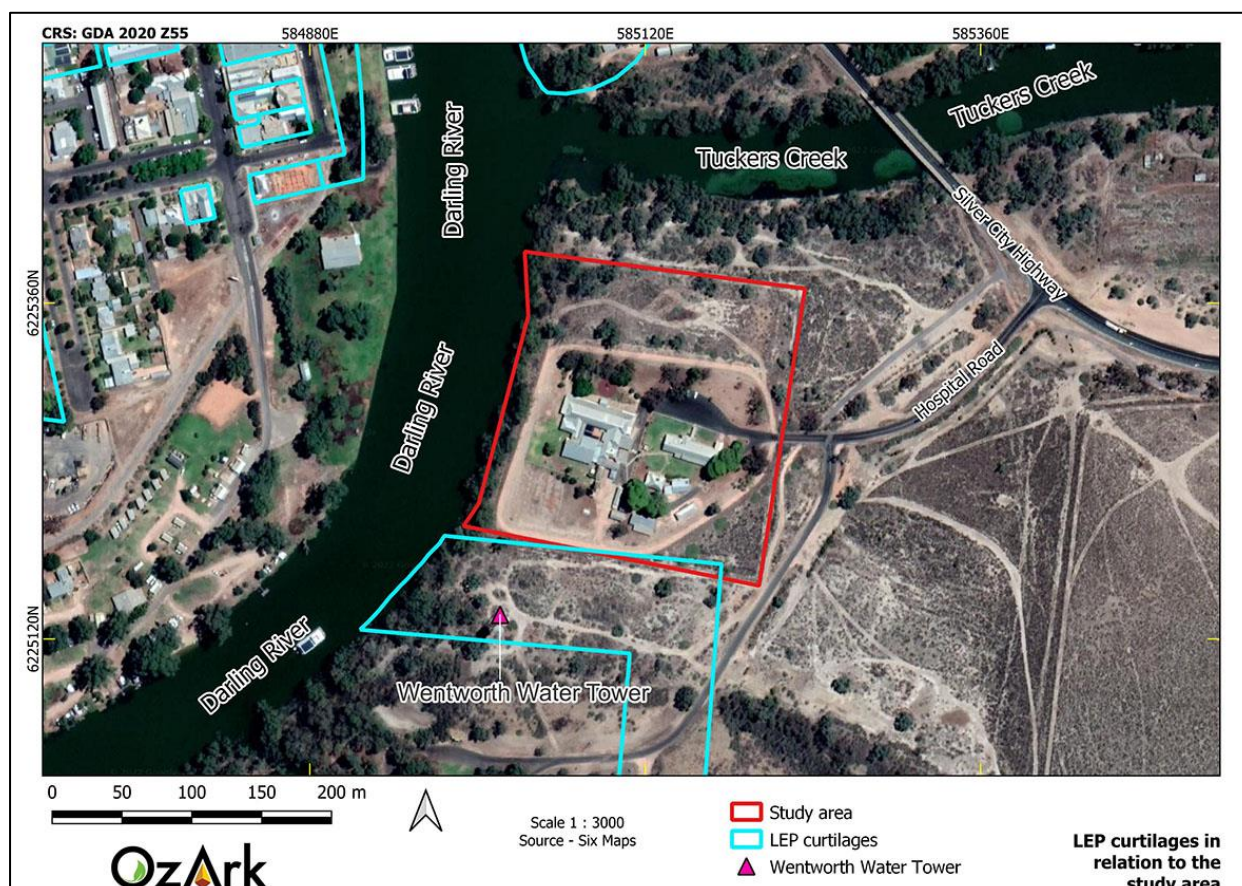
**Figure 2-7: The Wentworth Tower (I94) listing and curtilage in relation to the study area.**

In addition to this, a search of the Wentworth LEP returned one item (I94) adjacent to, and slightly overlapping, the study area. This is the Wentworth Water Tower (I94 on the Wentworth LEP), the Lot/DP curtilage for which extends slightly into the southern portion of the study area. This is likely to be a mapping error.

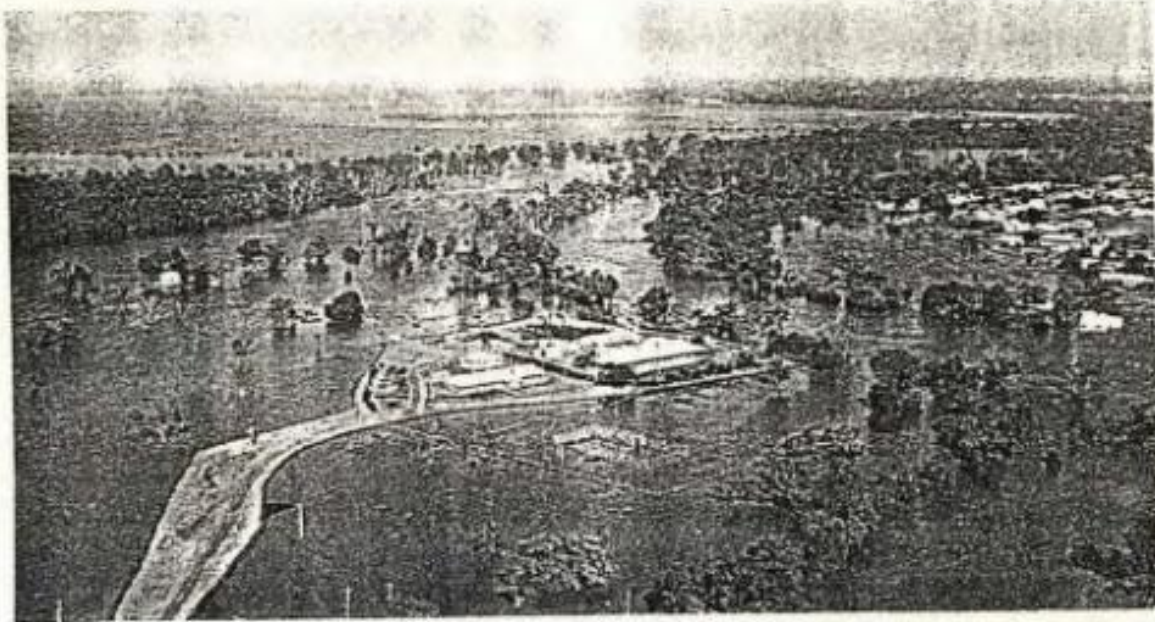
LEFT: AERIAL PHOTO OF WENTWORTH HOSPITAL SURROUNDED BY WATER DURING 1936 FLOOD. THE JUNCTION OF THE MURRAY AND DARLING CAN BE SEEN IN TOP RIGHT HAND CORNER AND TUCKERS CREEK BOTTOM RIGHT HAND.
