GEOTECHNICAL INVESTIGATION & PAVEMENT DESIGN

PROPOSED WENTWORTH HEALTH SERVICE REDEVELOPMENT
24 HOSPITAL ROAD, WENTWORTH, NSW

S22-348 REV 1
12 OCTOBER 2022

AITKEN ROWE TESTING LABORATORIES PTY LTD

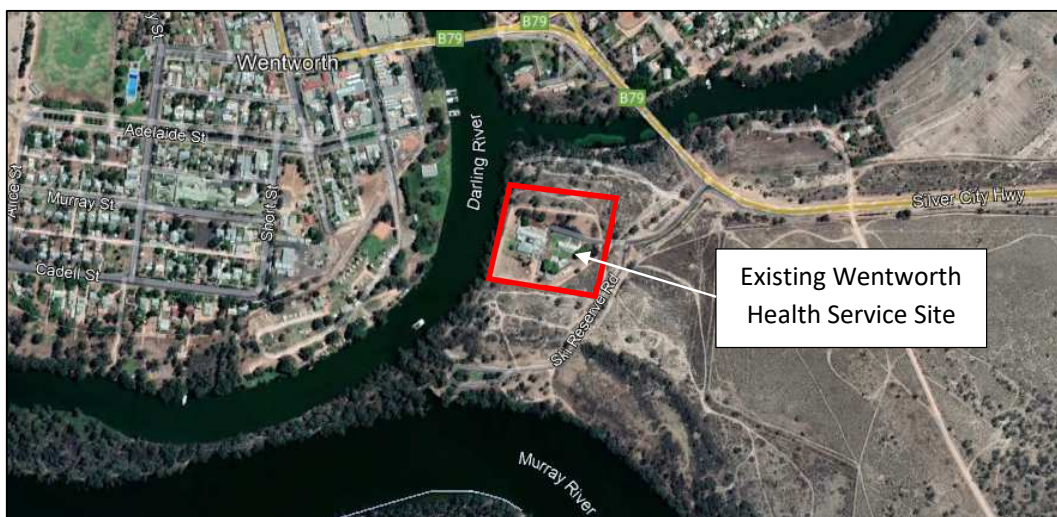
Figure 1 – The Subject Site (Google Earth Screen Image)

The site for the proposed development is located at DP 1136392, Lot 1, No. 24 Hospital Road, Wentworth, NSW approximately 0.45km south-east/east of the Wentworth town centre. The site consists of existing single-story buildings, concrete and bitumen sealed pavement areas and grassed lawn areas as part of the Wentworth hospital development which forms part of the Far West Local Health District (FWLHD). Small to large sized trees were also noted throughout the existing hospital grounds and surrounding the subject site as noted at the time of the investigation.

The subject site is surrounded by vacant land, Tucker Creek and the Silver City Highway to the north, vacant land to the east, vacant land including historic Wentworth Water Tower and Murray River to the south and the Darling River and Wentworth town centre to the west (refer to Figure 1 below). The subject site is generally flat and covered with buildings and lawn as noted at the time of the investigation. It should be noted an earthen levee bank approximately 1.5m in height above the natural ground level surrounds the exiting hospital site which was reportedly built pre the year 1956 protecting the subject site from the 1956 major flood which is reportedly the highest flood recorded in the local Wentworth area.
