Health Infrastructure Remedial Action Plan

Mental Health Unit and Emergency Department

Broken Hill Hospital

20 October 2023 63879/155,194 (Rev 0) JBS&G Australia Pty Ltd

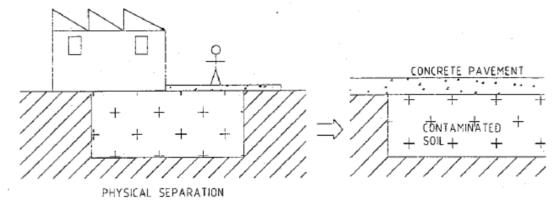
- A minimum soil cover thickness of 0.5 m in turfed areas, 0.5 m in mass planting/shallow landscaped areas, and 1.0 m in tree pit zones and on the raised levee, which is underlain by a "marker layer" in unpaved areas, i.e., parks, gardens and green open spaces etc.; or
- Permanent concrete floor/ground/wall slabs or asphaltic concrete surfaced pavements directly underlain by a "marker layer", i.e., underlying buildings, suspended slabs, roads, pathways; or
- Top (concrete) of pile foundations (no marker layer required for below pile foundations).

A conceptual sketch, sourced from ANZECC 1999¹¹⁴, is shown following:

The marker layer shall consist of a bright orange coloured non-woven polyester continuous filament or PET (such as nonwoven geotextiles) or similar with a minimum density of approximately 150 grams per square metre (or equivalent). The marker layer must:

At least 0.5 m depth capping layer in vegetated areas is required for containment of asbestos impacted soils (ANZECC 1999). Deeper capping layers have been specified in mass planting and tree pit zones to accommodate for the increased root depths of native tall grasses, shrubs and trees, and to minimise potential containment failure during future landscaping works in these areas. Furthermore, this enables the proposed finished ground surface levels of the redevelopment to be commensurate with the current ground surface levels of the hospital campus, thus eliminating additional unnecessary disturbance of asbestos impacted materials.

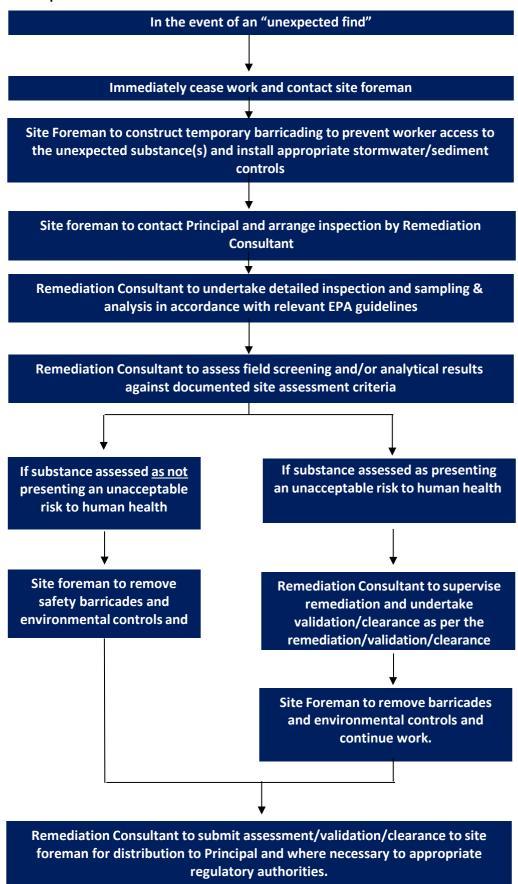
Flowchart 7.1: Unexpected Finds Protocol

As a precautionary measure to ensure the protection of the workforce and surrounding community, should any of the abovementioned substances be identified (or any other unexpected potentially hazardous substance), the procedure summarised in **Flowchart 7.1** is to be followed.
