Broken Hill Hospital Redevelopment

Results of Geotechnical Investigation

PSM4951-004R REV1

6 October 2023

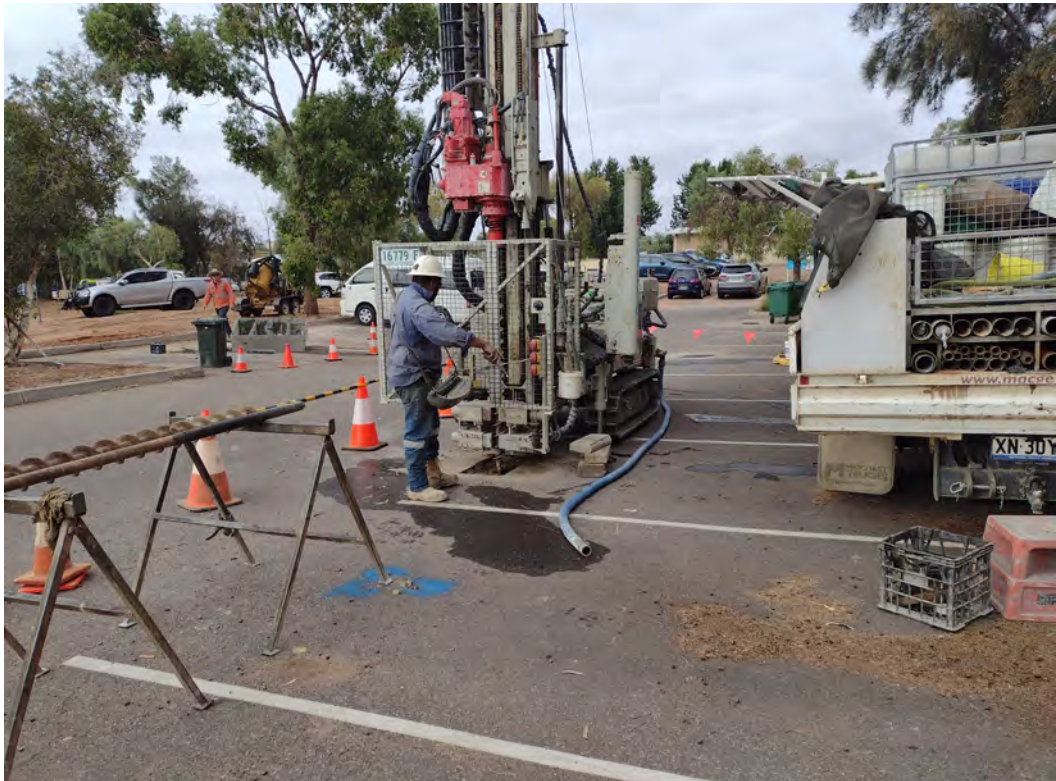
Photo 5 - General photo from fieldwork, showing drill rig set up at BH02

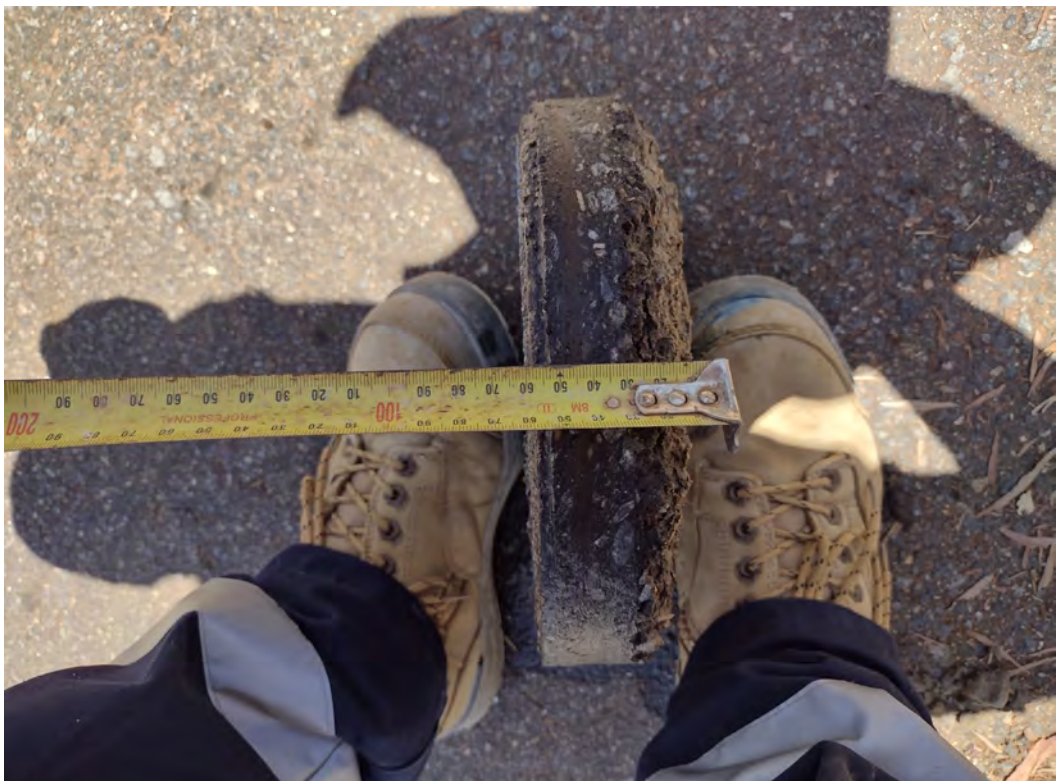
Photo 6 - General photo from fieldwork, showing a slab of pavement

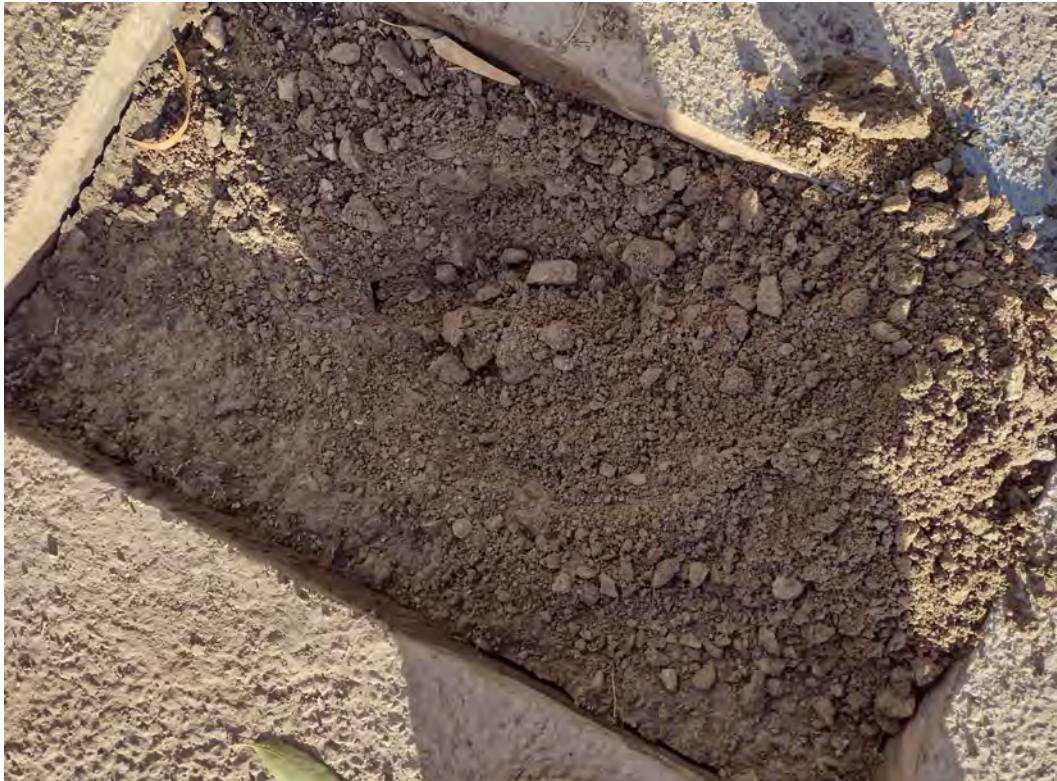
Photo 7 - General photo from fieldwork, showing typical roadbase material encountered on site

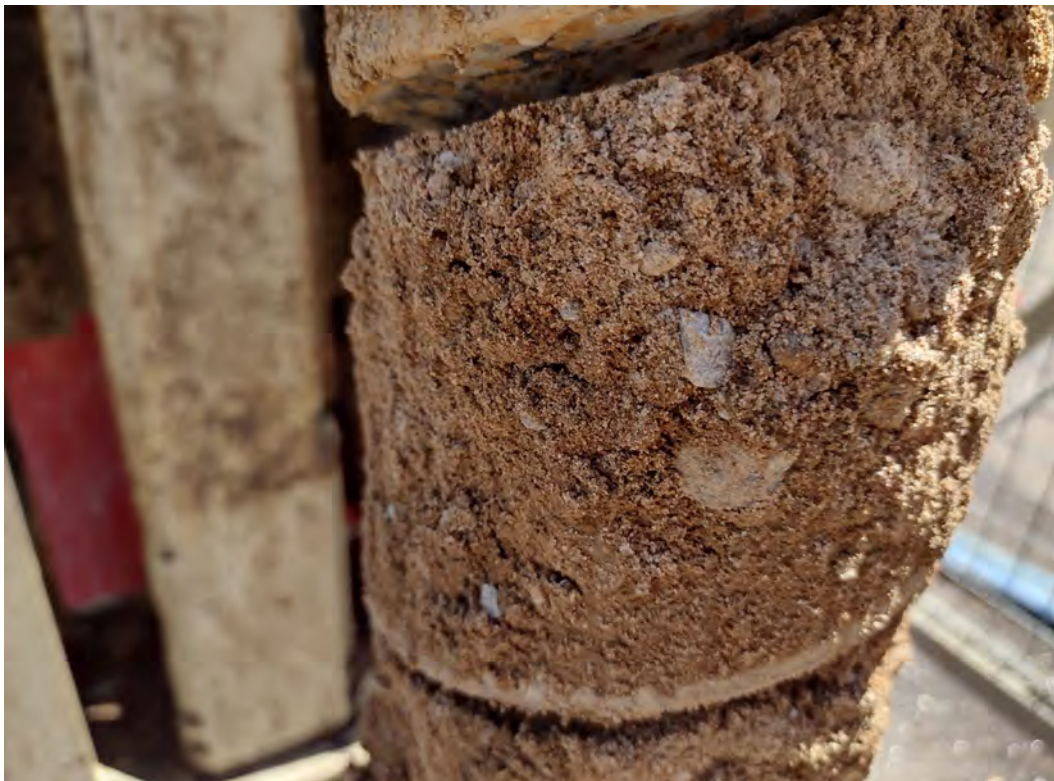
Photo 8 - General photo from fieldwork, showing typical gravelly sand FILL encountered on site

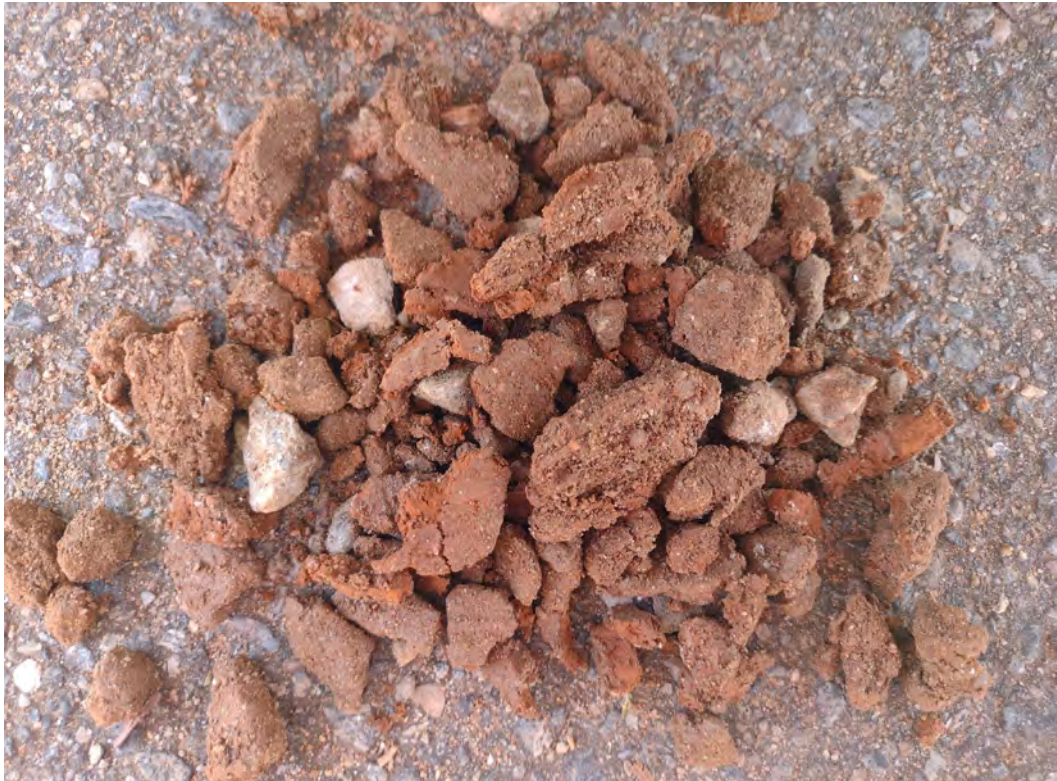
Photo 9 - General photo from fieldwork, showing typical gravelly CLAY soil encountered on site

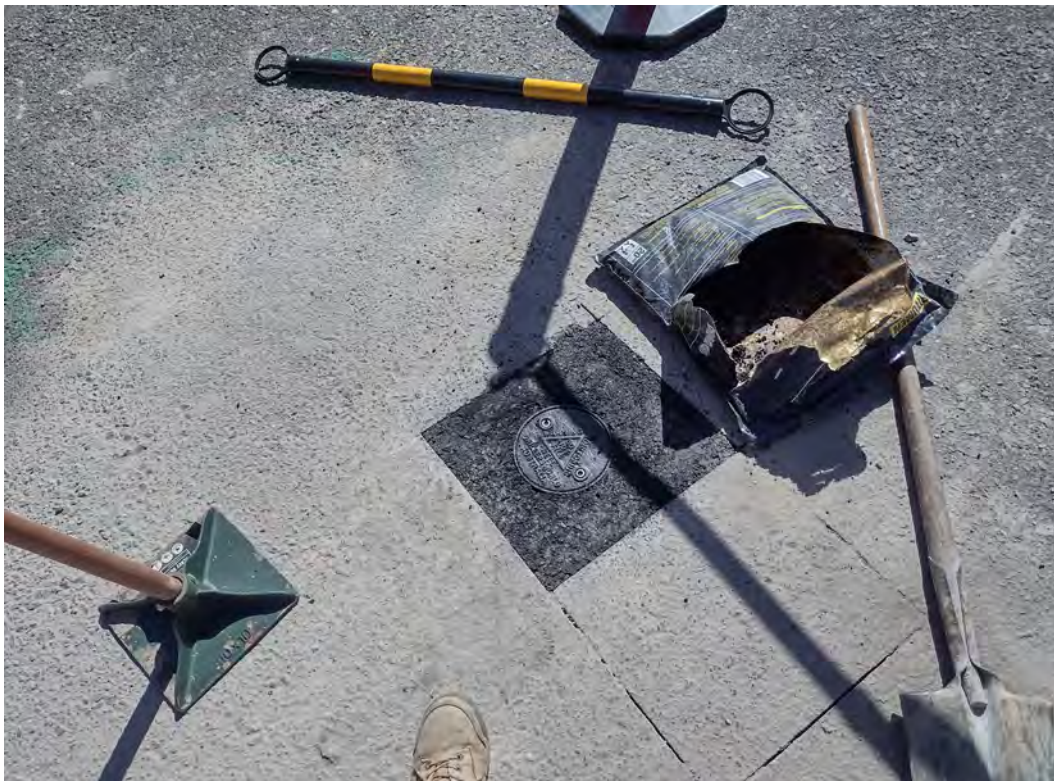
Photo 10 - General photo from fieldwork, showing well installed at BH05

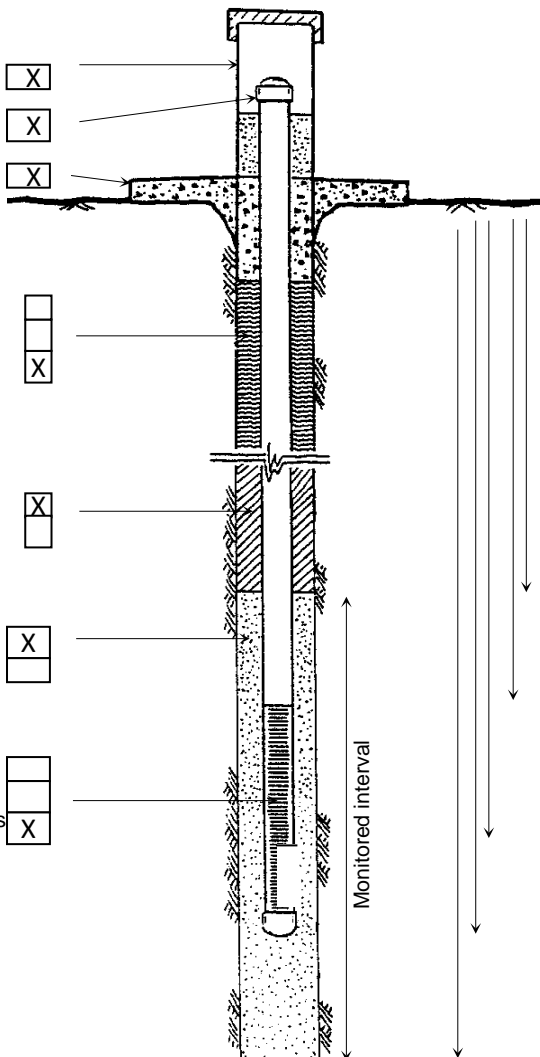
Height of stickup (m)	<u>0</u>
PVC cap	<input checked="" type="checkbox"/>		Diameter of PVC (mm)	<u>50</u>
Concrete collar	<input checked="" type="checkbox"/>			
Back fill type:				
Cement bentonite	<input type="checkbox"/>		Depth to top of seal	<u>0</u>
Soil	<input type="checkbox"/>		Depth to top of gravel pack	<u>2</u>
None	<input checked="" type="checkbox"/>		Depth to top of screen	<u>3</u>
Seal:			Depth to base of screen	<u>12</u>
Bentonite pellets	<input checked="" type="checkbox"/>		Depth to base of piezo	<u>12</u>
Other	<input type="checkbox"/>		Depth to base of gravel	<u>12</u>
Gravel type:				
2-5mm gravel	<input checked="" type="checkbox"/>			
Other	<input type="checkbox"/>			
Perforation type:				
Drill holes	<input type="checkbox"/>			
Hack saw cuts	<input type="checkbox"/>			
40um machine slots	<input checked="" type="checkbox"/>

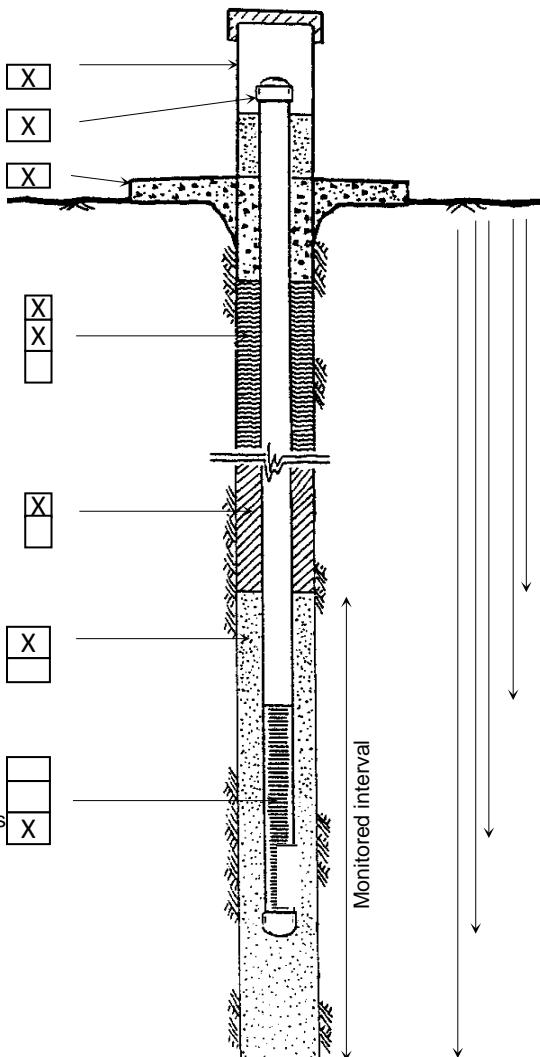
Height of stickup (m)	<u>0</u>
PVC cap	<input checked="" type="checkbox"/>		Diameter of PVC (mm)	<u>50</u>
Concrete collar	<input checked="" type="checkbox"/>			
Back fill type:				
Cement bentonite	<input checked="" type="checkbox"/>		Depth to top of seal	<u>7</u>
Soil	<input checked="" type="checkbox"/>			
None	<input type="checkbox"/>		Depth to top of gravel pack	<u>8</u>
Seal:				
Bentonite pellets	<input checked="" type="checkbox"/>		Depth to top of screen	<u>9</u>
Other	<input type="checkbox"/>			
Gravel type:				
2-5mm gravel	<input checked="" type="checkbox"/>	Depth to base of screen	<u>12</u>	
Other	<input type="checkbox"/>			
Perforation type:				
Drill holes	<input type="checkbox"/>	Depth to base of piezo	<u>12</u>	
Hack saw cuts	<input type="checkbox"/>			
40um machine slots	<input checked="" type="checkbox"/>	Depth to base of gravel	<u>12</u>

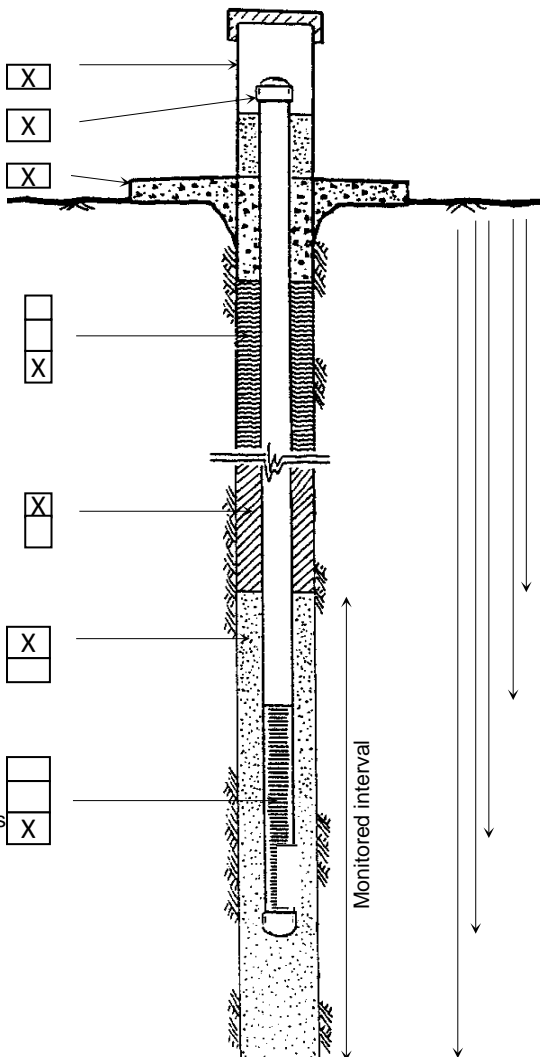
Height of stickup (m)	<u>0</u>
PVC cap	<input checked="" type="checkbox"/>		Diameter of PVC (mm)	<u>50</u>
Concrete collar	<input checked="" type="checkbox"/>			
Back fill type:				
Cement bentonite	<input type="checkbox"/>		Depth to top of seal	<u>0</u>
Soil	<input type="checkbox"/>			
None	<input checked="" type="checkbox"/>		Depth to top of gravel pack	<u>2</u>
Seal:				
Bentonite pellets	<input checked="" type="checkbox"/>		Depth to top of screen	<u>6</u>
Other	<input type="checkbox"/>			
Gravel type:				
2-5mm gravel	<input checked="" type="checkbox"/>	Depth to base of screen	<u>12</u>	
Other	<input type="checkbox"/>			
Perforation type:				
Drill holes	<input type="checkbox"/>	Depth to base of piezo	<u>12</u>	
Hack saw cuts	<input type="checkbox"/>			
40um machine slots	<input checked="" type="checkbox"/>	Depth to base of gravel	<u>12</u>

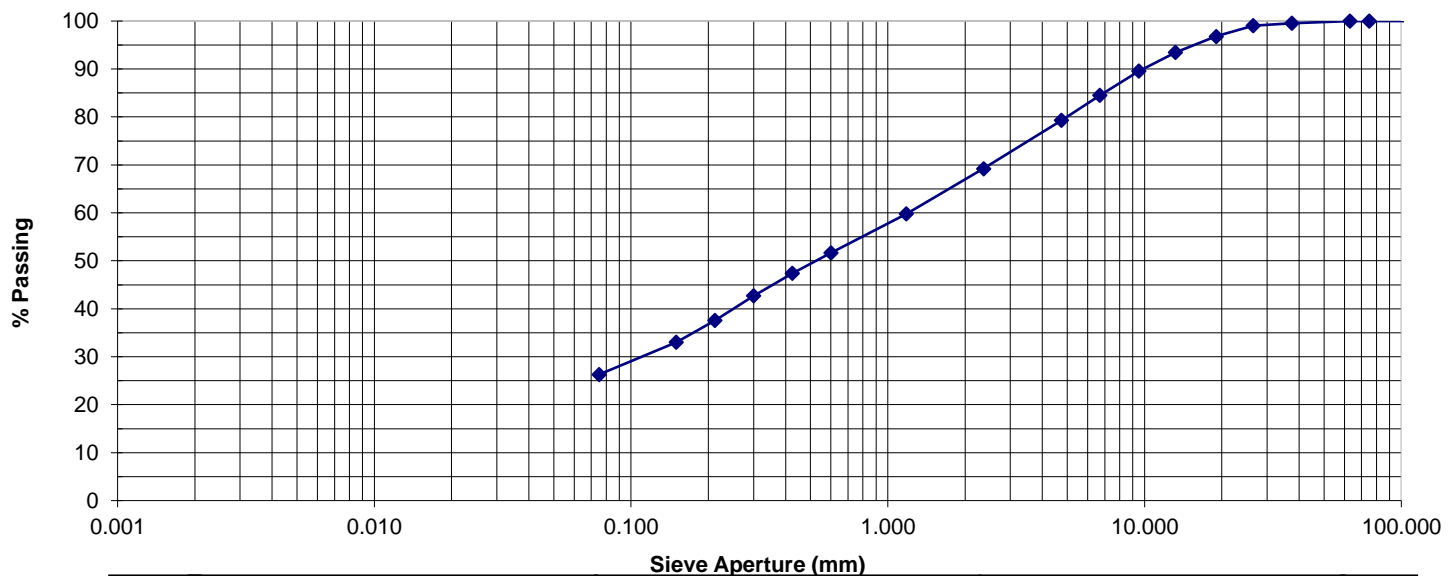
Sieve Aperture: (mm)	% Passing	Specification (..) Envelope	Sieve Aperture: (mm)	% Passing	Specification (..) Envelope
200	100		4.75	79	
75	100		2.36	69	
63	100		1.18	60	
37.5	100		0.600	52	
26.5	99		0.425	47	
19	97		0.300	43	
13.2	93		0.212	38	
9.5	90		0.150	33	
6.7	85		0.075	26
