Health Infrastructure  
Air Quality Assessment

Mental Health Unit and  
Emergency Department  
Broken Hill Hospital  
Broken Hill, NSW

20 October 2023

63879/151558 (Rev 1)  
JBS&G Australia Pty Ltd

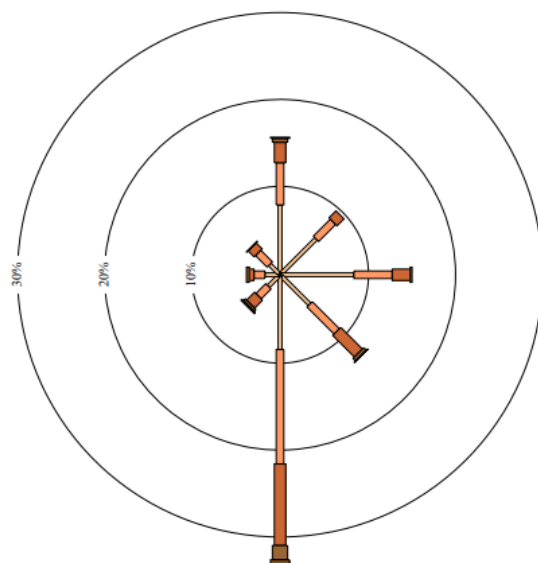
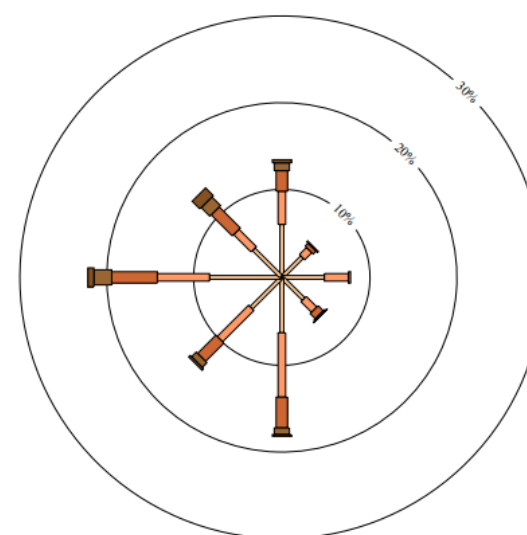
# Plate 3.1: Wind Speed Versus Direction Plot Recorded at Broken Hill (Patton Street) Weather Monitoring Station (047007) from 1959 to 2015

A review of average climatic data for the nearest Bureau of Meteorology monitoring location (Broken Hill Patton Street<sup>8</sup>) indicates the site is located within the following meteorological setting:

## Rose of Wind direction versus Wind speed in km/h (01 May 1959 to 01 Sep 2015)

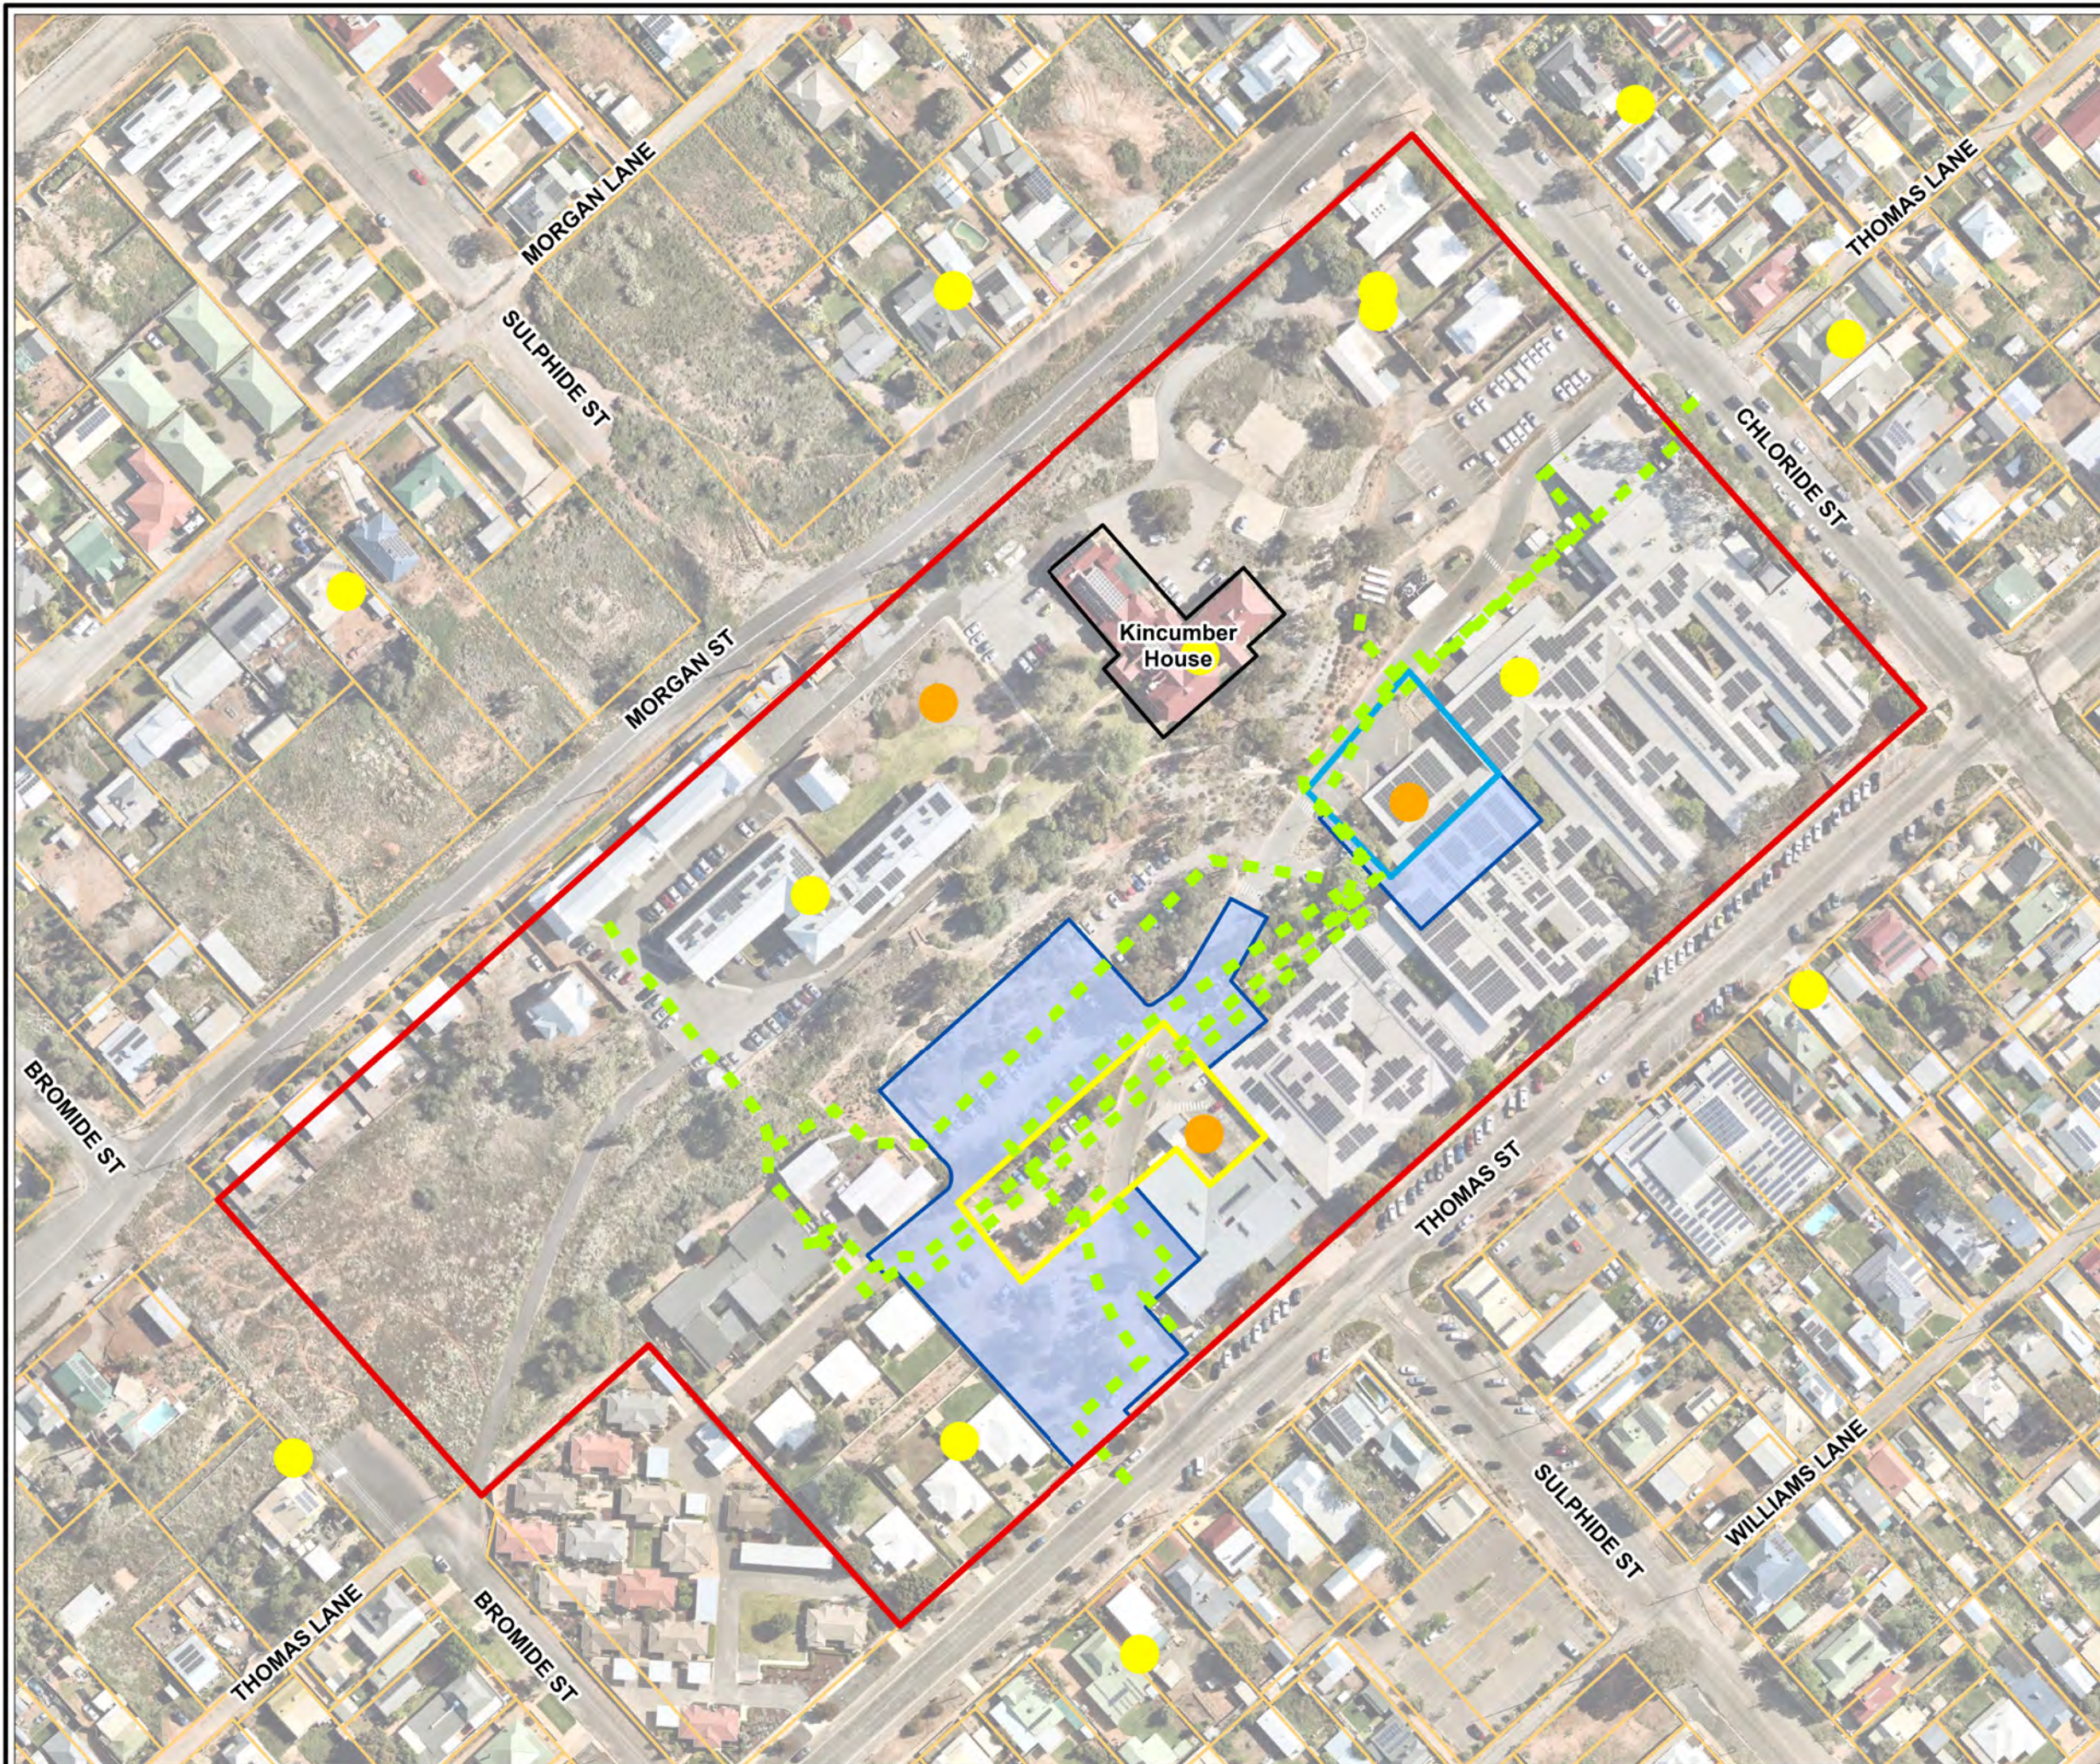
**FIGURE 2**

As discussed above, the site is proposed to be developed for ongoing hospital use, with Main Works comprising the construction of a new MHU and ED upgrade. The anticipated footprint of the Main Works areas are shown on **Figure 2** and detailed design plans are provided in **Appendix A**.

**SITE LAYOUT**

Site Legal Identifier (as shown on Figure 2)	Lot 4376 in DP 757298
Site Address	176 Thomas Street, Broken Hill, NSW 2880
Site Area	11,000 m <sup>2</sup>
Local Government Authority	City of Broken Hill
Approximate Coordinates (GDA 94 Map Grid of Australia (MGA) 54)	Easting: 542964.791 Northing: 6465282.82
Registered Site Owner	Health Administration Corporation
Current Zoning	Zone R1 – General Residential ( <i>Broken Hill Local Environmental Plan 2013</i> )
Previous Land Uses	Vacant Land
Current Land Uses	Health Service
Proposed Land Uses	Health Service
