**REPORT TO
HEALTH INFRASTRUCTURE**

**ON
GEOTECHNICAL INVESTIGATION**

**FOR
PROPOSED EUROBODALLA REGIONAL HOSPITAL
EARLY WORKS**

**AT
LOT 2 DP1281576, PRINCES HIGHWAY,
MORUYA, NSW**

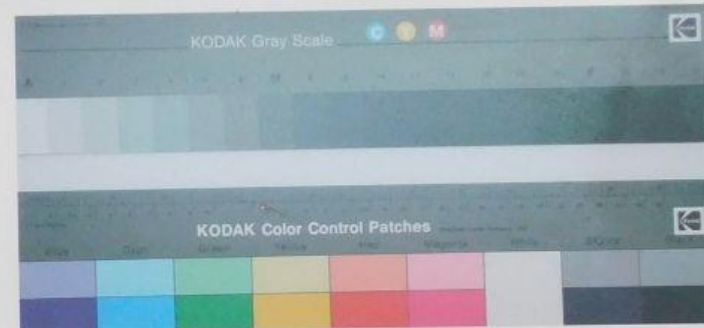
Job No: 33942LT
Borehole No: 16
Depth: 7.80m - 10.64m

Job No 33942LT BH16 START DEPTH AT 7.8m

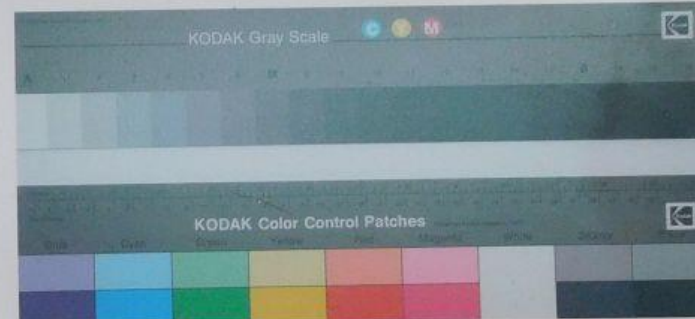
Borehole No: 30

JOB No. 33942LT BH30 START DEPTH AT 7.7m

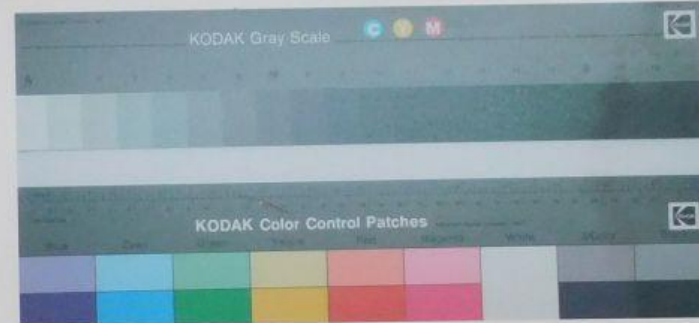
Borehole No: 35

Job No. 33942LT BH 35 START DEPTH AT 8.7m

> NO CORE 0.35m
