PRELIMINARY SALINITY ASSESSMENT

PROPOSED SOIL CONSERVATION WORKS

LOT 2 DP1281576, PRINCES HIGHWAY, MORUYA, NSW

Date: 14 December 2022 Ref: E33942PL2rpt4Rev1-SAL

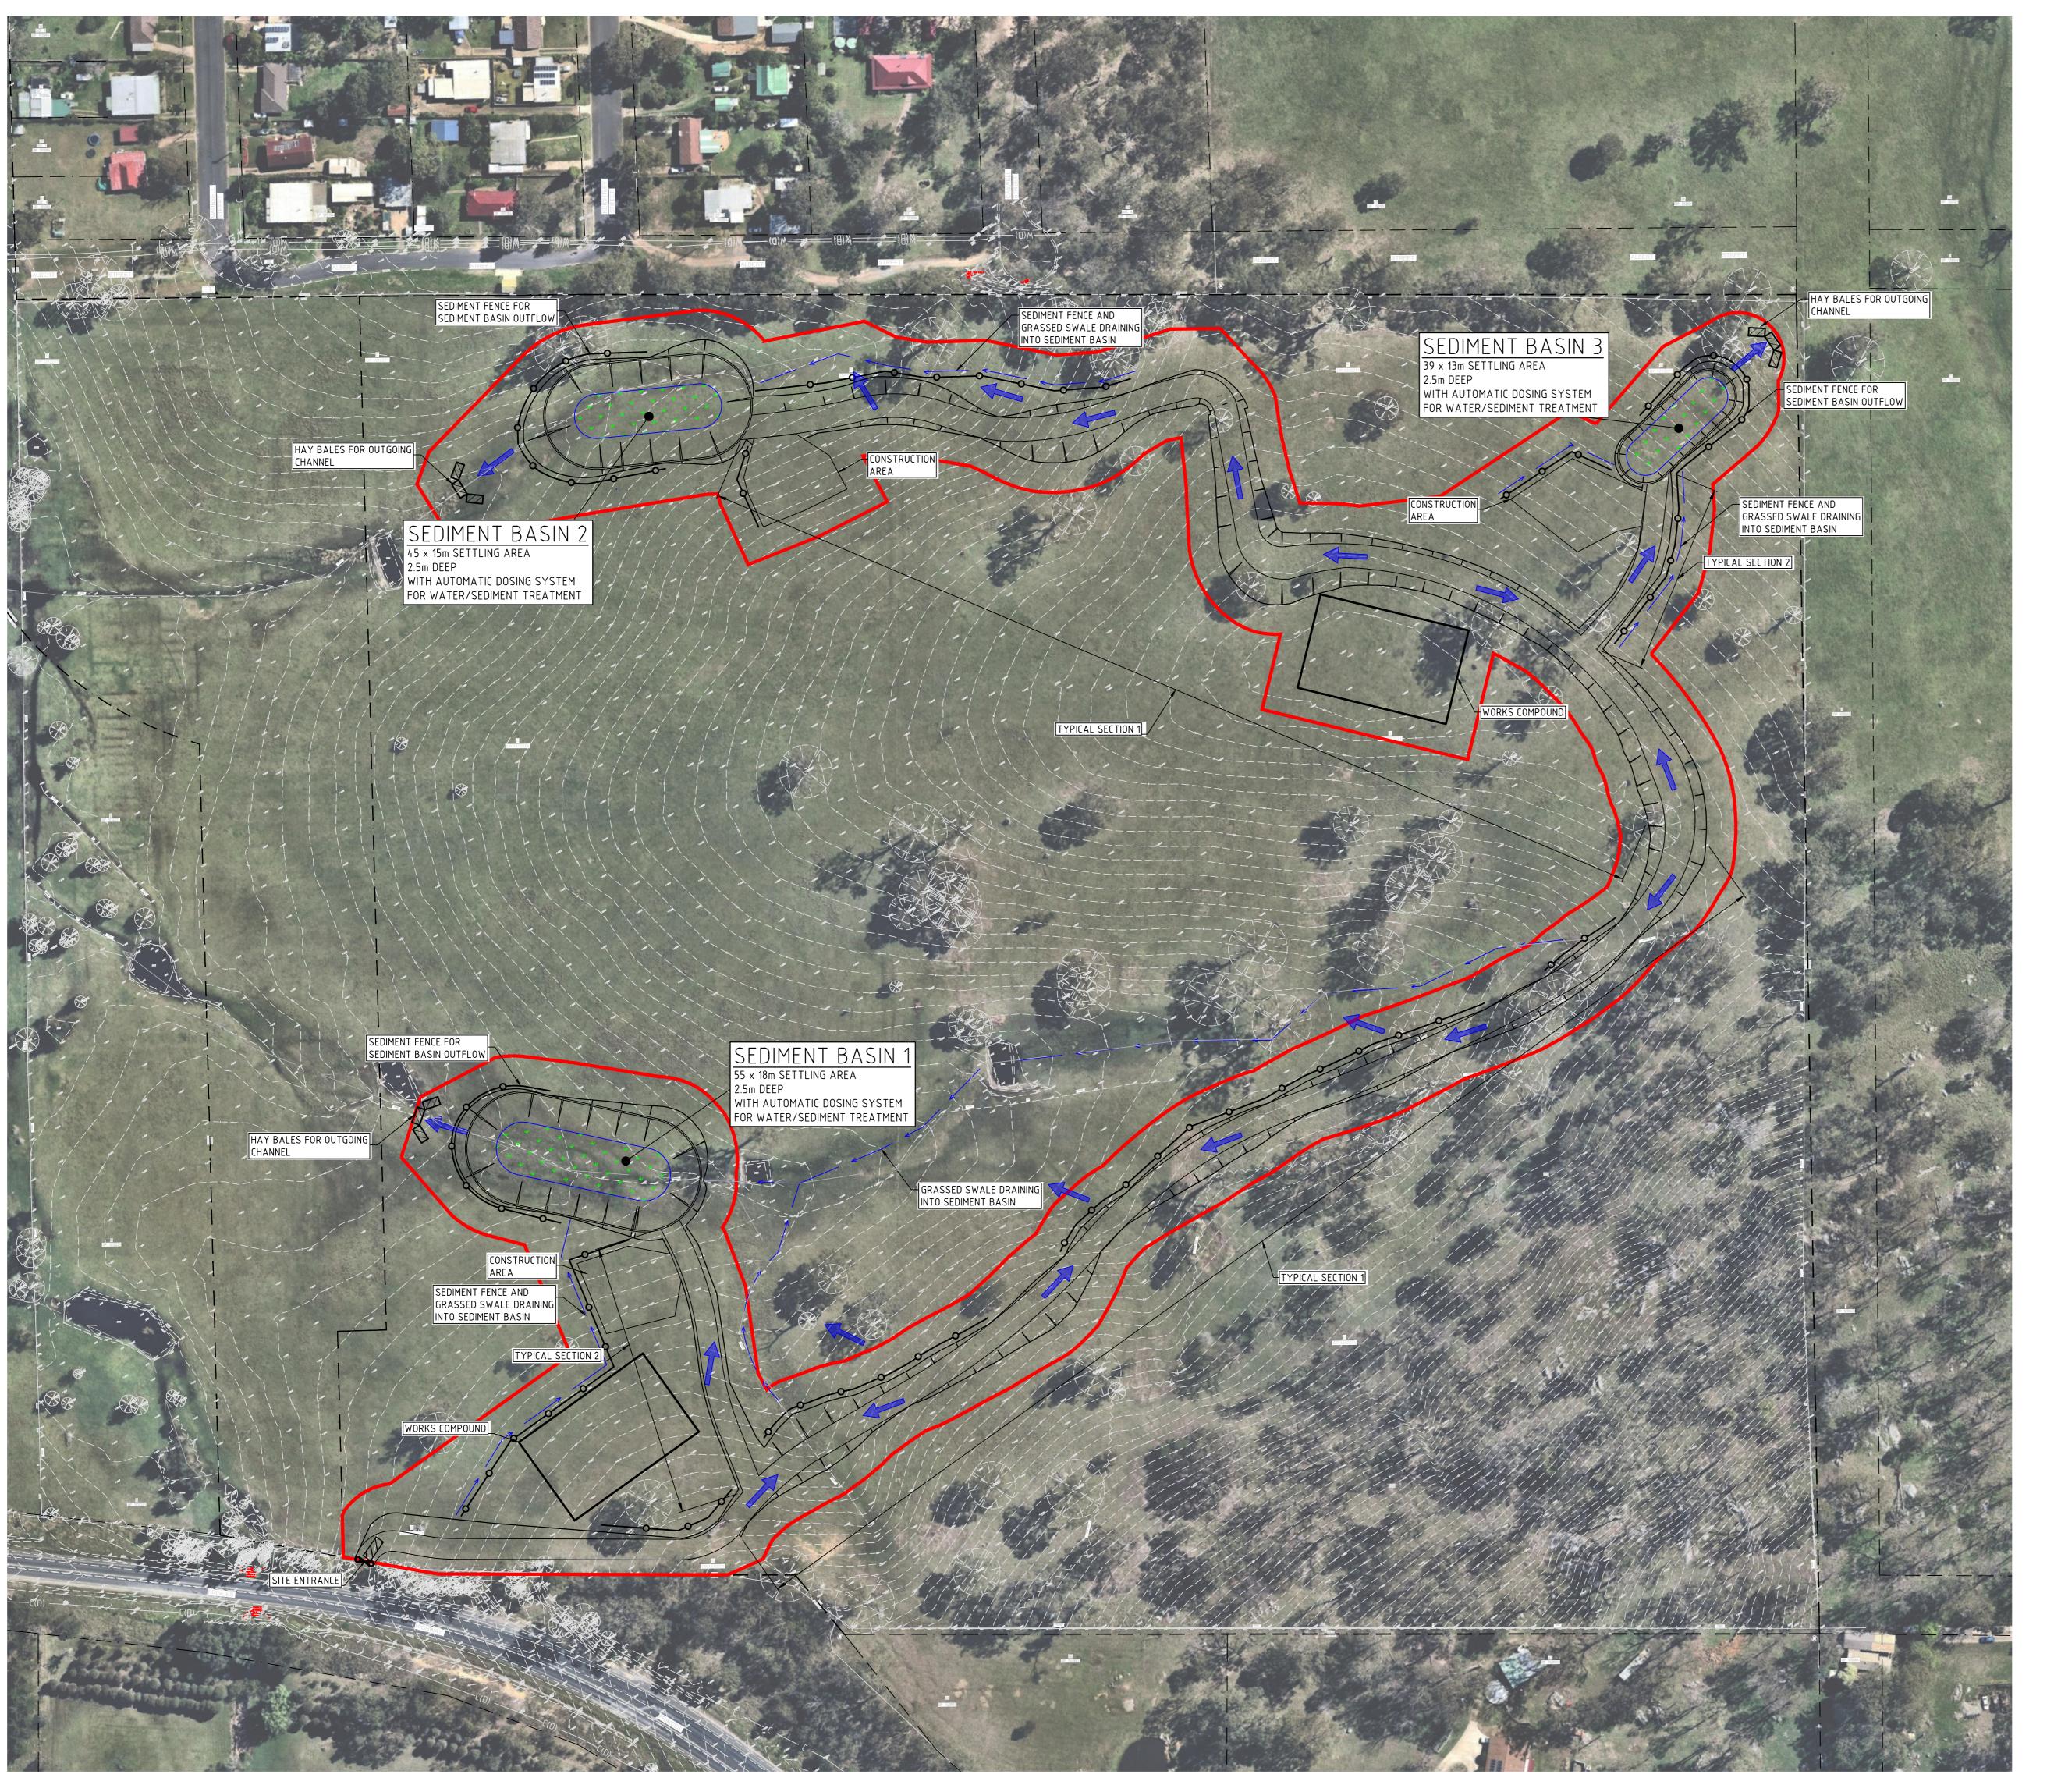
EXISTING SURFACE CONTOUR EARLY WORKS DESIGN CONTOUR LOT BOUNDARY SEDIMENT BASIN SETTLING AREA TEMPORARY SHAKER RAMP FOR ENTRY/EXIT OVERLAND FLOW SWALE DRAIN WORKS EXTENT (TOTAL AREA: 6.5Ha) WORKS COMPOUND

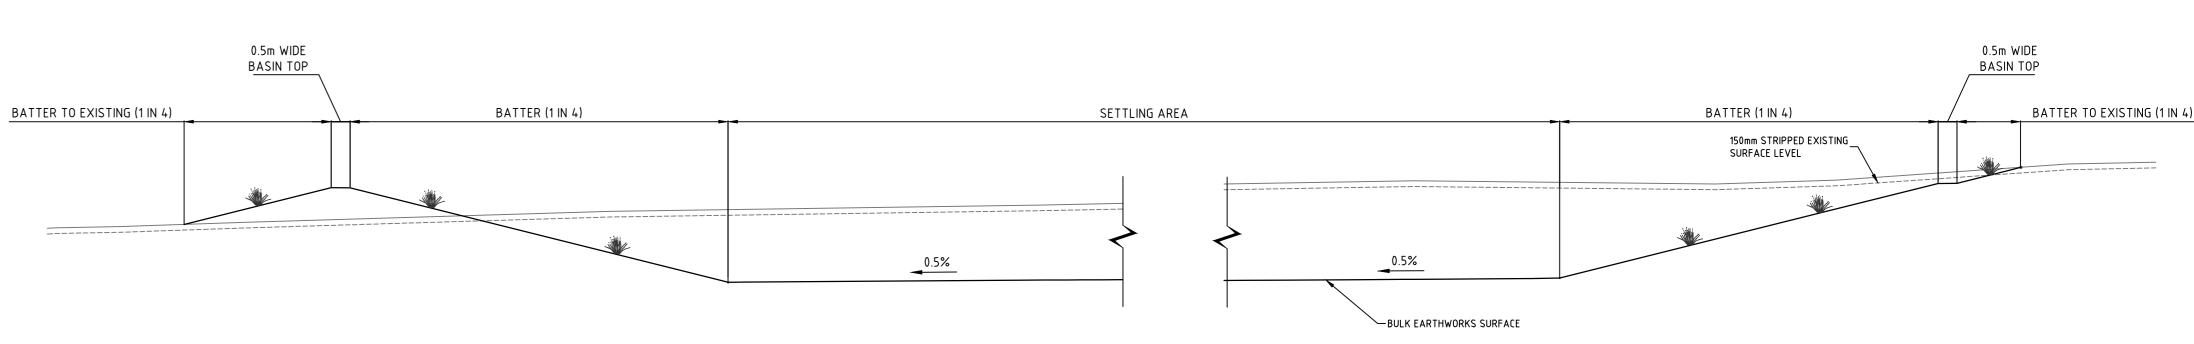
SEDIMENT BASIN TYPICAL SECTION
