**REPORT TO
HEALTH INFRASTRUCTURE**

**ON
DETAILED SITE INVESTIGATION (DSI)**

**FOR
PROPOSED SOIL CONSERVATION WORKS**

**AT
LOT 2 DP1281576, PRINCES HIGHWAY, MORUYA,
NSW**

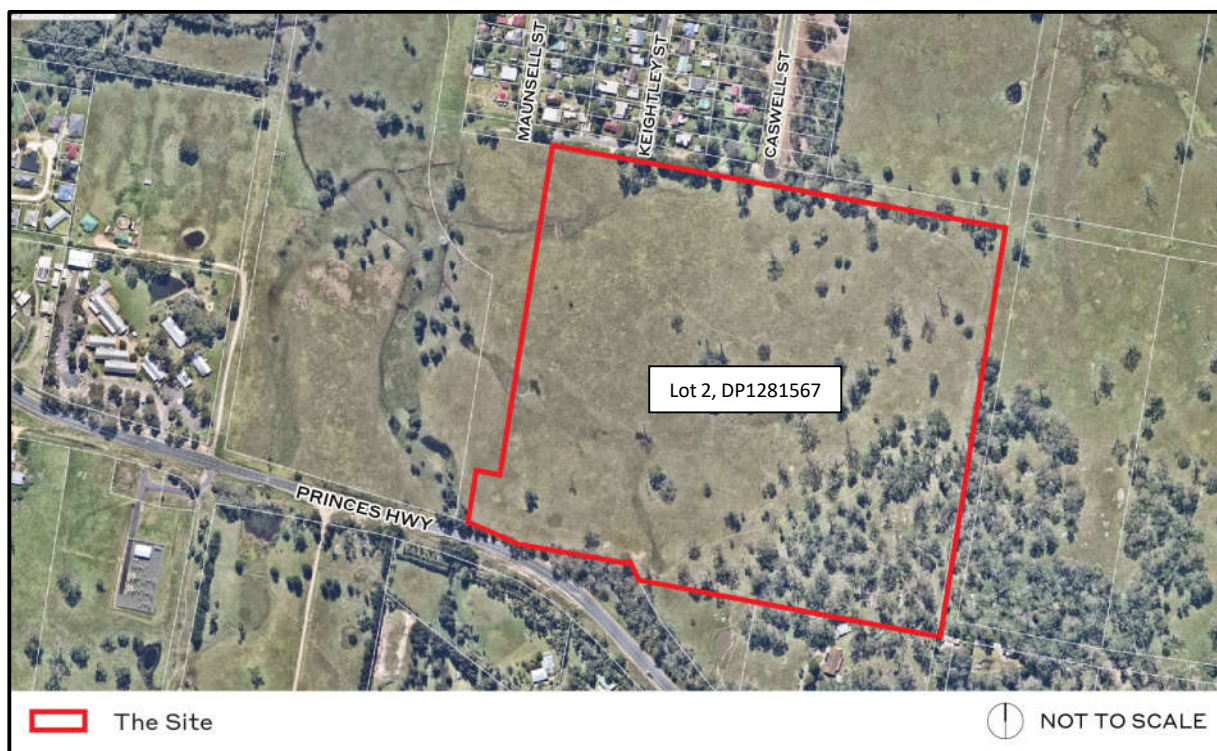
Plate 1: Proposed site location.
