**REPORT TO  
HEALTH INFRASTRUCTURE**

**ON  
PRELIMINARY SITE INVESTIGATION (DESKTOP  
CONTAMINATION ASSESSMENT)**

**FOR  
PROPOSED SOIL CONSERVATION WORKS**

**AT  
LOT 2 DP1281576, PRINCES HIGHWAY, MORUYA,  
NSW**

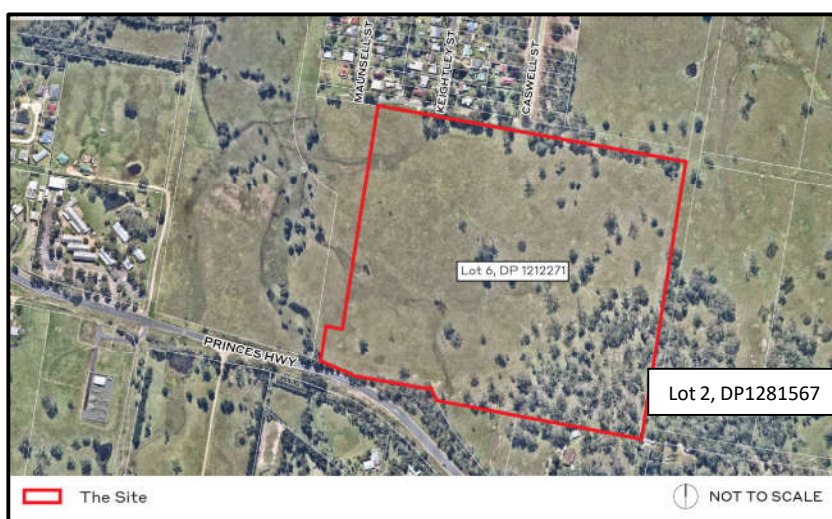
**Plate 1:** Proposed site location.

The site of the soil conservation works, and ancillary road works is located on the Princes Highway in the NSW south coast town of Moruya. The site is legally described as Lot 2 DP 1281576 and is a large vacant greenfield site. The soil conservation works will facilitate the ongoing management of the greenfield lot. To the west of the site is Moruya TAFE, and to the north is a small residential subdivision called Mynora Estate. An aerial figure of the site is shown in **Plate 1** below.

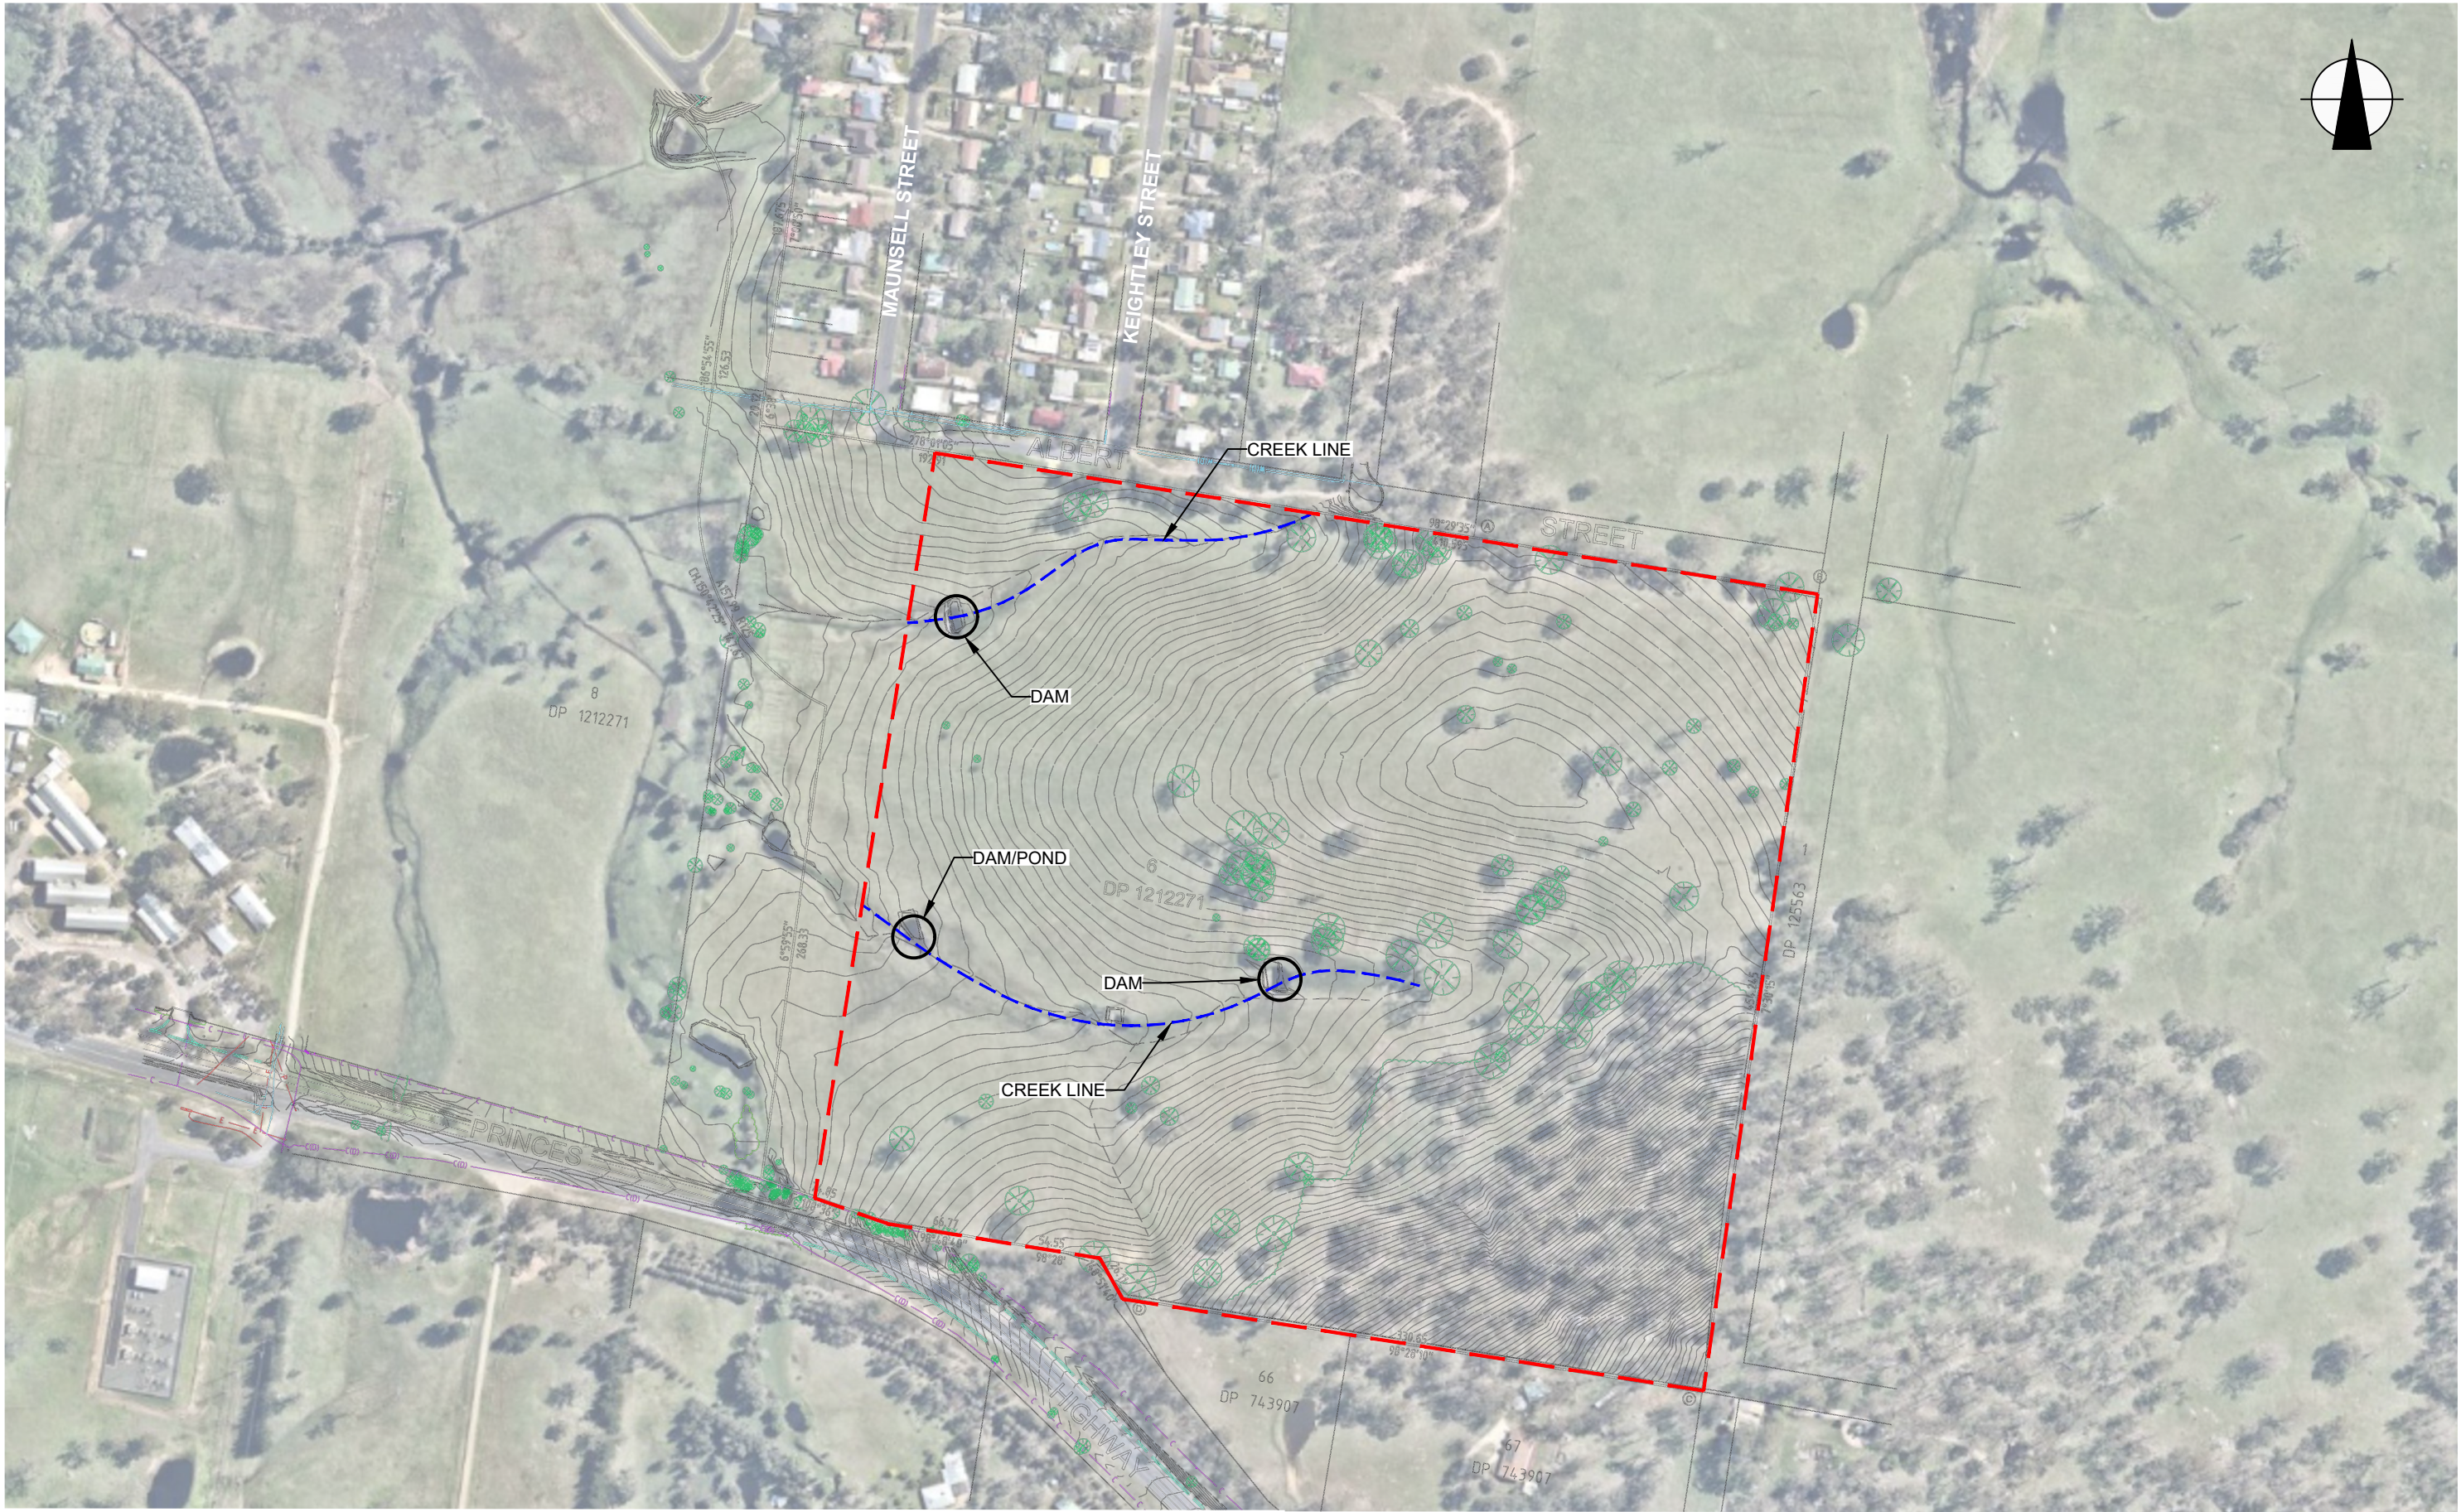
Project Name	SOIL CONSERVATION WORKS PRINCES HWY, MORUYA NSW 2537		REF SUBMISSION			
Drawing Title	Designed	AM	Approved	Date	North	
	Drawn	DN	SN	NOV. 2022

Scale AS SHOWN					
	Date	NOV. 2022	Project Ref	Drawing No	Rev	
	Sheet	A0	ERH-HV-CV-DWG-DD-01-PW-0521 B

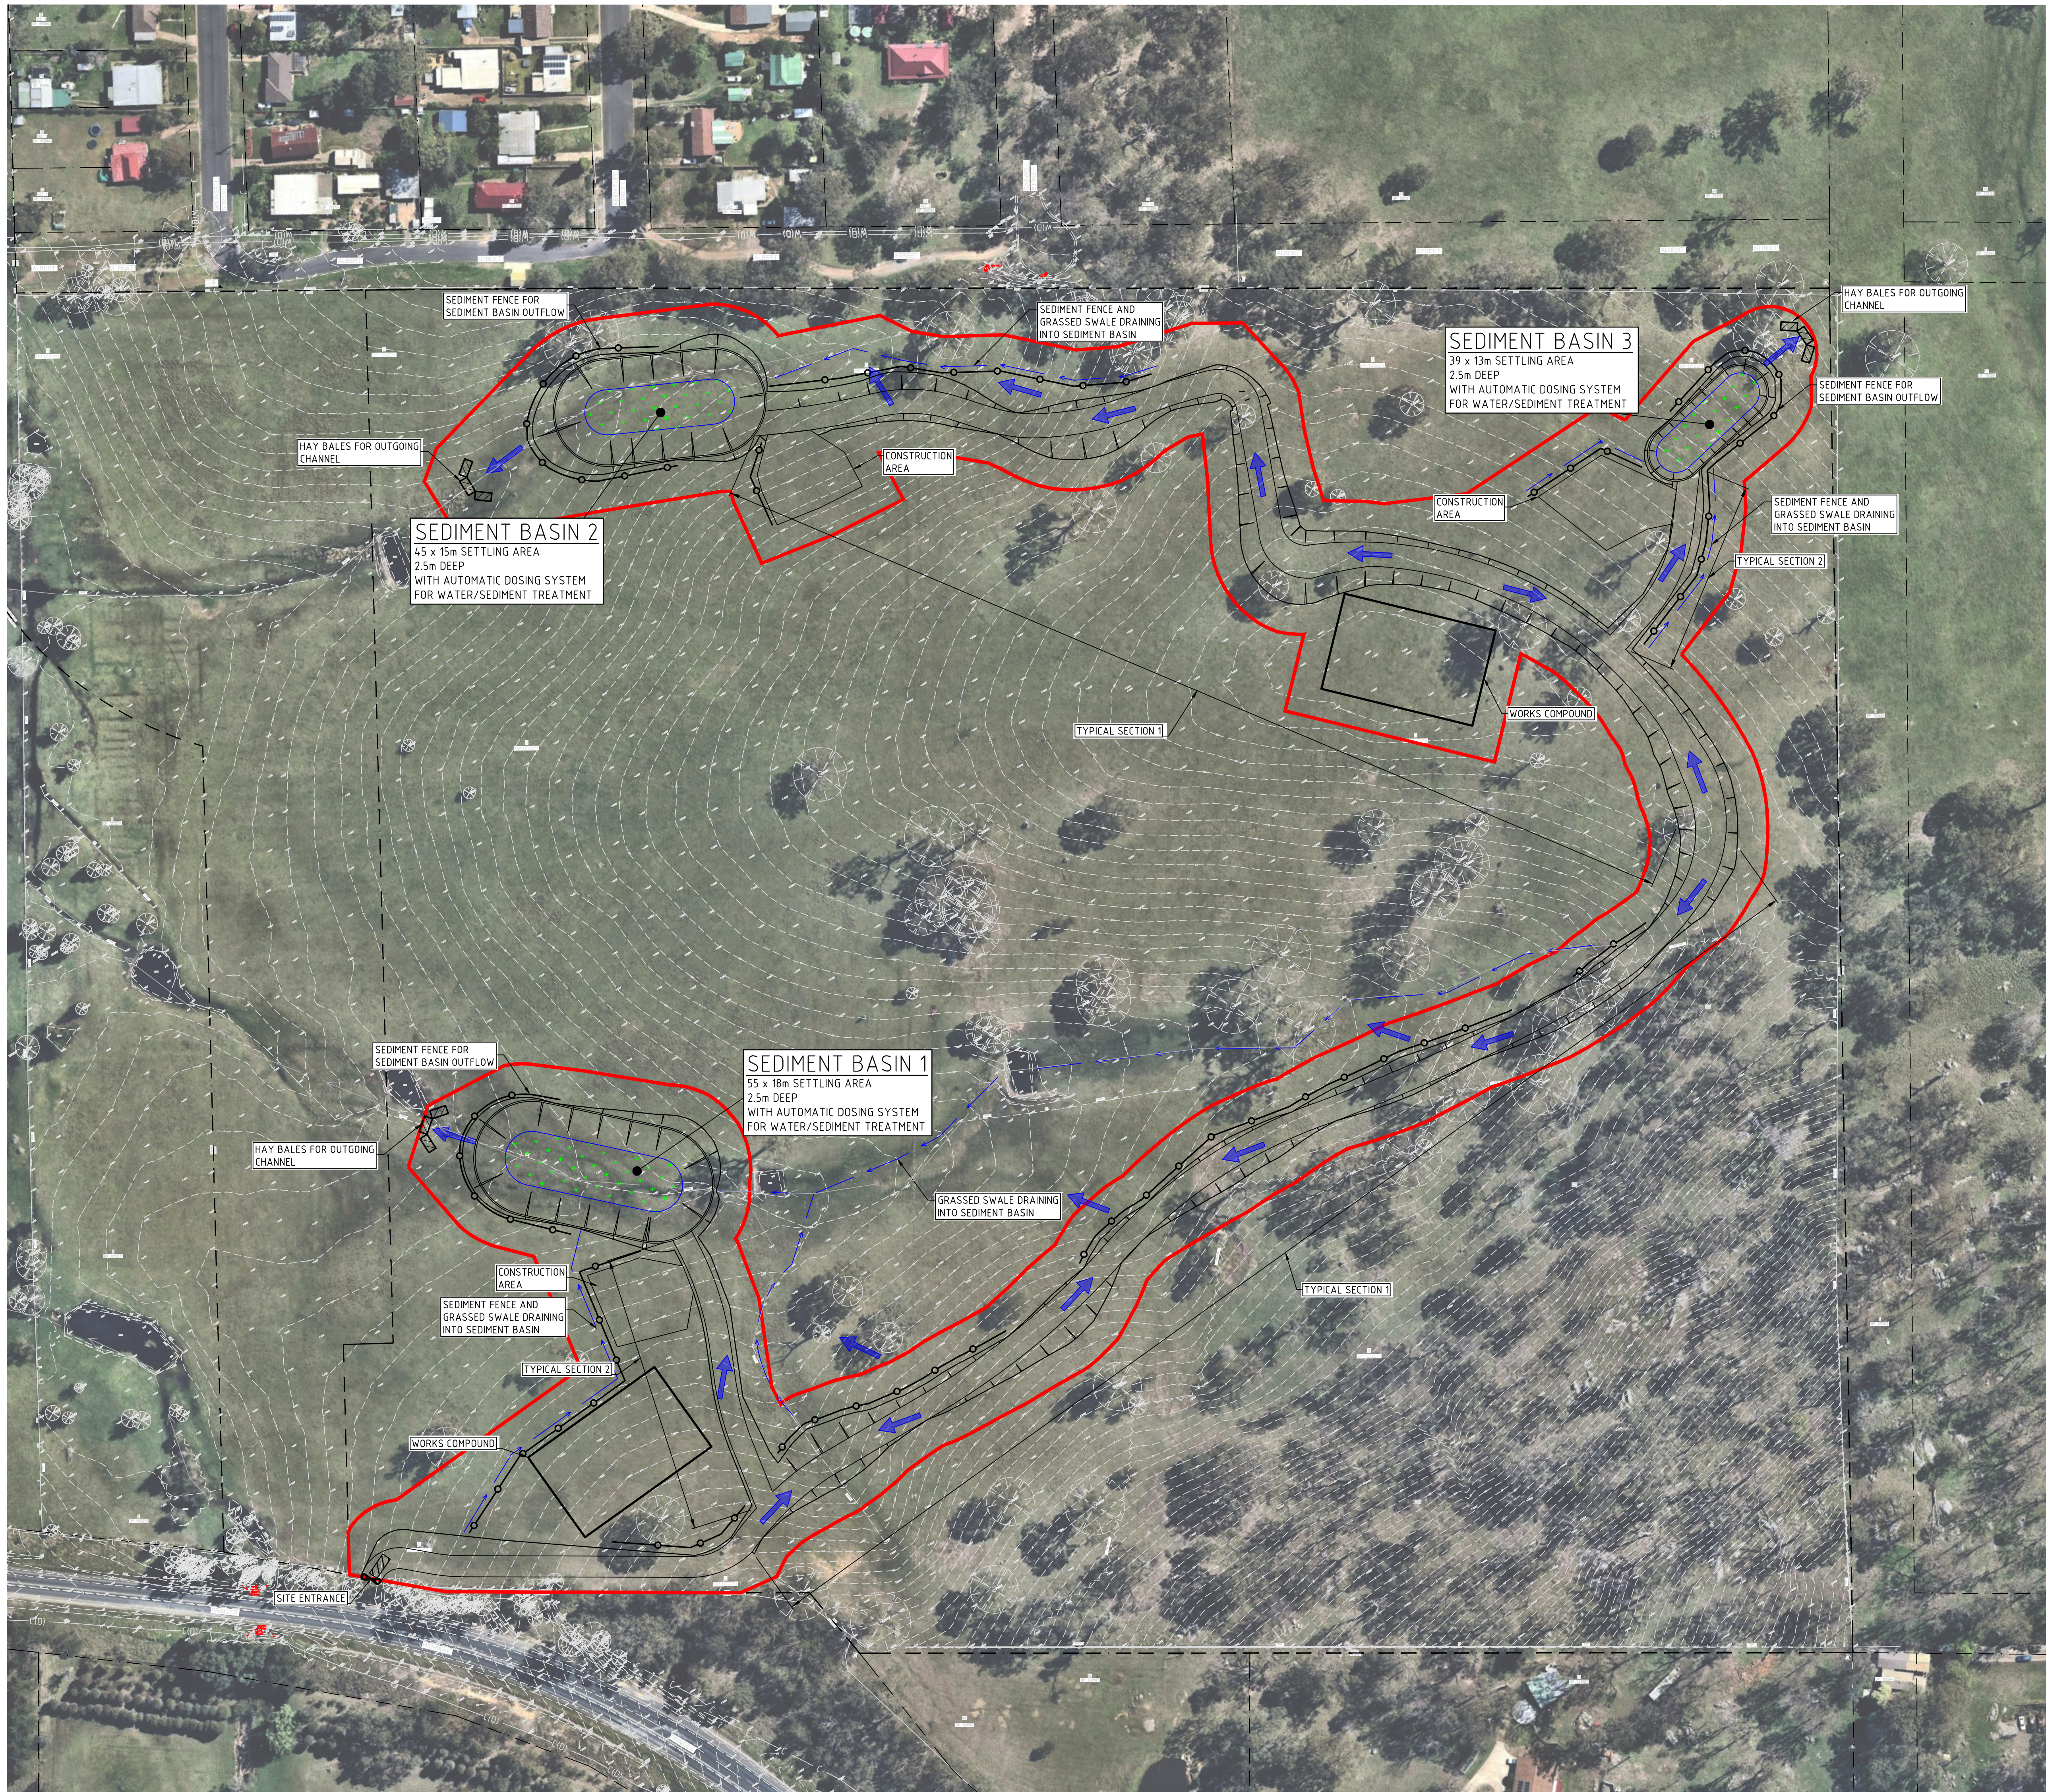
Figure B29 – Auckland-type floating decant system for Type A basins

DECANT SYSTEM TYPICAL DETAIL (EMPTYING FOR HIGH LEVEL)  
N.T.S

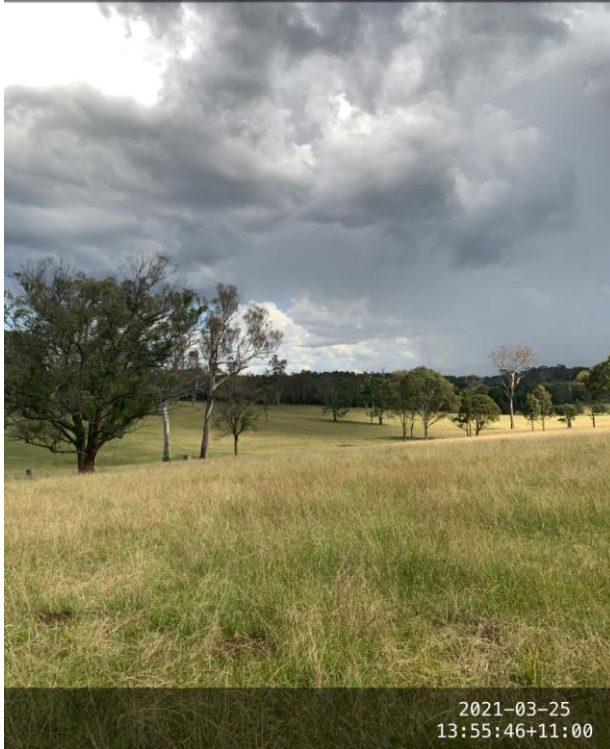
**Photograph 1:** Taken from the north-east hill peak, facing south-west. Note slope of the site down towards the distributary of Racecourse Creek.

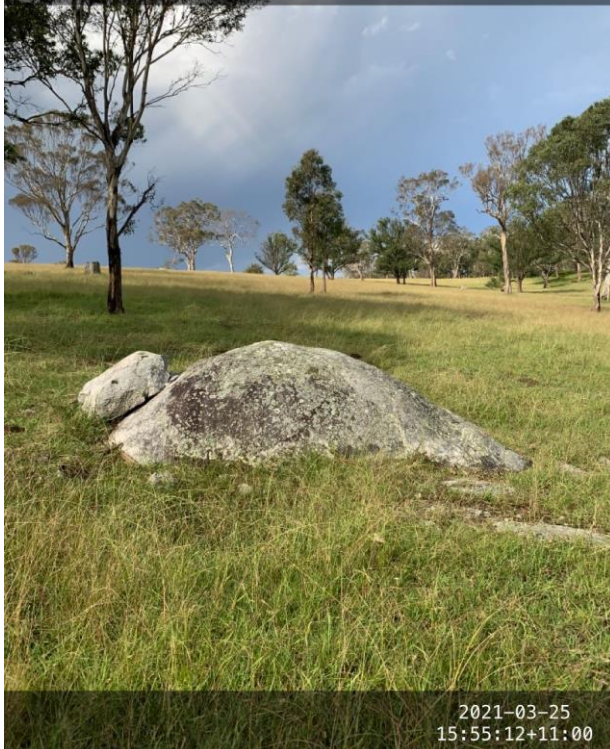
**Photograph 2:** Taken showing an example of granite outcropping at the surface, facing east. This outcropping was evident in various locations across the site.

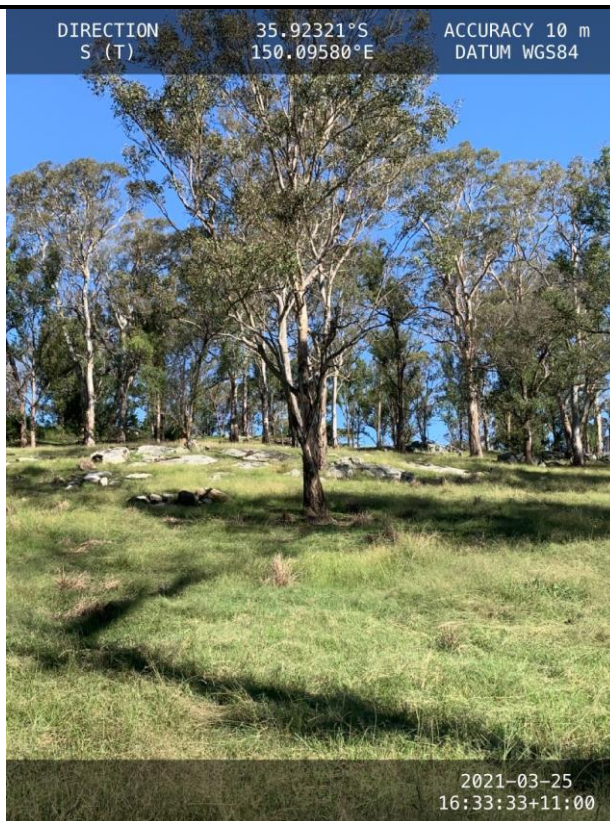
**Photograph 3:** Taken showing the south-western corner of the site, facing south. Note the steep slope of the hillside which was densely vegetated with extensive granite outcropping was visible in this area.

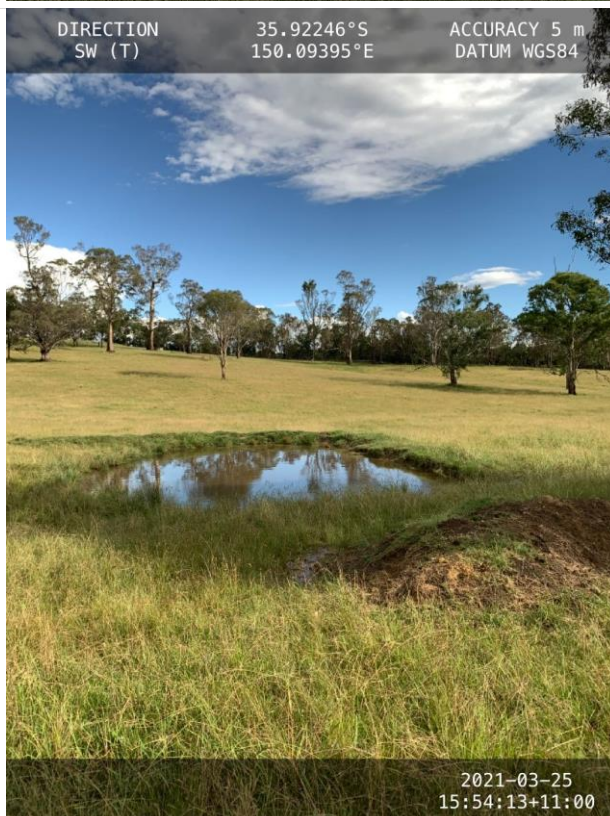
**Photograph 4:** Taken showing an example of one of the several dams across the site. Note the soil pushed to form a batter to create the dam.

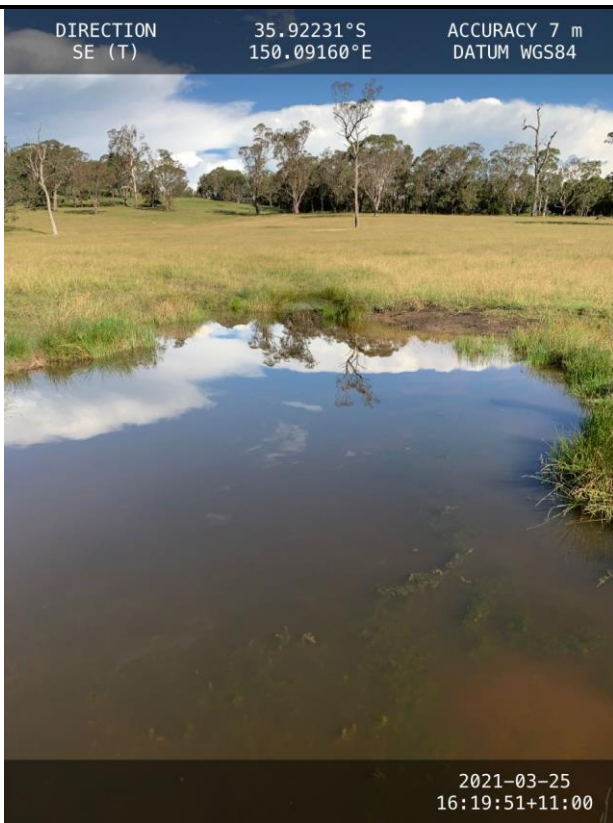
**Photograph 5:** Taken showing the one of the several dams across the site. Aquatic vegetation and fish were visible in the majority of these dams.

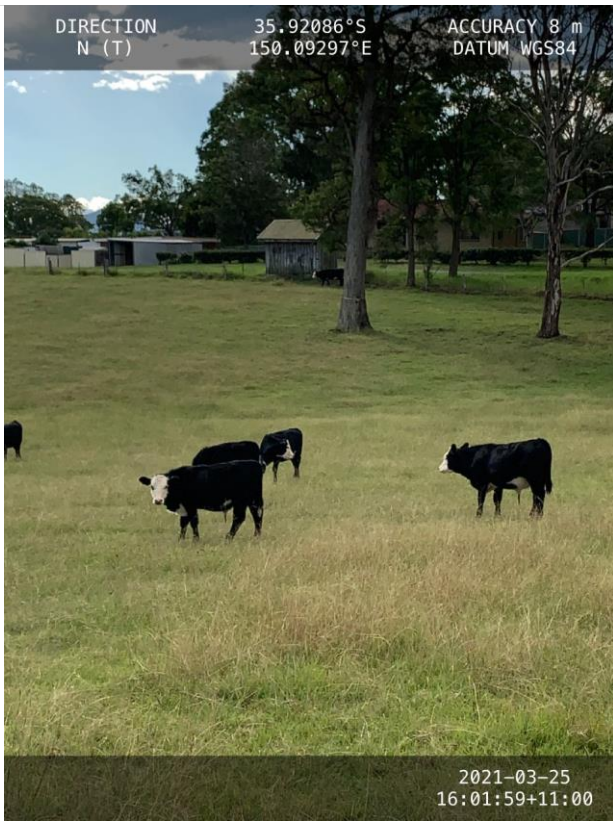
**Photograph 6:** Taken showing the northern portion of the site, facing north. Note the residential properties beyond the boundary of the site.
