Hospital Road REF Works Arboricultural Impact Assessment

Health Infrastructure

| Project Name | Hospital Road REF Works - Arboricultural Impact Assessment |

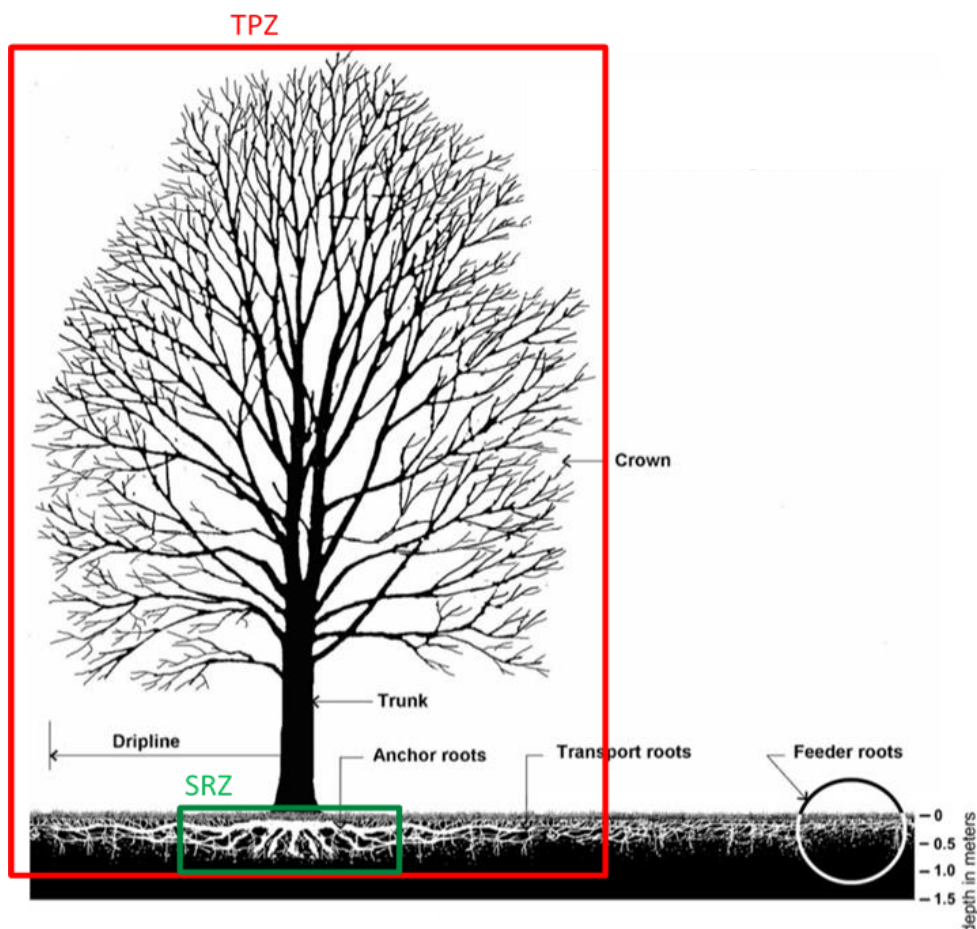
Figure 3: Representative tree structure and indicative TPZ and SRZ

The SRZ is the area of the root system (as defined by AS 4970-2009) used for stability, mechanical support and anchorage of the tree. It is critical for the support and stability of trees. Severance of roots within the SRZ is not recommended as it may lead to the destabilisation and/or decline of the tree.

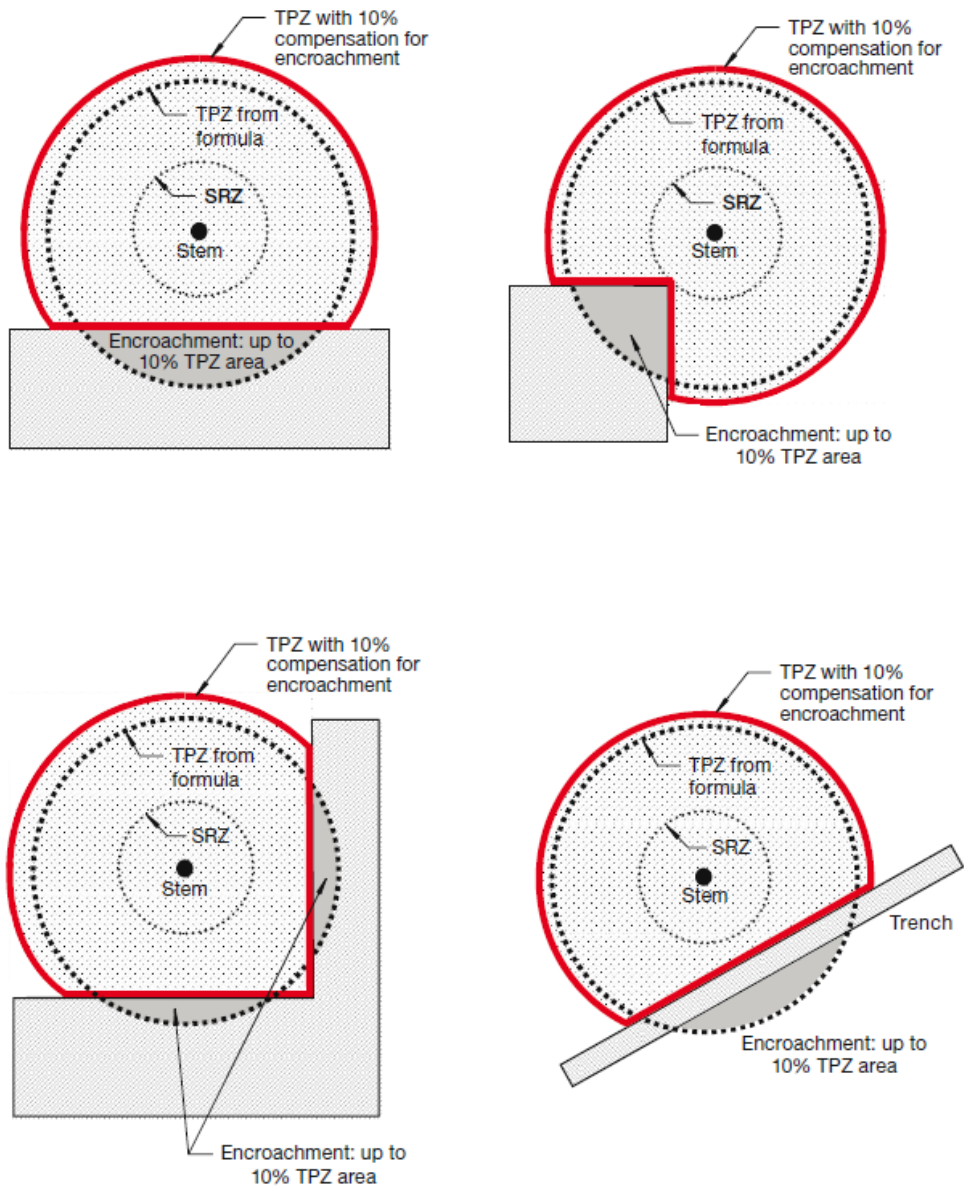
Appendix B Encroachment into tree protection zones - AS 4970-2009

- **Major encroachment** - If the proposed encroachment is greater than 10% of the TPZ or inside the SRZ, the project arborist must demonstrate that the tree(s) would remain viable. The location and distribution of roots may be determined through non-destructive excavation (NDE) methods such as hydro-vacuum excavation (sucker truck), Air Spade or manual extraction. The area lost to this encroachment should be compensated for elsewhere and contiguous with the TPZ.
- **Minor encroachment** – If the proposed encroachment is less than 10% of the TPZ, and outside of the SRZ, detailed root investigations should not be required. The area lost to this encroachment should be compensated for elsewhere and contiguous with the TPZ.

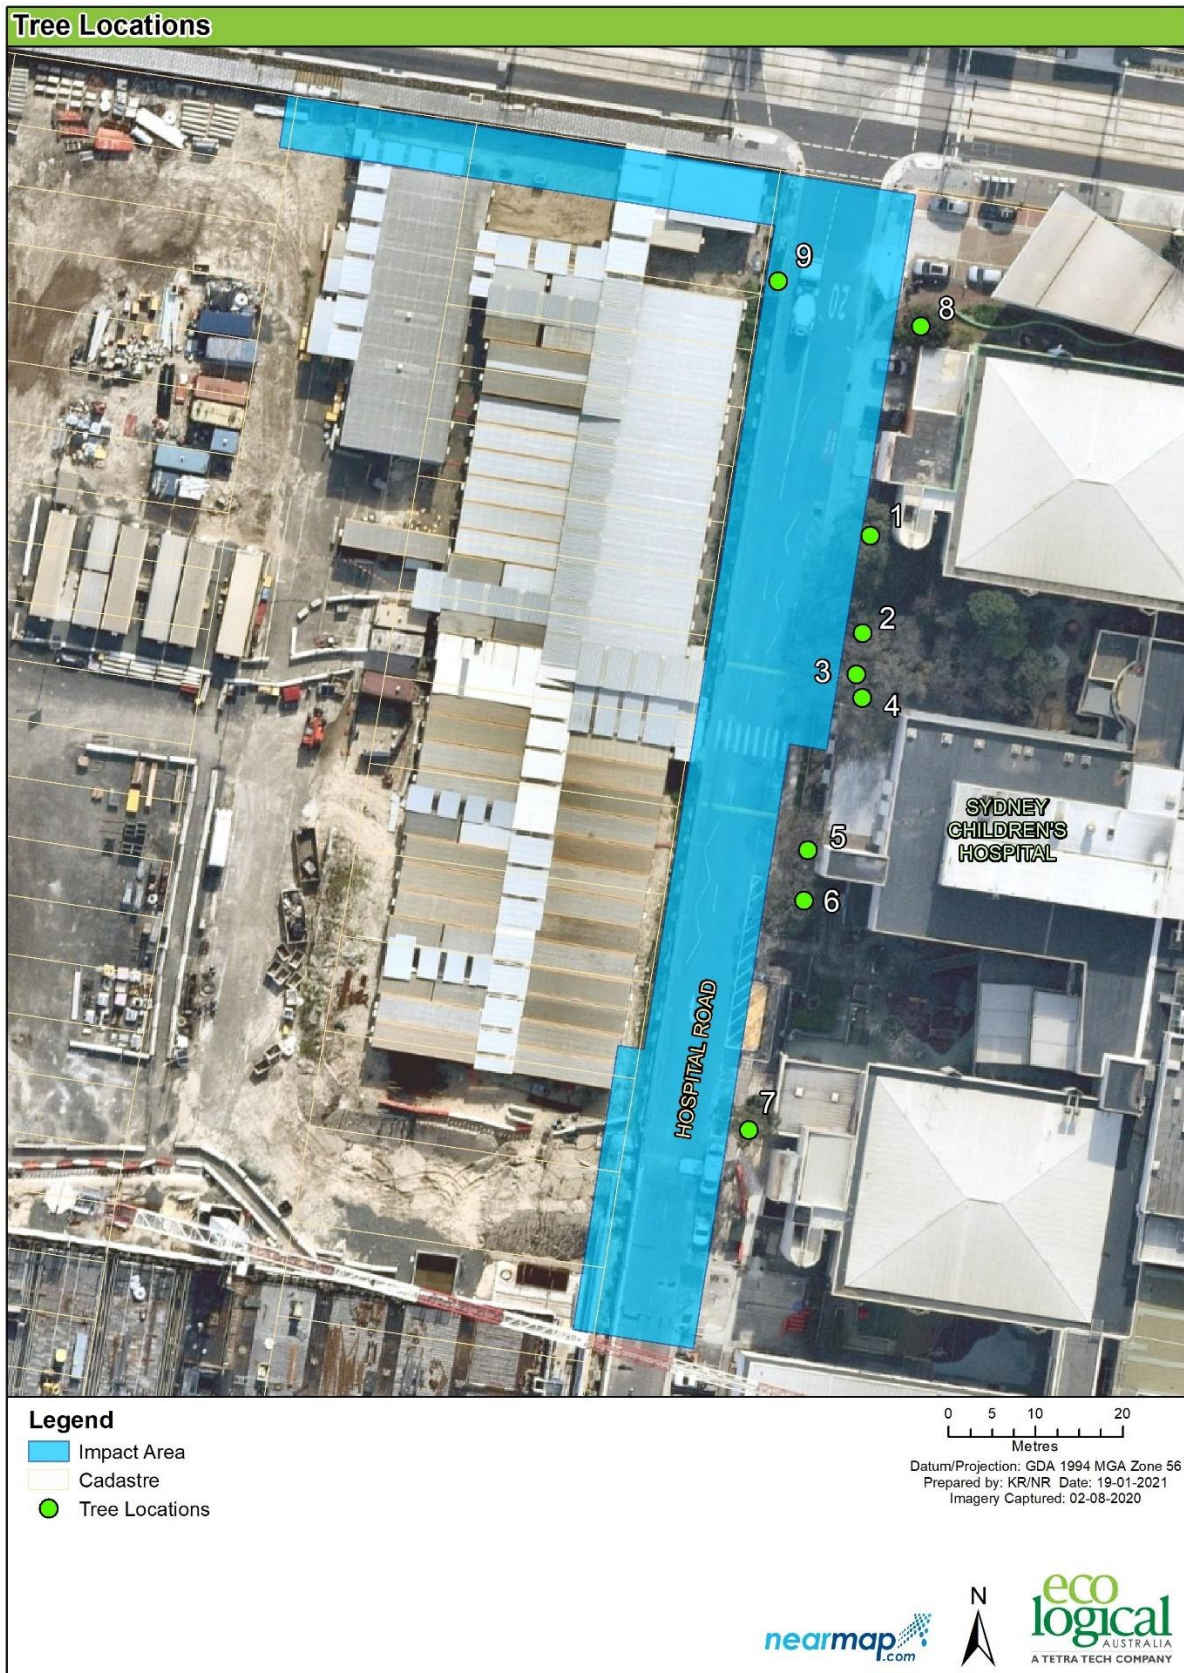
Figure 4: Tree locations

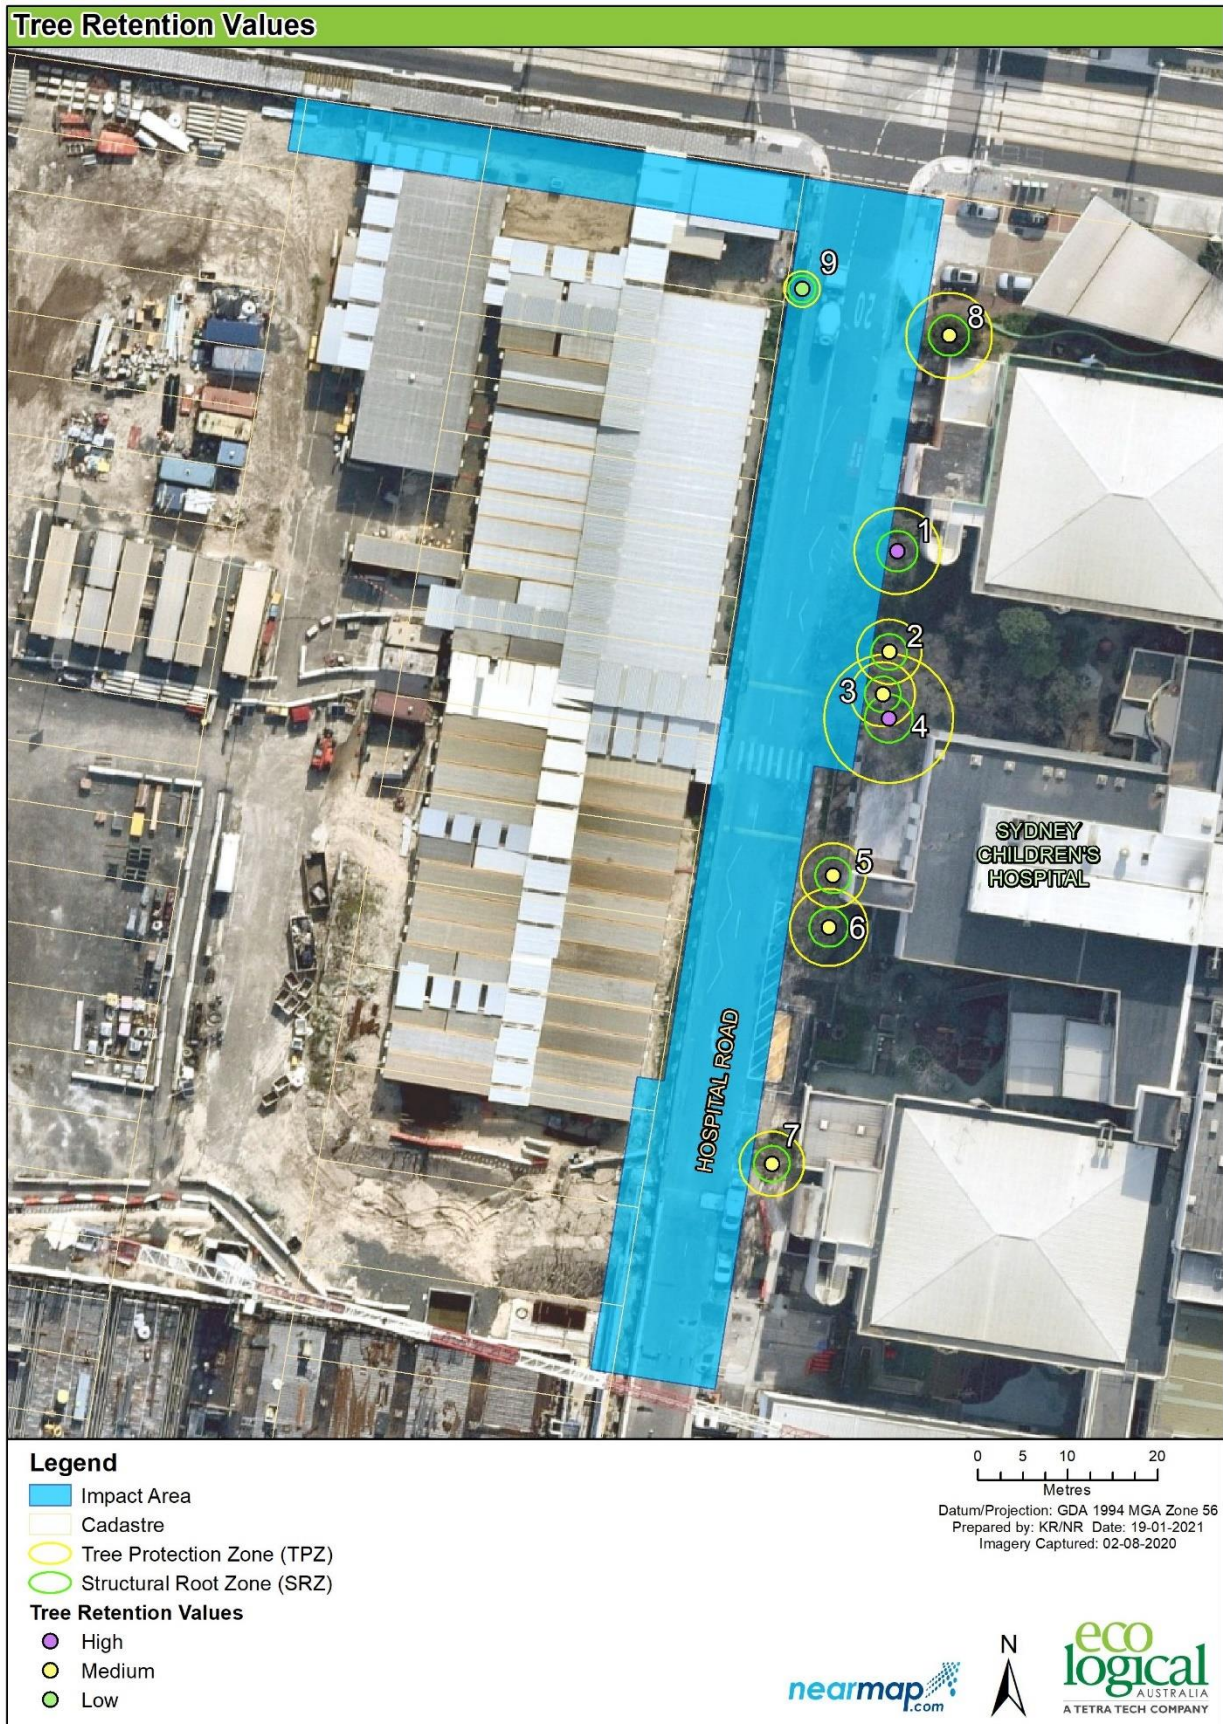
Figure 5: Retention value subject trees

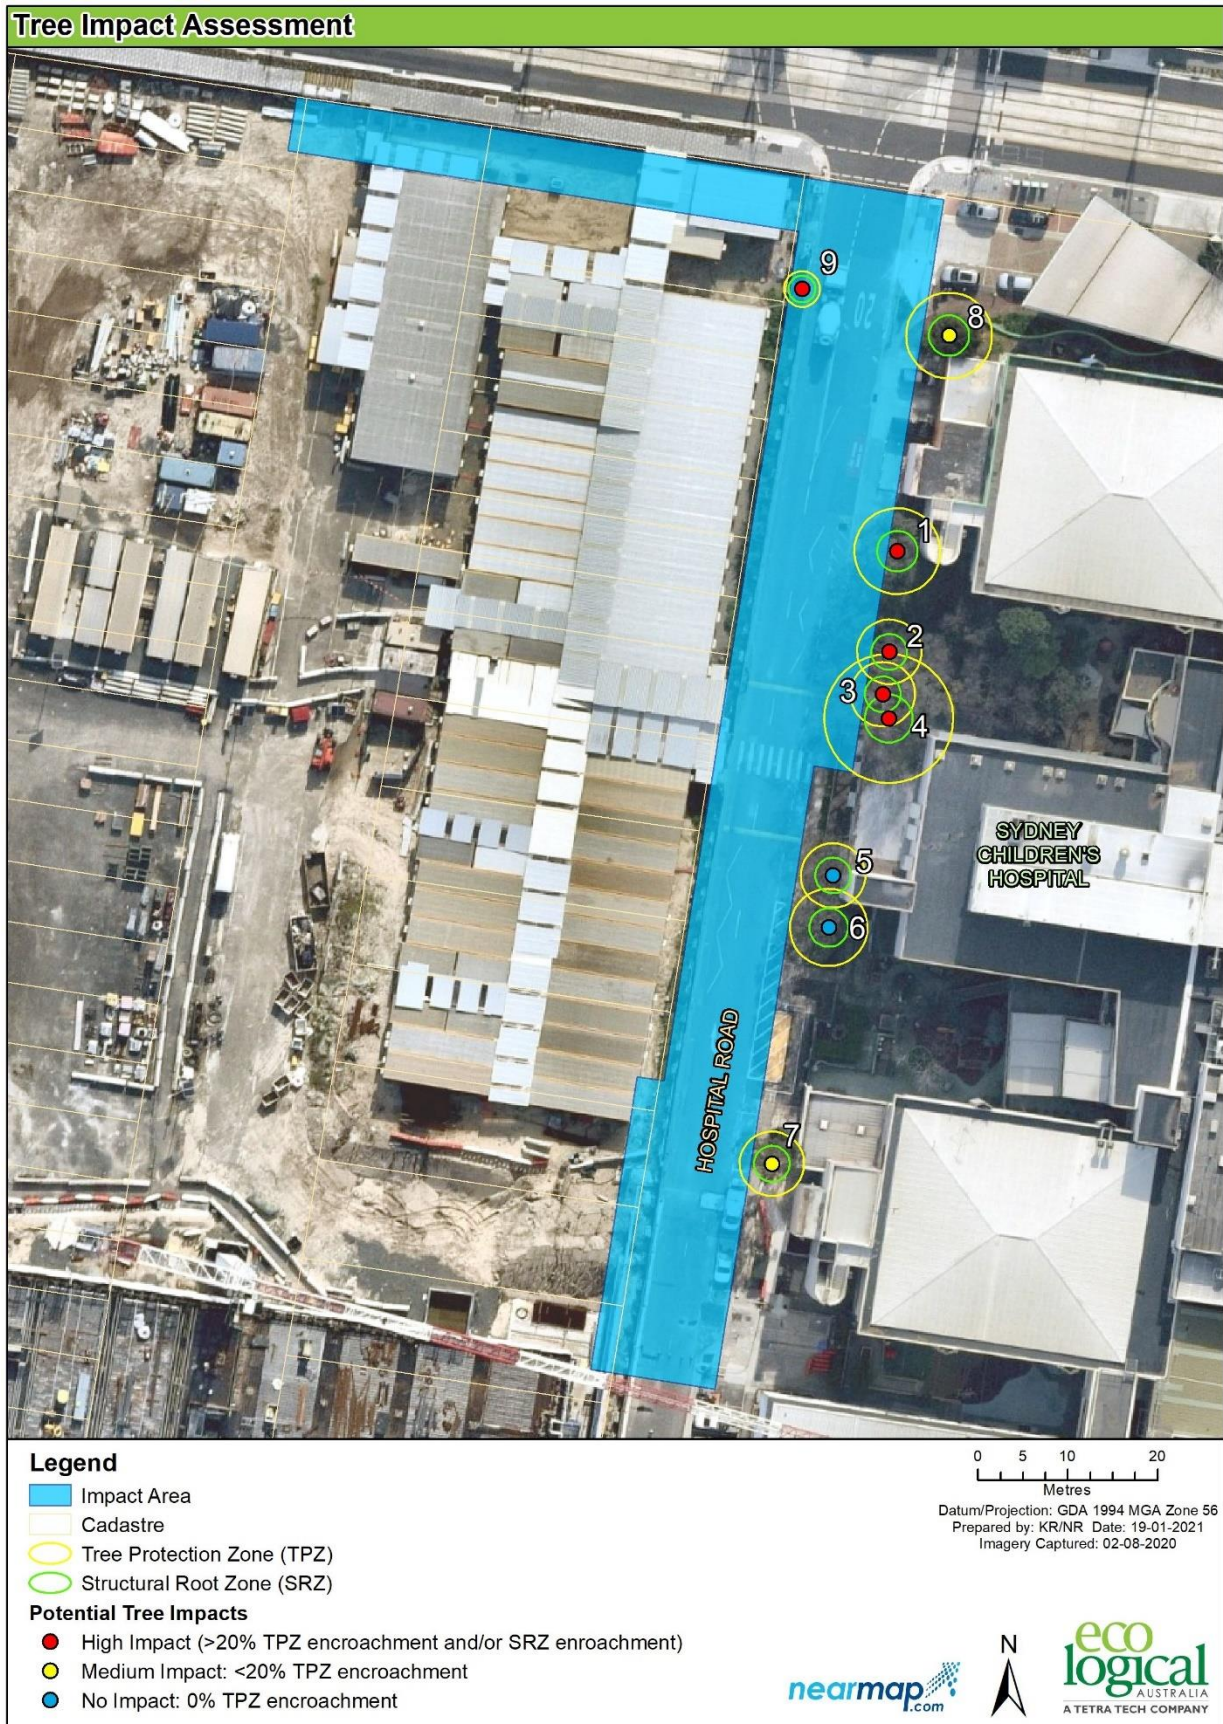
Figure 6: Arboricultural impact assessment

- **High Impact (>20% TPZ Encroachment):** a total of four trees will be highly affected by the proposed works and cannot be retained under the current proposal. Tree retention values are as follows:
 - High retention value: two high retention value trees (Tree 1 and 4) will be highly affected by the proposed works.
 - Medium retention value: two medium retention value tree (Tree 2 and 3) will be highly affected by the proposed works.
 - Low retention value: one low retention value tree (Tree 9) will be highly affected by the proposed works.

- **Medium Impact (<20% TPZ Encroachment):** two medium retention value trees (Trees 7 and 8) will be subject to medium impact from the proposed works. These trees may be able to be retained subject to root mapping investigation.

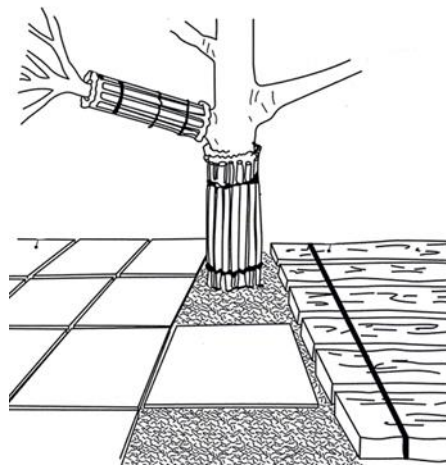
Trunk protection fencing

Trunk protection shall consist of a layer of either carpet underfelt, geotextile fabric or similar wrapped around the trunk, followed by 1.8 m lengths of softwood timbers aligned vertically and spaced evenly around the trunk (with an approx. 50 mm gap between the timbers).

The timbers must be secured using galvanised hoop strap (aluminium strapping). The timbers shall be wrapped around the trunk but not fixed to the tree, as this will cause injury/damage to the tree.

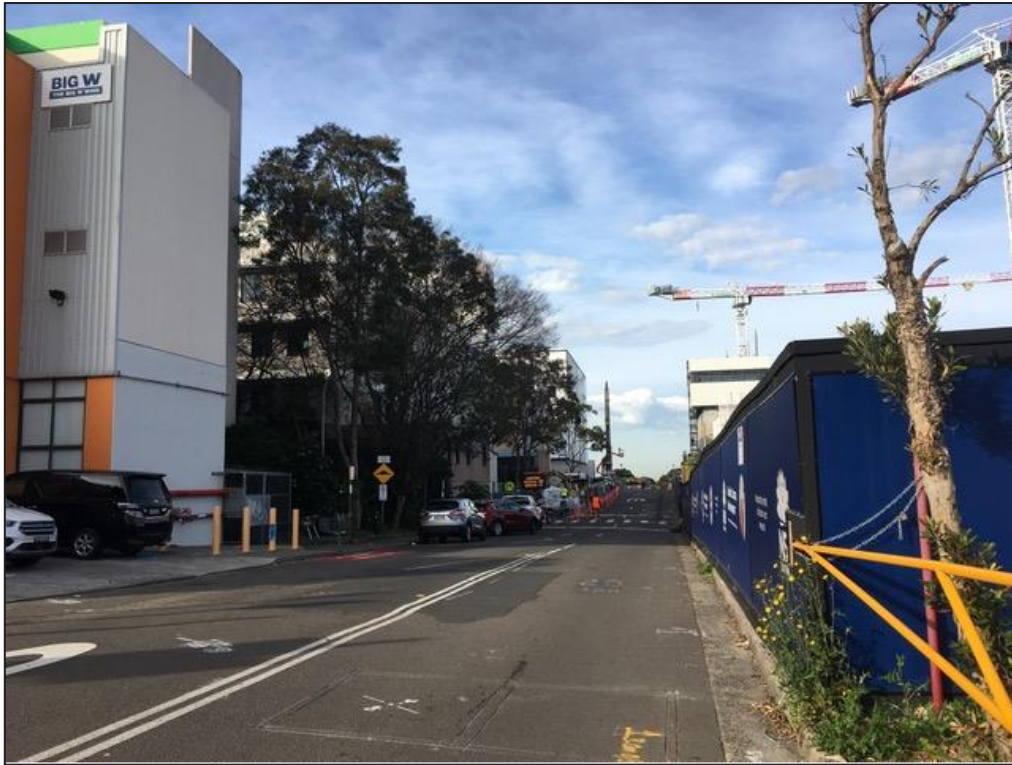
Figure 9: Trees 1 to 8 on the east side of Hospital Road and Tree 9 on west side of Hospital Road

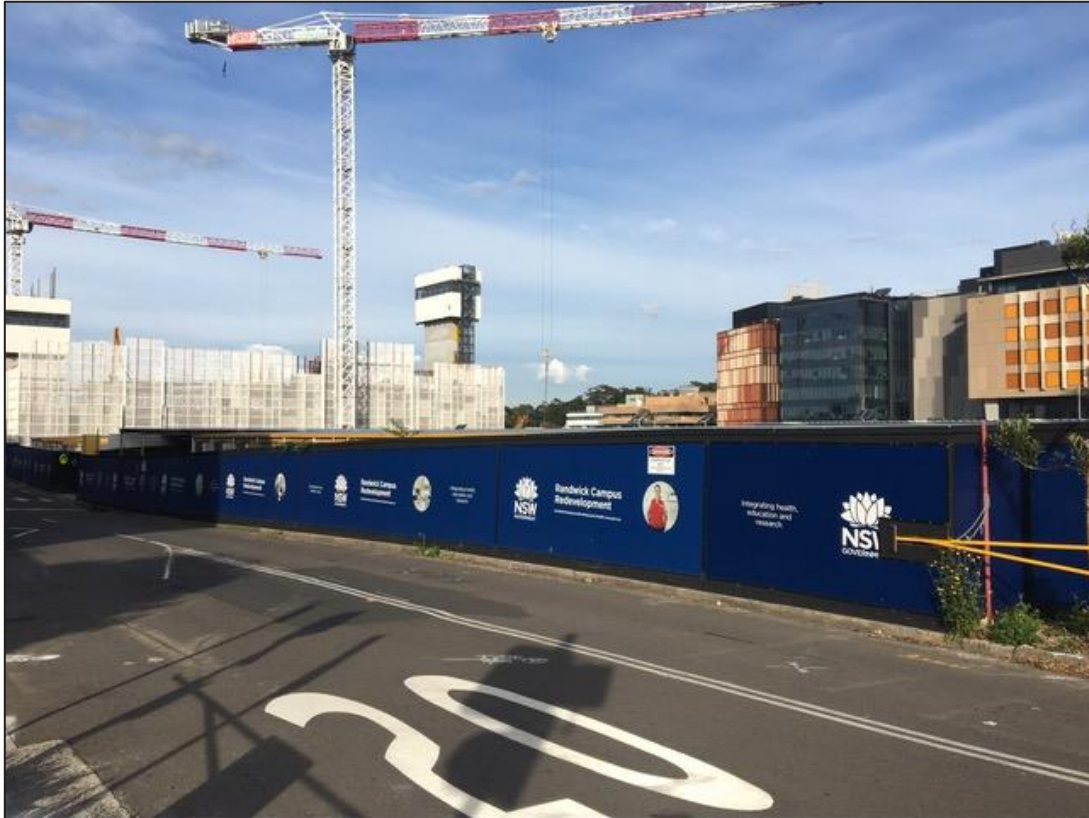
Figure 11: No trees remaining on the construction site

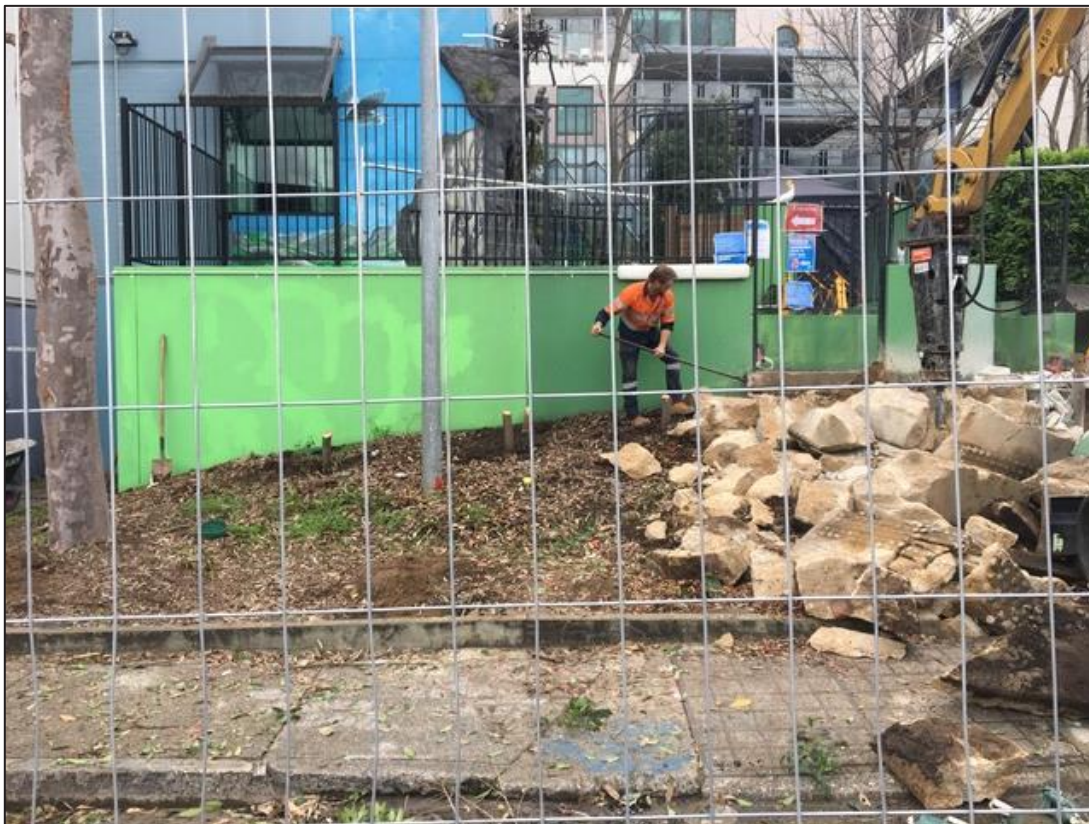
Figure 12: Construction work occurring in proximity to trees recommended for trunk protection within the garden bed

| Type | More details | Comment |
|---|---|---|
| Trunk and branch protection | Appendix E3 | When fencing is not practical or prior to any activities within the TPZ, trunk protection is required and consist of a layer geotextile fabric or similar followed by 1.8 m lengths of softwood timbers spaced evenly around the trunk and secured with a galvanised hoop strap. |

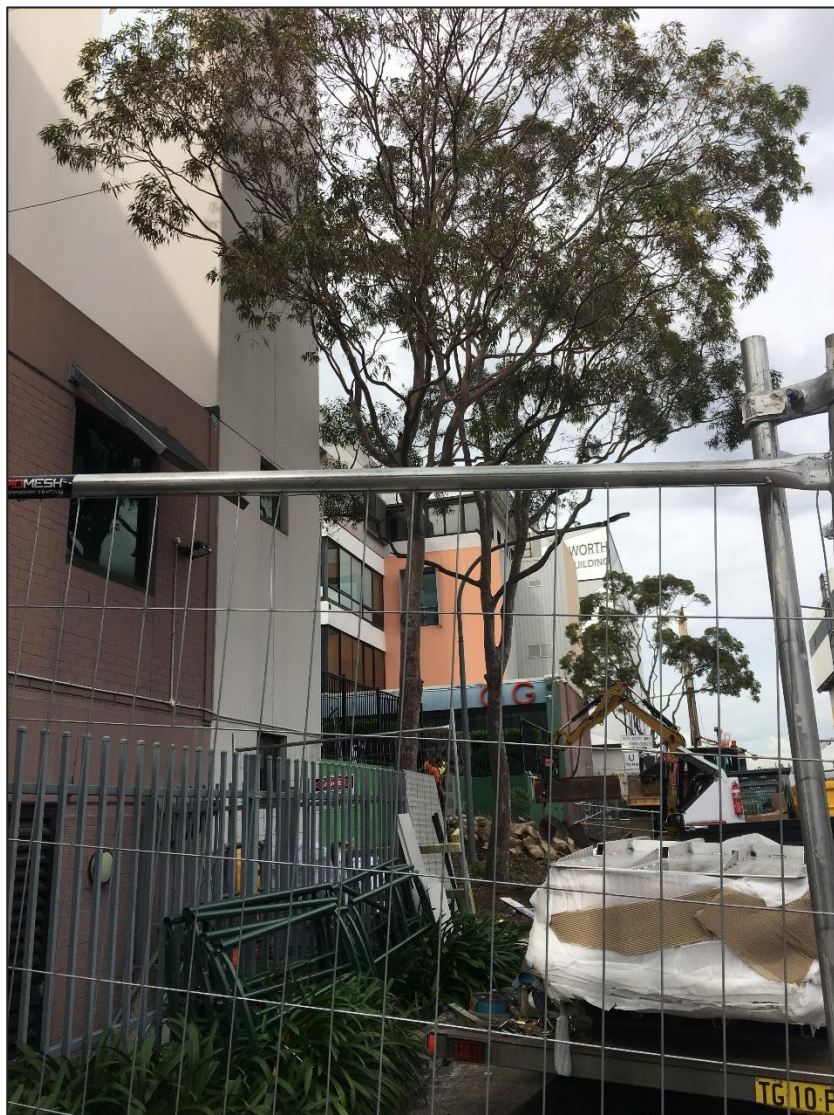
Figure 17: Tree 5

A total of two medium retention value trees (Trees 5 and 6) are proposed to be retained. These trees will be subject to no impact (0% TPZ encroachment) from the proposed development.

- Stockpiling within the TPZ of Tree 5 needs to be relocated outside the TPZ. No stockpiling of materials or contamination is to be within the TPZ or SRZ of subject trees.
- Tree trunk protection is to be installed on trees to be retained.
- Consider some minimal pruning of overhanging branches in accordance with AS4373-2007 prior to using piling rig to avoid tearing tree branches during piling.
- Avoiding the cutting or removal of tree roots larger than 25 mm in diameter to maintain tree health and stability.
- Retain roots and install electrical cabling underneath tree roots where possible.
