Report on  
Remediation Action Plan

Hospital Road REF,  
Randwick Campus Redevelopment  
Hospital Road, Randwick

Prepared for  
Health Infrastructure

Project 72505.22  
February 2021

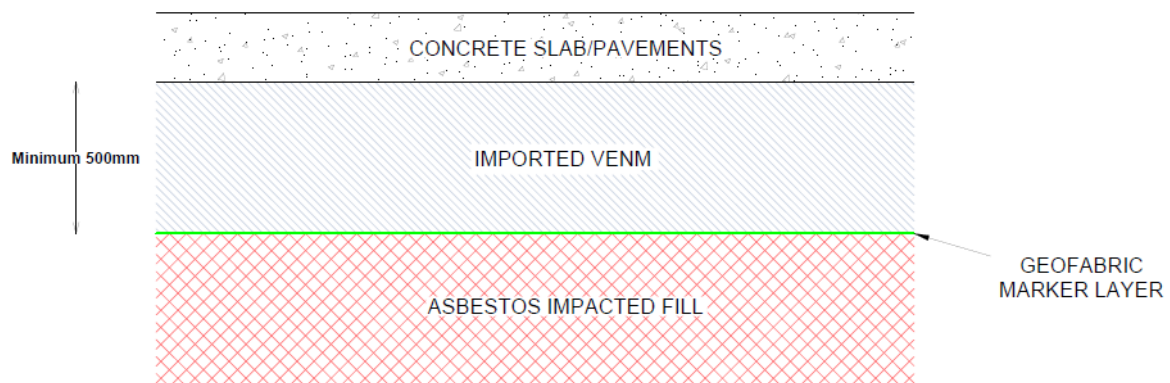
**Figure 1. Typical capping cross section for asbestos impacted materials**

Figures 1 and 2 below illustrate generic capping designs for asbestos contaminated materials under hardstand areas or for deeper service trenches. If burial and capping is adopted more detailed and site specific designs will need to be developed.

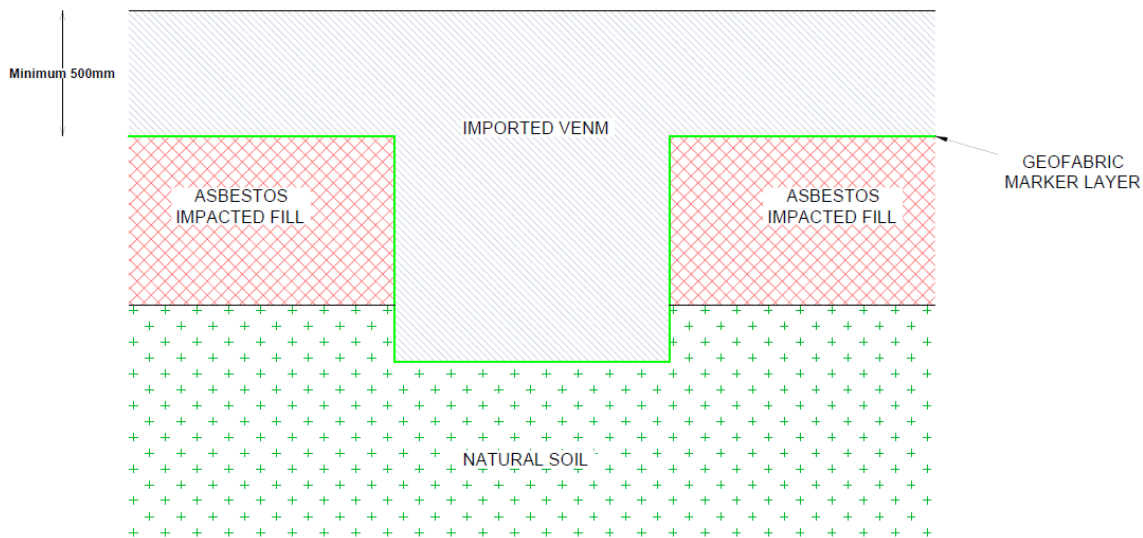
**Figure 2. Typical capping cross section for deeper services trenches with asbestos impacted materials. Noting that further civil design requirements are likely to apply to the design.**

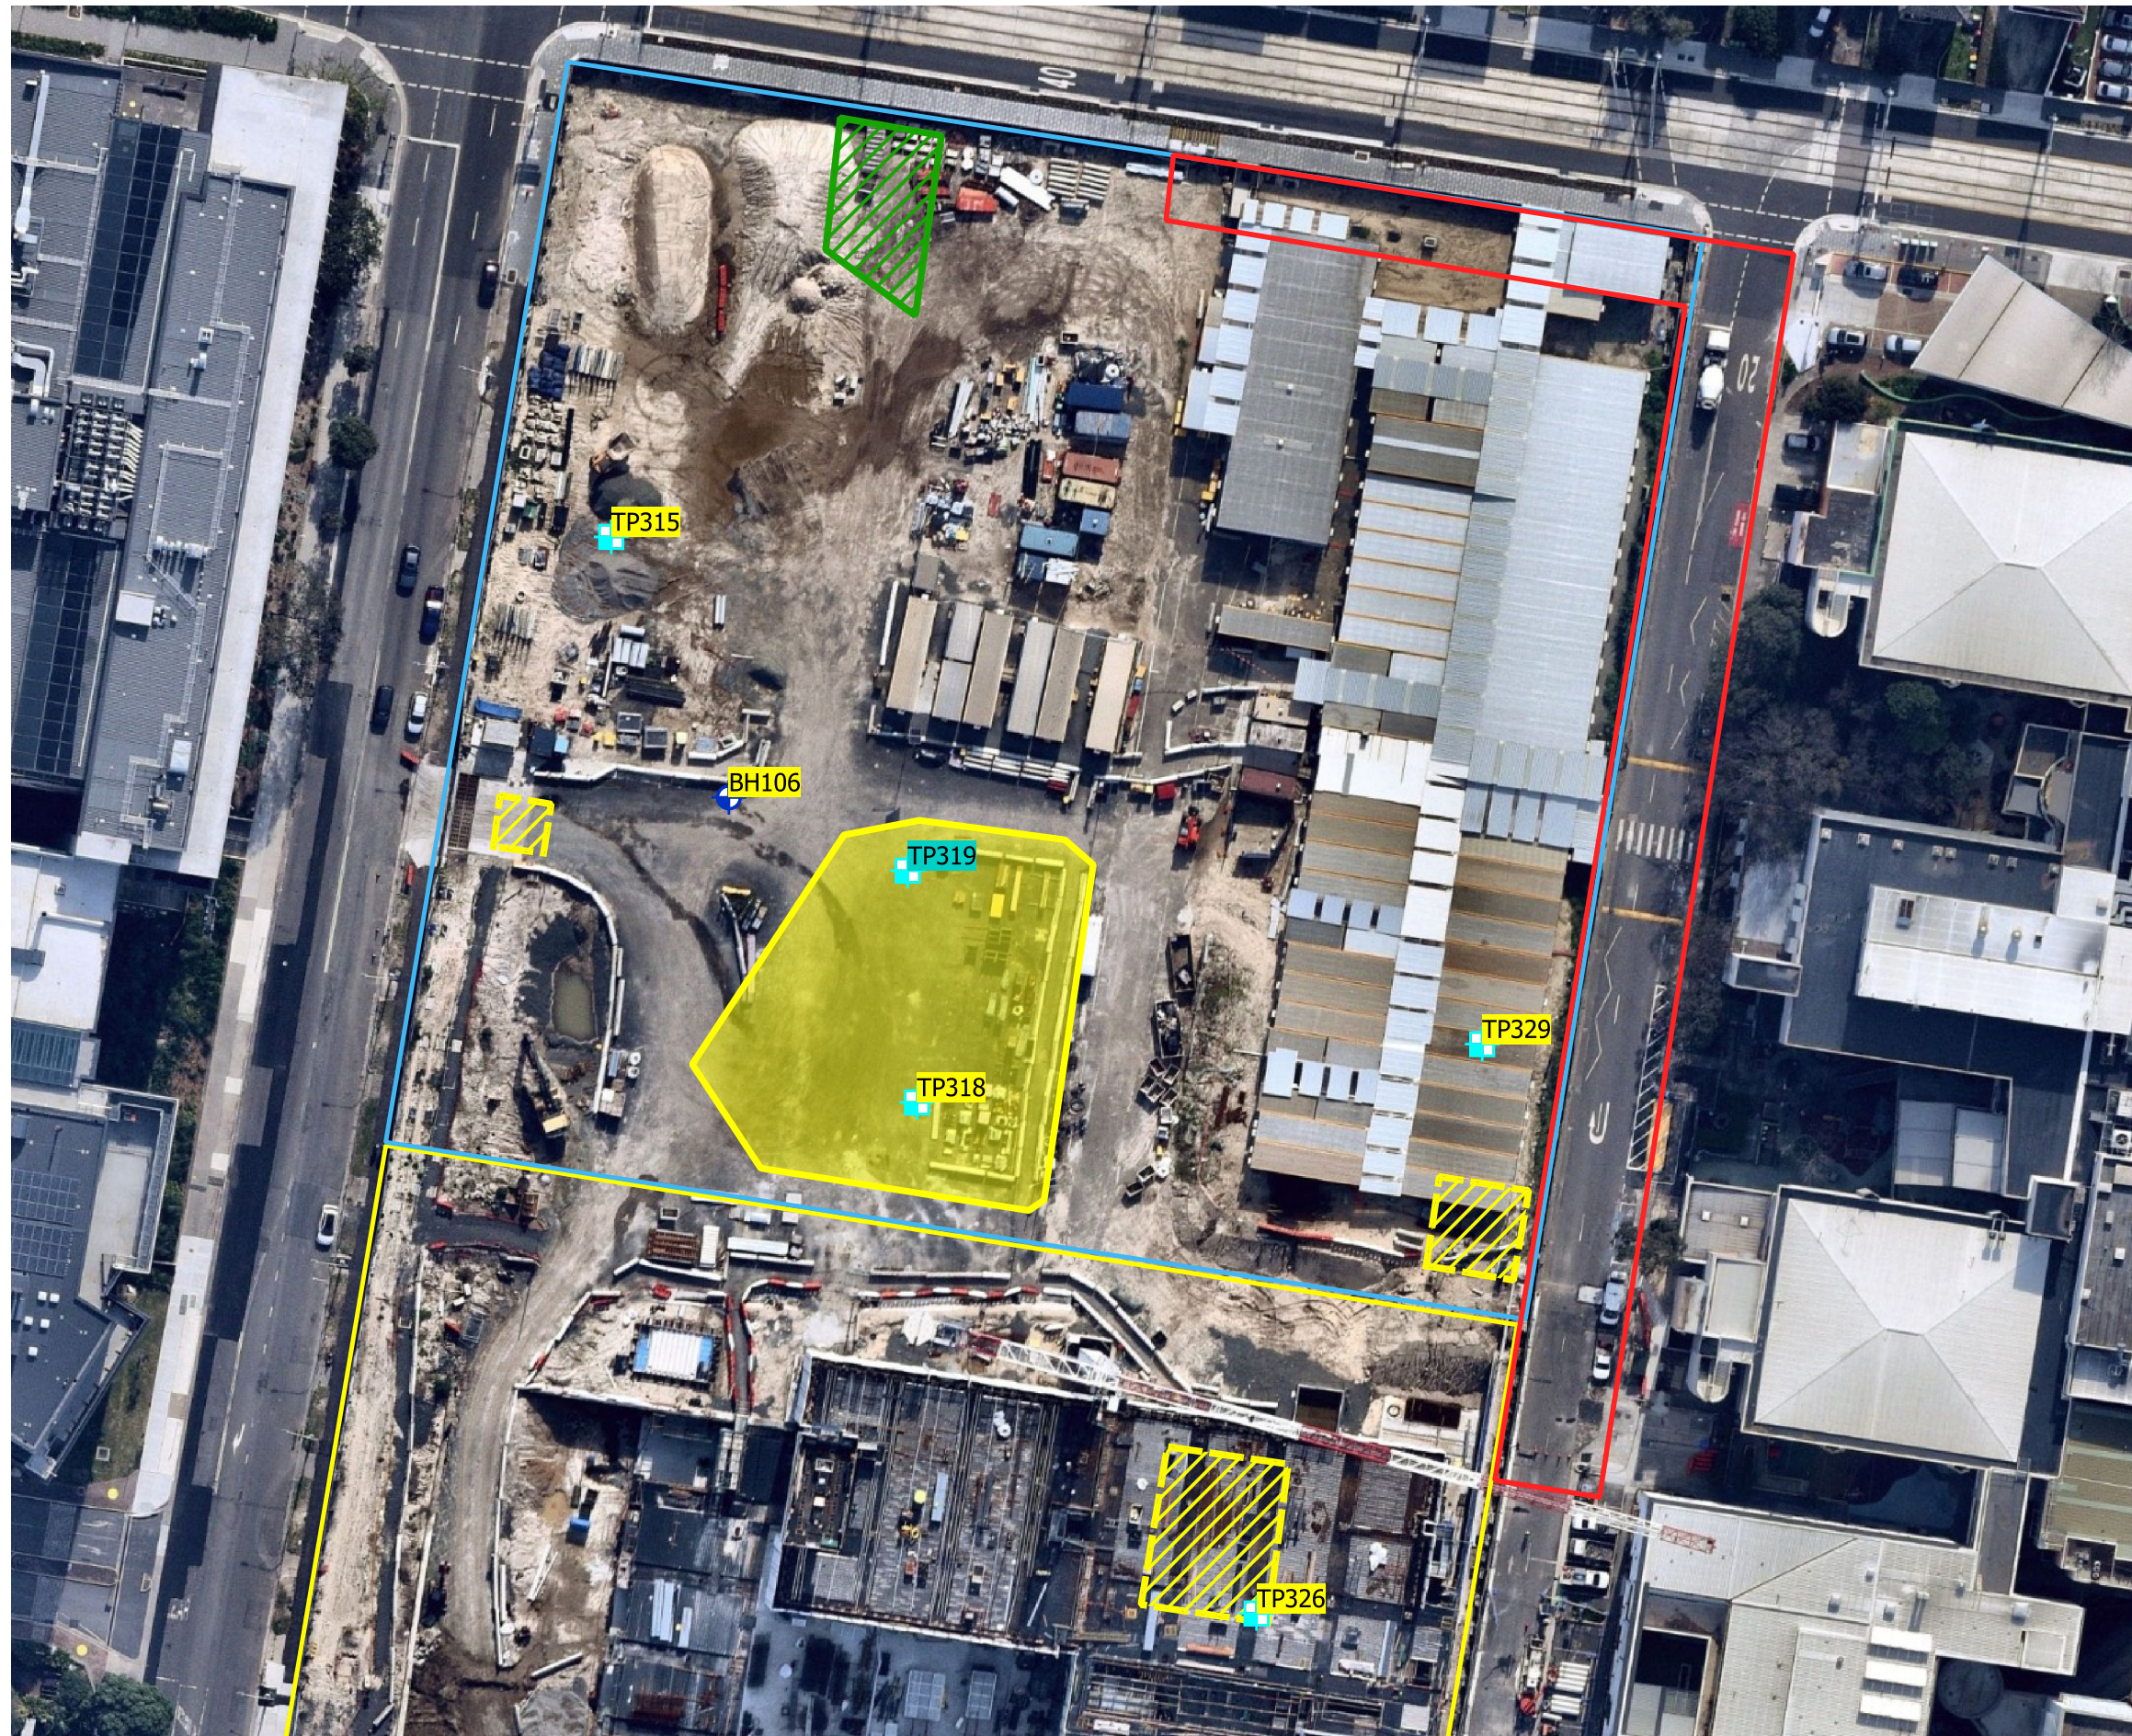
- Hospital Road REF (the site)
- Previous Surficial ACM Finds (DP 2019a)
- "Tear drop" area (soils may contain asbestos)
- + DP Environmental borehole (PSI, DP 2018)
- + DP test pit location (DSI, DP 2019a)
- + Post Demolition Test Pit (DSI, DP 2019a)
- Remediated Asbestos Hot Spot (DP2019c)
- ACM observed at test location/during sieving (0 - 0.2 m depth) (DP 2019a)
- ACM observed at test location/during sieving (0.4 - 0.5 m depth) (DP 2019a)

Additional surficial asbestos was noted in-between test locations, as summarised on the attached Drawing 5, Appendix A.

It is also noted that further surficial asbestos was previously identified within parts of Stage 1 and 2 of the RCR area, including the 'tear drop' shaped area. These areas are summarised in Drawing 5, Appendix A. These previous asbestos finds are considered indicative of the potential for asbestos to be present in fill in other parts of the RCR area.

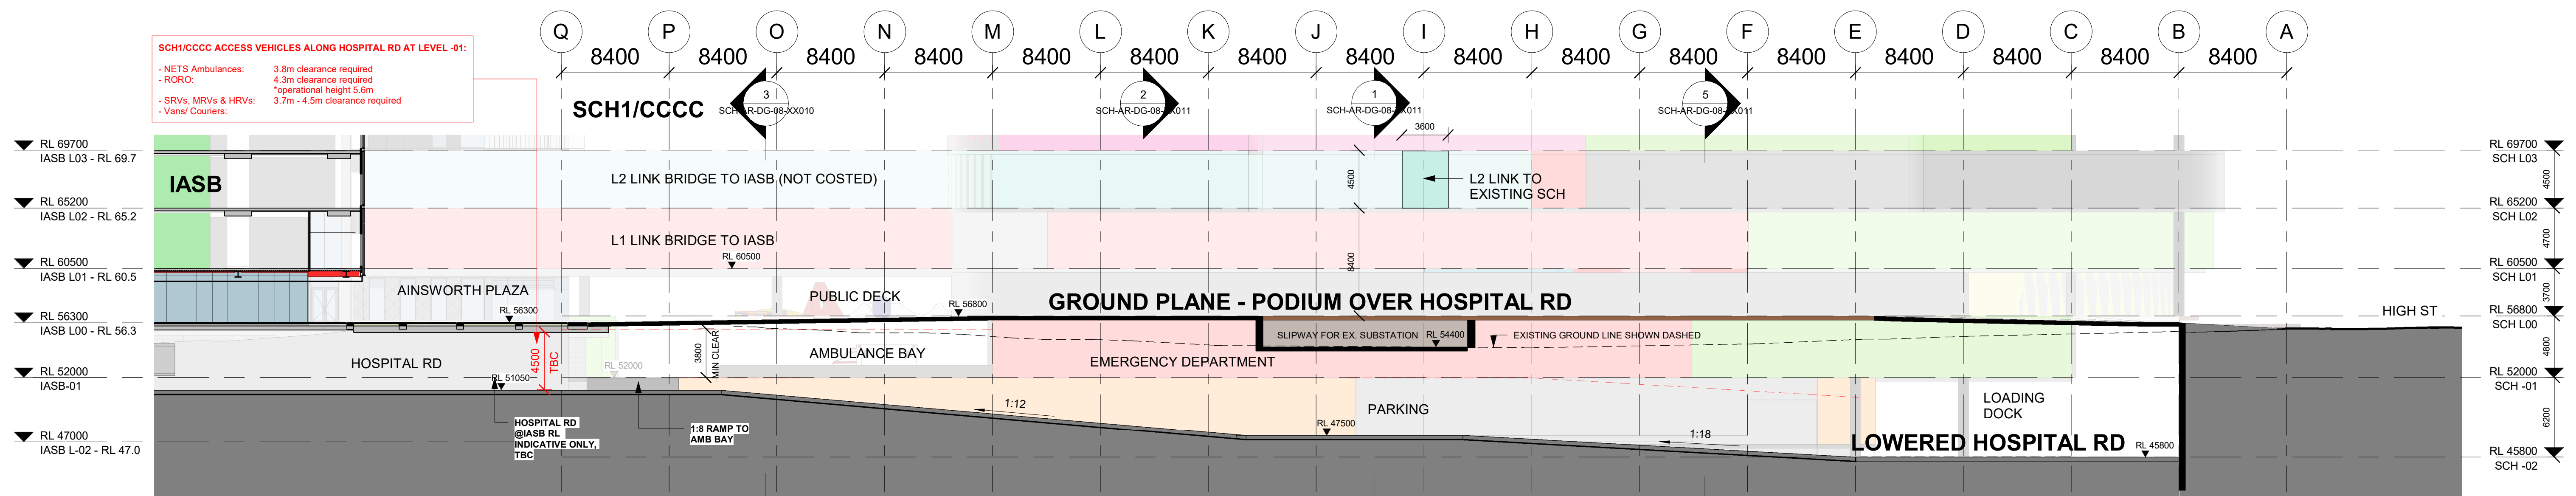
1 Section - Thru Hospital Rd  
1: 250

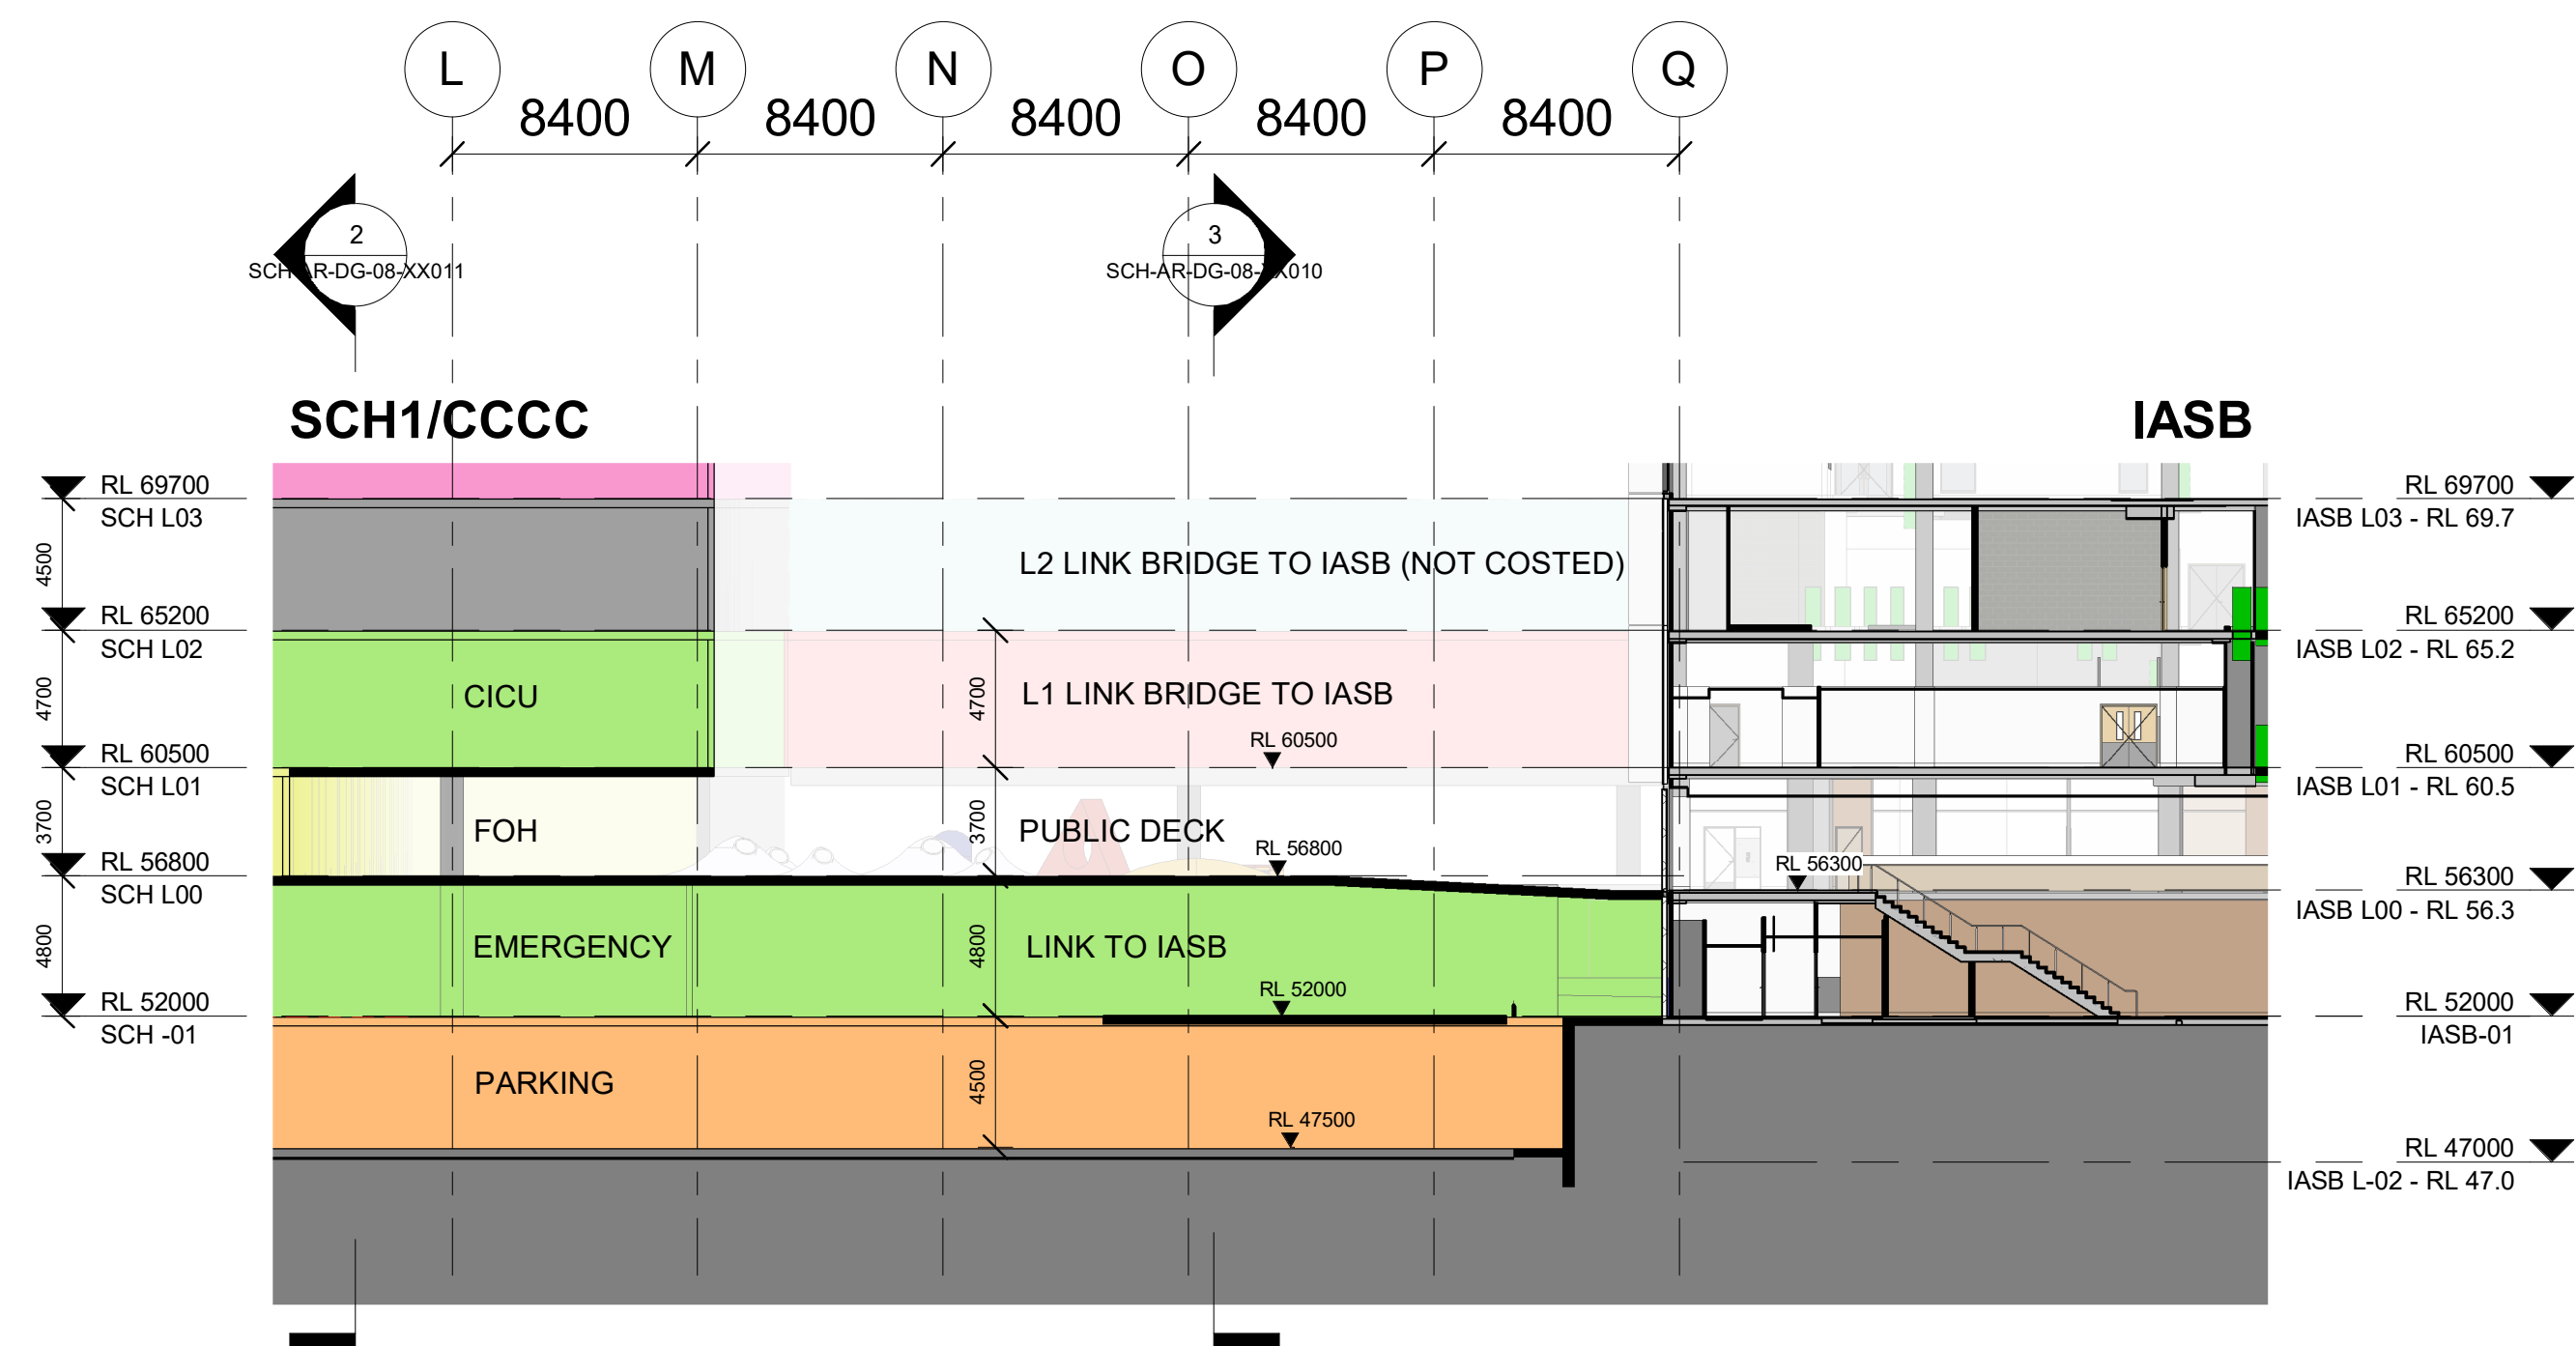
2 Section - Thru IASB L00 Stair  
1: 250

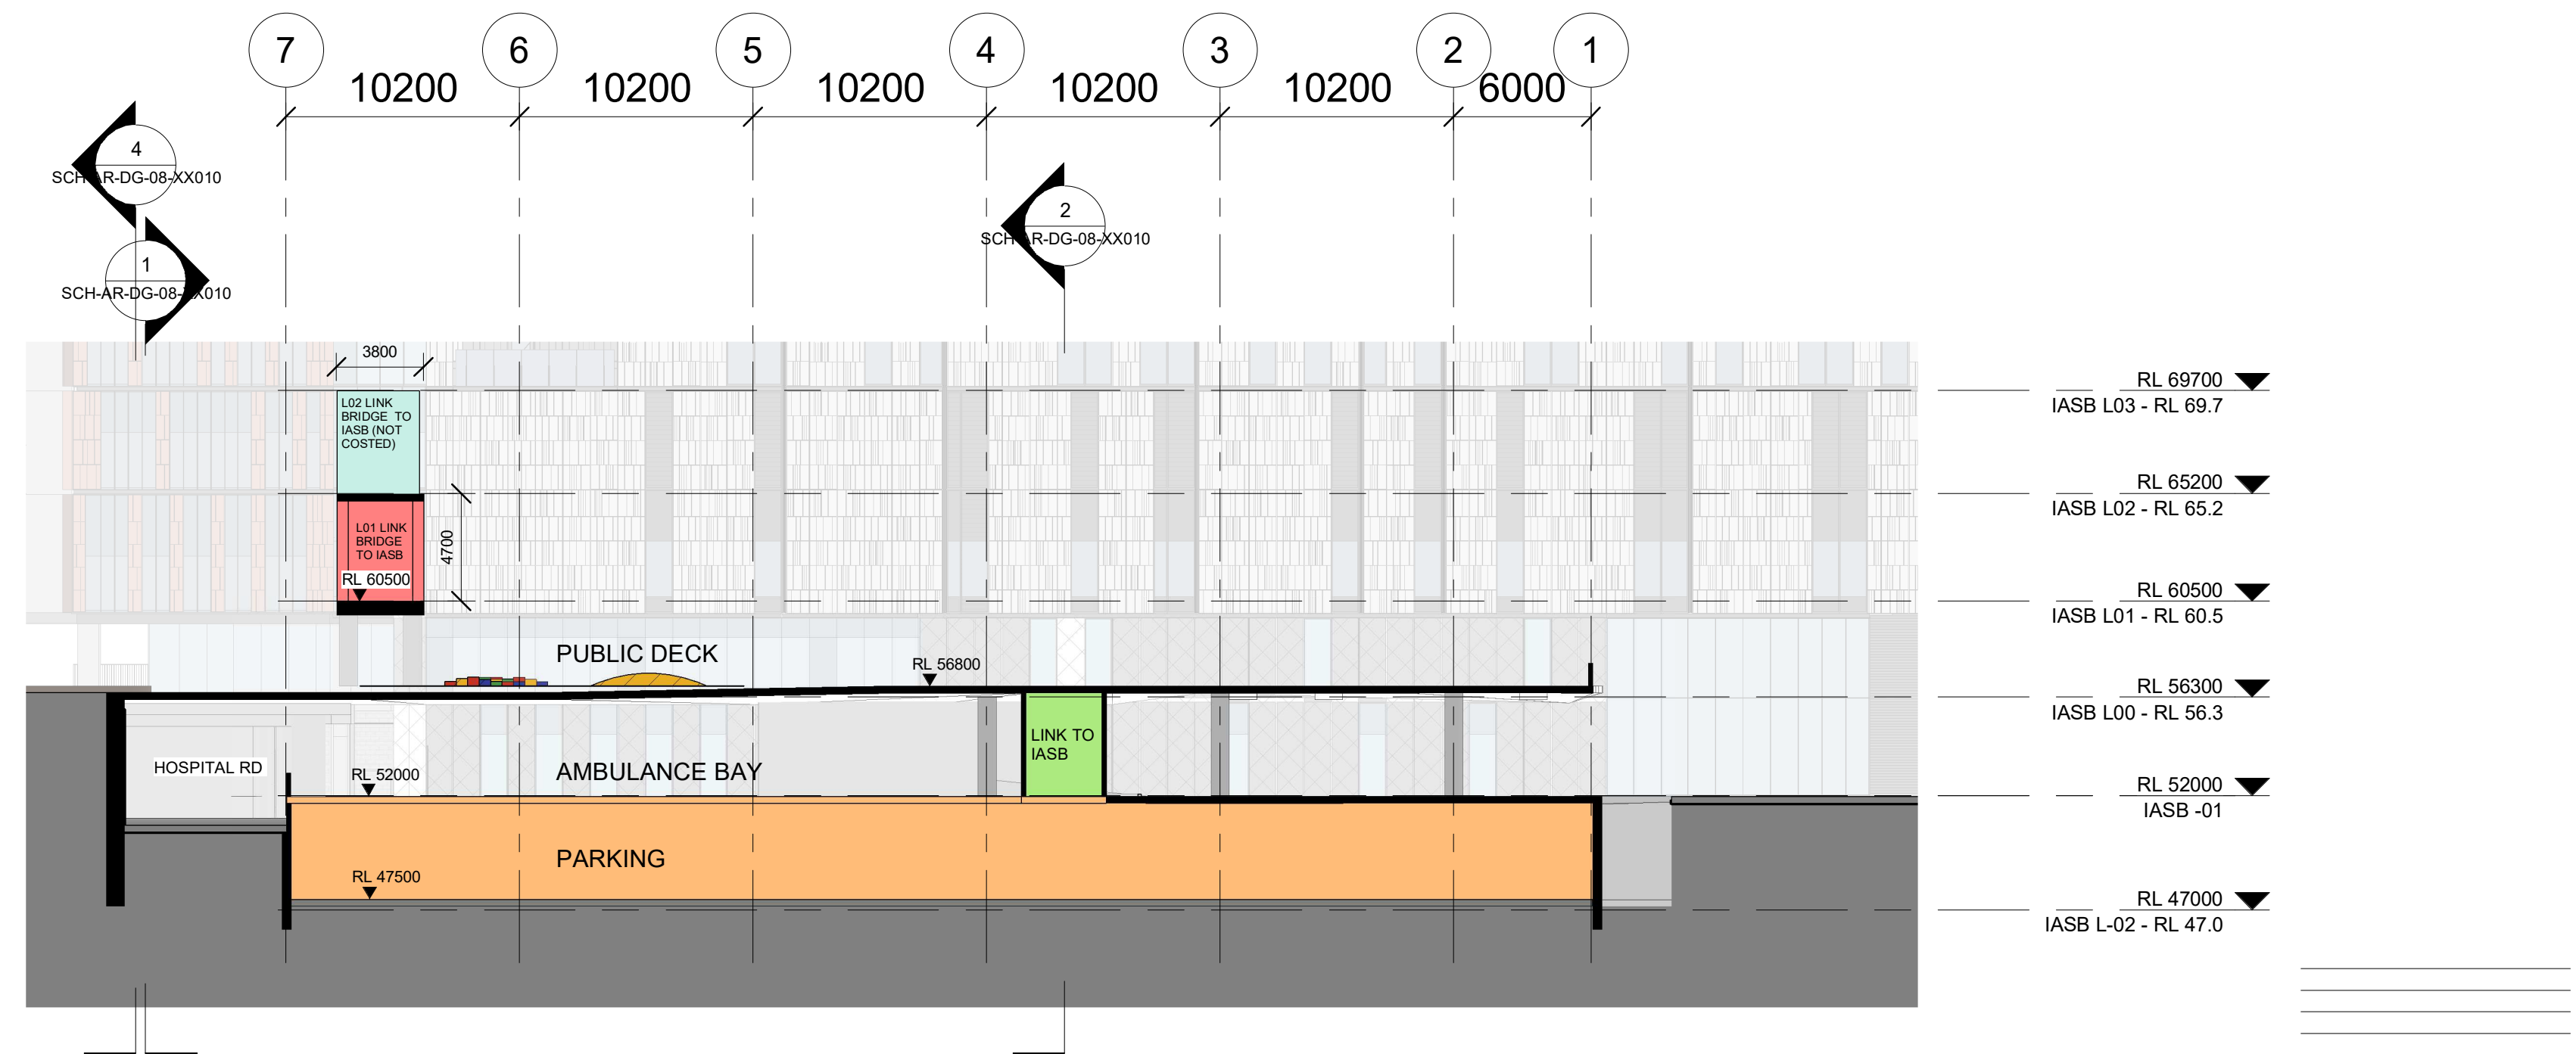
3 Section - Thru Ambulance Bay  
1: 250

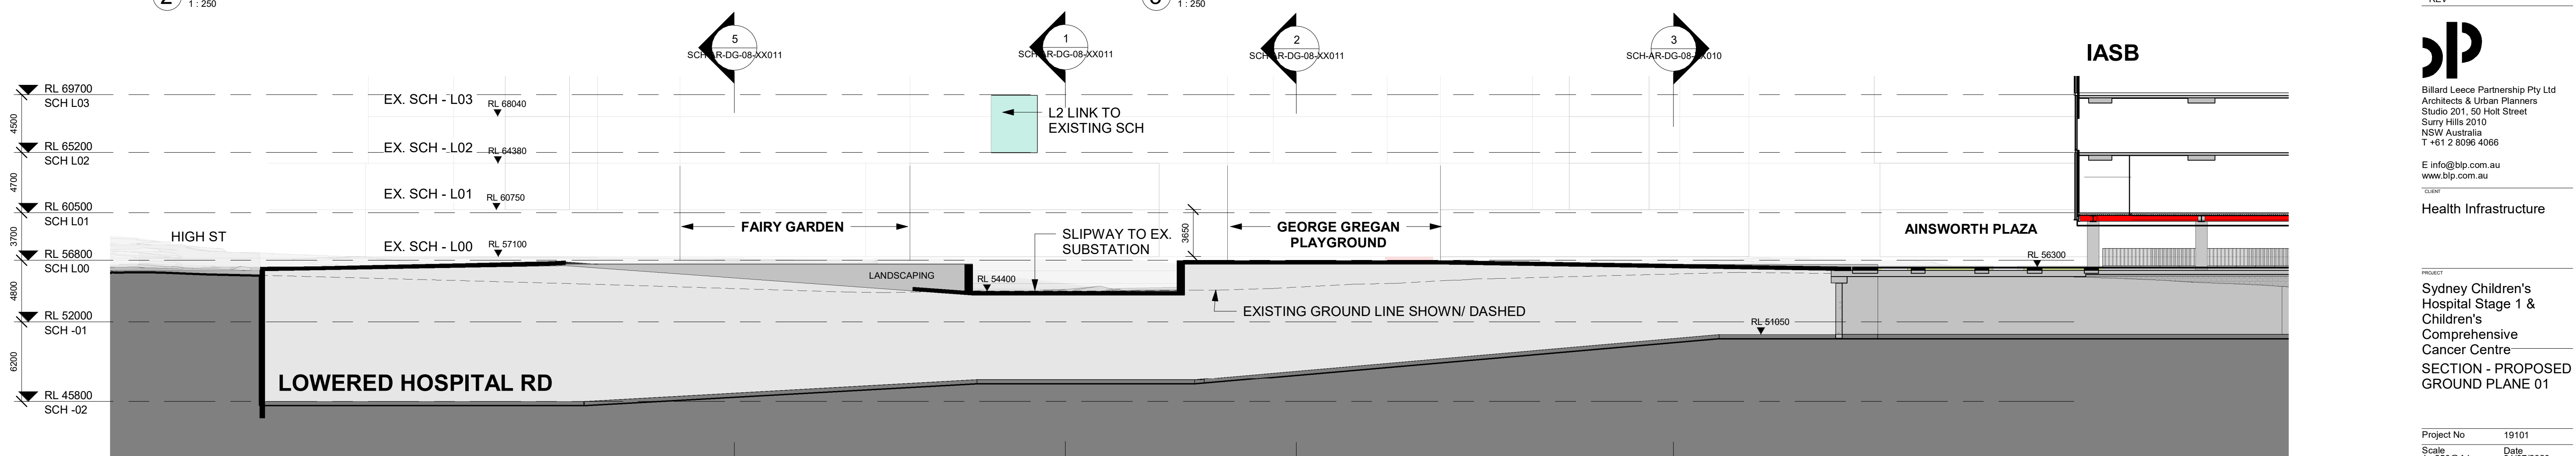
4 Section - Thru Hospital Rd-Looking at Ex.SCH  
1: 250
