PRELIMINARY HERITAGE ADVICE | BOWRAL & DISTRICT HOSPITAL (REF 2)

Urbis has been engaged by Capital Insight Pty Limited to provide preliminary heritage advice regarding the proposed new scope of works as part of the ongoing redevelopment of Bowral & District Hospital, Bowral.

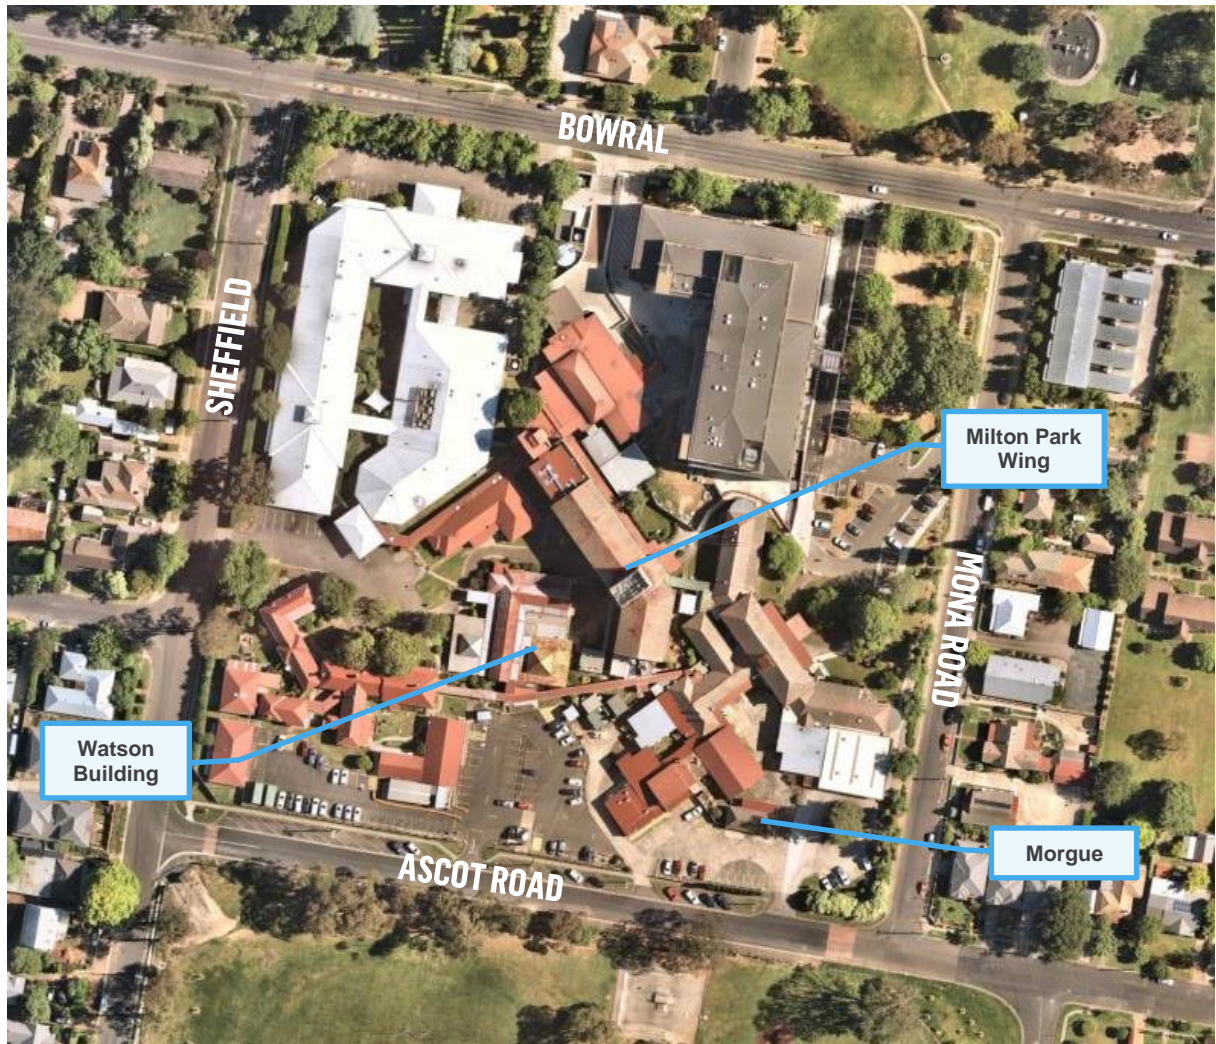
Figure 1 – Aerial image site with the Morgue, Watson Building, and Milton Park wing indicated
Source: Capital Insight 2021, with Urbis overlay

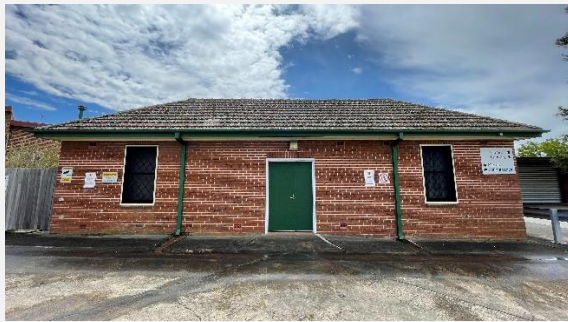
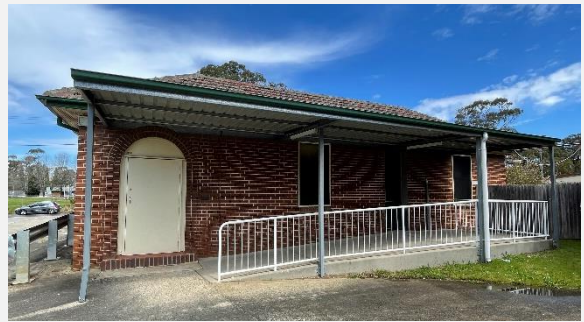
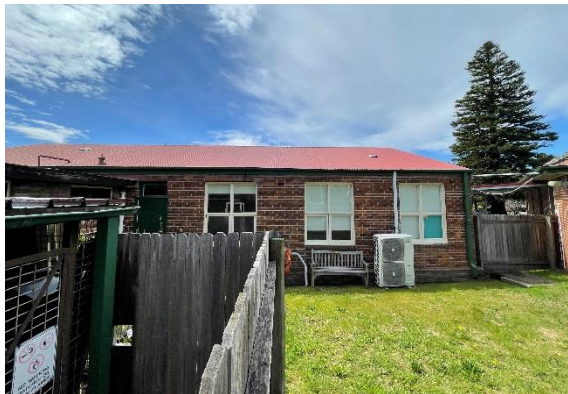
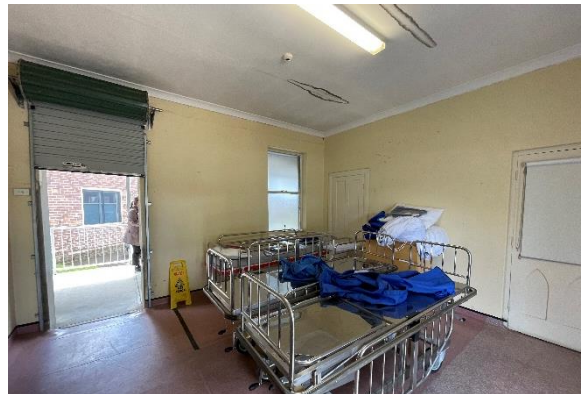
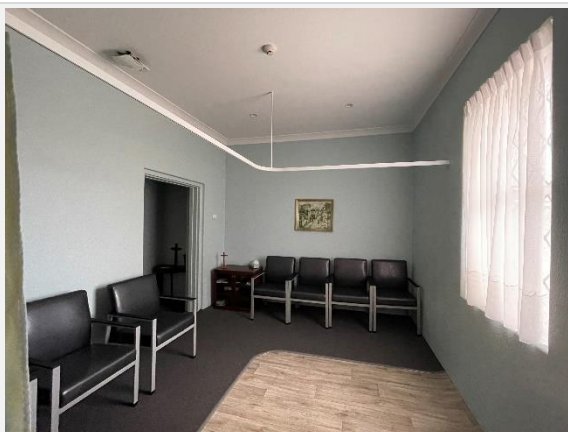
Morgue	
Date of construction	1932 (with later modifications)
Physical description	<p>Exterior:</p> <p><i>Face brick rectangular building with terracotta tile hipped roof with timber-lined eaves. Principal door openings are round headed with timber panel doors inspired by the Gothic Style. Windows on the southwest elevation appear to be original and have concrete lintels over openings with steel framed swiveling pane windows. A ramp is located on the northwest elevation and leads to a steel roller door. Numerous windows have been replaced on the southeast elevation. Numerous cracks are located in the southeastern wall.</i></p> <p>Interior (description by Urbis):</p>

The internal layout is divided into 3 spaces: the coolroom (west), the preparation area (centre), and the chapel / viewing room (east). Ceilings in all spaces are introduced plasterboard, with flooring lined with vinyl / carpet. The floor substrate was not inspected, but it is presumed that timber flooring remains.

The coolroom area contains original glazed ceramic wall tiles up to the dado line. The 2 internal doors are timber and appear to be original: one is in the gothic-inspired style (providing access to the viewing area) with glazed panels; the other is a simple 4-panelled door with no significant detailing.

The Morgue dates to a relatively early period in the development of the hospital, and to some extent is able to demonstrate the historical pattern of the site's development.

However, the building is utilitarian in nature and pedestrian in its form and character, with little by way of detailing. It cannot be considered a good or notable example of its type and, to our knowledge, does not demonstrate any qualities which would make it worthy of further research. Its connection to the functioning of the hospital notwithstanding, the Morgue does not, to our knowledge, have any particular associations with events, people, or community groups of historical or social importance.

As such, the Morgue is considered by Urbis to be of **Little** relative heritage significance.

- The proposed demolition of the Morgue is, at this stage, supportable from a heritage perspective as the building is of little relative heritage significance and the impacts of its demolition will not be more than minor or inconsequential.

- It is noted that discussions with Capital Insight during the site inspection indicated the possibility of retaining the Morgue building and carrying out internal refurbishment, the impacts of which would also not be more than minor or inconsequential. In this case, we would recommend the following:

- The original external window and door openings should be retained.
 - Explore opportunities to refurbish windows and external doors so that they are of a cohesive finish. New insertions which do not mimic traditional fabric could be supported, subject to appropriate detailing.

- Ideally, the glazed ceramic tiles within the cool room area should be retained and conserved as part of any internal refurbishment works.
- The proposed demolition of the Watson Building is, at this stage, supportable from a heritage perspective as the building is of little relative heritage significance and the impacts of its demolition will not be more than minor or inconsequential.

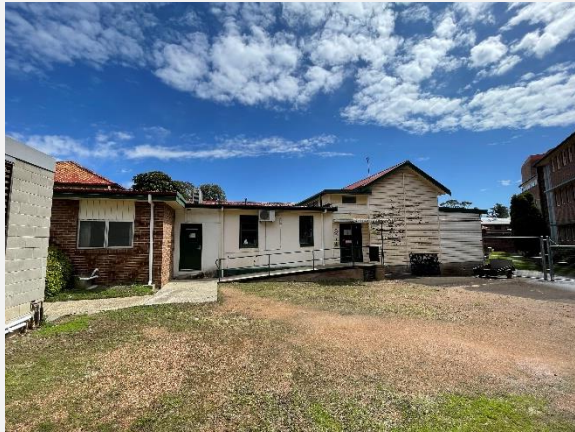
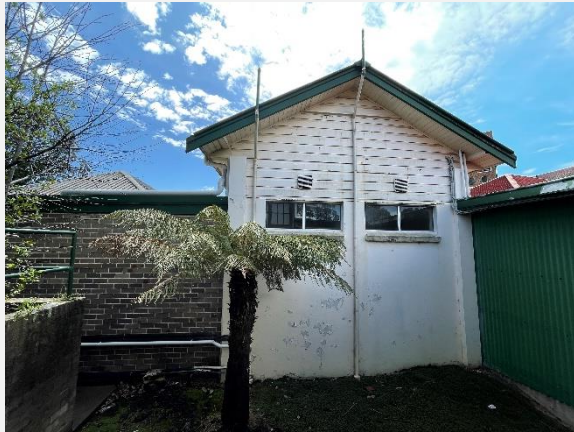
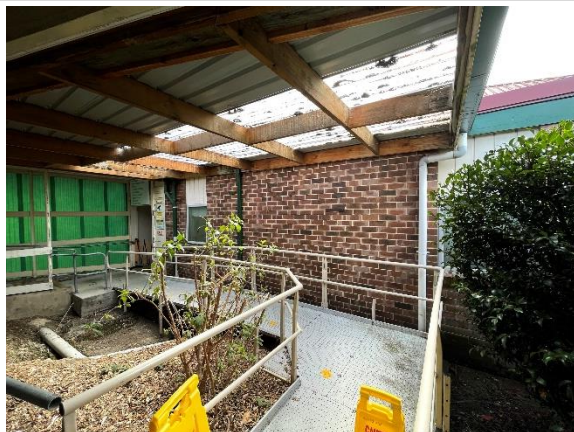
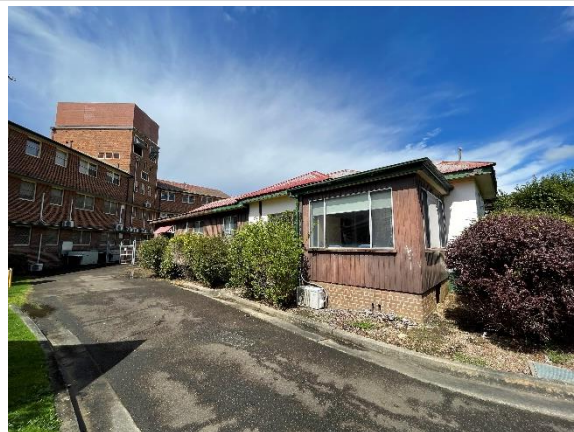
Watson Building (including the Social Work building)	
Date of construction	1928; 1970s; 1994
Physical description	<p>Watson Building – Exterior:</p> <p><i>The central section of this building appears to be the original Isolation Ward that dates to 1928. A series of later additions surround the original building. Single storey building. Original, central section, cement rendered and painted. Hipped roof is clad in corrugated steel with feature skylight windows. Later addition to the west constructed of unpainted brickwork with corrugated steel roofing aluminum framed sliding windows and timber paneling above.</i></p> <p><i>Later brickwork addition to east includes timber clad gabled profile with skillion roof. Southeast addition constructed of cement rendered brickwork with timber frame double hung windows.</i></p> <p>Social Work – Exterior:</p> <p><i>Single-storey timber weatherboard building with painted corrugated steel gable roof. Later additions in weatherboard, asbestos cement sheeting and brick. Aluminum framed sliding and double hung windows to north, south and west elevations and timber double hung windows to east elevation. Access via covered walkway on west elevation. Skillion roof supported on steel verandah posts. East elevation comprises brick ramp with steel handrail.</i></p> <p>Interior:</p> <p>Not accessed.</p>

The Watson Building comprises an original structure from the Inter-War period, however has been progressively added to over time such that its original form and envelope has largely been obscured.

From what was inspected, the building is functional in nature and is of no particular aesthetic merit. The accretions have detracted from significance and are considered intrusive. Its connection to the functioning of the hospital notwithstanding, the building does not, to our knowledge, have any particular associations with events, people, or community groups of historical or social importance.

As such, the Watson Building is considered by Urbis to be of **Little** relative heritage significance.

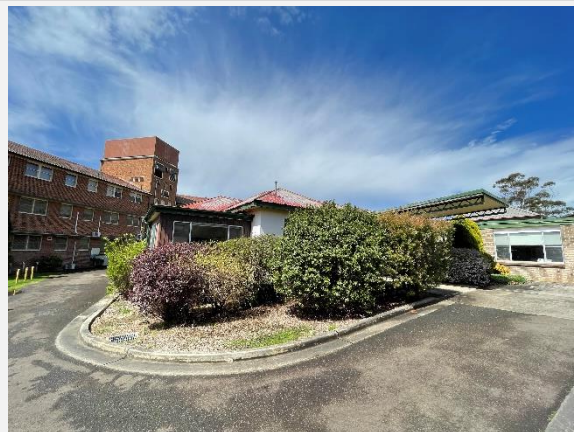
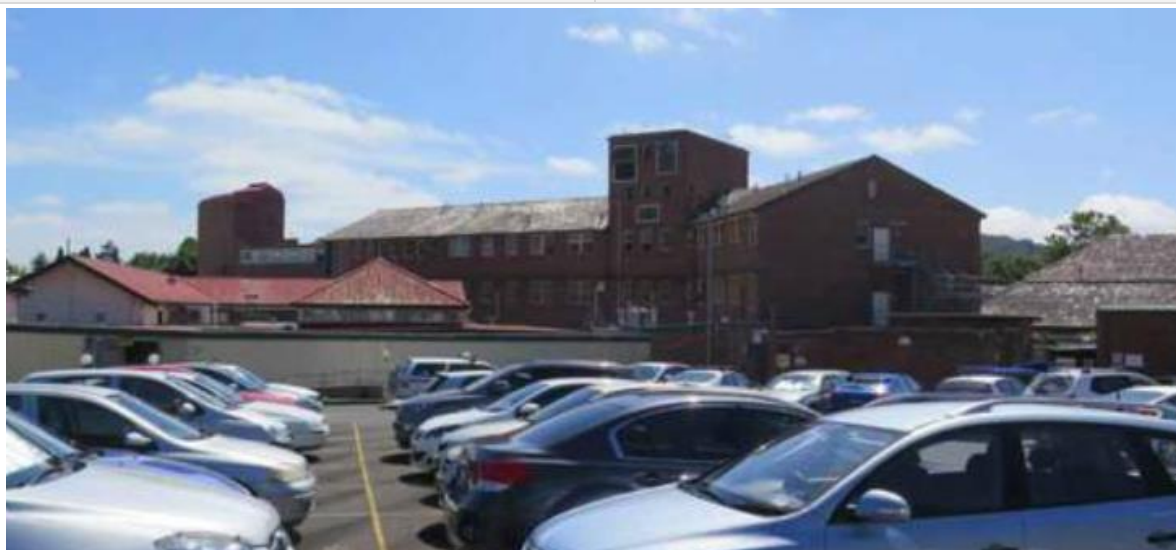
Milton Park Wing	
Date of construction	1960-61; 1994
Physical description	<p>Exterior:</p> <p>Three-storey face brick building with gabled roof comprising terracotta tiles Northwest and southeast elevations extend to a fourth level containing lift plant and ducting. Timber double hung windows, ground level windows covered with security screens. Concrete horizontal blade awnings over ground and first floor windows. Wide lined eaves over second storey windows. Concrete verandah located at ground floor level on northeast elevation with steel balustrade and handrail and fixed highlight glazing. Main entry contains steel framed glazed enclosed entry with electronic sliding doors. Above the entry the stair core is expressed at levels two and three with aluminum framed glazing. The staircore projects above the roof level and is a later addition. Northwest section of building is two storeys with roof addition and adjoining south elevation of Building 9.</p> <p>Interior:</p> <p>Not accessed.</p>

The Milton Park Wing is a post-War functionalist building which is notable primarily for its prominent stair / lift core structure which projects above the roofline (which itself is not original). The building is relatively pedestrian in its form and character, with the most notable part of its external form being the horizontal concrete fins which align with the internal floor levels. The existing window arrangement is intact, however all window assemblies are introduced aluminium.

Its connection to the functioning of the hospital notwithstanding, the Milton Park Wing does not, to our knowledge, have any particular associations with events, people, or community groups of historical or social importance.

Accordingly, the Milton Park Wing is considered by Urbis to be of **Little** relative heritage significance.

- The proposed part-demolition of the Milton Park wing is, at this stage, supportable from a heritage perspective as the building is of little relative heritage significance and the impacts of its demolition will not be more than minor or inconsequential.
- Any new additions to the Milton Park Wing should be designed with the following considerations:
 - New work should be noticeable as such
 - New work should be sympathetic to the existing form and character of the retained section of the building
 - New work should be used as an opportunity to remove other introduced accretions / parts of the building which do not contribute to (or detract from) its character as a post-War functionalist building
