**REPORT TO  
NSW HEALTH INFRASTRUCTURE**

**ON  
GEOTECHNICAL INVESTIGATION**

**FOR  
EARLY WORKS - INTEGRATED MENTAL HEALTH COMPLEX**

**AT  
WESTMEAD HOSPITAL, DRAGONFLY DRIVE,  
WESTMEAD, NSW**

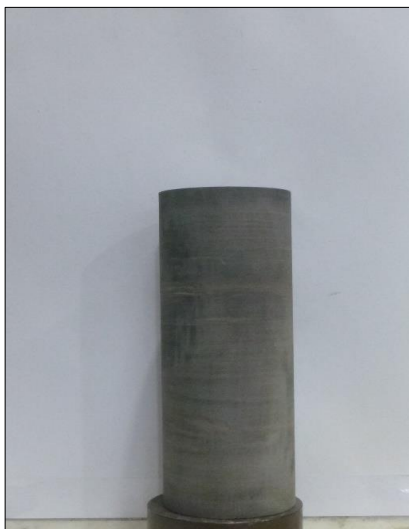
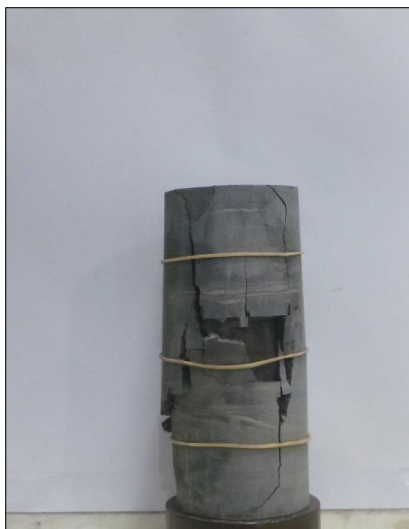
| Uniaxial Compressive Strength | | | |
|---|---|---|---|
| <b>Uniaxial Compressive Strength      28      MPa</b> | | | |

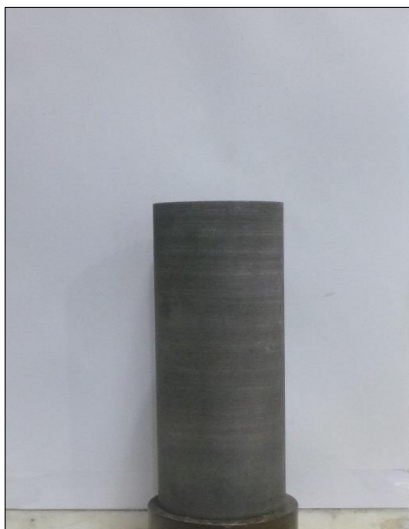
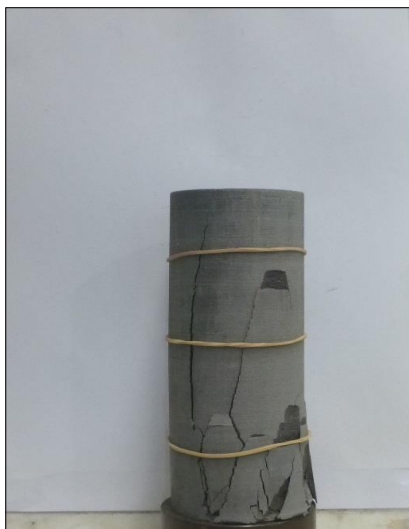
| Uniaxial Compressive Strength | | | |
|---|---|---|---|
| <b>Uniaxial Compressive Strength      41      MPa</b> | | | |

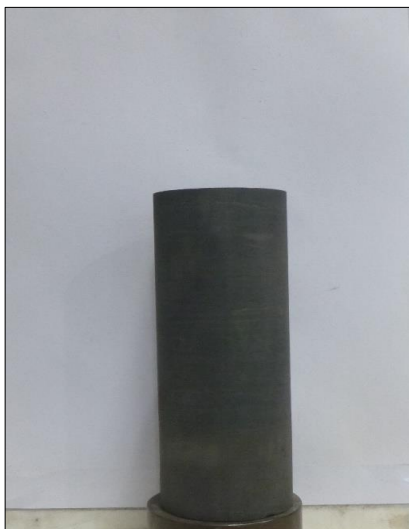
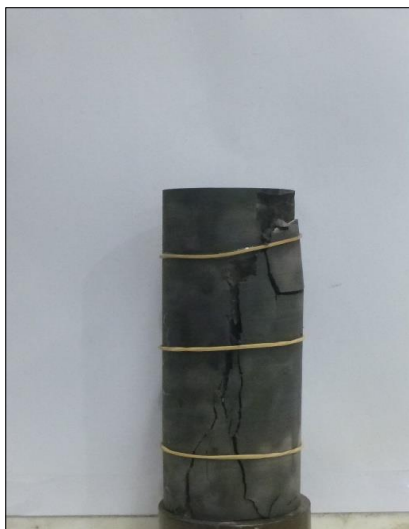
| Uniaxial Compressive Strength | | | |
|---|---|---|---|
| <b>Uniaxial Compressive Strength      16      MPa</b> | | | |

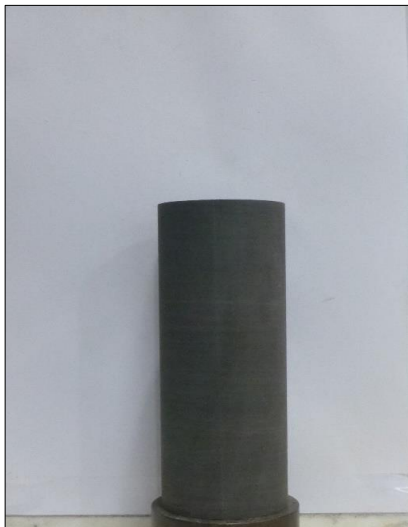
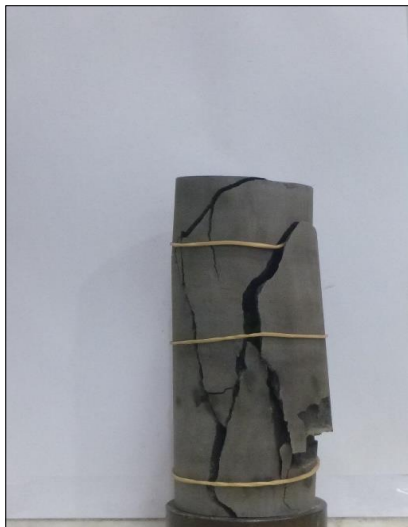
| Uniaxial Compressive Strength | | | |
|---|---|---|---|
| <b>Uniaxial Compressive Strength      29      MPa</b> | | | |

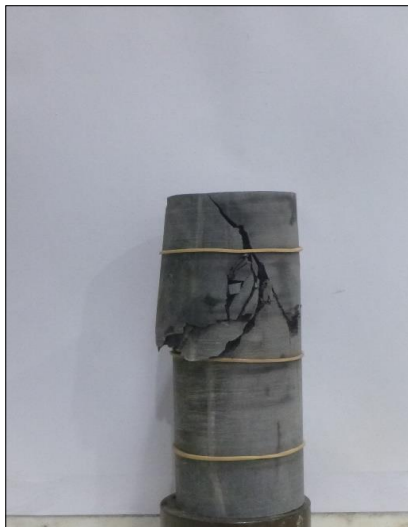
| Uniaxial Compressive Strength | | | |
|---|---|---|---|
| <b>Uniaxial Compressive Strength      19      MPa</b> | | | |

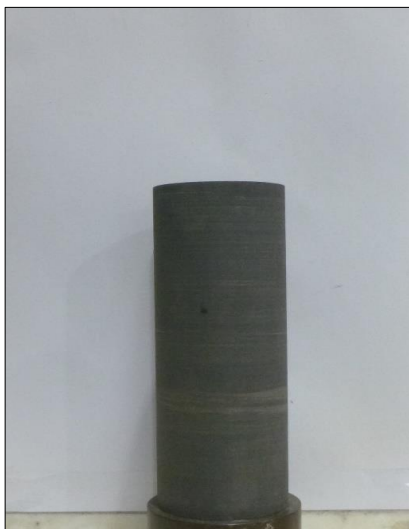
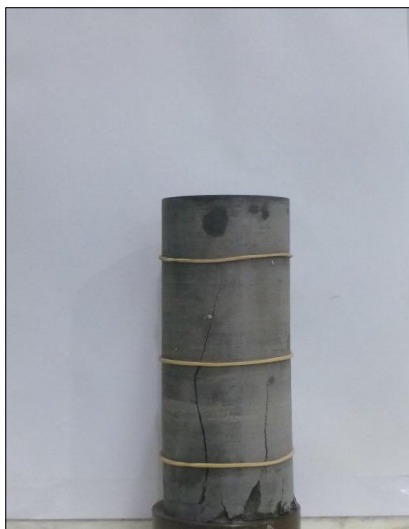
| Uniaxial Compressive Strength | | | |
|---|---|---|---|
| <b>Uniaxial Compressive Strength      31      MPa</b> | | | |

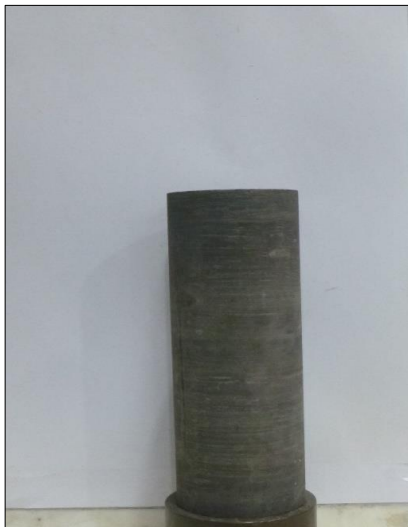
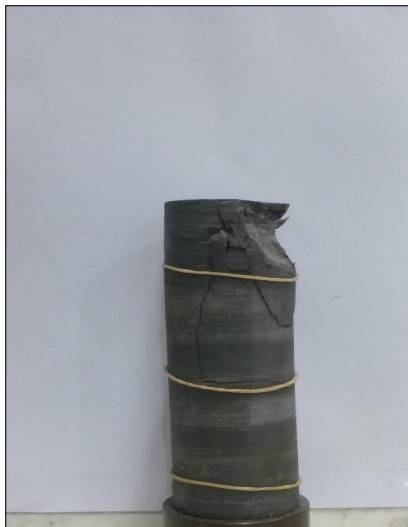
| Uniaxial Compressive Strength | | | |
|---|---|---|---|
| <b>Uniaxial Compressive Strength      13      MPa</b> | | | |

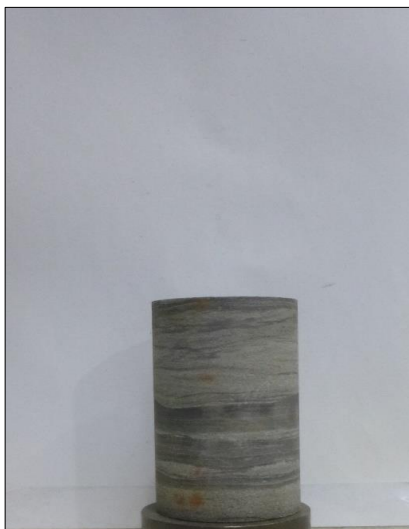
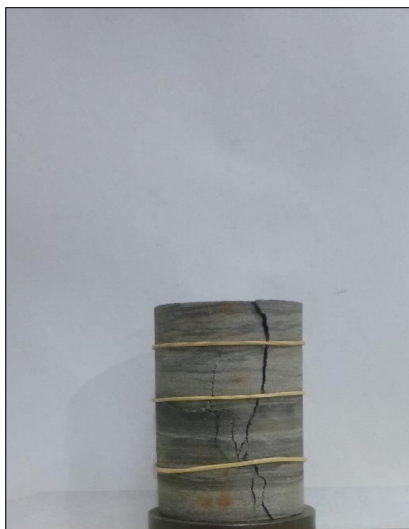
| Uniaxial Compressive Strength | | | |
|---|---|---|---|
| <b>Uniaxial Compressive Strength      20      MPa</b> | | | |

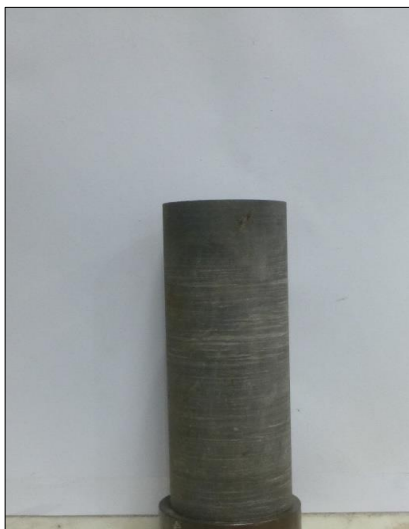
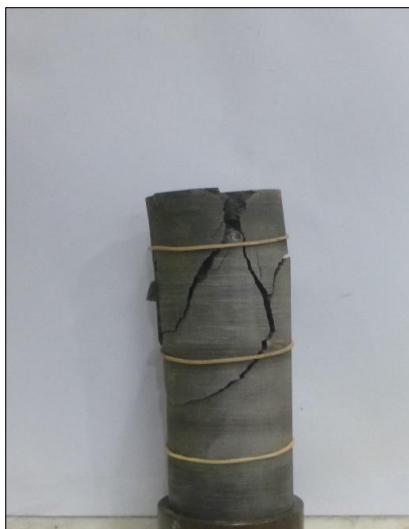
| Uniaxial Compressive Strength | | | |
|---|---|---|---|
| <b>Uniaxial Compressive Strength      24      MPa</b> | | | |

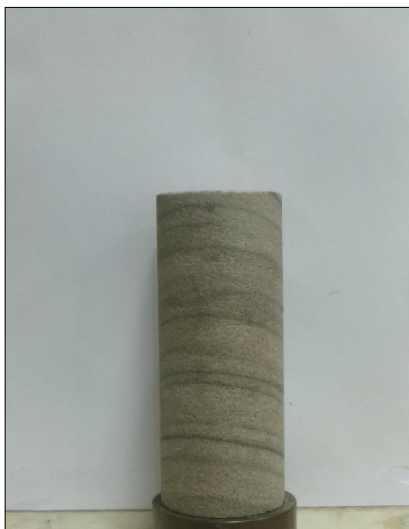
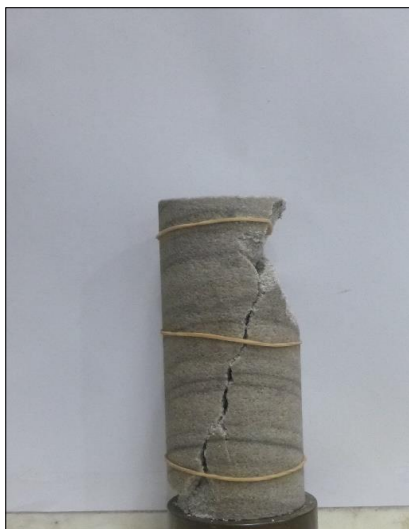
| Uniaxial Compressive Strength | | | |
|---|---|---|---|
| <b>Uniaxial Compressive Strength      27      MPa</b> | | | |

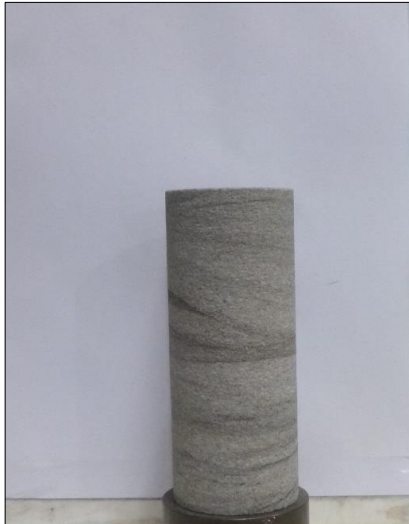
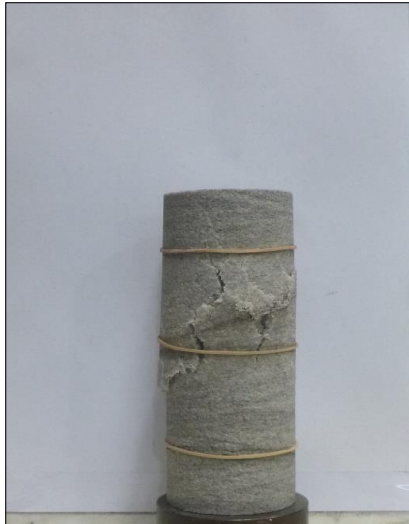
| Uniaxial Compressive Strength | | | |
|---|---|---|---|
| <b>Uniaxial Compressive Strength      25      MPa</b> | | | |

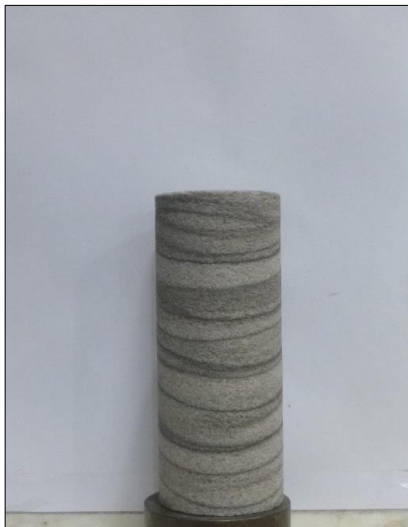
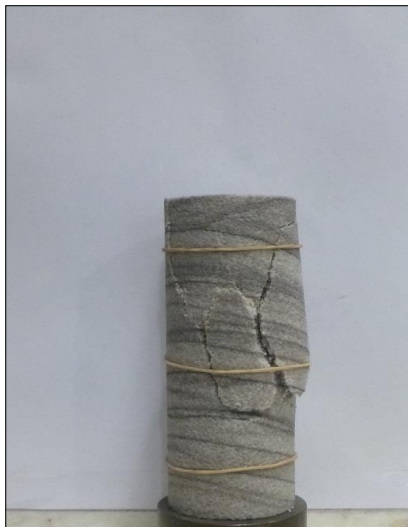
| Uniaxial Compressive Strength | | | |
|---|---|---|---|
| <b>Uniaxial Compressive Strength      30      MPa</b> | | | |

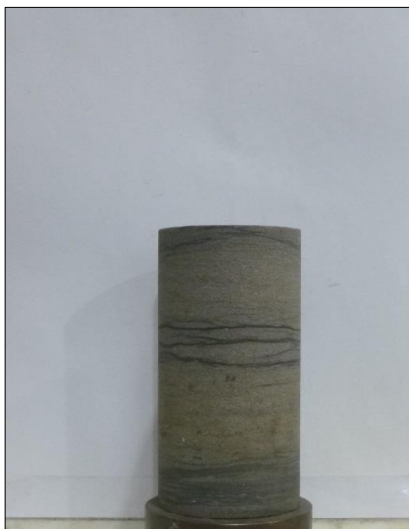
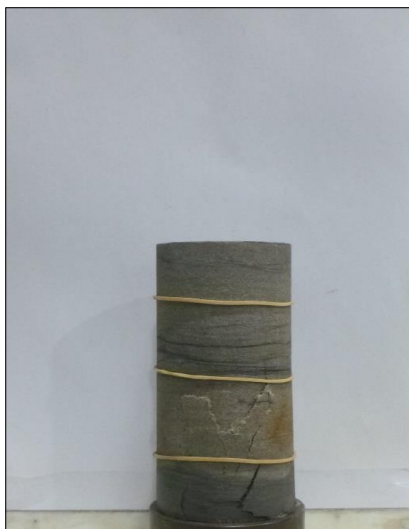
| Uniaxial Compressive Strength | | | |
|---|---|---|---|
| <b>Uniaxial Compressive Strength      31      MPa</b> | | | |

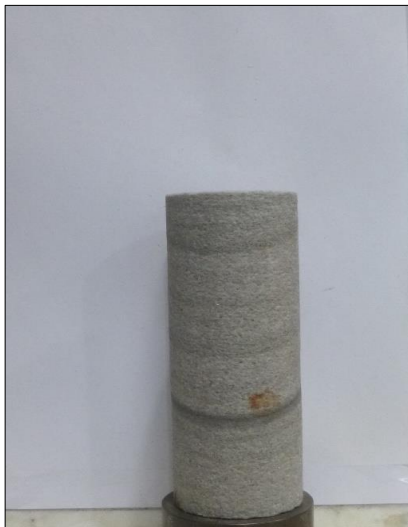
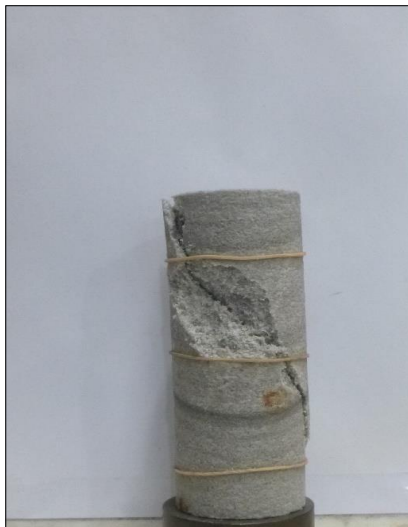
| Uniaxial Compressive Strength | | | |
|---|---|---|---|
| <b>Uniaxial Compressive Strength      18      MPa</b> | | | |

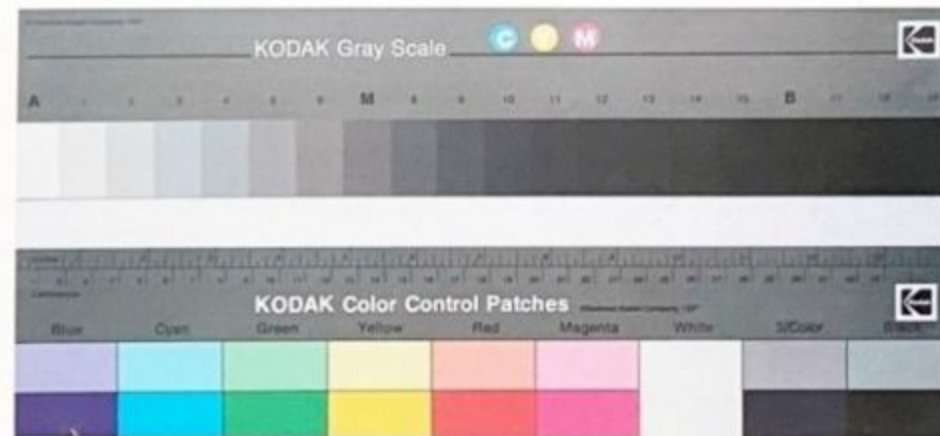
34294LF BH6 START CORING AT 9.54m

Depth: 9.54m to 15.56m

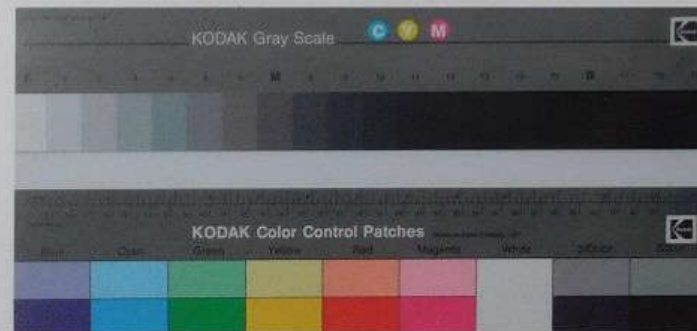
33303BT WESTMEAD BH2 START CORING AT 8.47m

Job No: 33303BT  
Borehole No: BH2  
Depth: 8.47m - 11.00m
