GEOTECHNICAL INVESTIGATION

NSW LAND AND HOUSING CORPORATION

36 & 38 Birdwood Avenue, Pagewood, New South Wales (BGYGN)

Report No: 22/2043

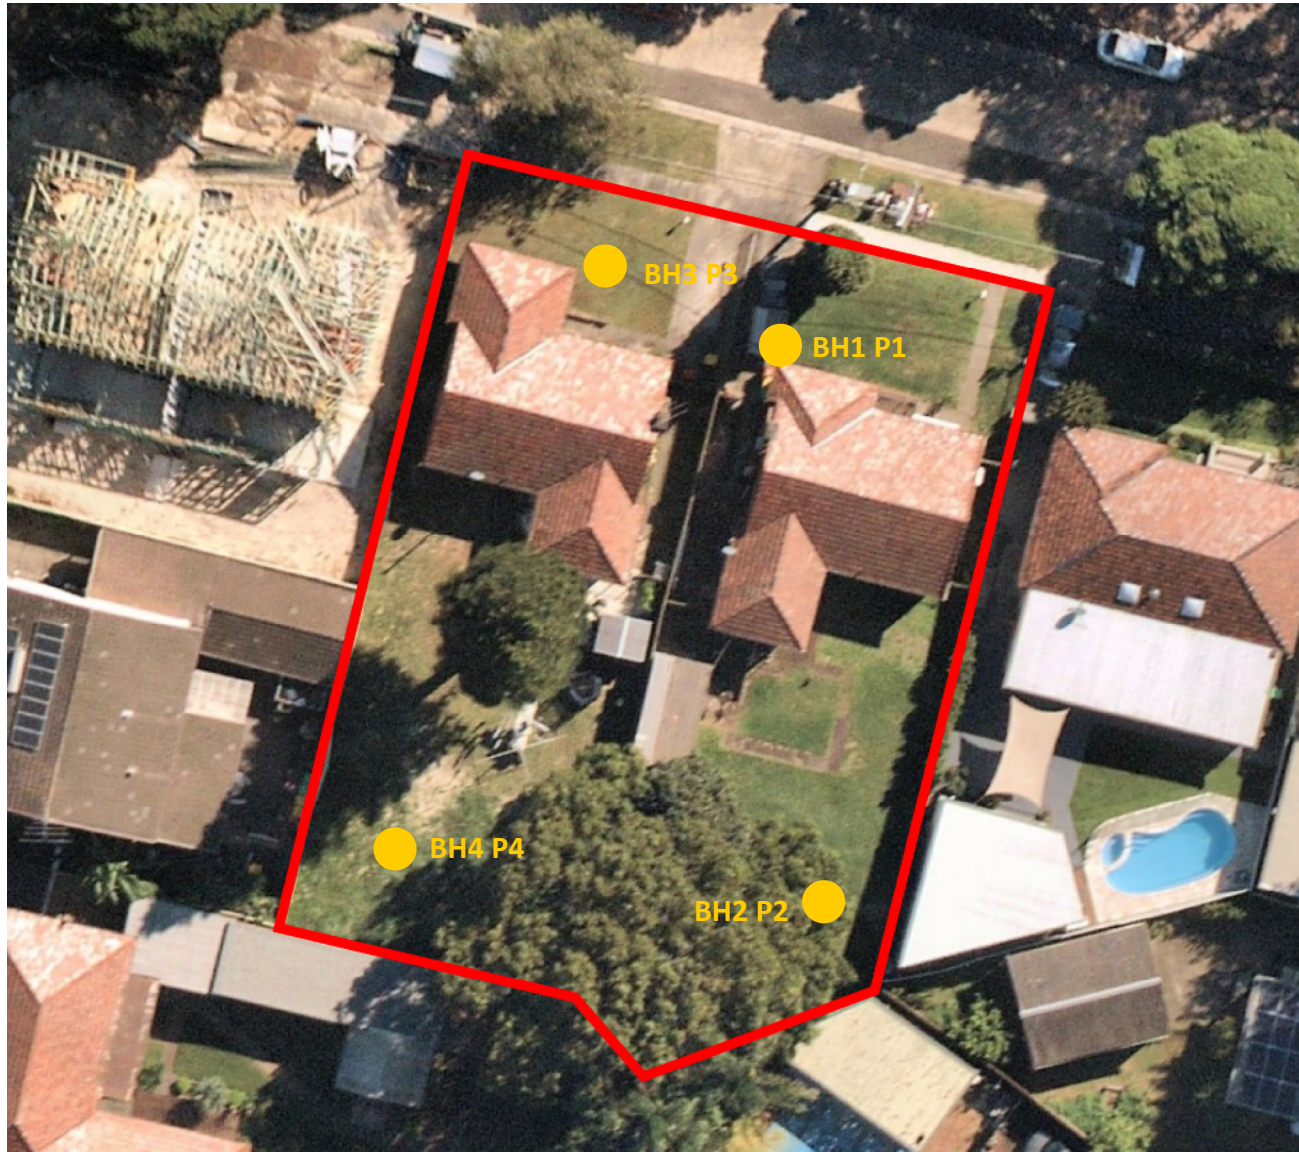
Drawing No: 22/2043

**GEOTECHNICAL INVESTIGATION
36-38 BIRDWOOD AVENUE, PAGEWOOD
BOREHOLE AND PENETROMETER LOCATIONS**

The fieldwork consisted of four (4) boreholes numbered BH1 to BH4 (inclusive), at the locations shown on attached Drawing No. 22/2043. ***Due to access limitations, BH2 and BH4 were drilled using hand auger equipment.*** The remaining boreholes were drilled using our track mounted mini Christie rig, owned and operated by STS. Soils strengths were assessed by carrying out a Perth Sand Penetrometer (PSP) test adjacent to each borehole location.
