**REPORT TO
NSW HEALTH INFRASTRUCTURE**

**ON
MINE SUBSIDENCE ASSESSMENT**

**FOR
MUSWELLBROOK HOSPITAL REDEVELOPMENT
STAGE 3**

**AT
BRENTWOOD STREET, MUSWELLBROOK, NSW**

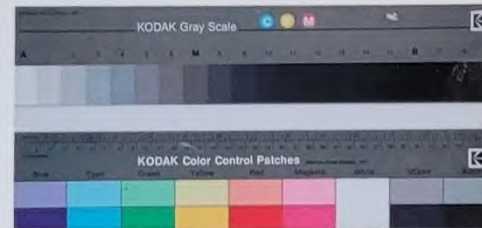
Job No: 34804LF
Borehole No: 1
Depth: 3.10-13.47m

34804LF BH1 START CORING AT 3.10m

3	→ NO CORE: 0.29m	
4		
5		NO CORE 0.06m
6		
7		NO CORE: 0.08m
8		
9	NO CORE: 0.08m	
10		
11		
12		NO CORE 0.06m
13		EOH AT 13.47m

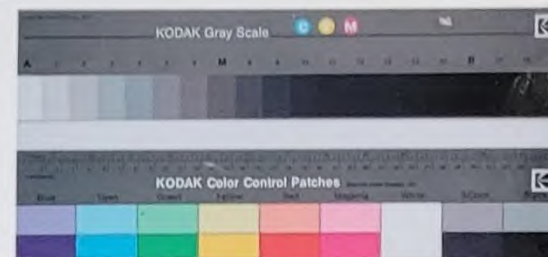
Job No: 34804LF
Borehole No: 6
Depth: 5.93-14.14m

34804LF BH 6 START CORING AT 5.93m →

6 NO CORE: 0.48m
